## HARRISON SUB-RESIDENCY FIELD INSPECTION

**Name of Inspector(s):** Christopher Kappeller

**Date:** 11/8/11

### Semi-Annual

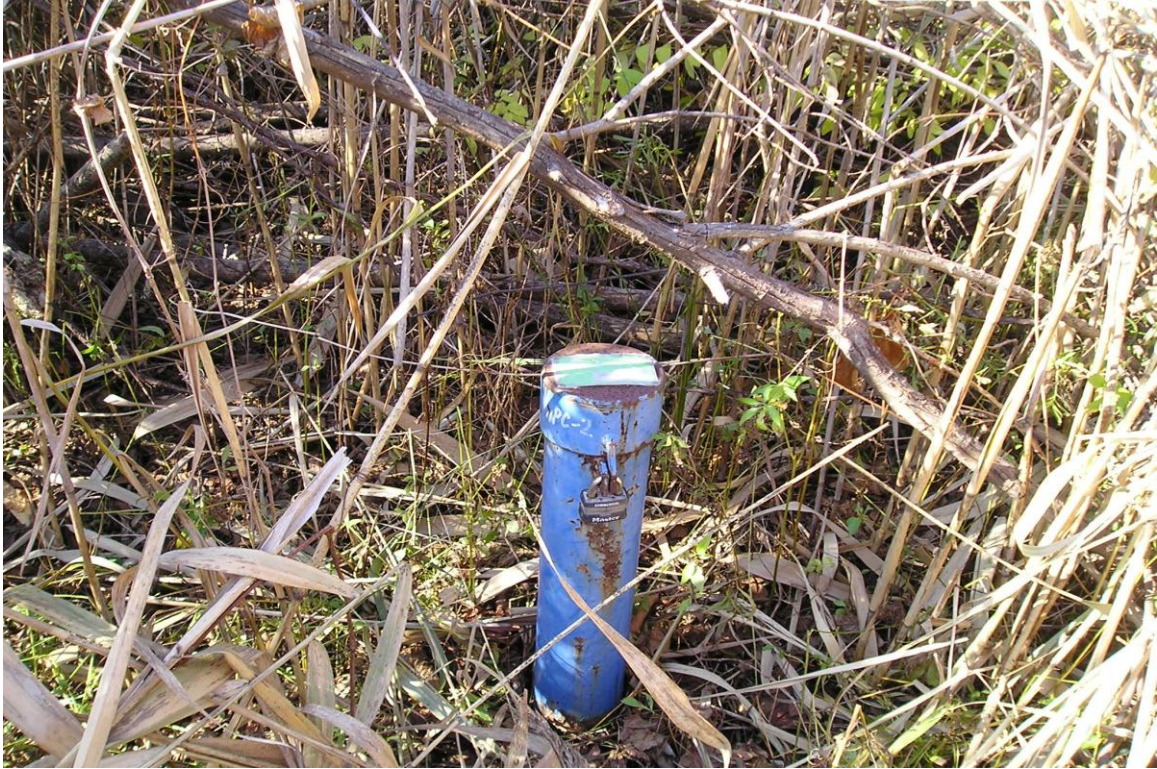
Photo 8: Well PC-1 appears in good condition (couldn't get close to well due to debris and high water).
