HARRISON SUB-RESIDENCY FIELD INSPECTION

Date: 4/18/12

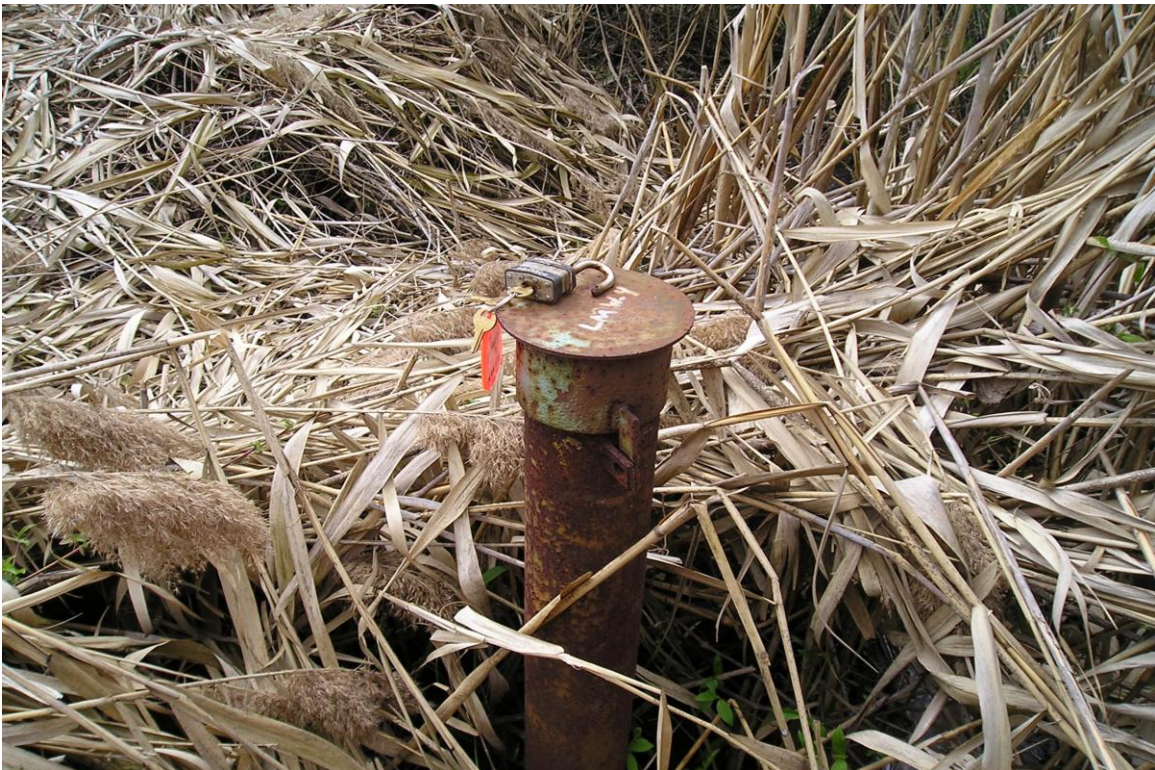
Photo 5: Well LMW-2

The lock on LMW-2 was rusted shut and could not be opened.

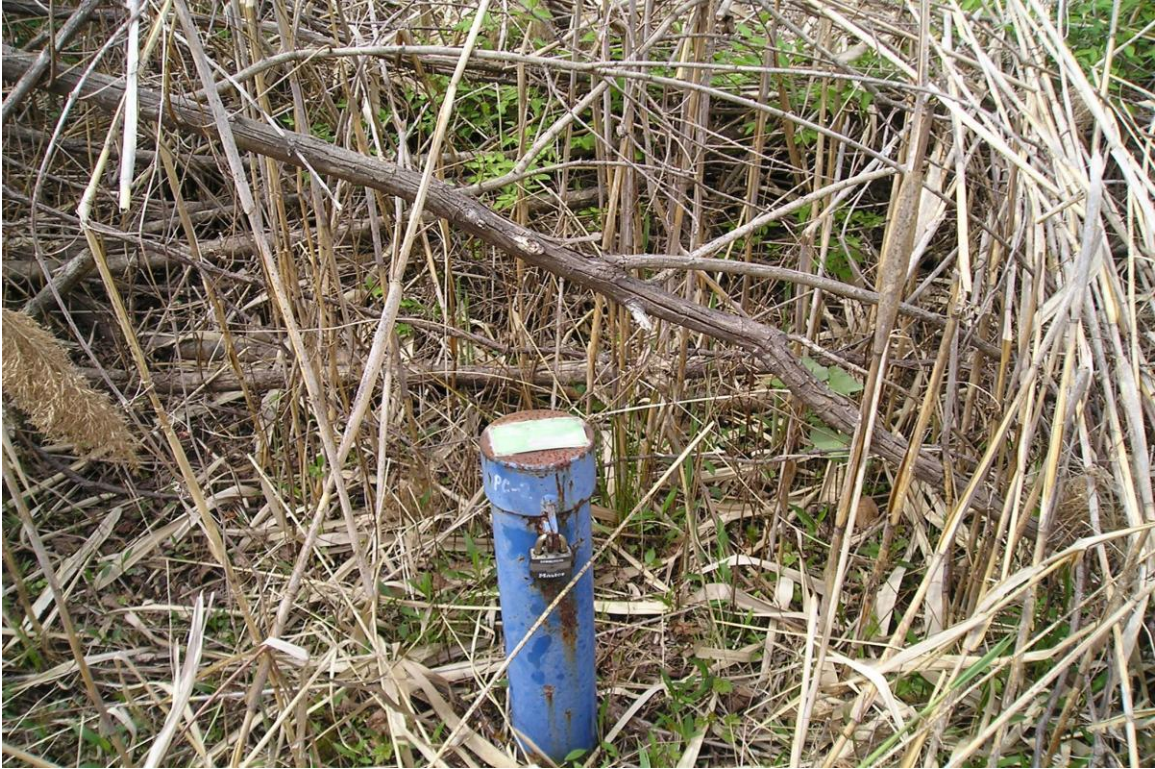
The wells are in satisfactory condition. The steel well casings are secured with locks, with one exception: the key in the lock on PC-1 is broken off inside and the tab on the casing cap that the lock went through has been cut through. NYSDOT's hazardous waste consultant did this to remove the rust-frozen lock so they could obtain a water sample during the last periodic 15-month sampling cycle in April 2011.

Photo 8: Well PC-1
