HARRISON SUB-RESIDENCY SEMI-ANNUAL FIELD INSPECTION

Name of Inspector(s): Christopher Kappeller

Date: 10/29/19

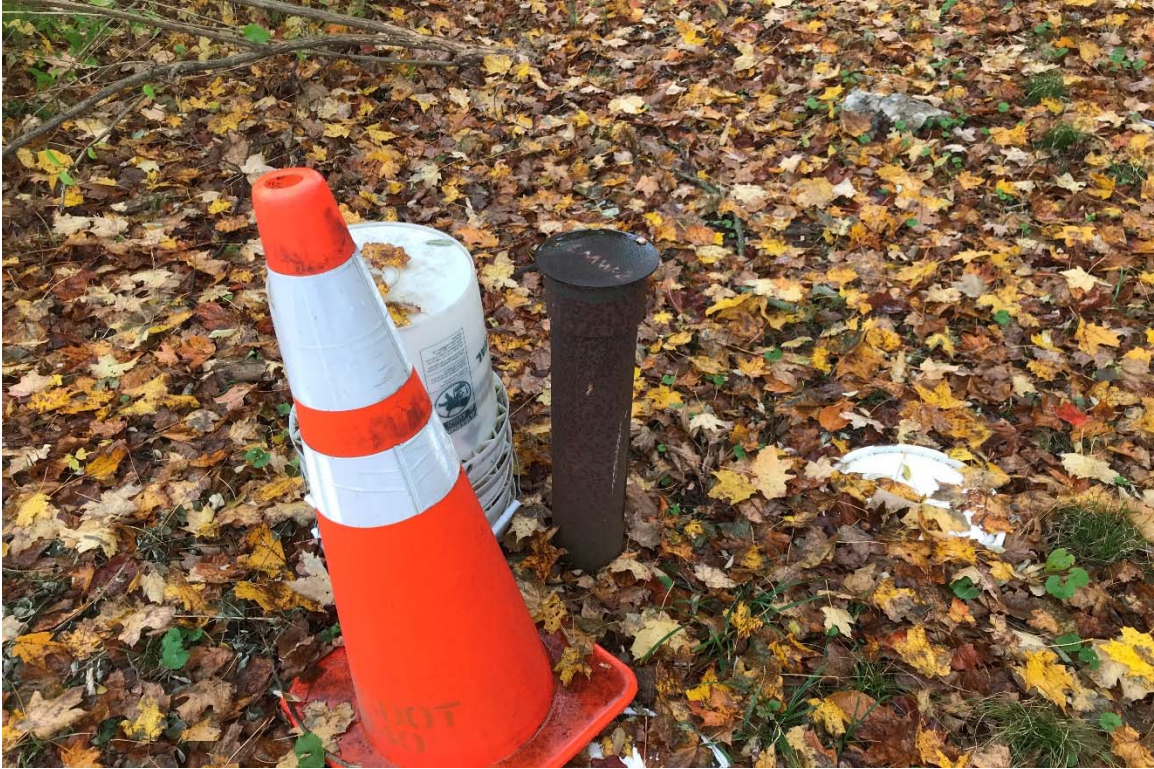
Photo 4: Vent V-4

Four vents (V-1 to V-4) were inspected (Photos 1-4). V-1 and V-2 had their plastic casing holes repaired with fiberglass epoxy in August 2015. A hole presumed to be from a boring insect or woodpecker was made through the previous fiberglass repair in V-2. The hole will be repaired in Spring 2020. V-3 and V-4 were in good condition (neither cracks nor movement was observed). V-2 leans slightly to the north.

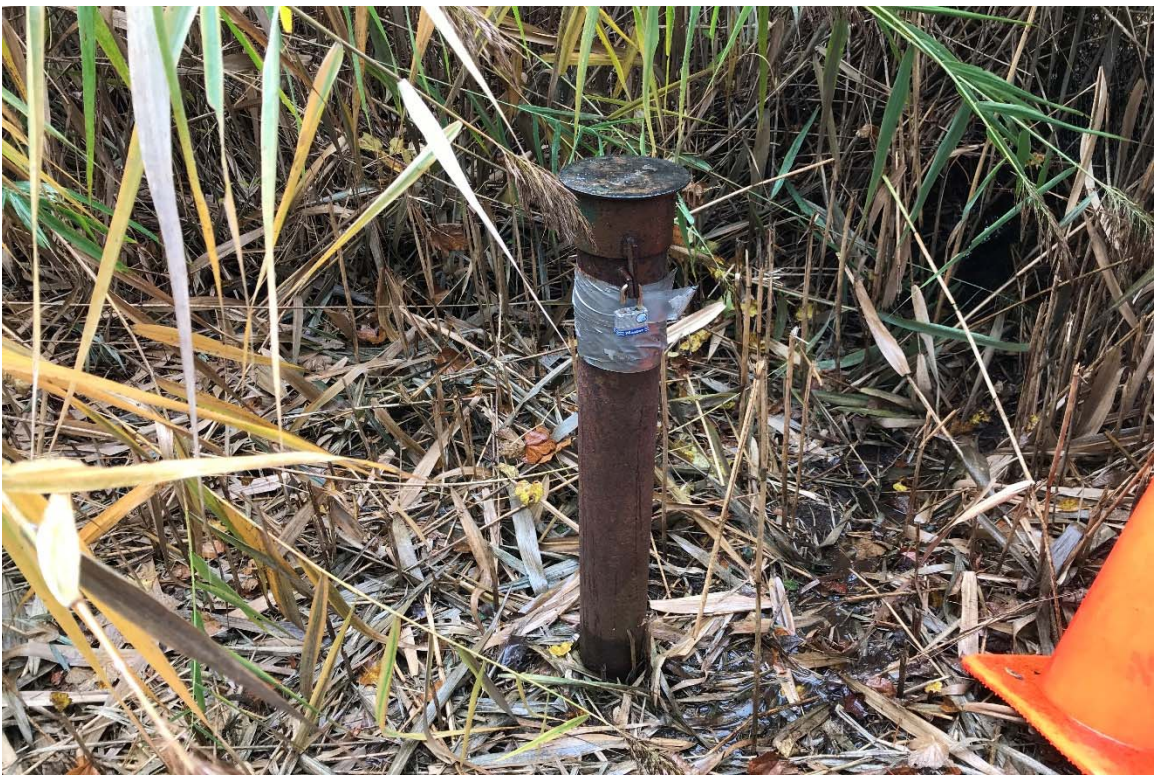
Photo 5: Well LMW-2

All wells were inspected and found to be in good condition. Paths to these wells were weed-wacked prior to inspection.
