## **HARRISON SUB-RESIDENCY SEMI-ANNUAL FIELD INSPECTION**

**Name of Inspector(s):** Christopher Kappeller

**Date:** 4/29/20

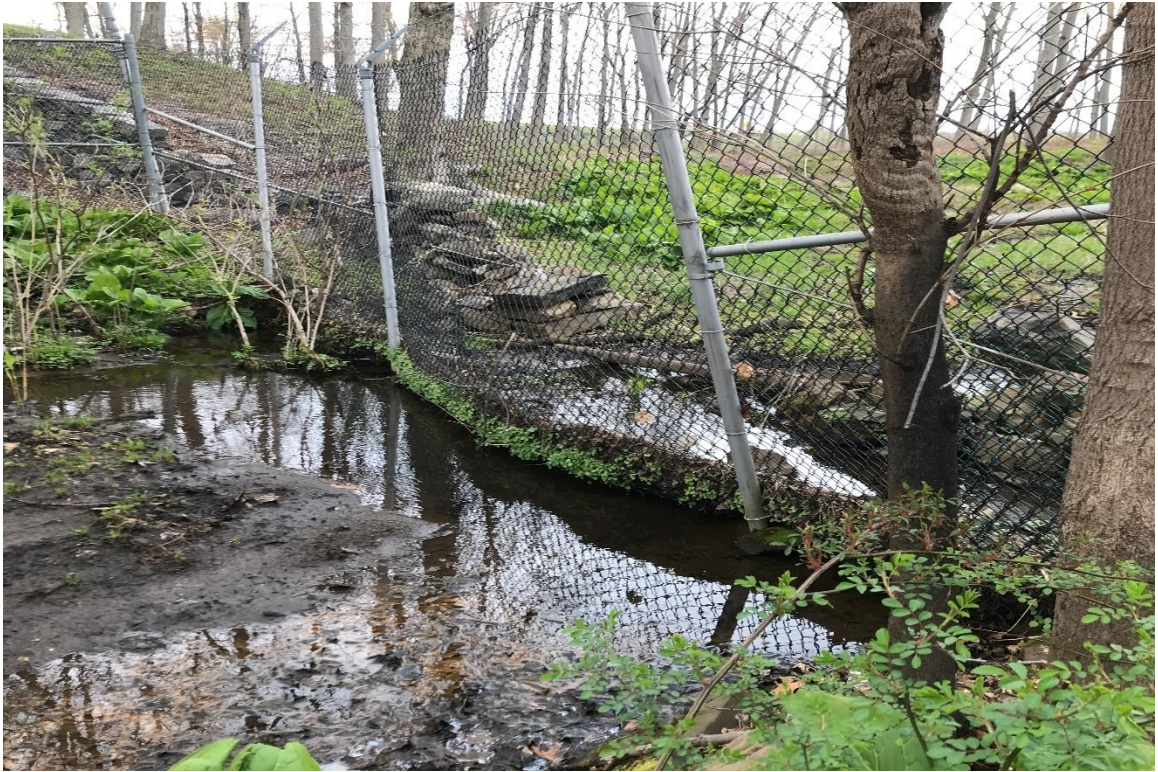
Grass height was satisfactory at the time of inspection (Photo 10). Grass should be cut in June and September.

Photo 10: Grass on landfill cap
