HARRISON SUB-RESIDENCY SEMI-ANNUAL FIELD INSPECTION

Date: 4/28/23

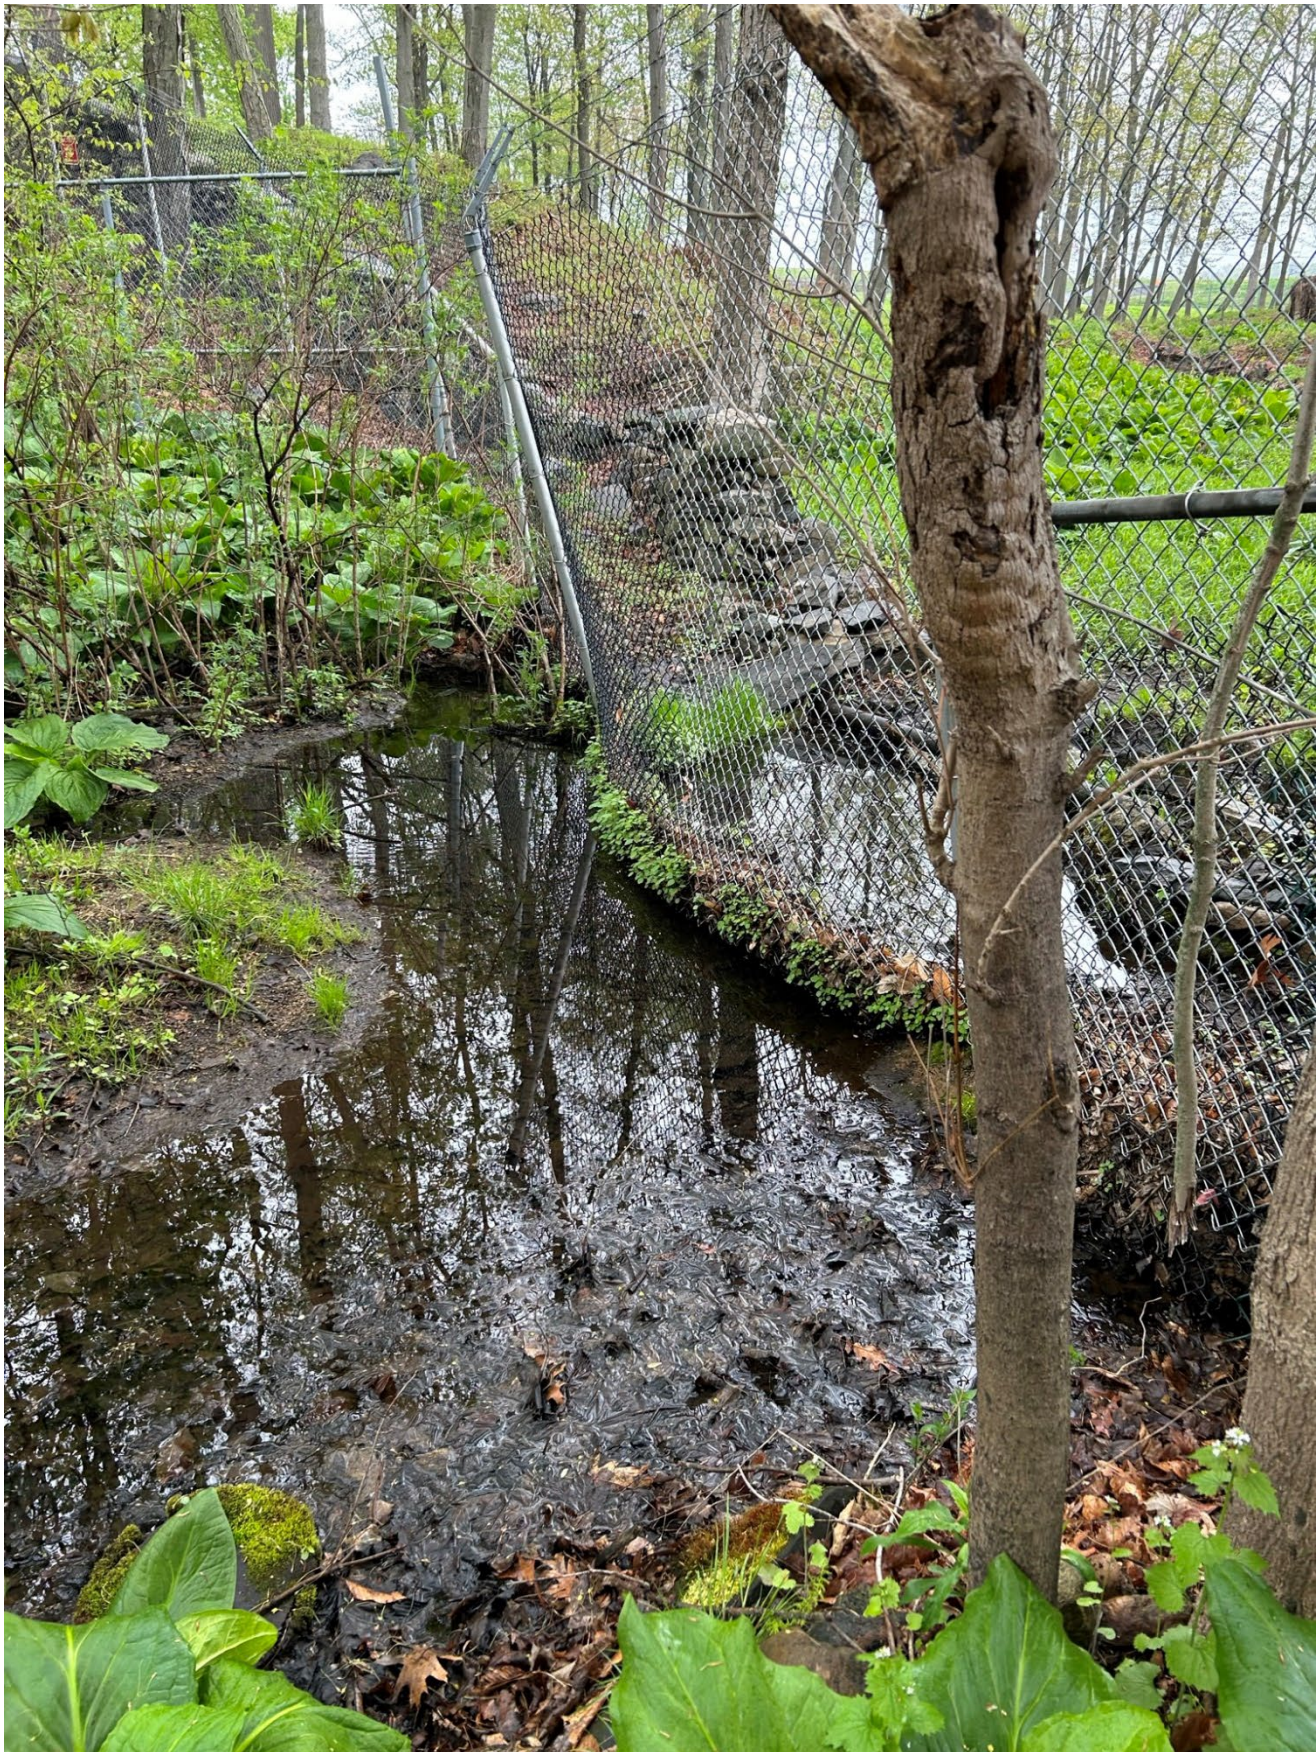
Grass height was satisfactory at the time of inspection (Photo 9). Grass should be cut in June and September. No damage observed on landfill cap.

Photo 9: Grass on landfill cap cut to correct height (looking northeast).
