May 22, 2025

Subject:       **2025 Annual Inspection Report**  
                  **AL Tech Specialty Steel (Site No. 401003)**  
                  **Earth Environment Engineering and Geology P.C., Project No. 3616206100**

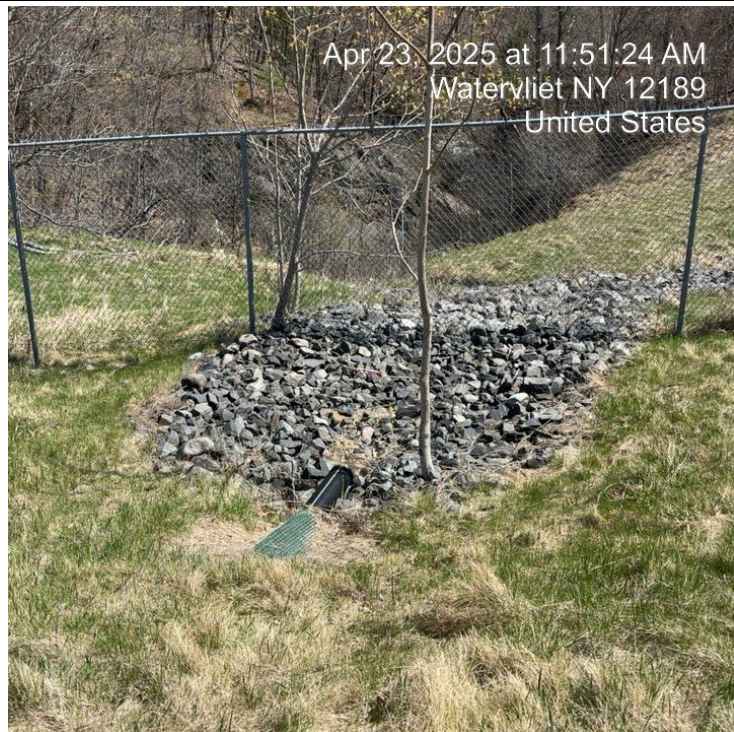
Exposed mesh and woody growth around north drainage basin discharge pipe.

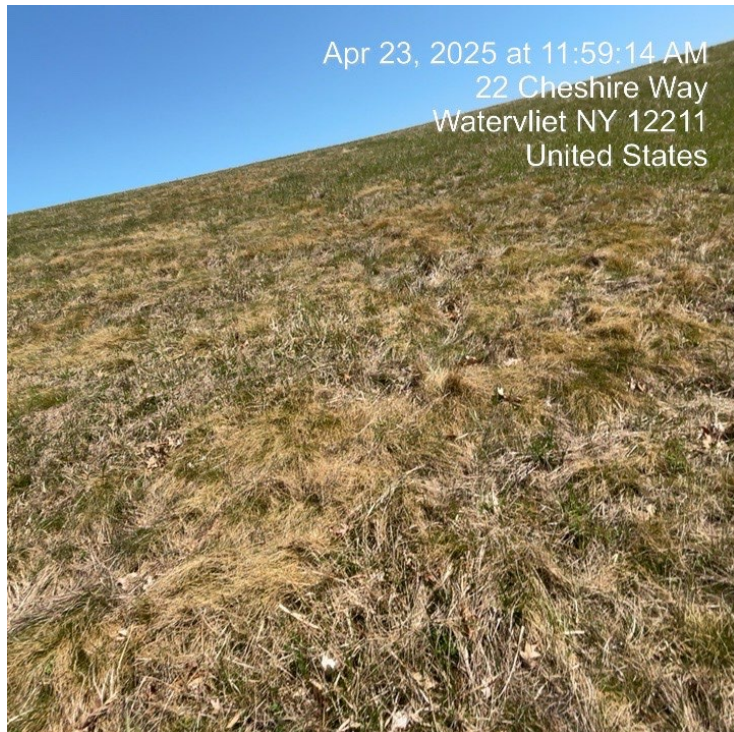
Minor soil erosion from storm water runoff on southwest side of the landfill.

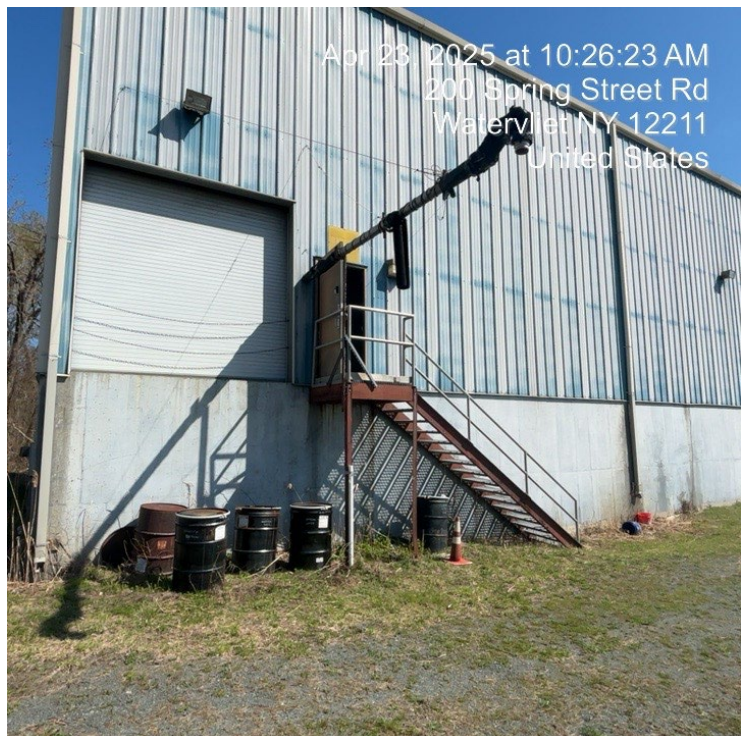
- Debris pile noted on western side of building (**Attachment 2; Photograph 3**).
- Insulation falling off discharge line along main entry area of Leachate building (**Attachment 2; Photograph 2**).

Main entry area of Leachate Building with Bearoff drums and insulation falling off discharge line.

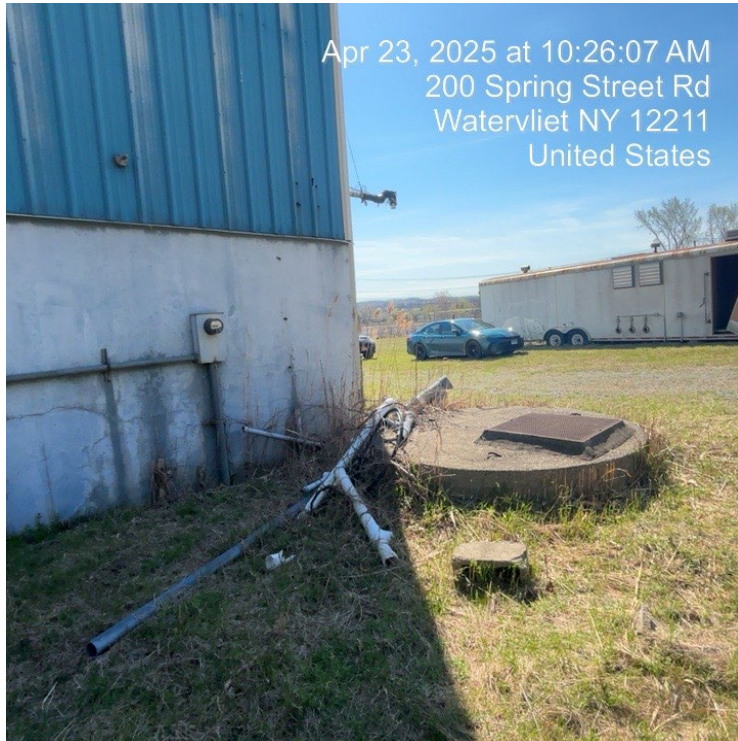
Southwest corner of leachate collection building manhole for old leachate line and other debris.

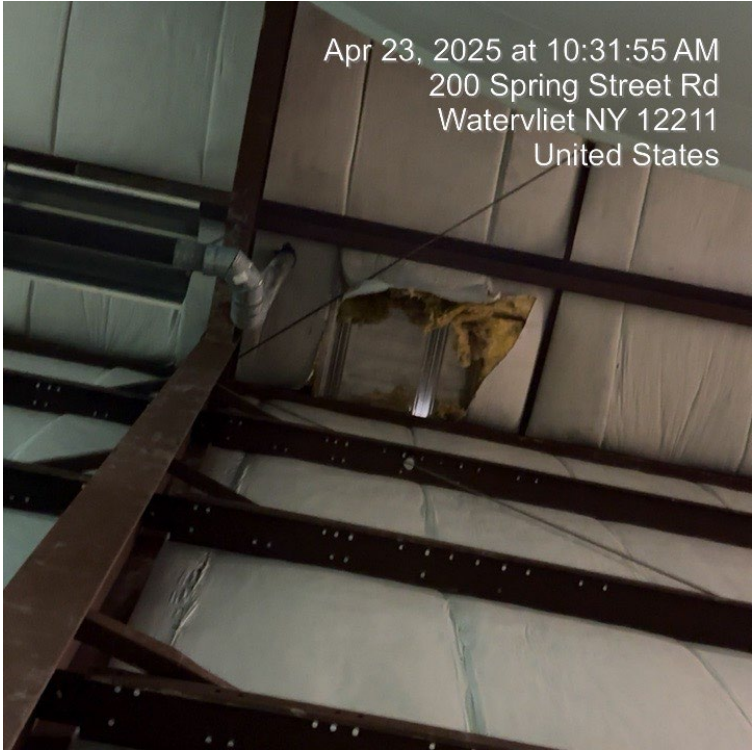
<p style="text-align: right; color: white; font-size: 0.9em;">                         Apr 23, 2025 at 10:31:55 AM                          200 Spring Street Rd                          Watervliet NY 12211                          United States                     </p>		
<b><i>Date:</i></b>  April 23, 2025			
<b><i>Photograph:</i></b> 5			
<b><i>Direction:</i></b>  Northwest			
<b><i>Description:</i></b> Insulation damage at building's top north wall. North of east tank. Daylight visible through damaged area.			
<b><i>Photographer:</i></b>  John Walsh

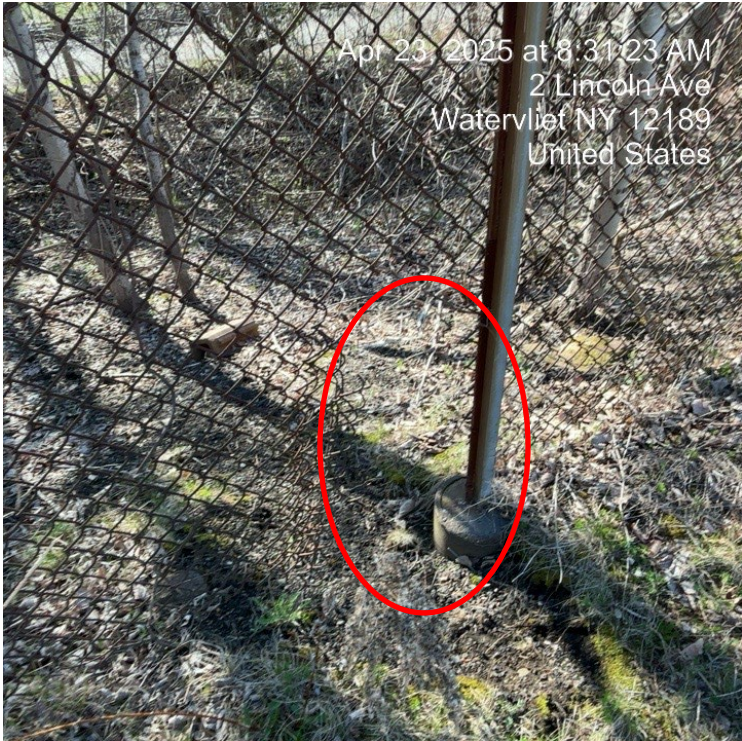
- The perimeter fence around the eastern and northern portions of the MPA is largely intact; however, several cut openings were observed south of Lincoln Ave along the railroad tracks and along Spring Street Road (**Attachment 3; Photographs 3, 4, 7, 11, 12, 13, 17, 20 and 36**). These openings allow access to Site trespassers and should be secured in anticipation of future activities for OU-1 and OU-4.
- The access gate and fencing near the guard shack on Spring Street Ave was observed to be in poor shape, with gaps and dumped material in the area (**Attachment 3; Photographs 30, 31 and 32**). The access gate for the northern portion of the site was observed to be missing a lock (**Attachment**

<b>Date:</b> April 23, 2025			
<b>Photograph:</b> 3			
<b>Direction:</b> Southwest			
<b>Description:</b> Hole in the Southeast side fence near Lincoln Ave.			
<b>Photographer:</b> John Walsh

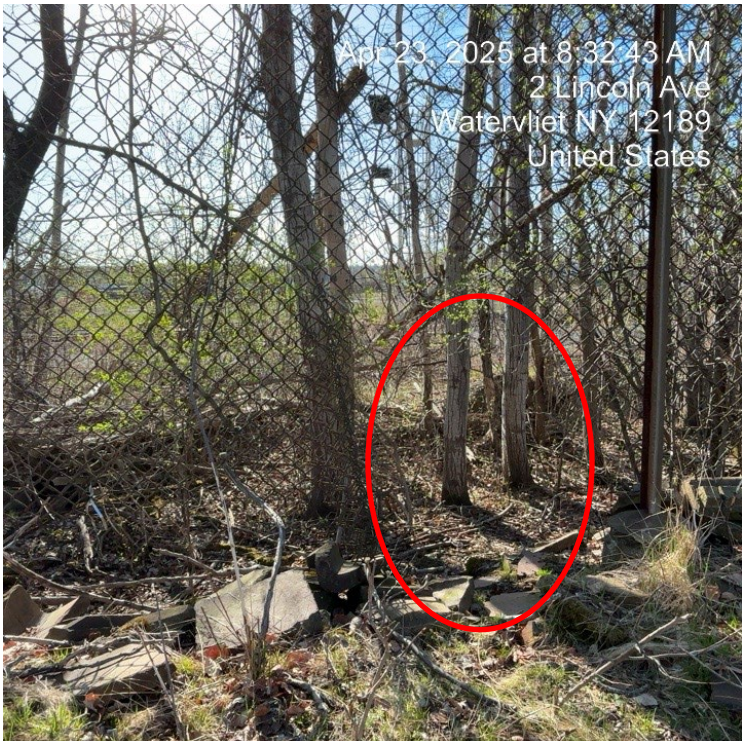
<b>Date:</b> April 23, 2022			
<b>Photograph:</b> 4			
<b>Direction:</b> South			
<b>Description:</b> Hole in the Southeast side fence near Lincoln Ave.

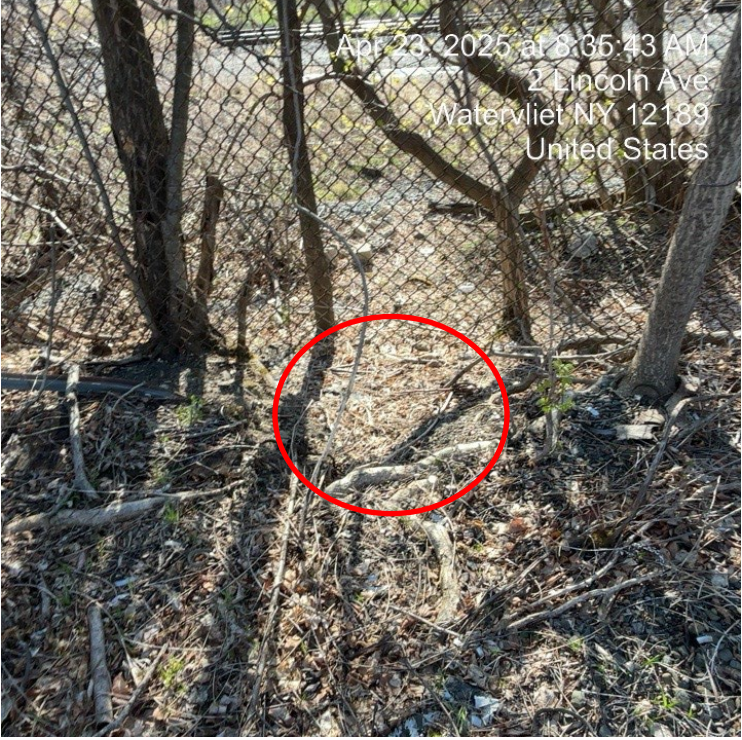
<b>Date:</b> April 23, 2025			
<b>Photograph:</b> 6			
<b>Direction:</b> South			
<b>Description:</b>  Large gap at the bottom of the Southeast side fence near Lincoln Ave.

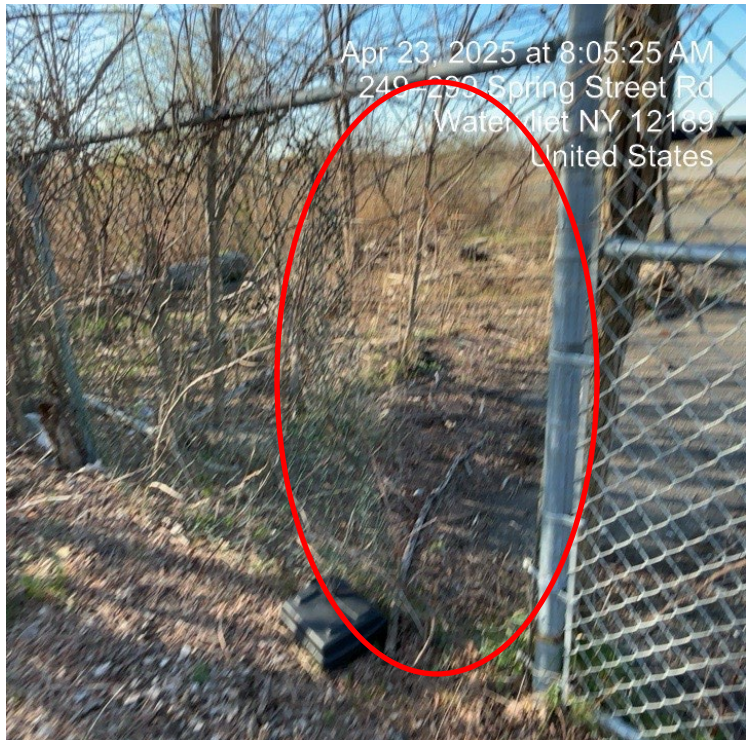
Large opening in fence  
along Spring Street Rd.
