**Interim Remedial Measure No. 1
Scope of Work - Building Demolition
Former Admiral Cleaners Site (No. 401075)**

**City of Watervliet
Albany County, New York**

April 2019
Version: FINAL
EA Project No. 14907.38

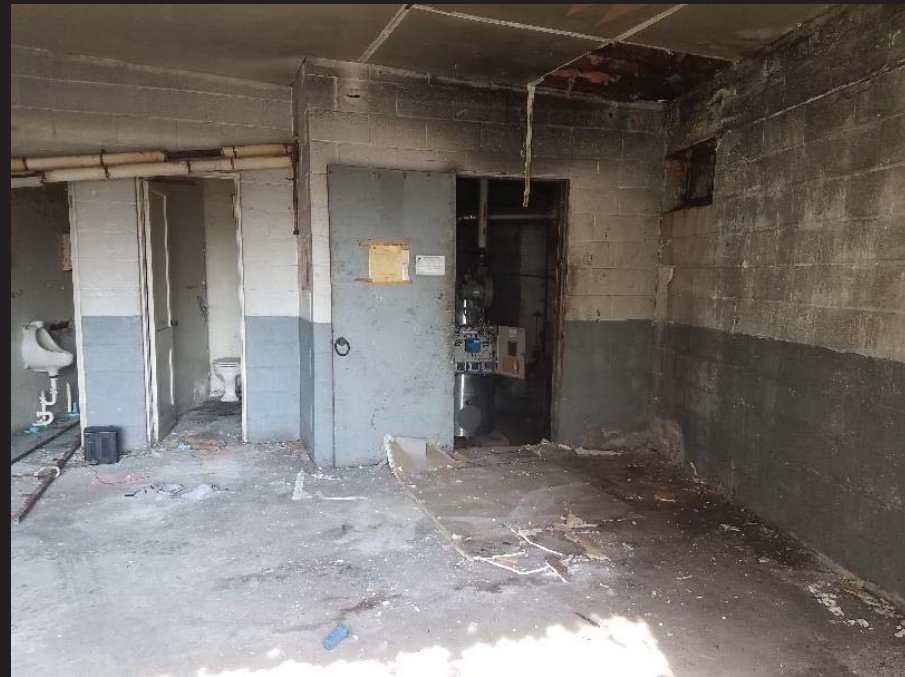
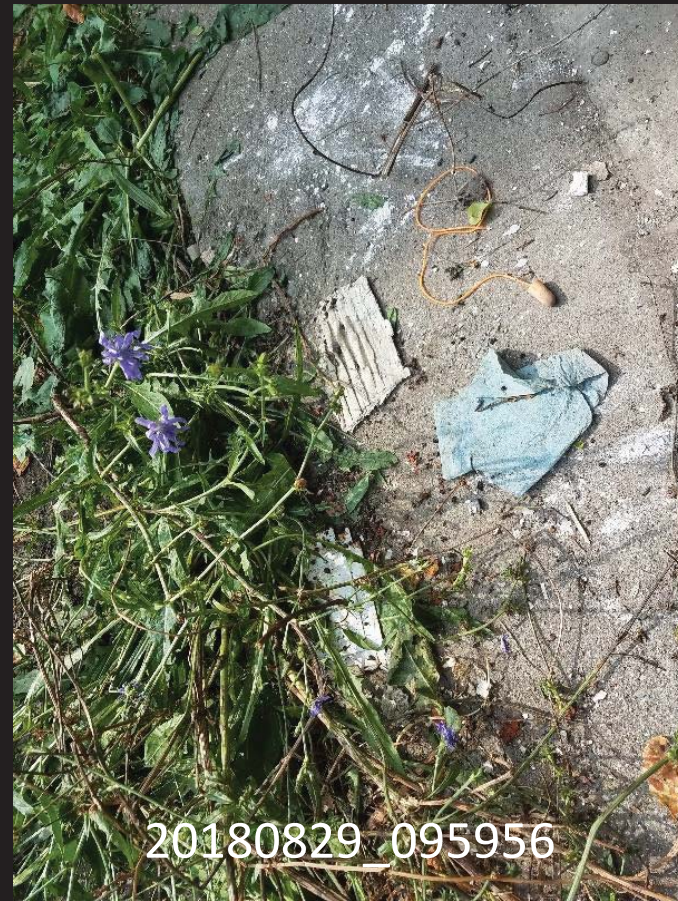
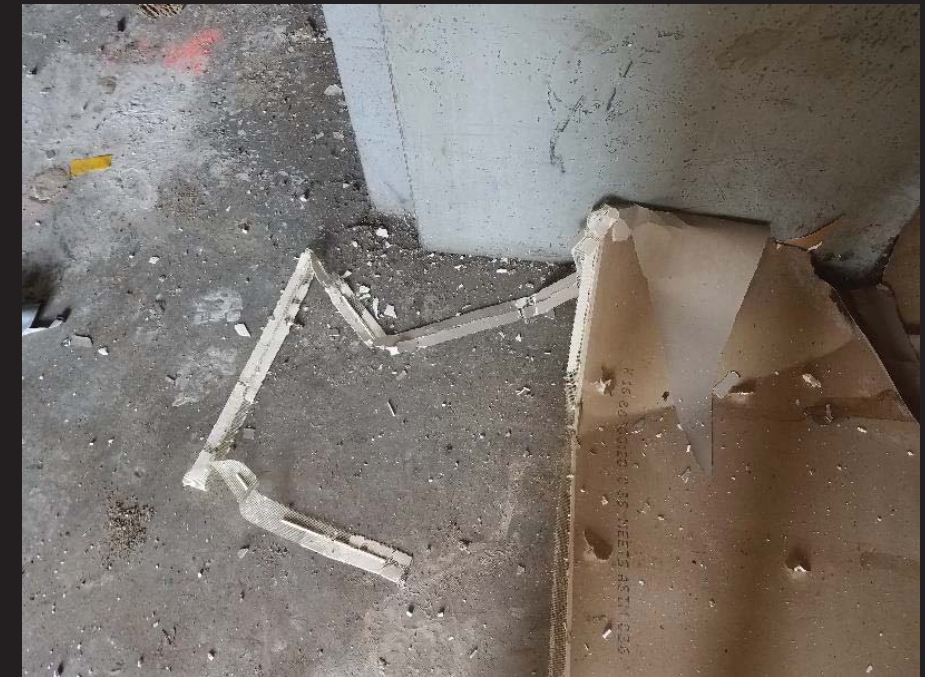
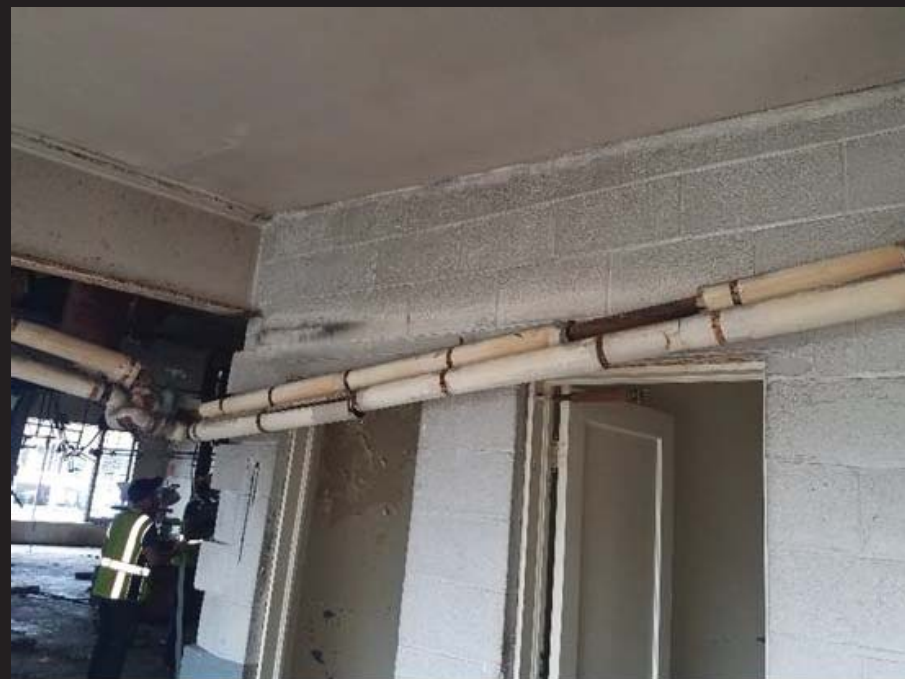
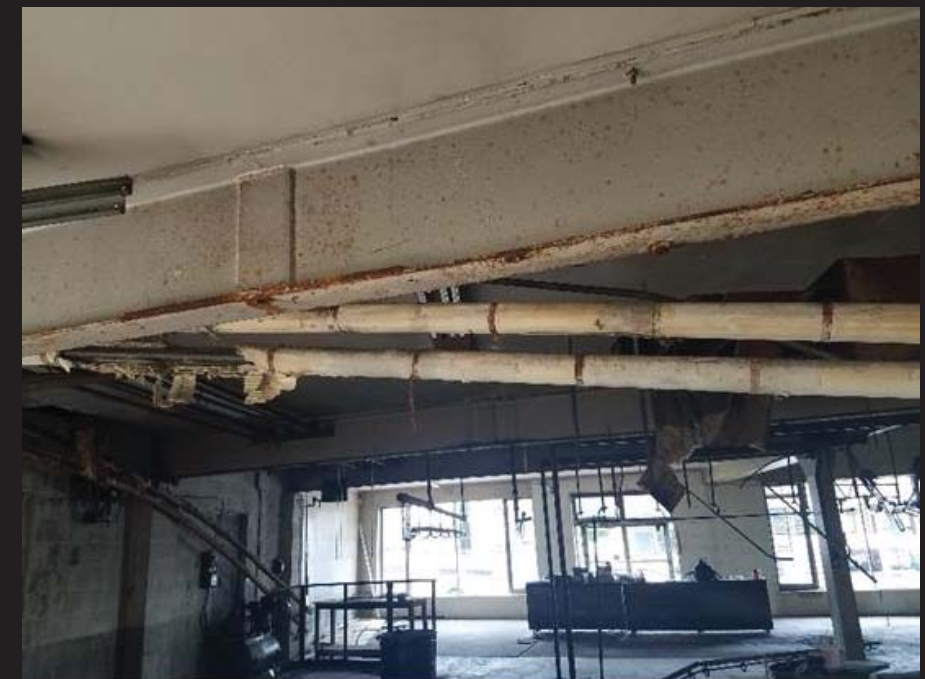
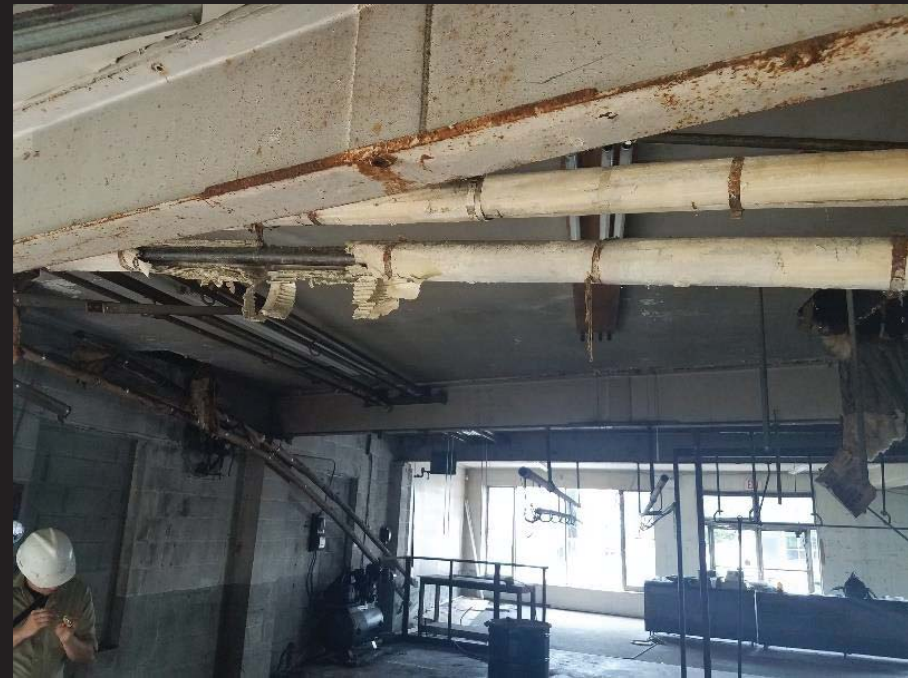
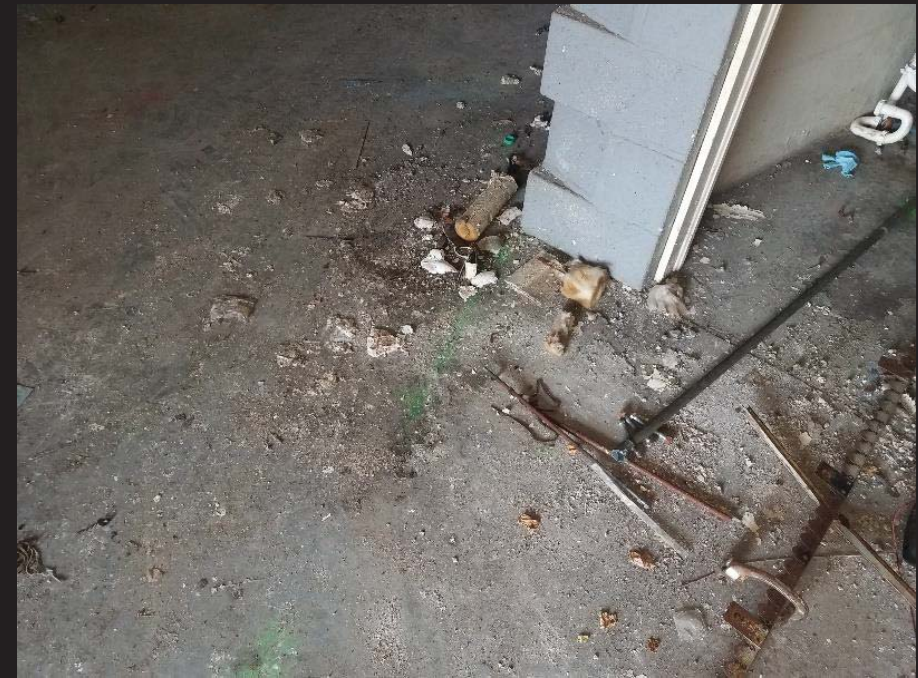
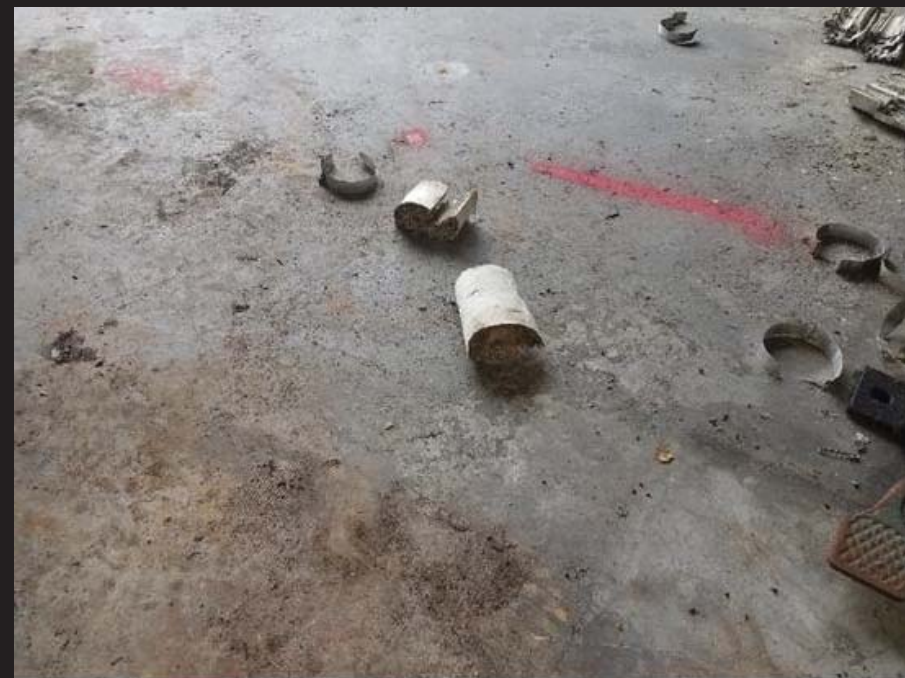
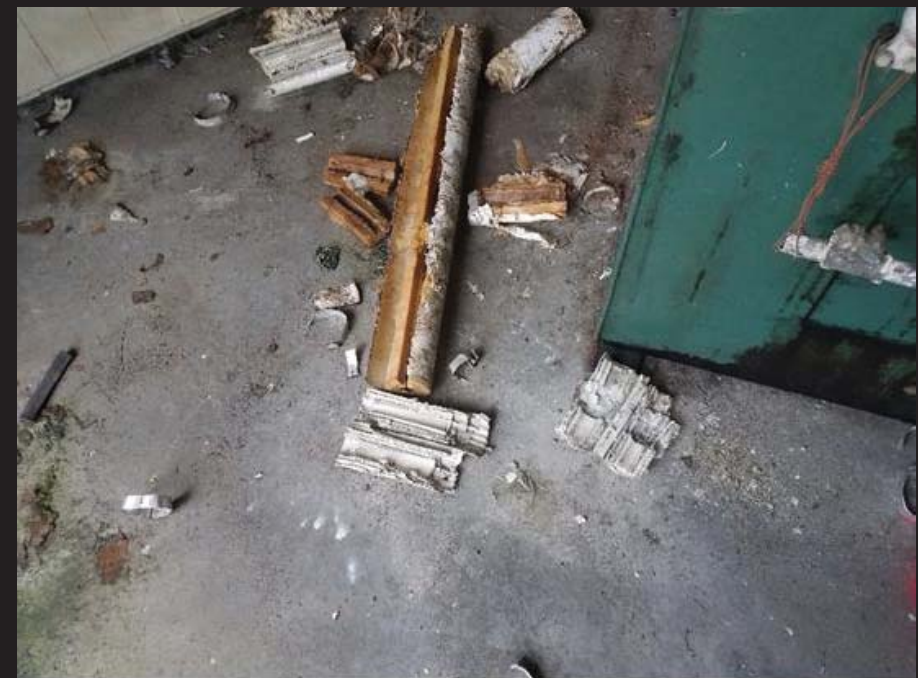
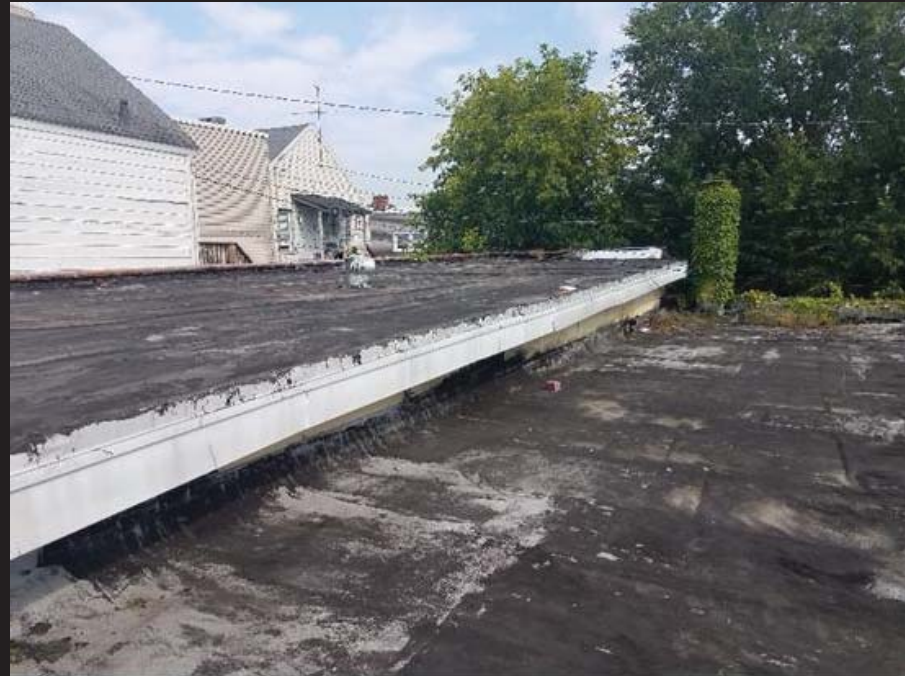
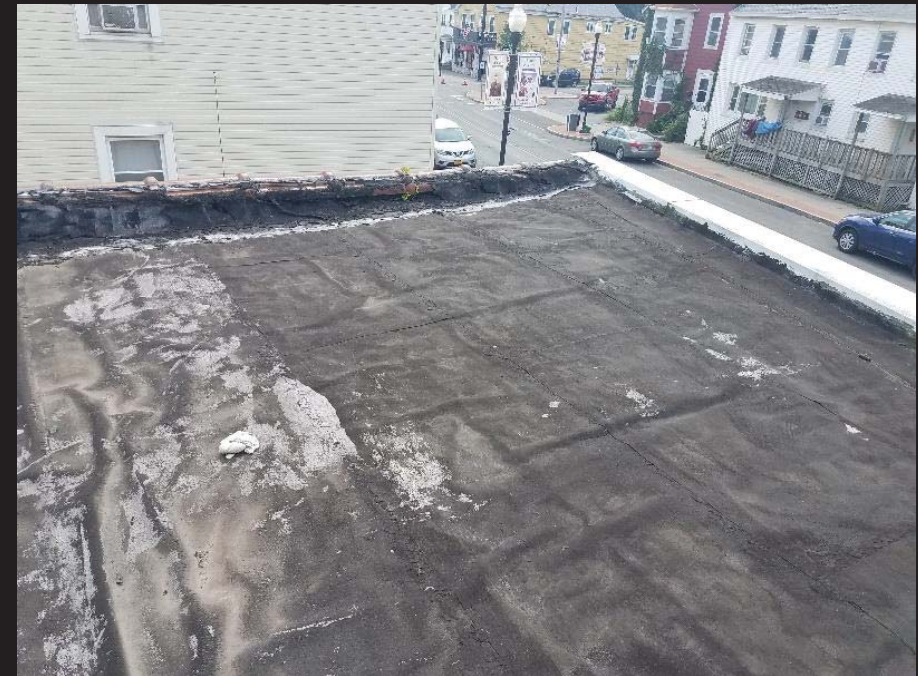
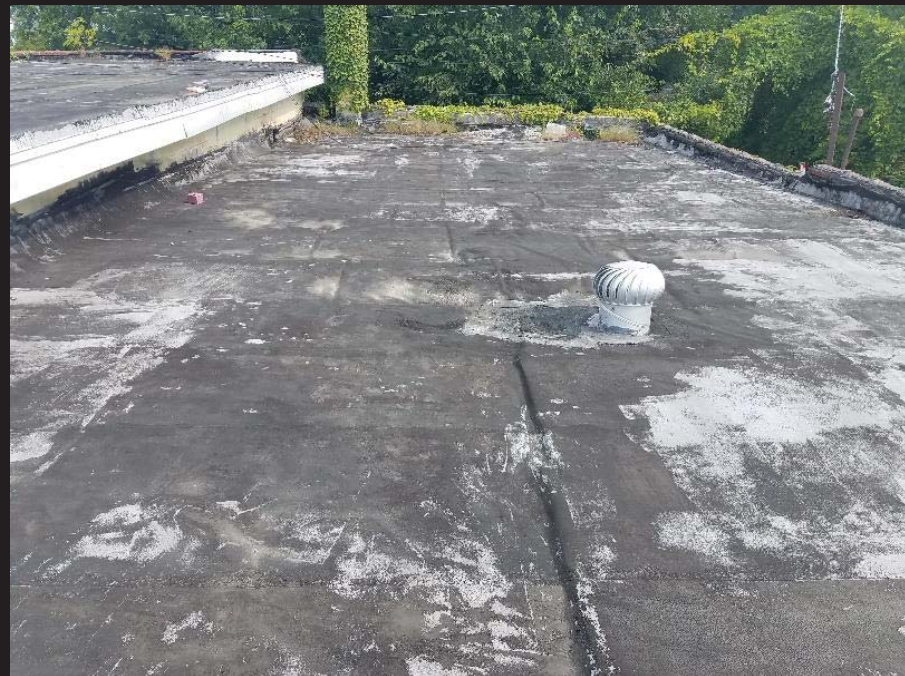
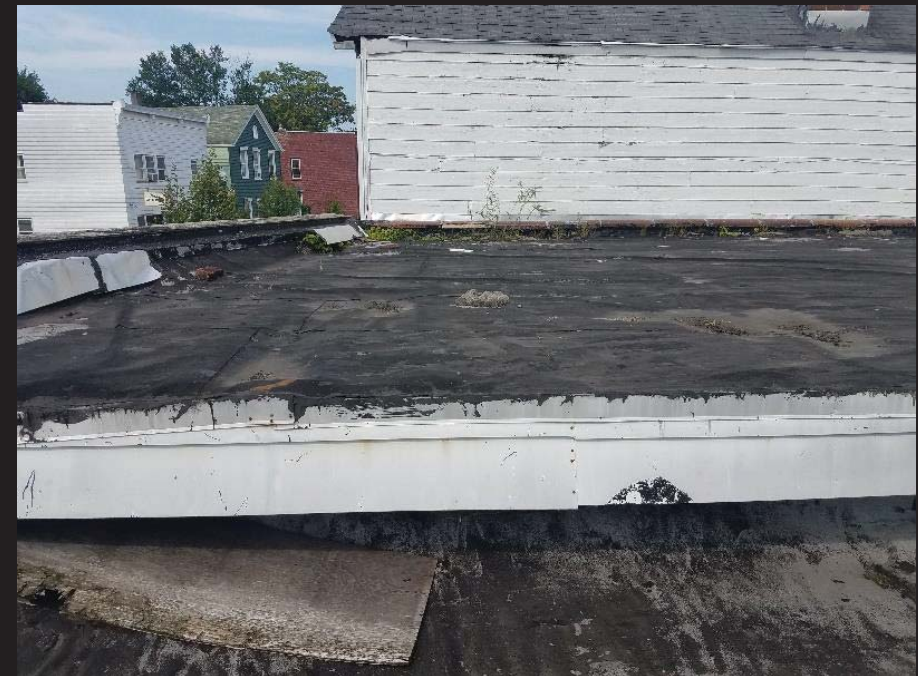
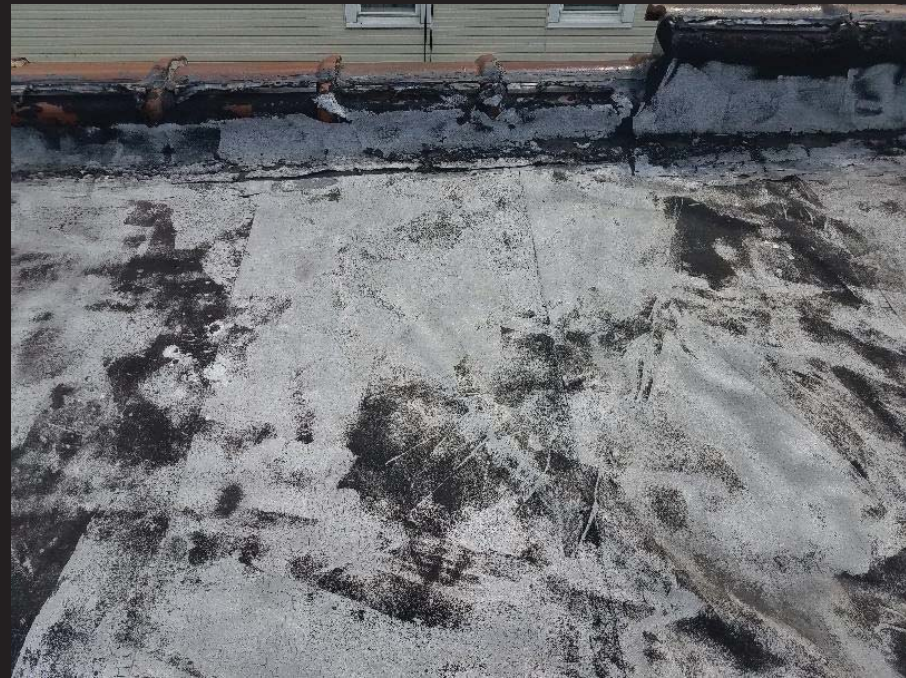
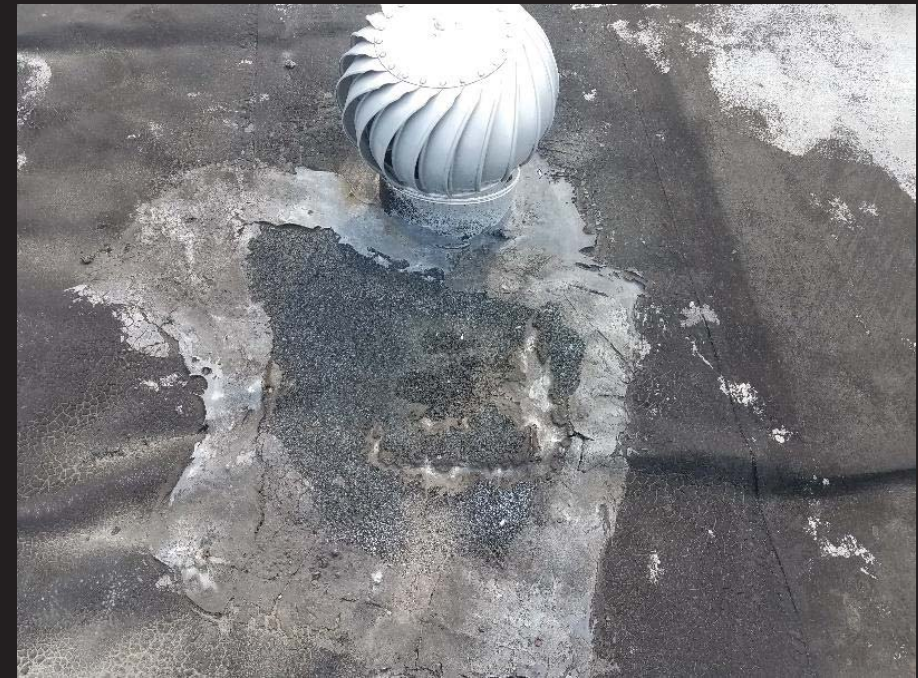
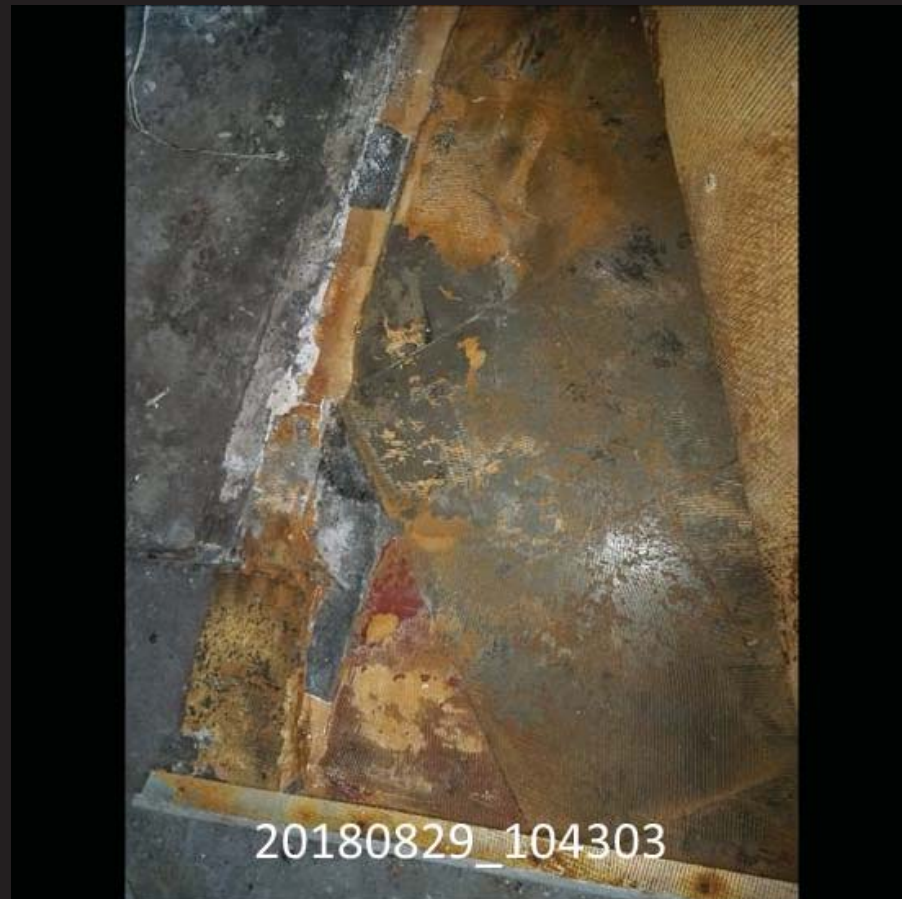
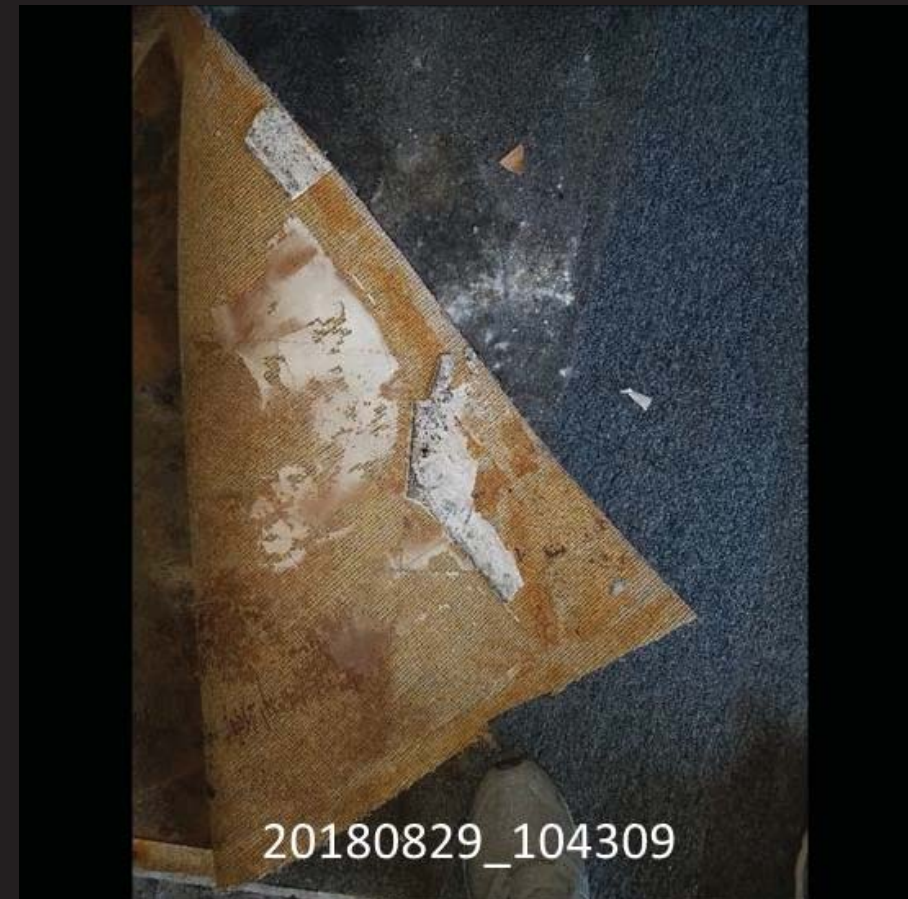
Material	Location/Area	Estimated Quantity*	Condition/Damaged
9x9 Mastic	Front of Store Under Carpet	~400 sf	Poor
9x9 Gray			
9x9 Red			
Ceiling Panels	Boiler Room Ceiling	~ 120 sf	Poor
Caulk	Metal Door Frame – Exterior	30	Poor
Air Cell Pipe Insulation ¹	Long Pipe That Crosses The Store Front & Floor	60 lf on piping & entire floor covered needs variance	Poor
Pipe Elbow Insulation	Elbow on Pipe with Air Cell	2 ea	Poor
Parapet Wall Roofing Material	Along Parapet Wall East Side	3,150 sf	Poor
Parapet Wall Roofing Sealer	Along Parapet Wall East Side		
Roof Seam Sealer	On Seams of Flat Roof and Flashing

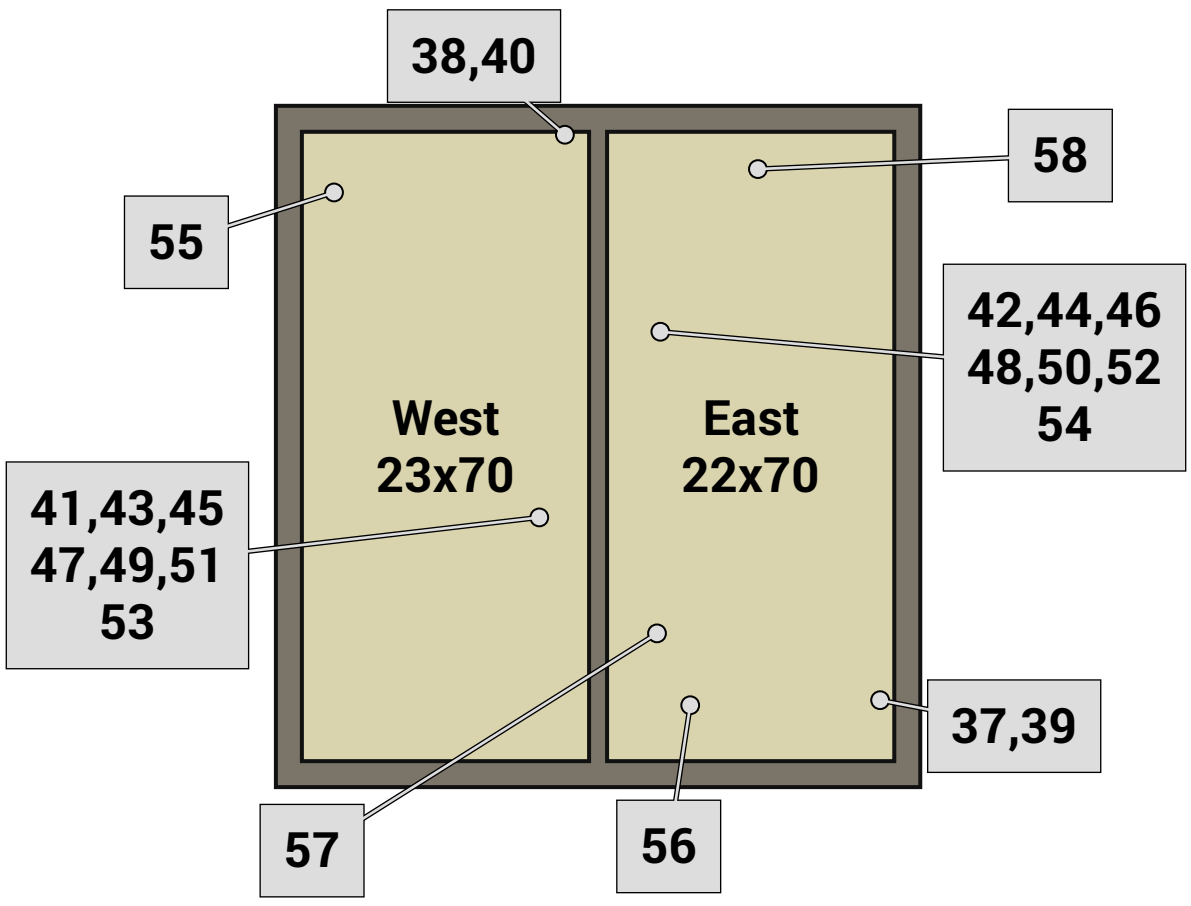
18-516
Admiral Cleaners Watervliet
Demo Survey (Roof)
Pictorial Representation - NTS

Sample ID #:	Group #: *	Material	Sample Location	Condition/Comment
49	17	Roofing layer 2	On top of layer 3	Poor
50	17	Roofing layer 2	On top of layer 3	
51	17	Roof vapor barrier	Between layers 2 and 1	
52	17	Roof vapor barrier	Between layers 2 and 1	
53	17	Roofing top layer	Top layer of roof	
54	17	Roofing top layer	Top layer of roof	
55	17	Roof seam sealer	On seams of flat roof and flashing	
56	17	Roof seam sealer	On seams of flat roof and flashing	
57	18	Silvercoat	West side of roof	Approx 50 sq' spread out in random areas
58	18	Silvercoat	East side of roof	Approx 50 sq' spread out in random areas
				Poor

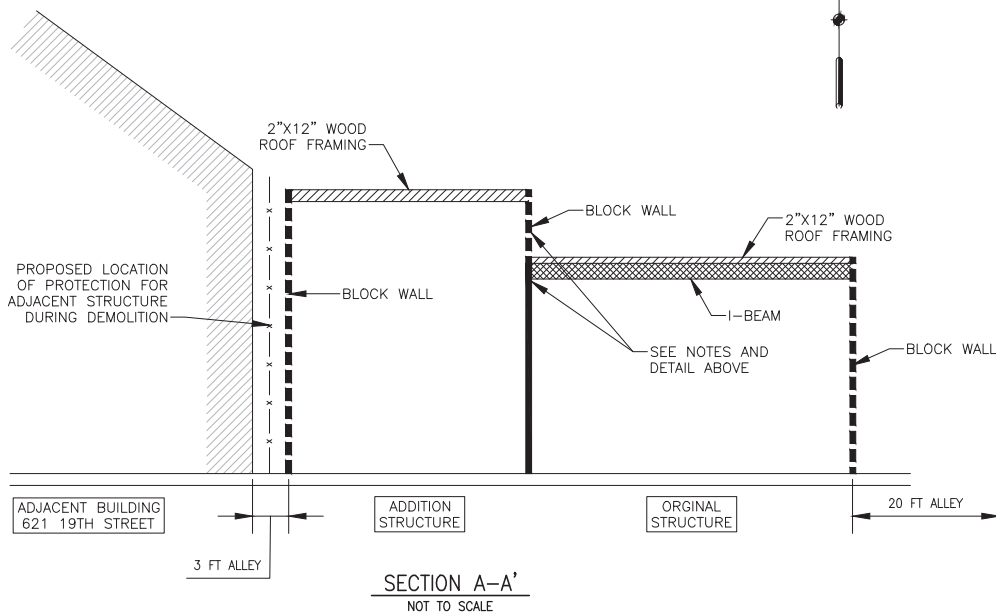
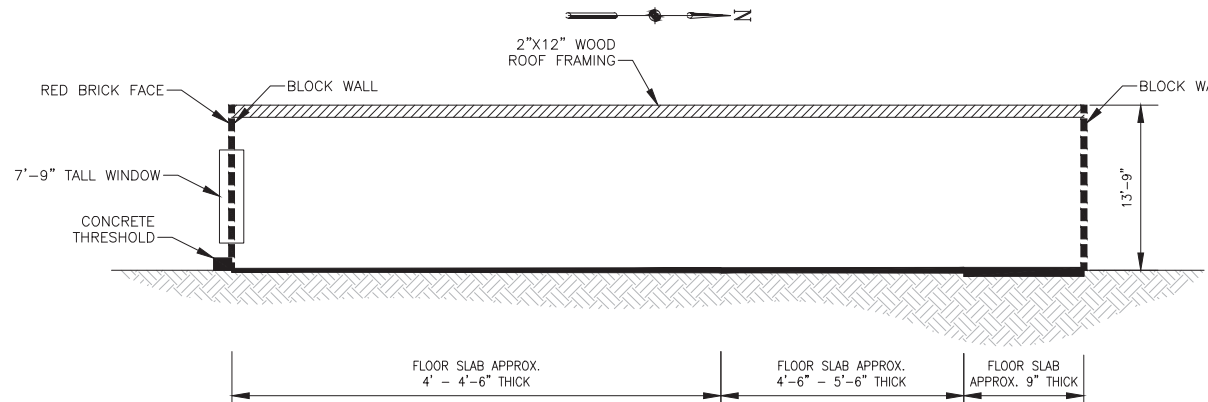
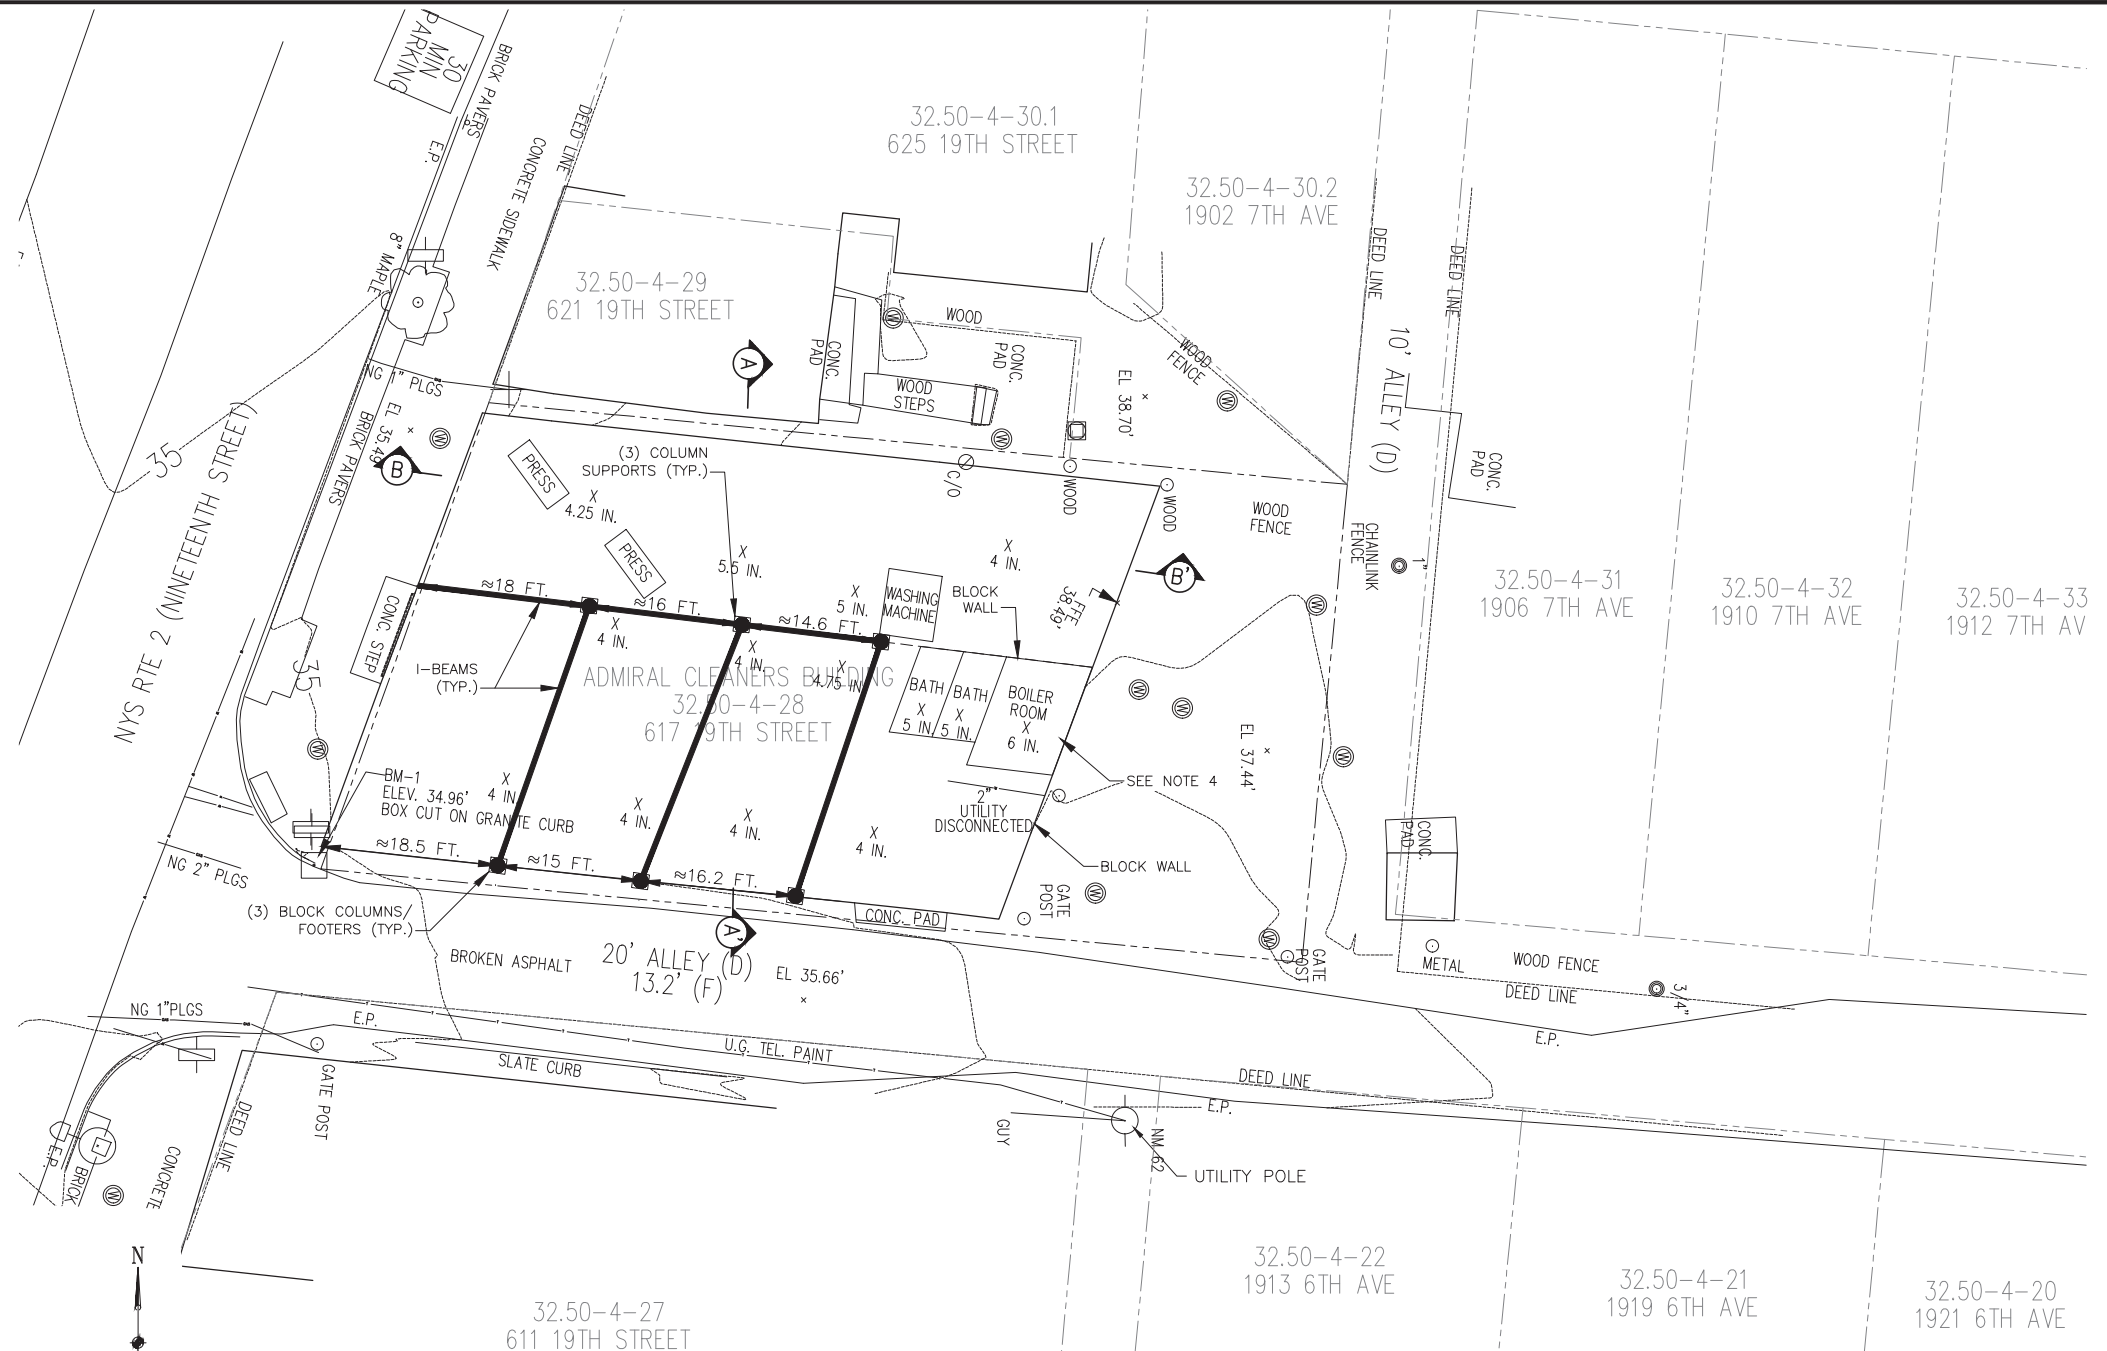
- SECTION VIEWS OF THE ADMIRAL CLEANERS BUILDING ARE APPROXIMATE.
- CONTRACTOR SHALL REVIEW THE STRUCTURAL CONDITION ASSESSMENT PREPARED BY RUSS REEVES, PE. THE ASSESSMENT IS PROVIDED IN APPENDIX C OF THE INTERIM REMEDIAL MEASURE NO. 1 SCOPE OF WORK - BUILDING DEMOLITION.
- ECCENTRIC COLUMN LOADING MAY BEHAVE UNPREDICTABLY.
- THE BOILER ROOM, LOCATED ALONG THE NORTH WALL OF THE BUILDING, HAS A SLAB DEPRESSED APPROXIMATELY 15-INCHES BELOW GRADE. THE FOOTPRINT OF THE BOILER ROOM WILL BE BACKFILLED WITH GRAVEL TO GRADE.
