DAILY FIELD ACTIVITY REPORT

PROJECT	Former Bouchard Junkyard	WEATHER	TIME	TEMP.	PRECIP.	WIND (MPH)	WIND (DIR)
LOCATION	Town of New Lebanon, NY	Sunny	0700	60-65 F	None	Calm	NA
ATTACHMENTS	Photo Log and Photos	Sunny	1700	75-80 F	None	5-10	SW

PHOTOGRAPHIC LOG
July 2, 2008
D&B JOB NO. 2605
FORMER BOUCHARD JUNKYARD SITE
TOWN OF NEW LEBANON, NEW YORK

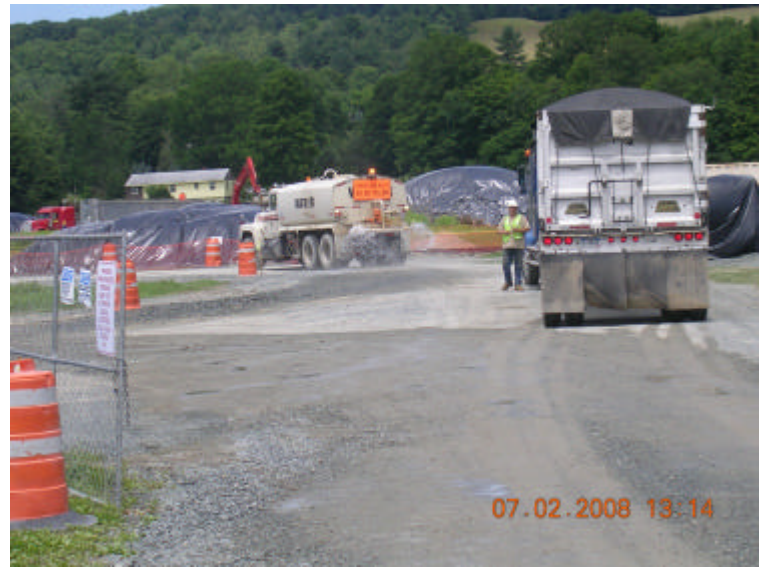
DSCN3918.JPG

DSCN 3918	7/2/2008	1143	Closeup of remedial excavation activities within the central part of Area 1 within Grid J-18 utilizing a Link-Belt 240 Trackhoe for excavation; An unknown, corroded 55-gallon drum was uncovered within the excavation; Proper PPE was used to approach and assess the drum; Abundant tires and metallic debris can be readily seen within the excavation; View of Area 1 looking NW.
DSCN 3921	7/2/2008	1314	Active dust suppression of the ground surface across the site interior and truck access road using a Mack 6561 Water Truck; Area 3 and 9 looking N.
DSCN 3924	7/2/2008	1450	View of DAC loading of TSCA PCB-contaminated soil using a Link-Belt 240 Trackhoe from a TSCA soil stockpile near the southwest corner of Area 2 looking S.
DSCN 3926	7/2/2008	1621	View of grid J-18 remedial excavation at the site of the unknown drum looking E; The debris and drum were covered with 6 mil polyethylene sheeting for the overnight hours; The drum is scheduled to be removed upon receipt of a delivery of overpack drums.
