# Herrick Hollow Creek

## Final Remedial Action (RA) Report

### Remedial Action for Herrick Hollow Creek Restoration

March 2009

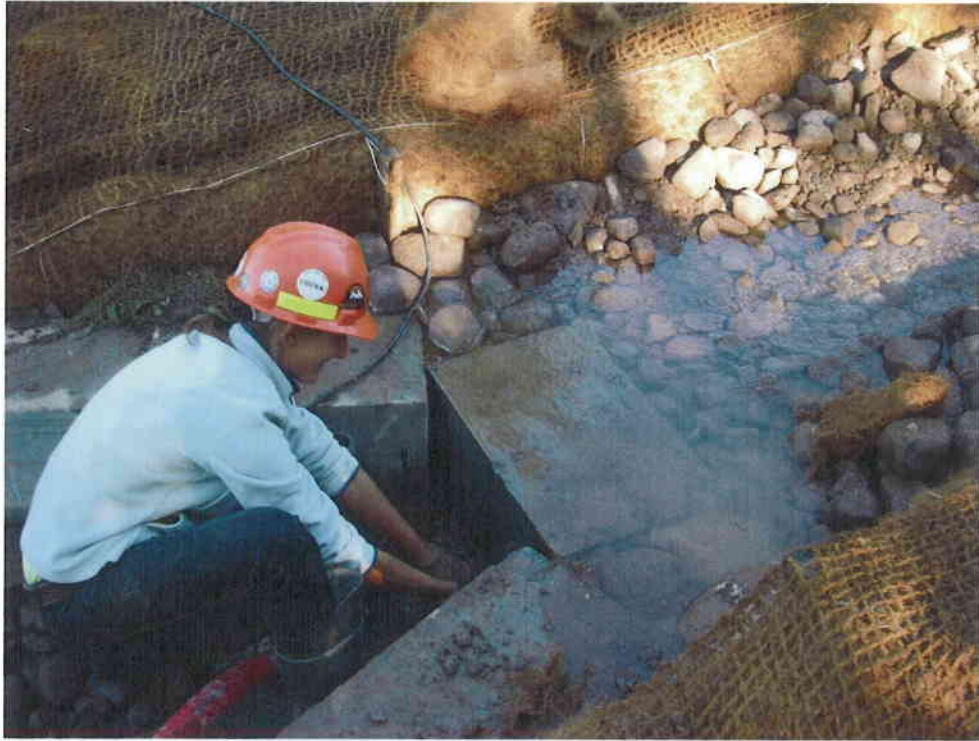
**7. Step 1 of channel construction. Pump-around system was installed in a sump left at the end of the previous day's work, typically at a cross-vane structure. The entire downstream area to be constructed each day was dewatered.**

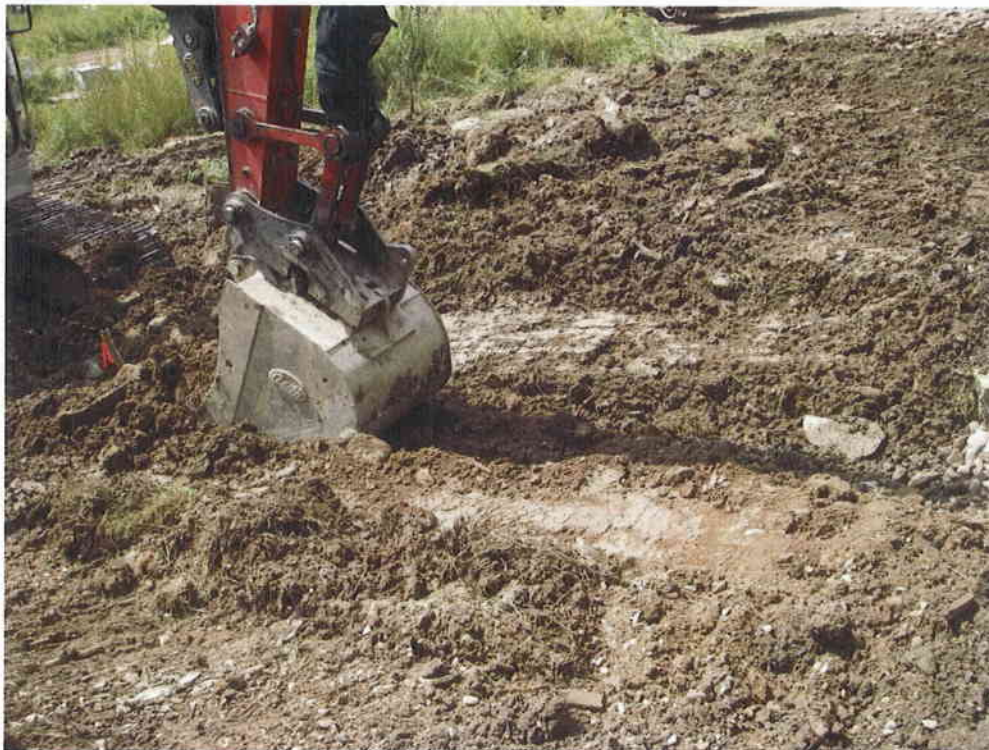
**8. Step 2 of channel construction. Sub-grades were excavated for the streambed and bank treatments downstream to the location of the next grade control structure to be built. Rough grades were dug with the excavator and fine-tuned by hand.**

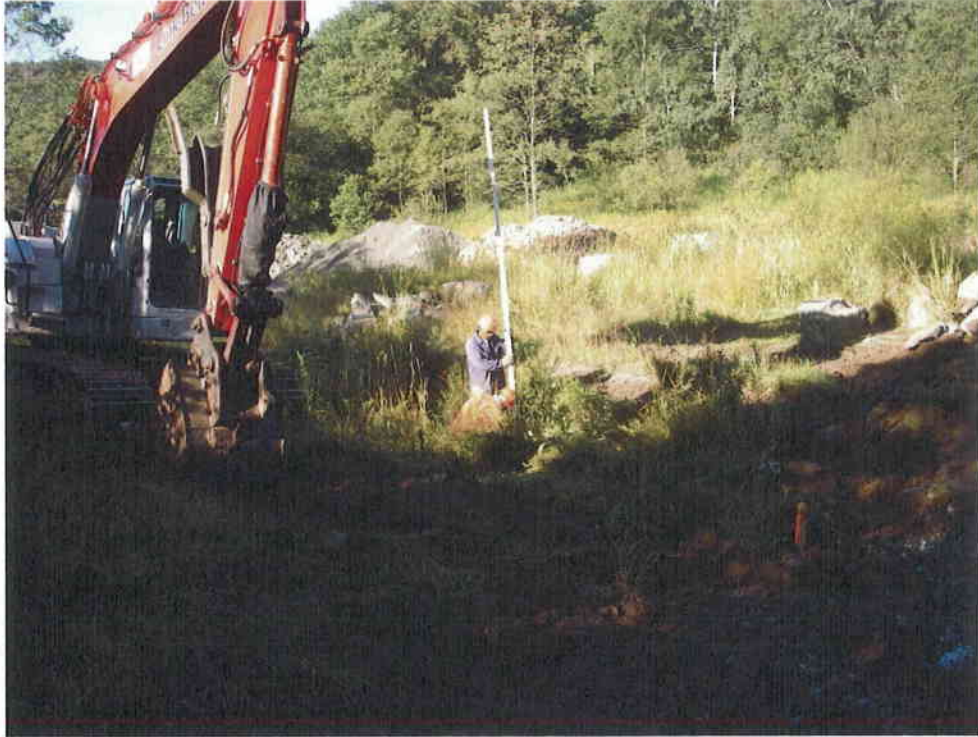
**9. Step 3 - elevations of all sub-grades and structure footers were verified prior to continuation of the construction process.**

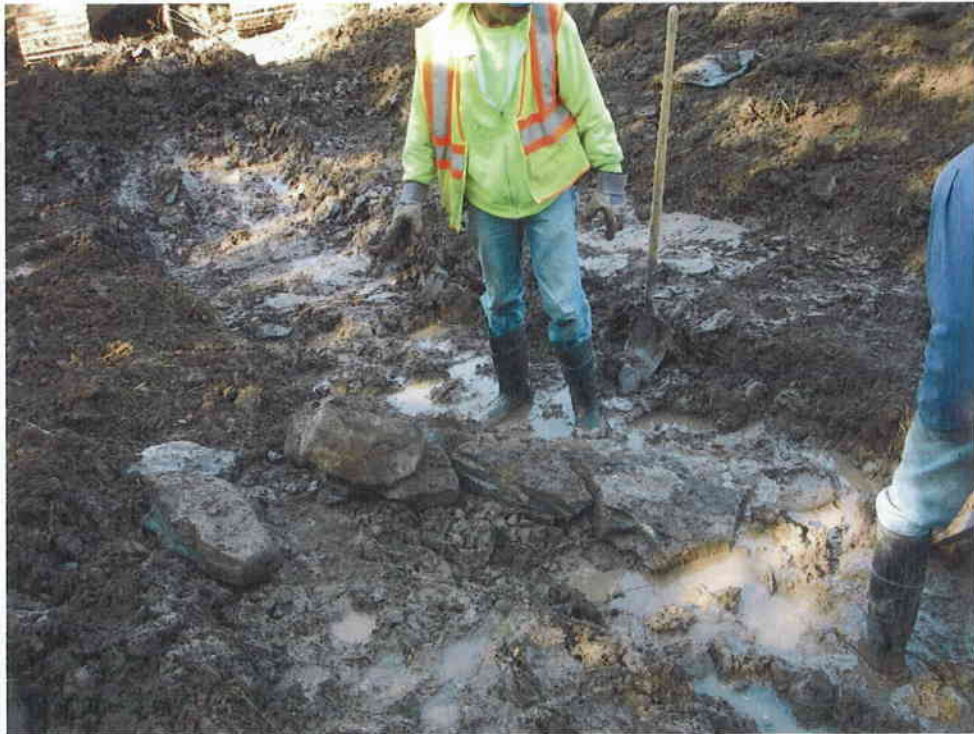
**10. Step 4 - rock cascades were constructed by hand in locations indicated in the design. Sub-grade and final elevations were verified with survey equipment prior to continuation of the construction sequence.**

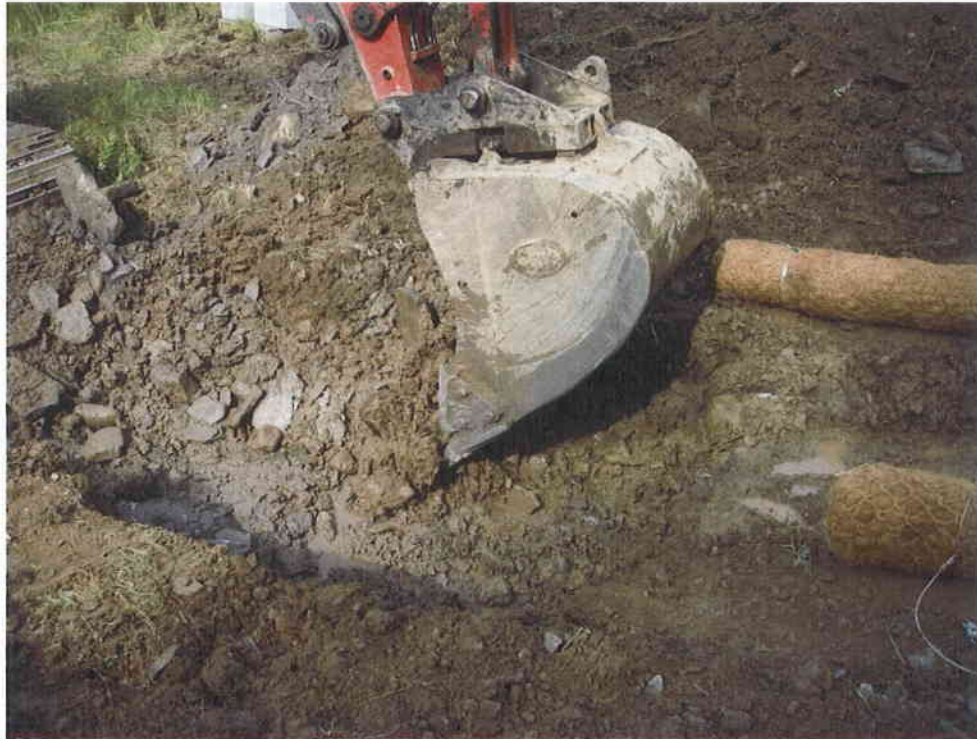
**11. Step 5 - A footer was excavated at the location of each cross-vane and log vane as indicated in the design plans.**

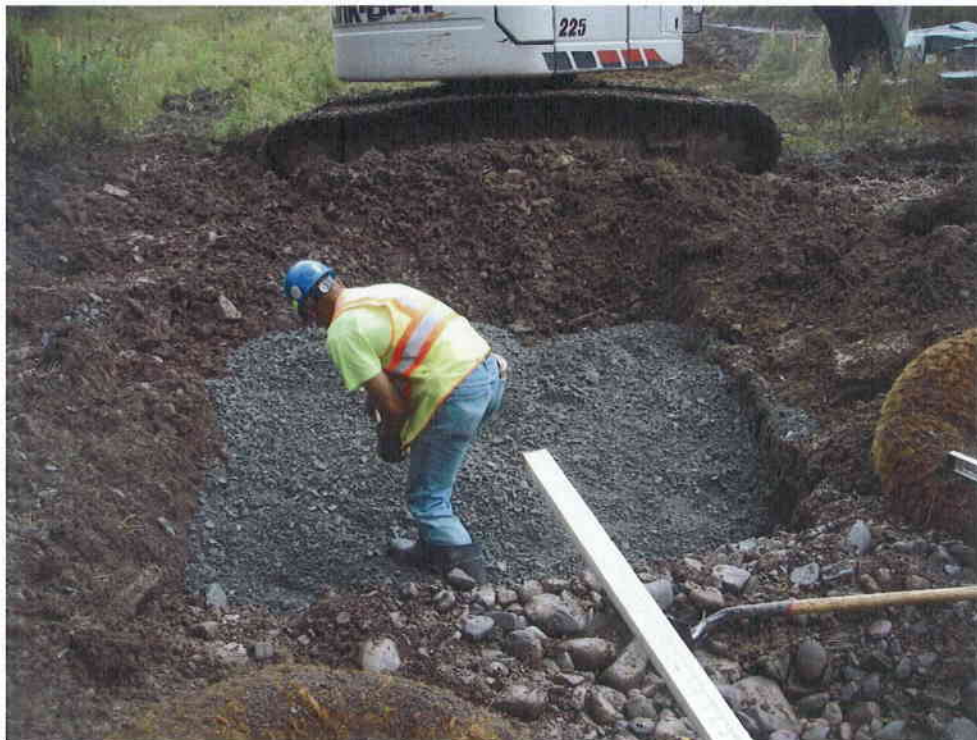
**12. Step 6 - Gravel was placed to create a stable sub-grade for the placement of cross vane footer rocks. Gravel sub-grade was sloped so that footer and vane rocks would achieve the desired arm slope of 4% to 7% as indicated in the cross vane details and specifications.**

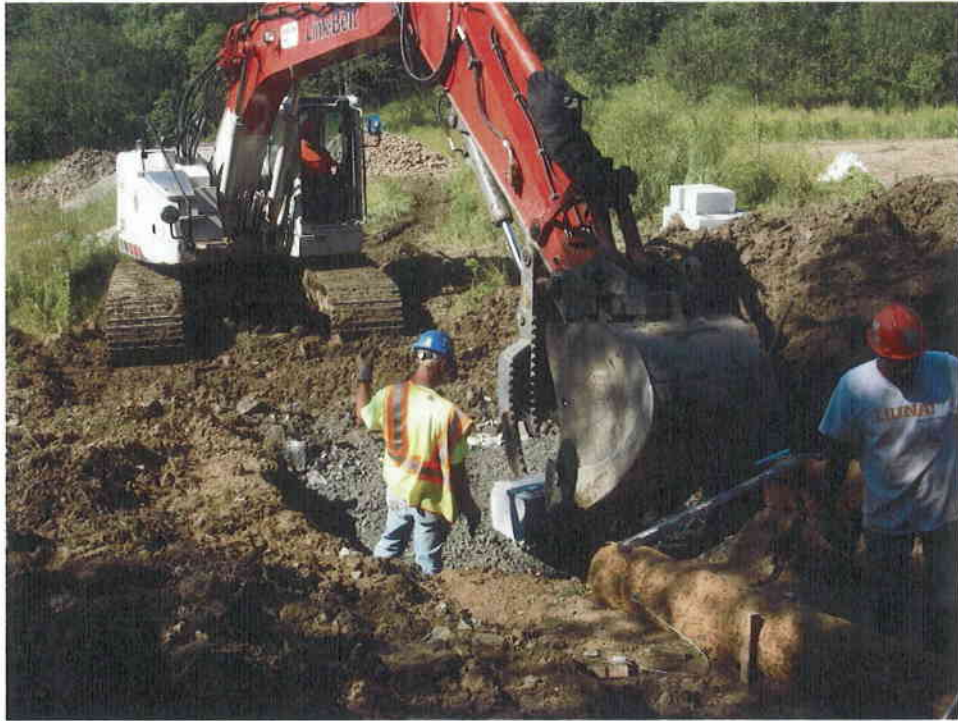
**13. Step 7 - Rocks used to construct cross vanes were installed with an excavator, and fine-tuned in place by hand. Use of a hydraulic thumb is paramount to successful cross vane construction.**

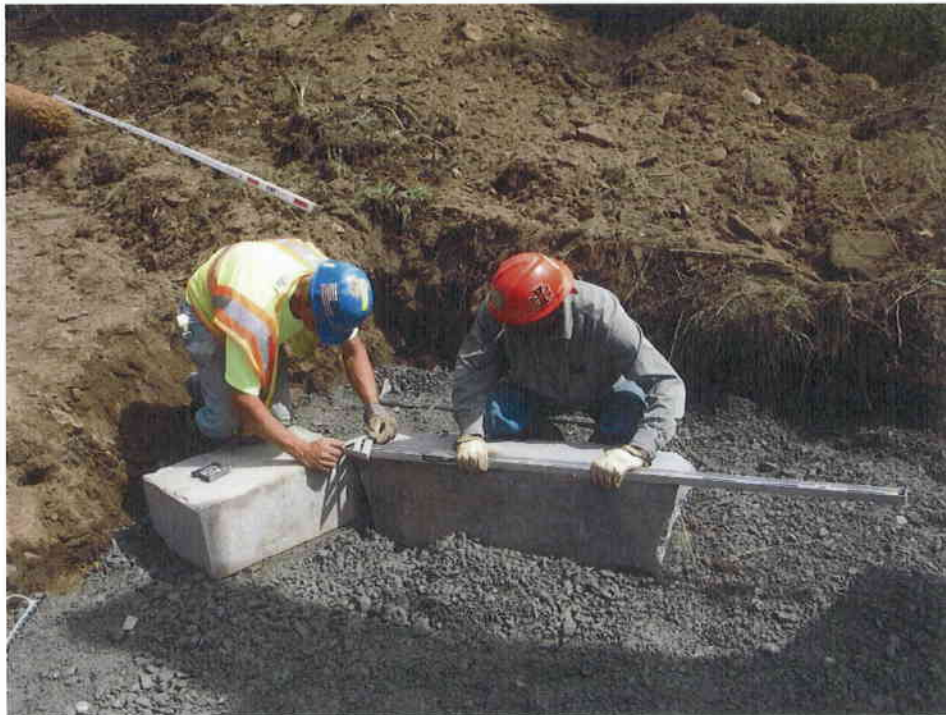
**14. Step 8 - Footer rocks were checked to ensure proper elevation, arm slope and arm angle was achieved prior to installing the vane (upper) tier of rocks.**

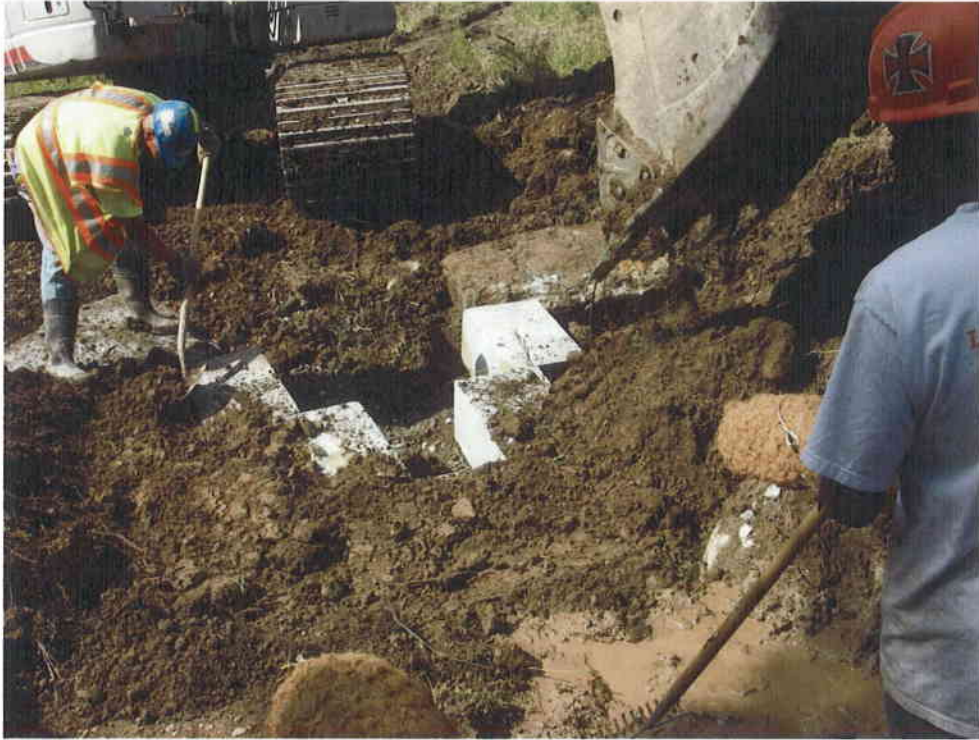
**15. Step 9 - Footer rocks were placed and backfilled.**

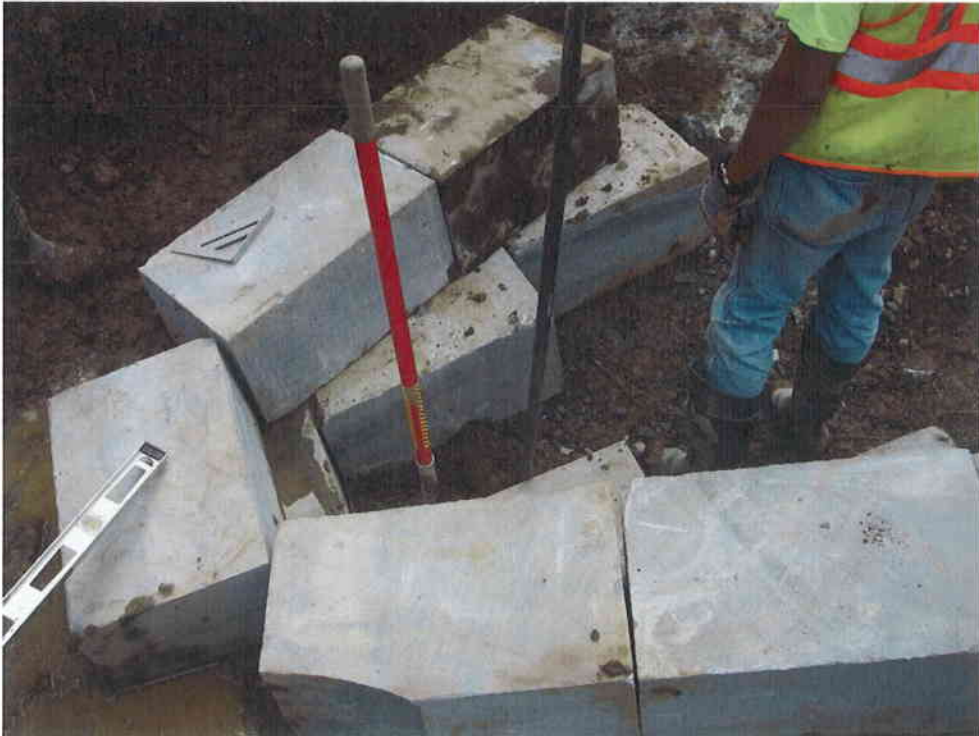
**16. Step 10 - Vane rocks were installed. Vane rocks are set back upon the footer rocks to prevent undercutting of the structure.**

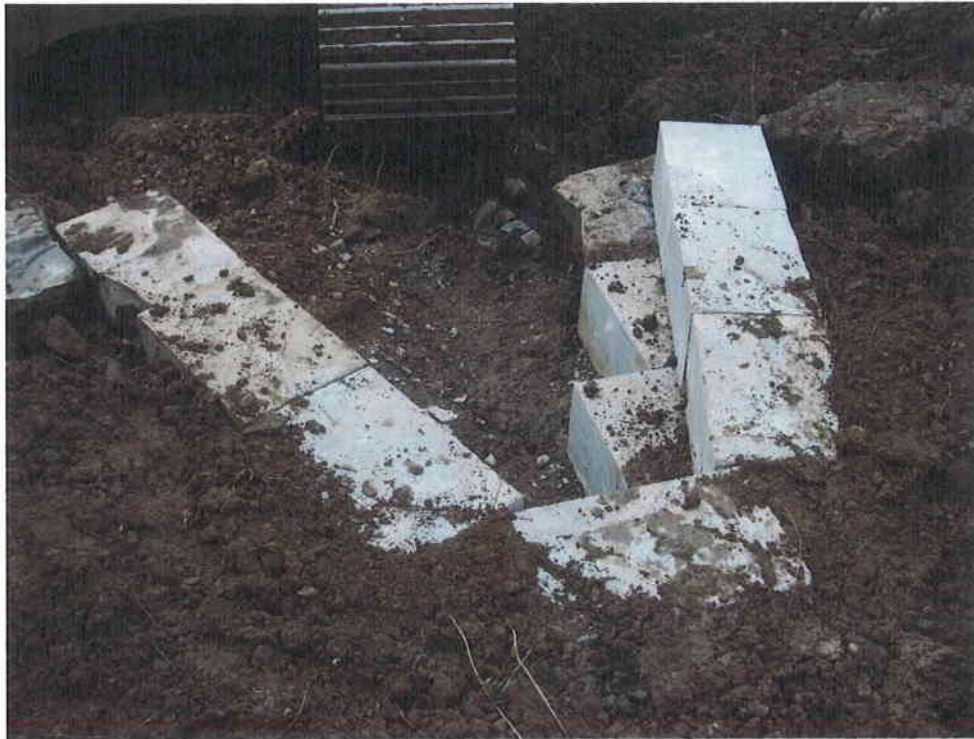
**17. Step 11 - Constructed cross vanes were backfilled with soil and fine gravel.**

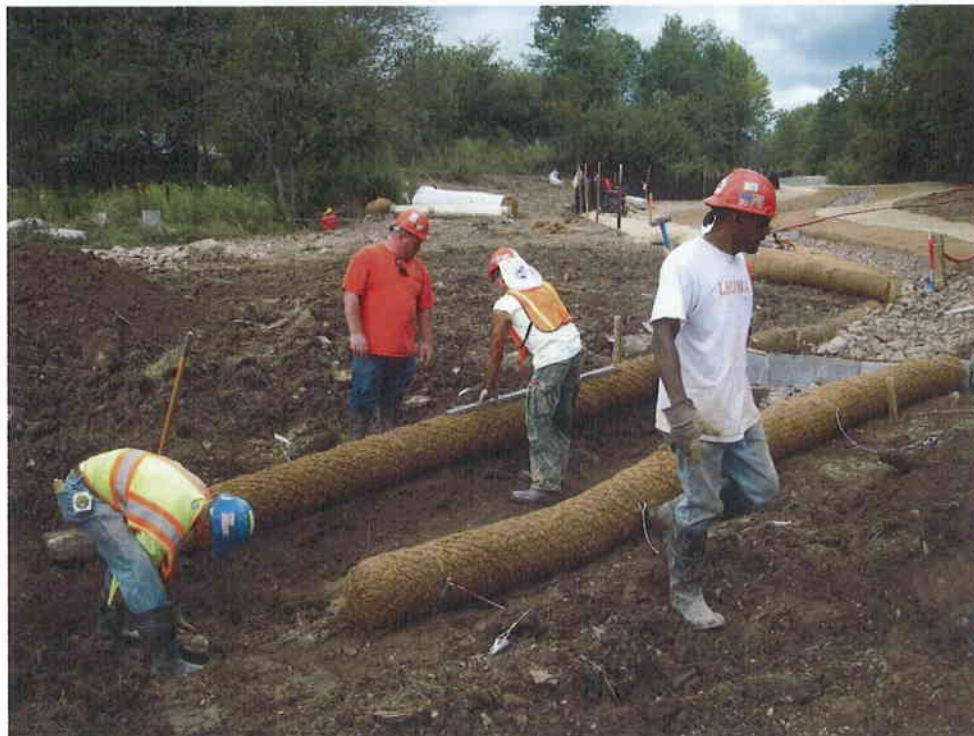
**18. Step 12 - Streambank treatments were installed up to and beyond the location of the completed cross vane. Coir logs were used along the stream banks, with coir mats and erosion control fabric installed across disturbed portions of the floodplain.**

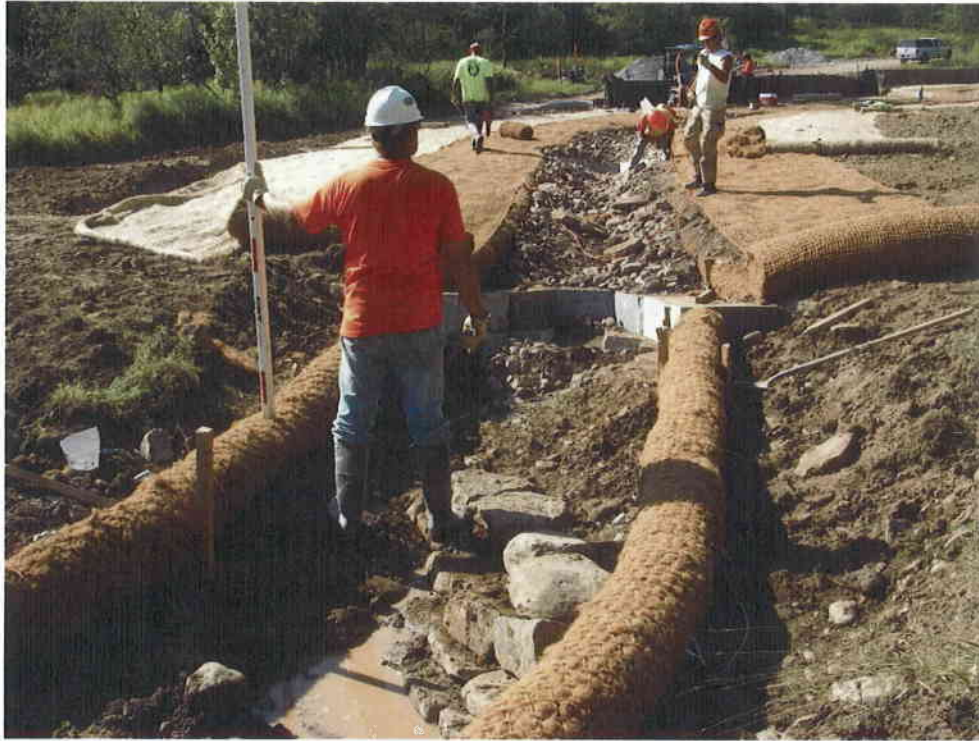
**19. Step 13 - Finished stream bank and structure elevations were verified in the field prior to proceeding with the construction sequence.**

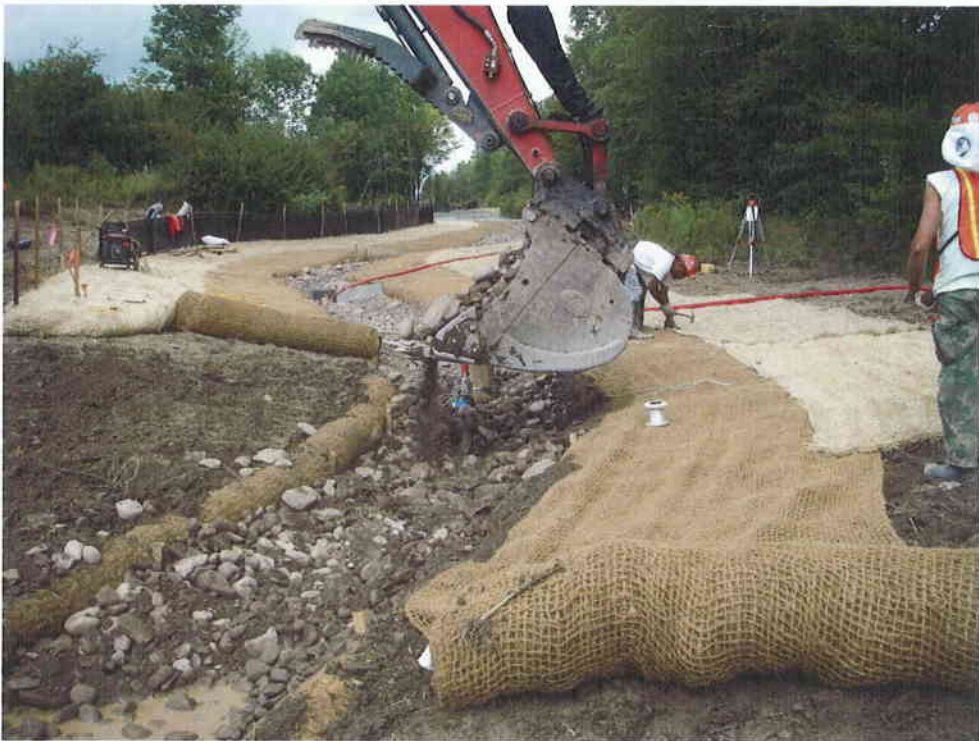
**20. Step 14 - Imported gravel material was mixed on-site and placed in the stream channel. Over time, response of the stream to flood events will progressively sort and distribute bed material in an appropriate manner.**

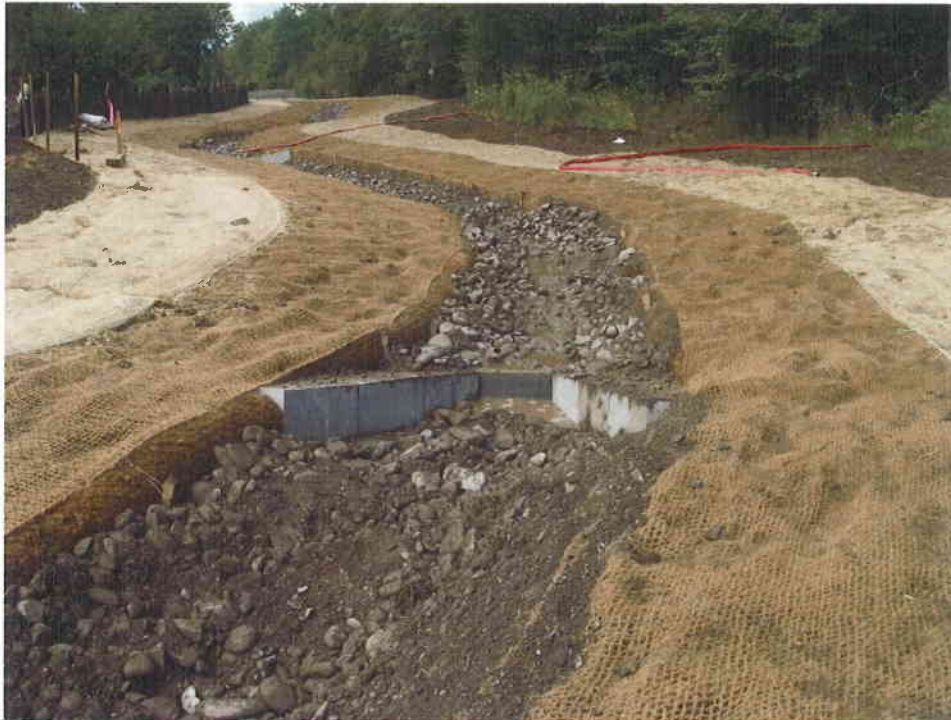
**21. Step 15 - At the end of each work day, the pump-around system was disabled, and flow returned to the constructed channel. A sump hole was left at the downstream end of the last constructed cross vane to set the pump-around the following day.**

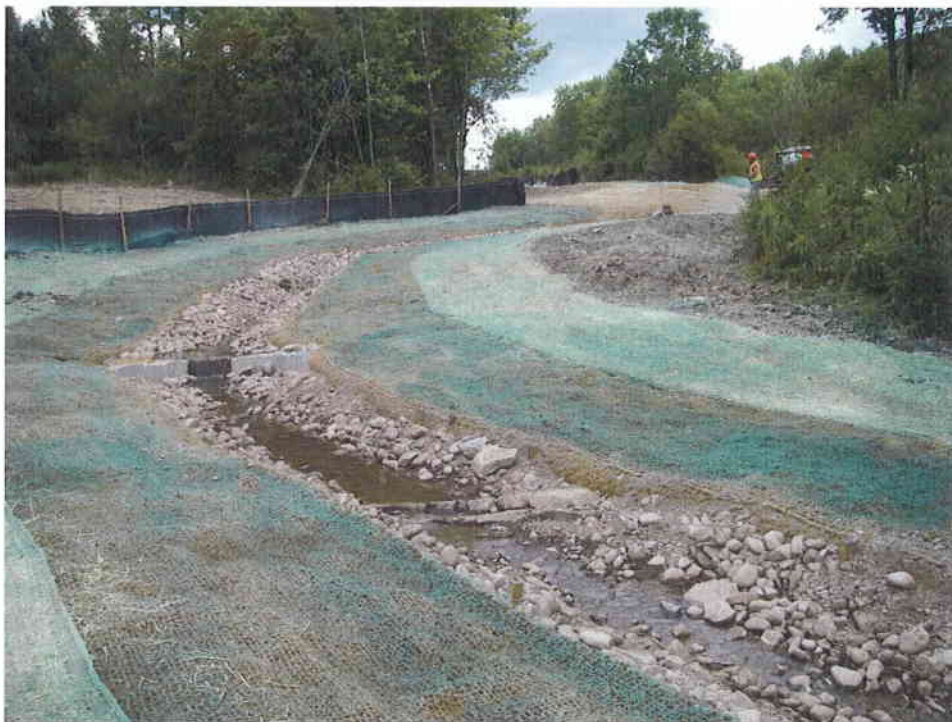
**22. Step 16 - The finished portion of the stream channel was hydroseeded.**

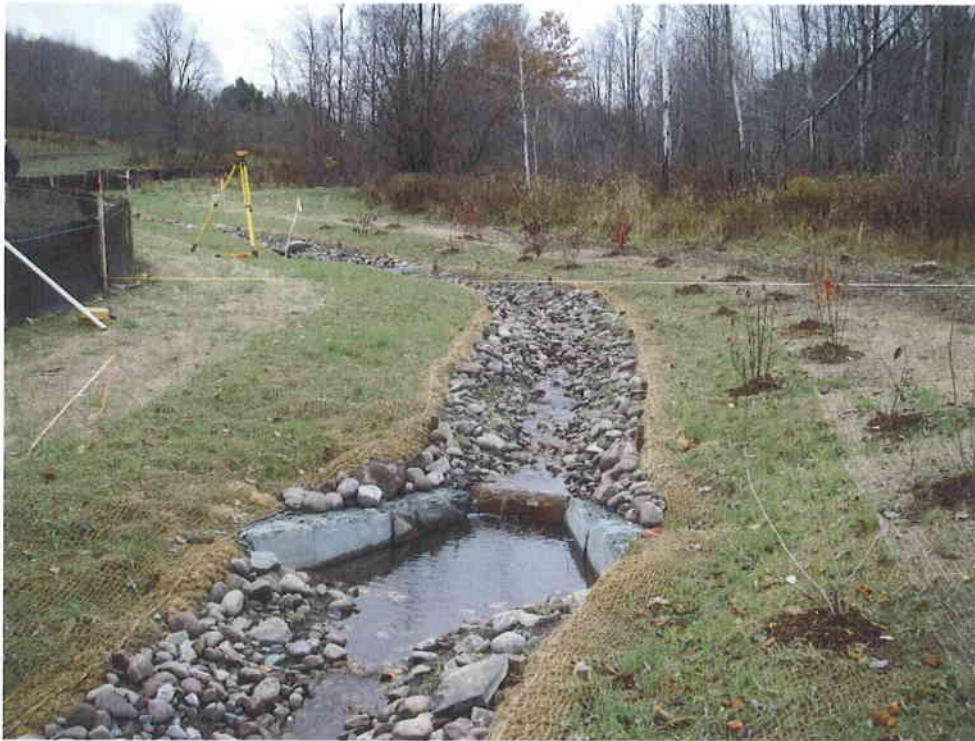
**23. Shrubs were planted in the riparian corridor in select areas.**

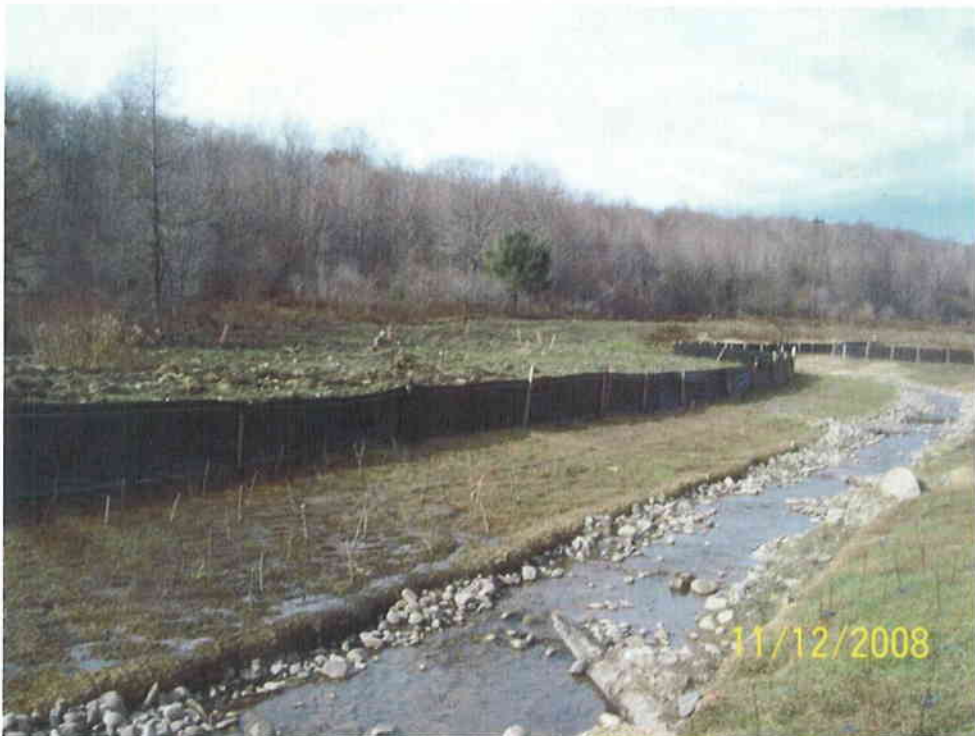
**24. Live stakes were installed in the riparian corridor along the entire course of the restored channel.**

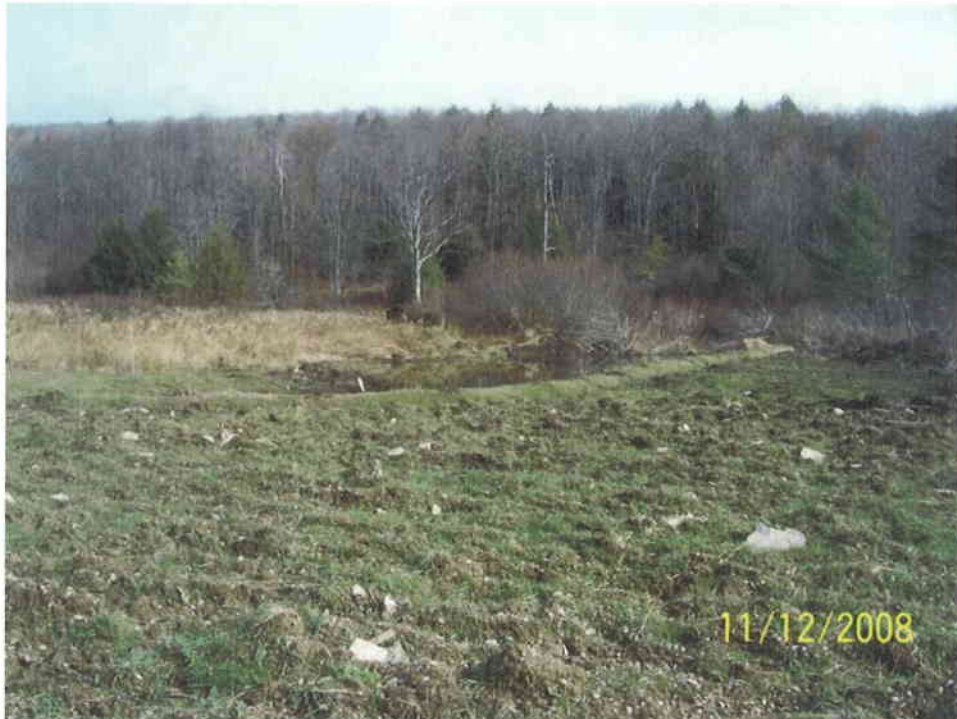
**25. Level spreaders were constructed to maintain the hydrology needed to sustain existing wetlands adjacent to those areas disturbed during construction of the stream channel. Restored wetland areas were treated with peat and seeded with a wetland seed mix.**
