Re: Richardson Hill Landfill Site – Final Stream Restoration Monitoring Report
June, September, and October 2011 Inspection Events

**Final Stream Restoration
Monitoring Report:
June, September, & October 2011
Inspection Events**

April 2012

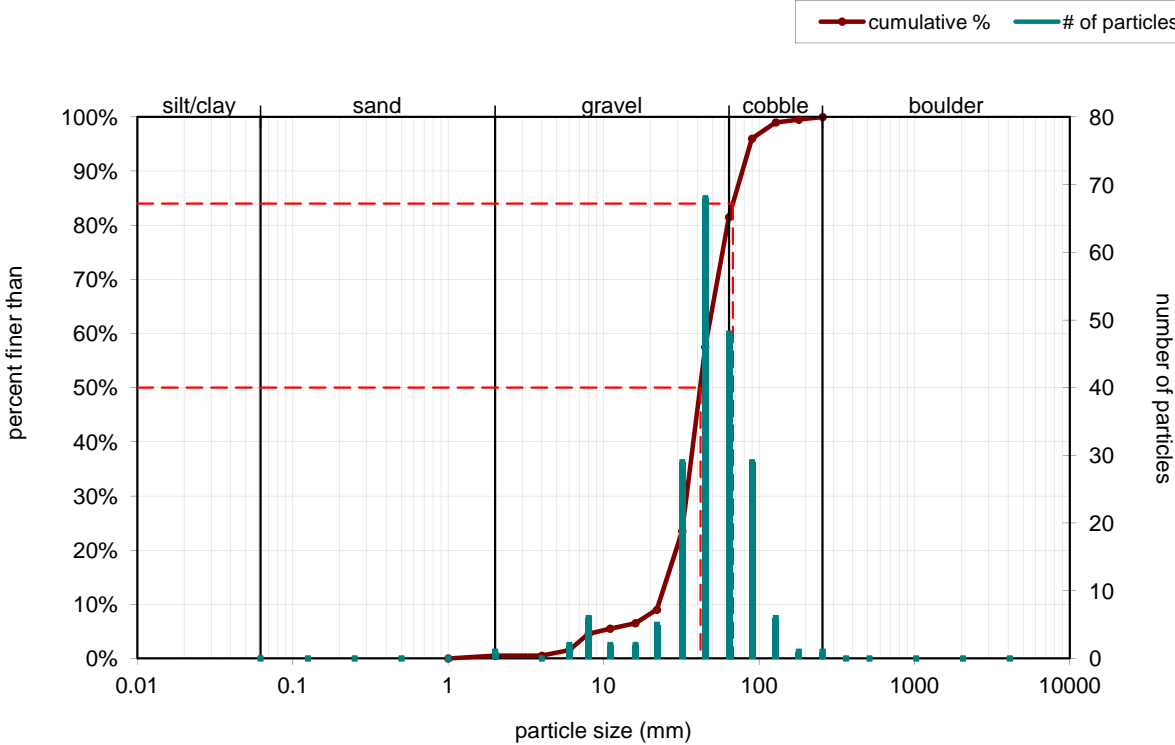
A-1. Cumulative weighted bed particle distribution - Segment I (0+00 to 7+00), Herrick Hollow Creek (October 2011)

Size (mm)		Size Distribution		Type	
D16	26	mean	42.0	silt/clay	0%
D35	36	dispersion	1.6	sand	1%
D50	42	skewness	0.00	gravel	81%
D65	50			cobble	19%
D84	68			boulder	0%
D95	88

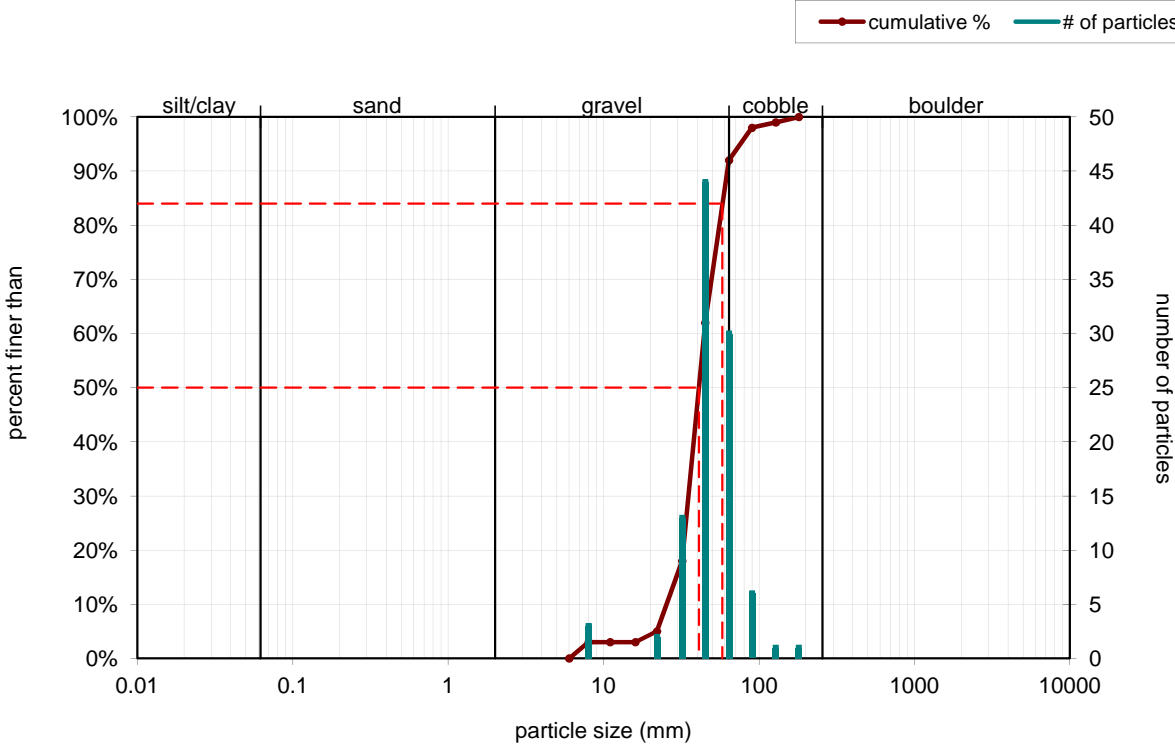
A-2. Bed particle distribution at station 2+50 (riffle/run/pool) - Segment I, Herrick Hollow Creek (October 2011)

Size (mm)		Size Distribution		Type	
D16	30	mean	41.7	silt/clay	0%
D35	37	dispersion	1.4	sand	0%
D50	41	skewness	0.01	gravel	92%
D65	47			cobble	8%
D84	58			boulder	0%
D95	76

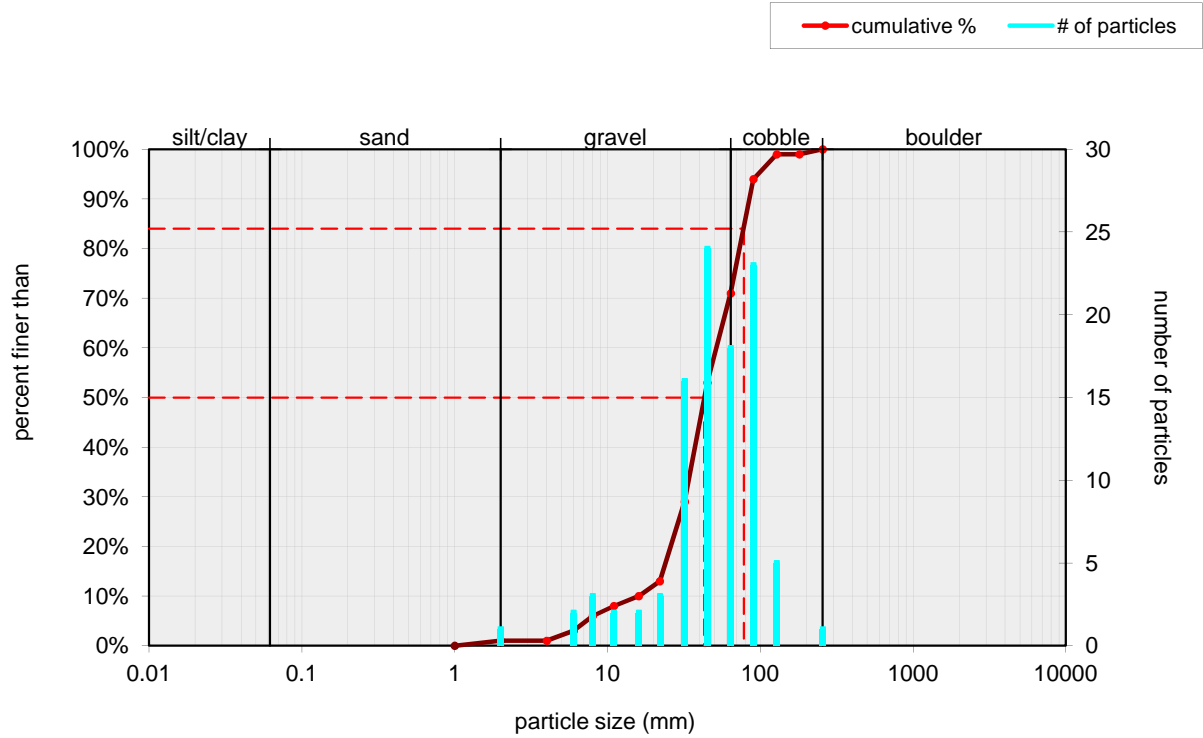
A-3. Bed particle distribution at station 5+50 (riffle/run/pool) - Segment I, Herrick Hollow Creek (October 2011)

Size (mm)			Size Distribution		Type	
D16	24	3.4	mean	43.3	silt/clay	0%
D35	35	12	dispersion	1.8	sand	1%
D50	43	17	skewness	0.00	gravel	70%
D65	57	20			cobble	29%
D84	78	29			boulder	0%
D95	97	39

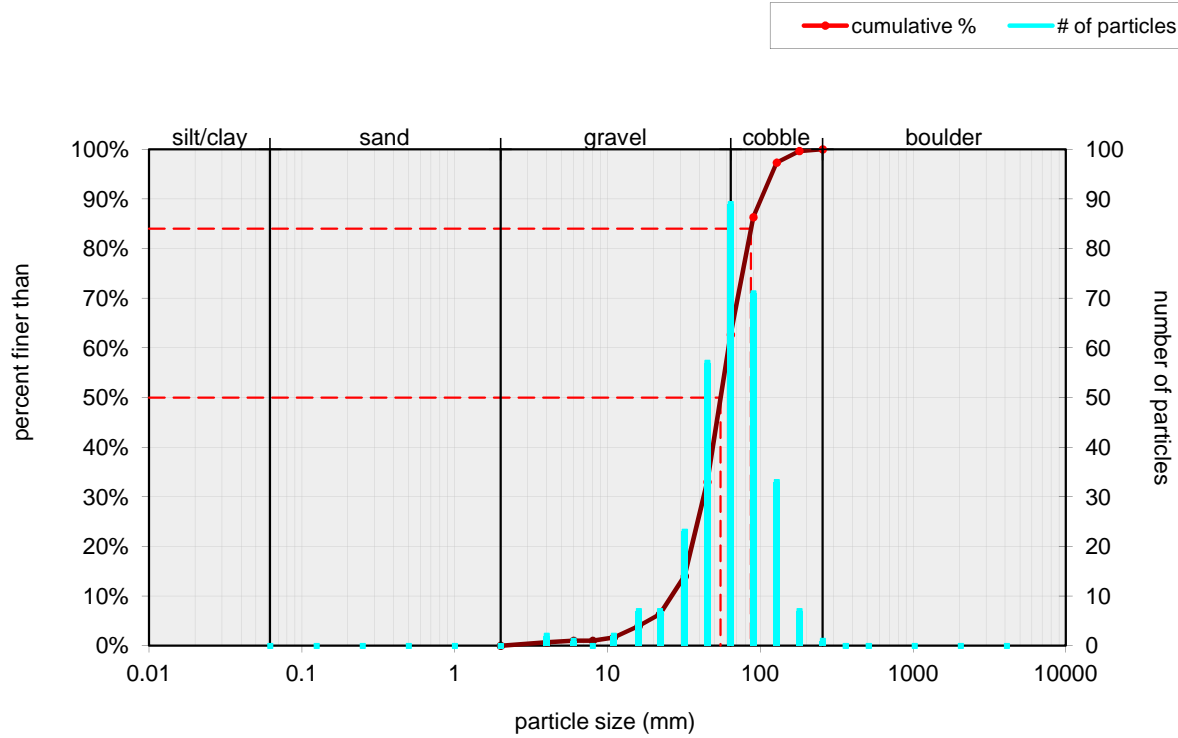
A-4. Cumulative weighted bed particle distribution - Segment II (7+00 to 22+00), Herrick Hollow Creek (October 2011)

Size (mm)			Size Distribution		Type	
D16	33	3.4	mean	53.6	silt/clay	0%
D35	46	12	dispersion	1.6	sand	0%
D50	55	17	skewness	-0.02	gravel	63%
D65	66	20			cobble	37%
D84	87	29			boulder	0%
D95	120	39

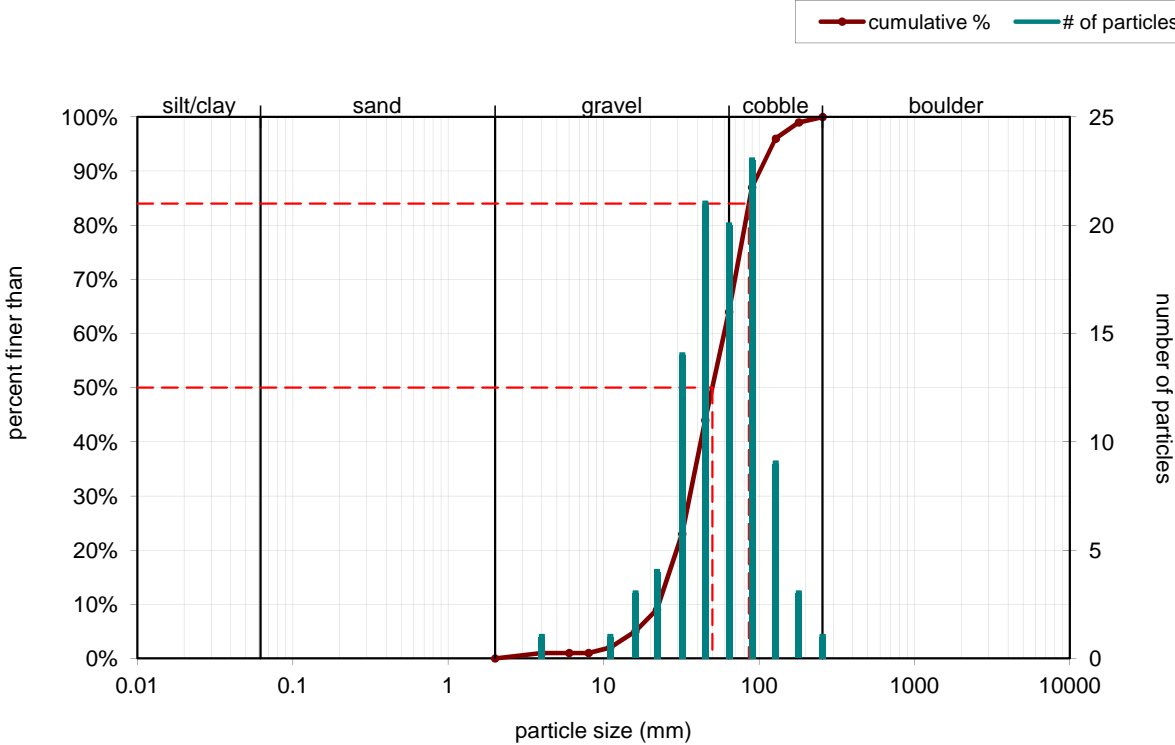
A-5. Bed particle distribution at station 9+00 (riffle/run/pool) - Segment II, Herrick Hollow Creek (October 2011)

Size (mm)		Size Distribution		Type	
D16	27	mean	48.2	silt/clay	0%
D35	39	dispersion	1.8	sand	0%
D50	50	skewness	-0.02	gravel	64%
D65	65			cobble	36%
D84	86			boulder	0%
D95	120

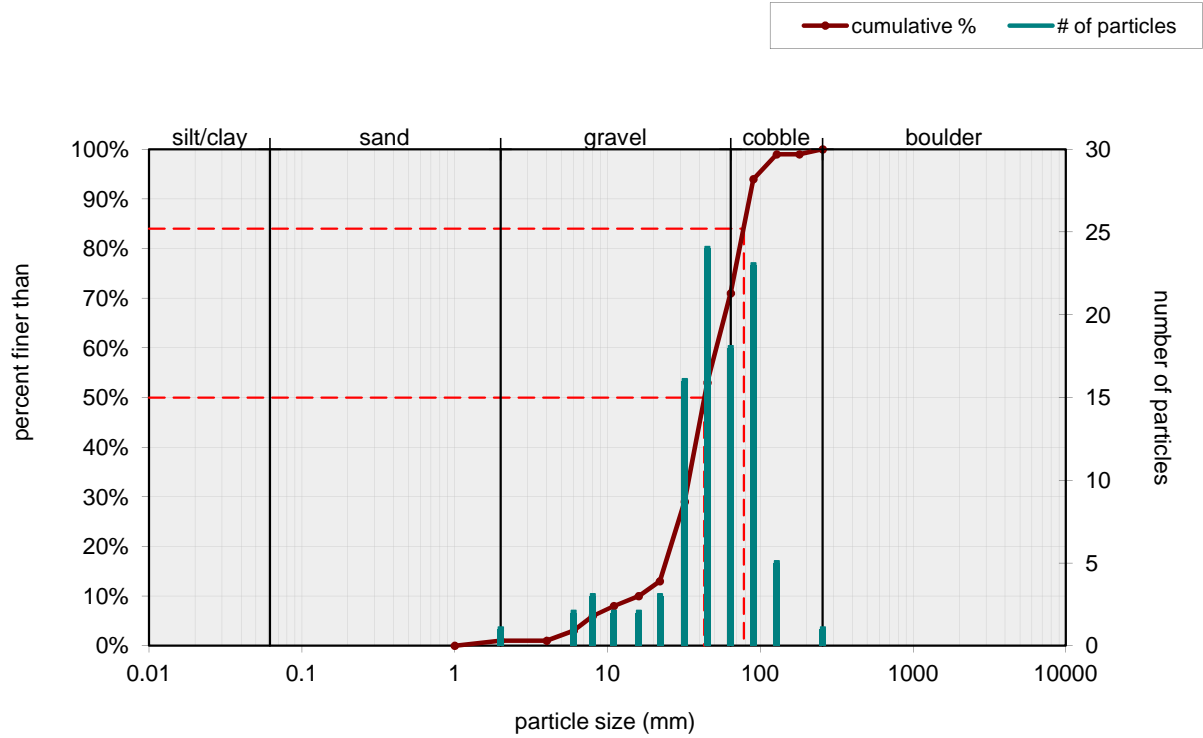
A-6. Bed particle distribution at station 15+50 (riffle/run/pool) - Segment II, Herrick Hollow Creek (October 2011)

Size (mm)			Size Distribution		Type	
D16	24	3.4	mean	43.3	silt/clay	0%
D35	35	12	dispersion	1.8	sand	1%
D50	43	17	skewness	0.00	gravel	70%
D65	57	20			cobble	29%
D84	78	29			boulder	0%
D95	97	39

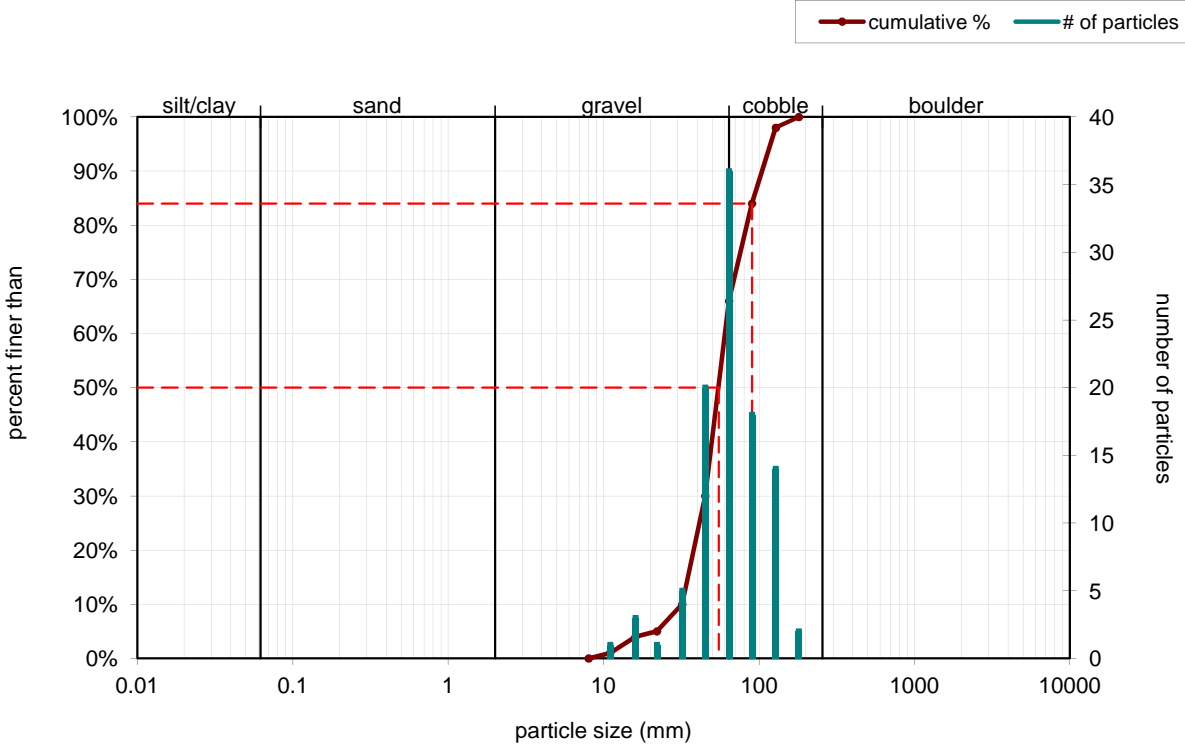
A-7. Bed particle distribution at station 19+00 (riffle/run/pool) - Segment II, Herrick Hollow Creek (October 2011)

Size (mm)		Size Distribution		Type	
D16	35	mean	56.1	silt/clay	0%
D35	47	dispersion	1.6	sand	0%
D50	55	skewness	0.01	gravel	66%
D65	63			cobble	34%
D84	90			boulder	0%
D95	120

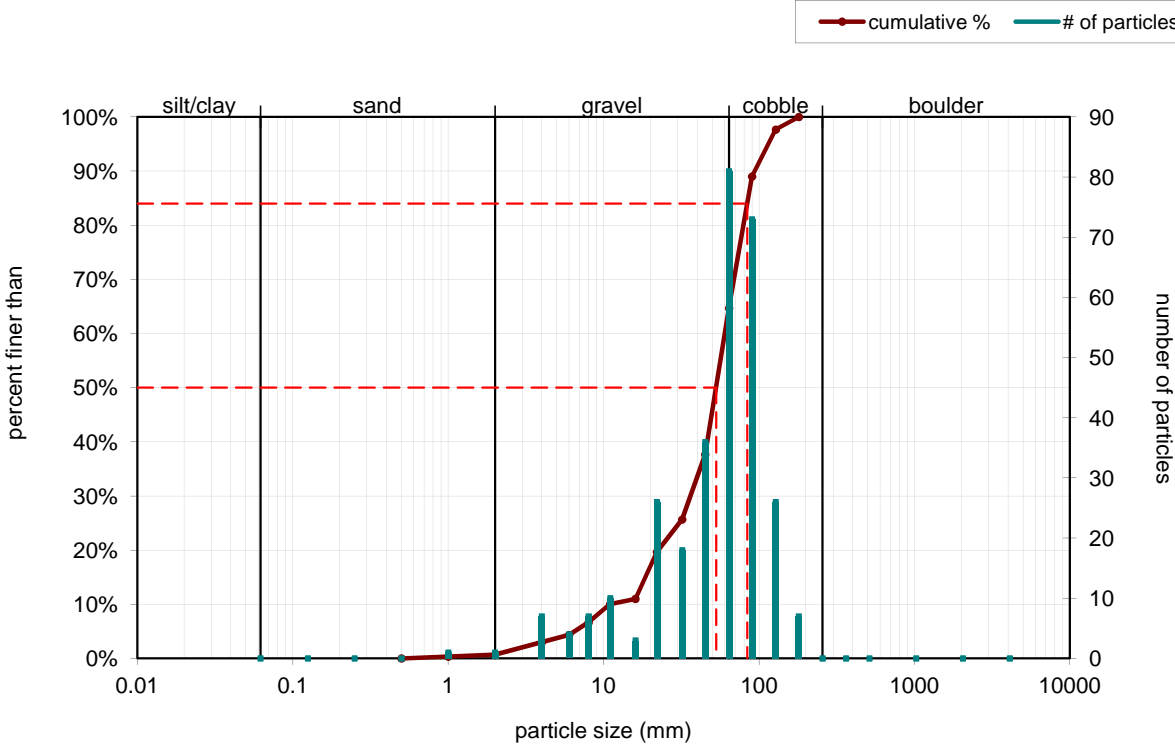
A-8. Cumulative weighted bed particle distribution - Segment III (22+00 to 35+00), Herrick Hollow Creek (October 2011)

Size (mm)		Size Distribution		Type	
D16	19	mean	39.9	silt/clay	0%
D35	42	dispersion	2.2	sand	1%
D50	53	skewness	-0.15	gravel	64%
D65	64			cobble	35%
D84	84			boulder	0%
D95	110

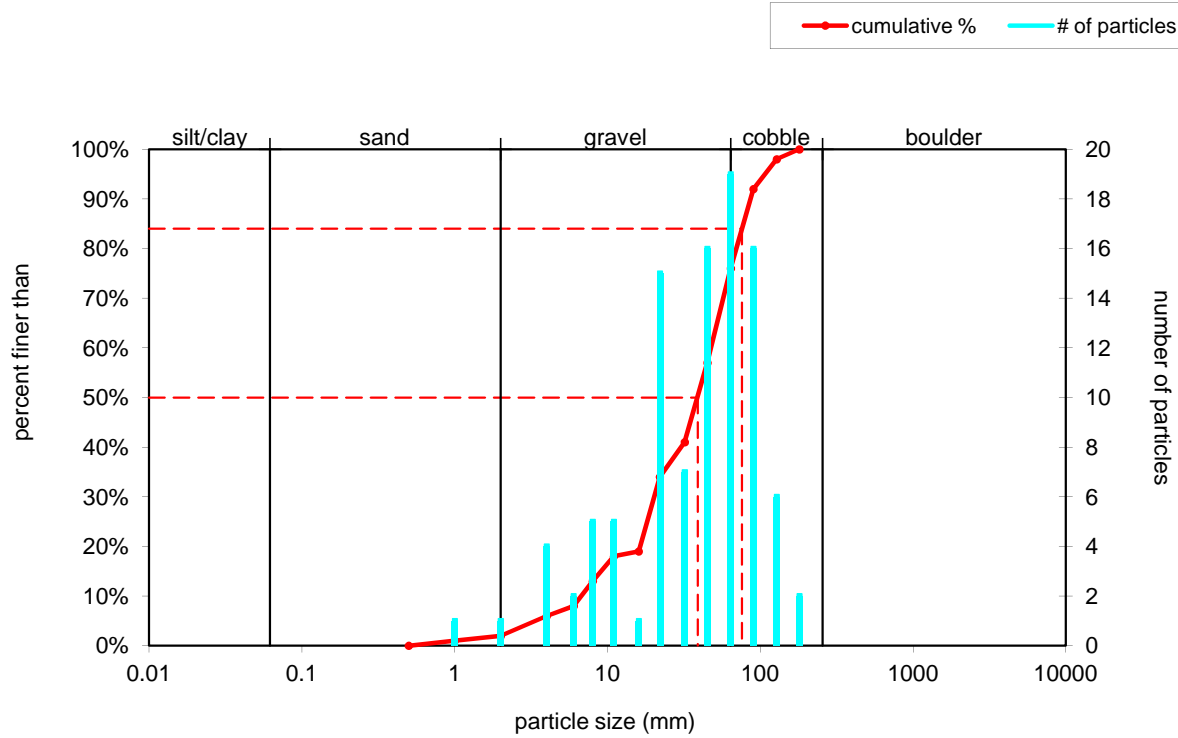
A-9. Bed particle distribution at station 22+00 (riffle/run/pool) - Segment III, Herrick Hollow Creek (October 2011)

Size (mm)			Size Distribution		Type	
D16	9.7	3.4	mean	27.2	silt/clay	0%
D35	23	12	dispersion	3.0	sand	2%
D50	39	17	skewness	-0.17	gravel	74%
D65	52	20			cobble	24%
D84	76	29			boulder	0%
D95	110	39

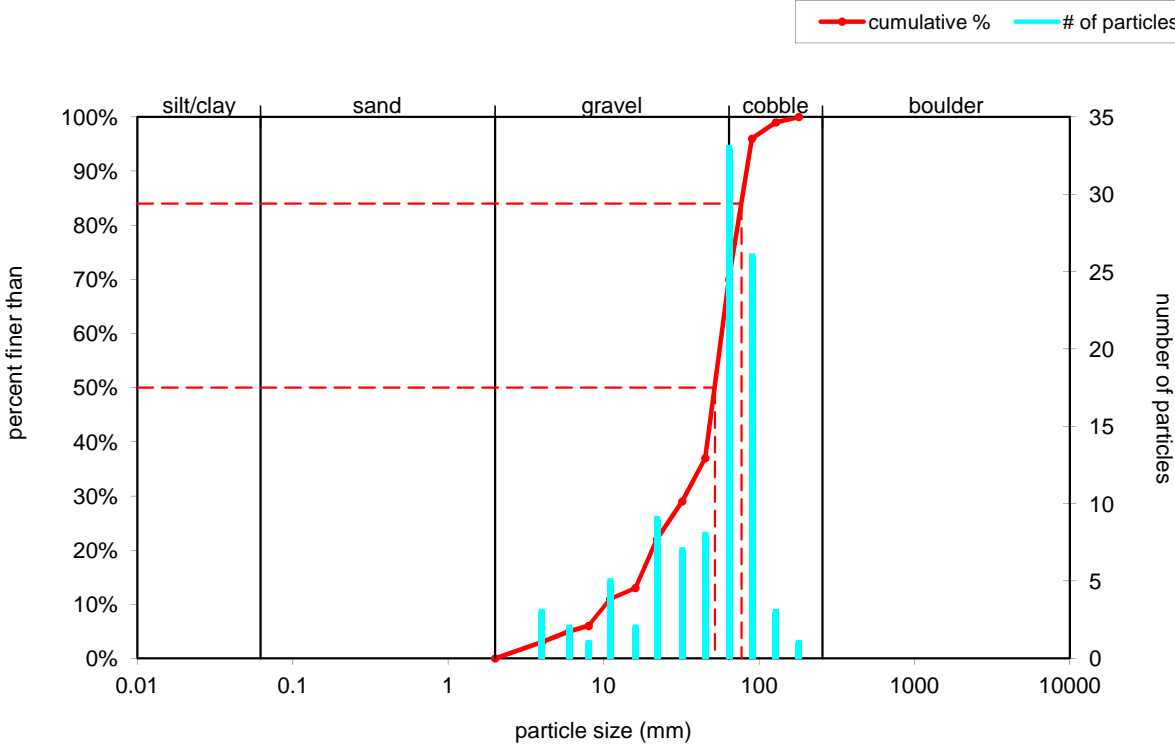
A-10. Bed particle distribution at station 24+50 (riffle/run/pool) - Segment III, Herrick Hollow Creek (October 2011)

Size (mm)		Size Distribution		Type	
D16	18	mean	37.2	silt/clay	0%
D35	41	dispersion	2.2	sand	0%
D50	52	skewness	-0.18	gravel	70%
D65	61			cobble	30%
D84	77			boulder	0%
D95	89

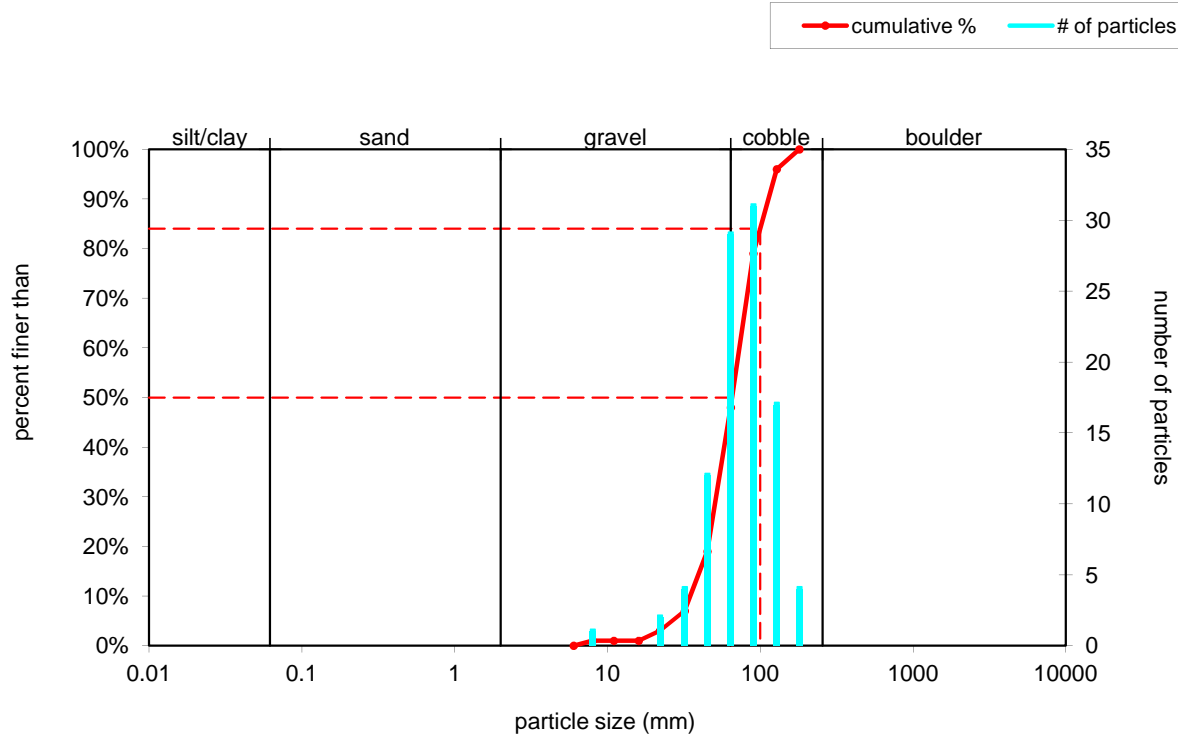
A-11. Bed particle distribution at station 30+00 (riffle/run/pool) - Segment III, Herrick Hollow Creek (October 2011)

Size (mm)			Size Distribution		Type	
D16	41	3.4	mean	64.0	silt/clay	0%
D35	55	12	dispersion	1.6	sand	0%
D50	65	17	skewness	-0.01	gravel	48%
D65	77	20			cobble	52%
D84	100	29			boulder	0%
D95	130	39

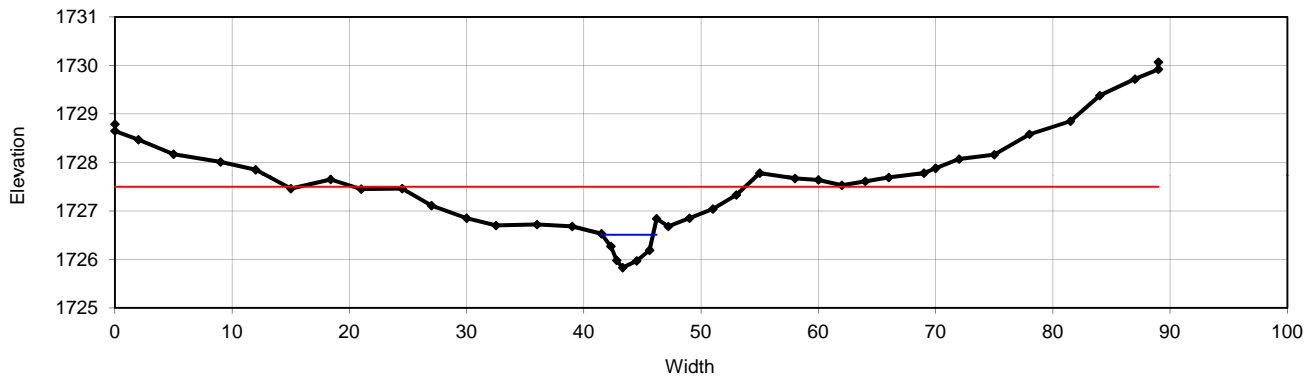
B-1. XS #1 at station 4+63 (run) - Segment I, Herrick Hollow Creek (October 2011)

1.8	x-section area (ft.sq.)
4.3	width (ft)
0.4	mean depth (ft)
1.0	max depth (ft)
6.0	wetted parimeter (ft)
0.3	hyd radi (ft)
10.2	width-depth ratio

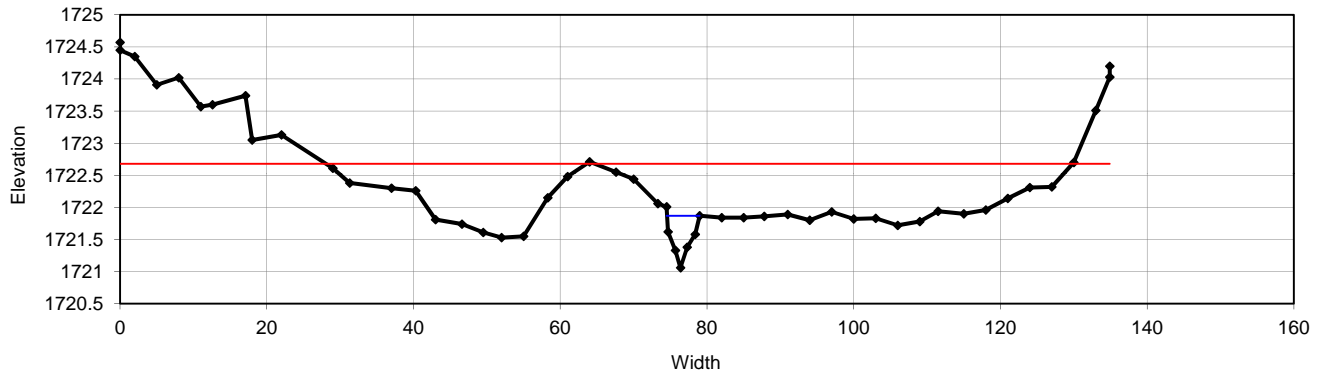
B-3. XS #2 at station 6+92 (riffle) - Segment I, Herrick Hollow Creek (October 2011)

2.0	x-section area (ft.sq.)
4.4	width (ft)
0.4	mean depth (ft)
0.8	max depth (ft)
4.8	wetted parimeter (ft)
0.4	hyd radi (ft)
9.9	width-depth ratio

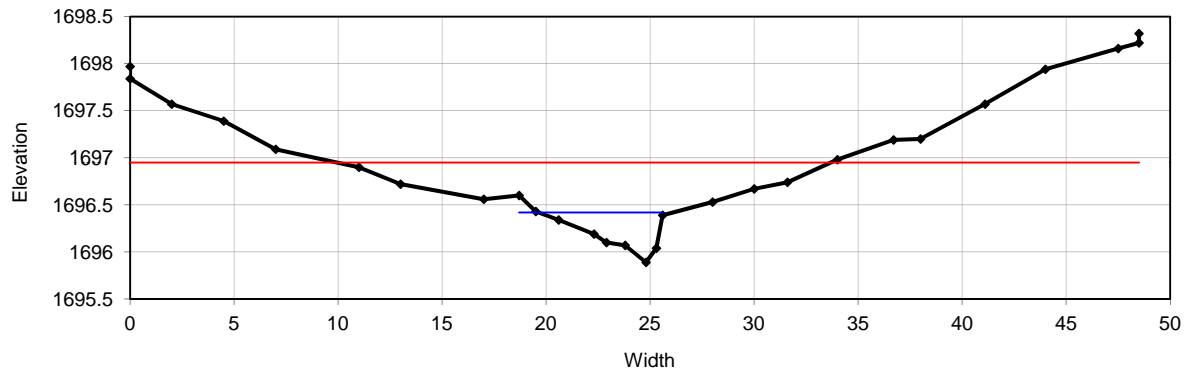
B-5. XS #3 at station 11+75 (run) - Segment II, Herrick Hollow Creek (October 2011)

1.5	x-section area (ft.sq.)
6.0	width (ft)
0.3	mean depth (ft)
0.5	max depth (ft)
6.2	wetted parimeter (ft)
0.2	hyd radi (ft)
23.9	width-depth ratio

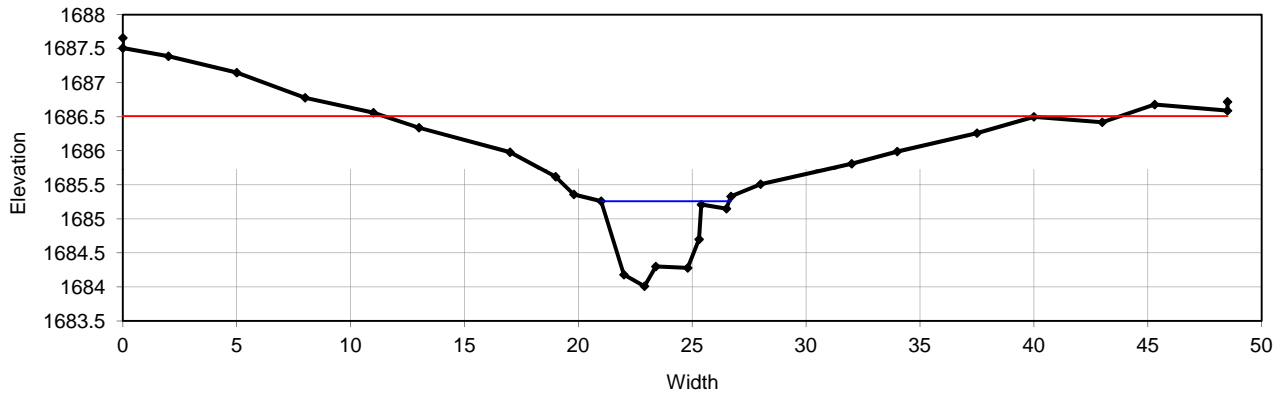
B-7. XS #4 at station 15+19 (riffle) - Segment II, Herrick Hollow Creek (October 2011)

4.0	x-section area (ft.sq.)
5.6	width (ft)
0.7	mean depth (ft)
1.3	max depth (ft)
6.8	wetted parimeter (ft)
0.6	hyd radi (ft)
7.9	width-depth ratio

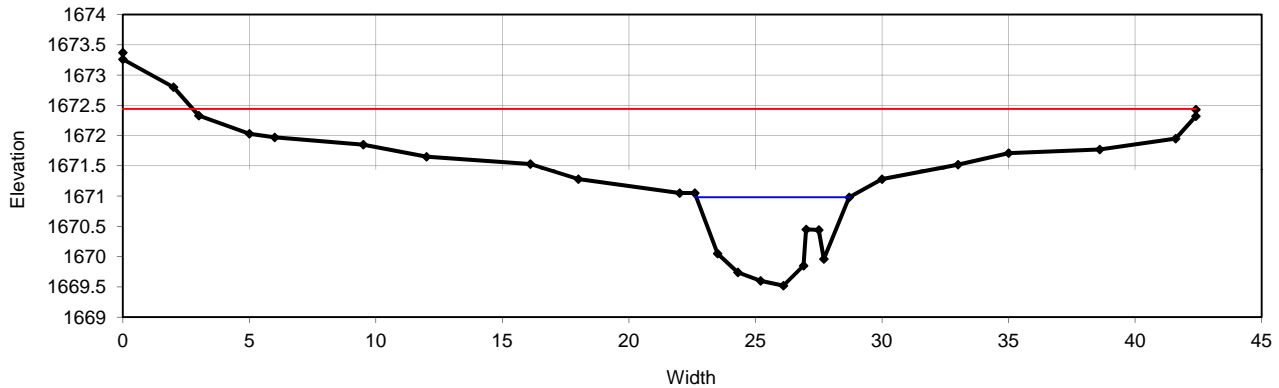
B-9. XS #5 at station 20+05 (run) - Segment II, Herrick Hollow Creek (October 2011)

5.8	x-section area (ft.sq.)
6.0	width (ft)
1.0	mean depth (ft)
1.5	max depth (ft)
7.8	wetted parimeter (ft)
0.7	hyd radi (ft)
6.3	width-depth ratio

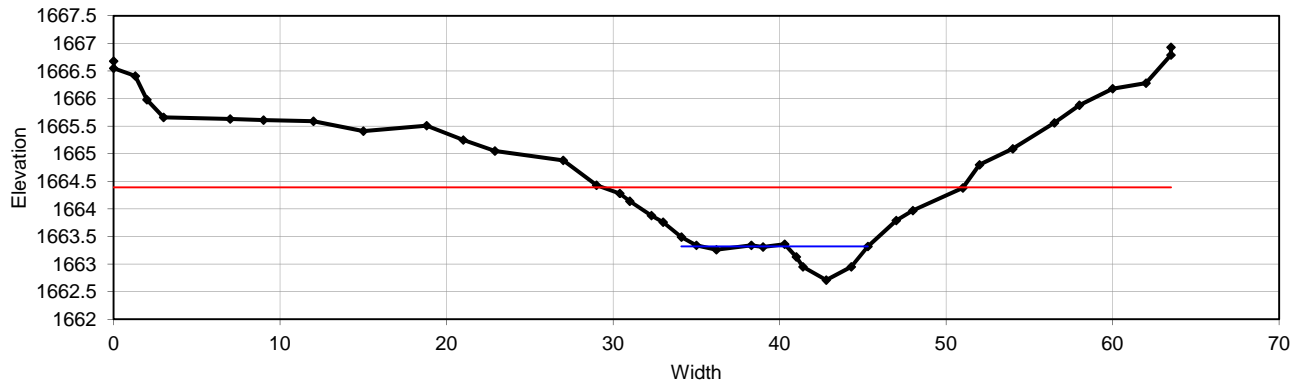
B-11. XS #6 at station 22+18 (pool) - Segment III, Herrick Hollow Creek (October 2011)

1.8	x-section area (ft.sq.)
7.8	width (ft)
0.2	mean depth (ft)
0.6	max depth (ft)
8.0	wetted perimeter (ft)
0.2	hyd radi (ft)
33.3	width-depth ratio

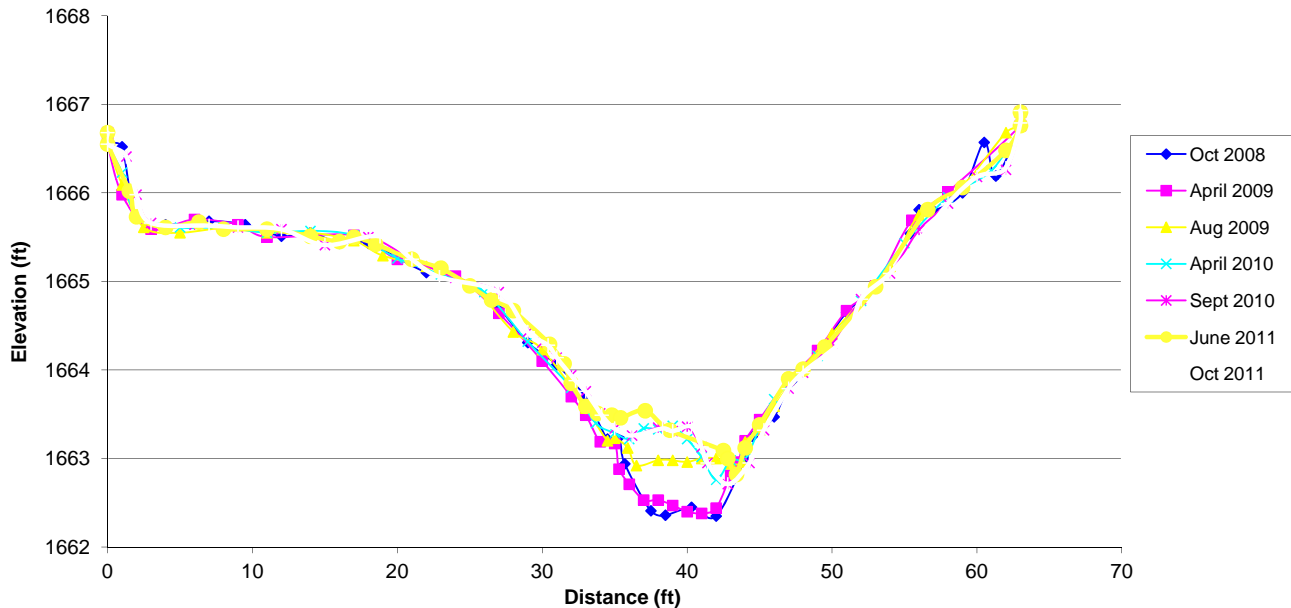
B-12. Comparison of cross-section surveys at XS #6 (21+18) - October 2008 to October 2011

At cross section #6, comparison of previous surveys with those collected in 2011 reflects little change in channel geometry within this area of slope transition. Due to the stable nature of Segment II upstream and subsequent reduction in bedload moving from Segment II to Segment III, the channel aggrading anticipated in this area as a result of the flood events of May and September 2011 was not observed. This observed condition once again reflects the ability of the channel to mobilize and transport sediment through all three segments of the restored reach effectively, without formation of areas of excessive sediment deposition or scour.

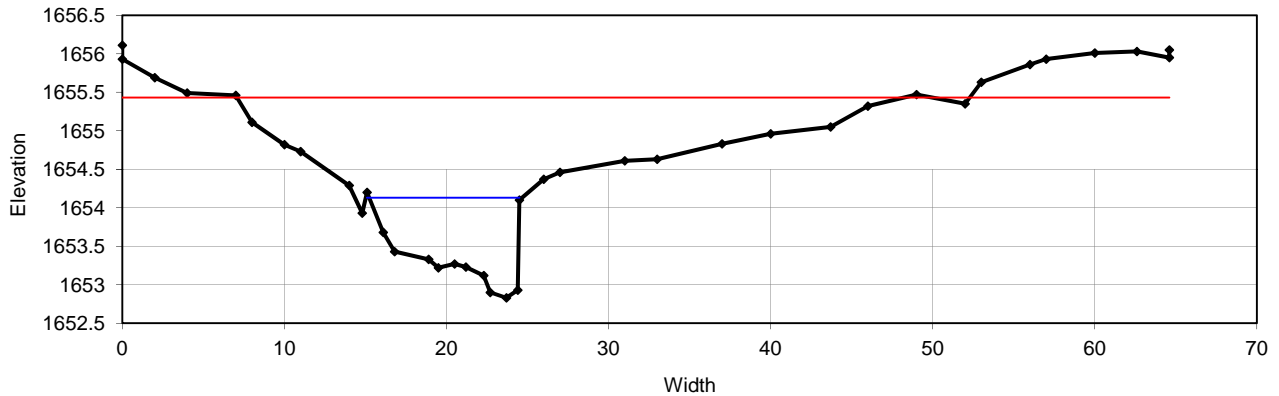
B-13. XS #7 at station 28+25 (riffle) - Segment III, Herrick Hollow Creek (October 2011)

7.9	x-section area (ft.sq.)
9.3	width (ft)
0.9	mean depth (ft)
1.3	max depth (ft)
10.6	wetted parimeter (ft)
0.7	hyd radi (ft)
10.9	width-depth ratio

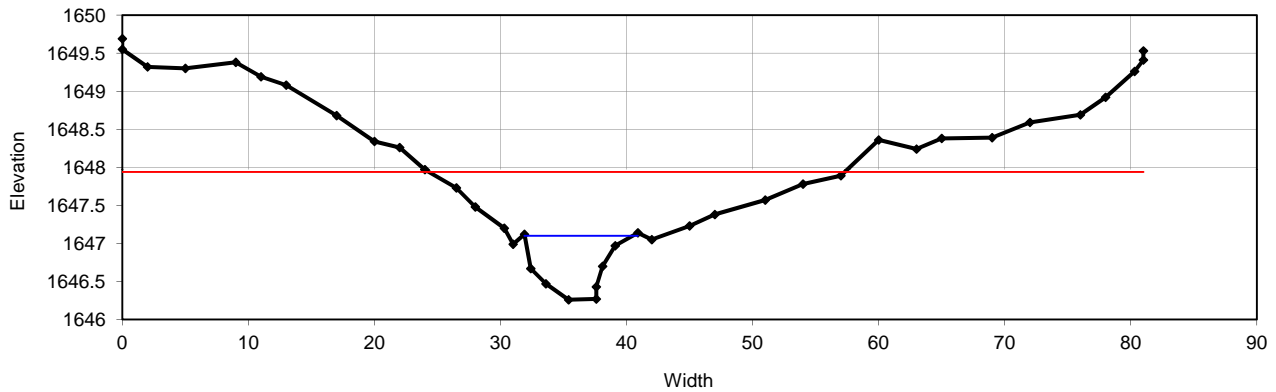
B-15. XS #8 at station 2+76 (riffle) - Segment III, Herrick Hollow Creek (October 2011)

4.5	x-section area (ft.sq.)
8.6	width (ft)
0.5	mean depth (ft)
0.8	max depth (ft)
9.0	wetted parimeter (ft)
0.5	hyd radi (ft)
16.2	width-depth ratio
