**Brown and Caldwell Associates**

**Letter Report**

Subject: Completion Letter Report  
Gas Utility (PL E-20) Partial Replacement Project  
Troy, Rensselaer County, New York  
NYSDEC Site No. 4-42-029

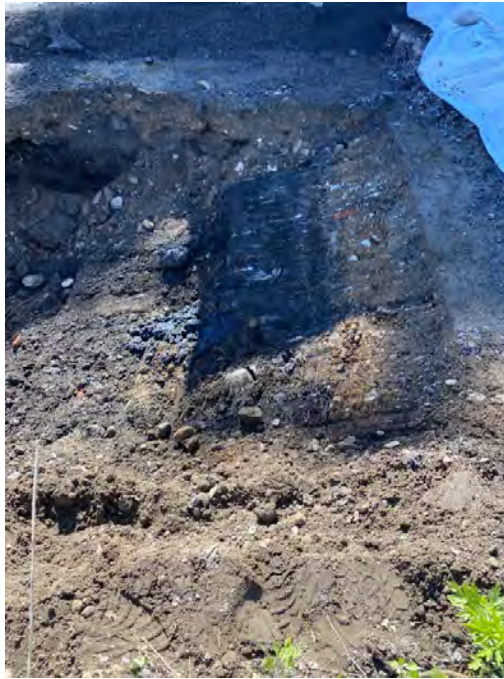
Photograph #39 – View looking west. Photo depicts a layer of tacky tar-like material approximately 1 ft. bgs at test pit completed at Sta. 22+53 on CSX property. (Photo Taken 6/10/2022).

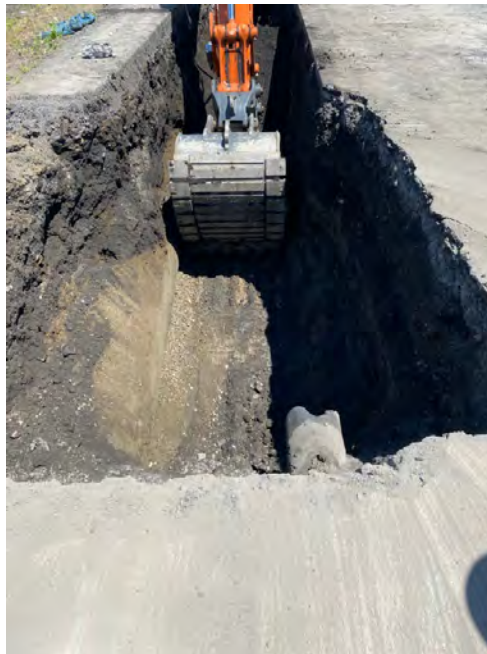
Photograph #40 – View looking north. Trench excavation starting at Sta. 22+00 on CSX property after skipping approximately 278 linear feet north due to potential for tar-like material. Photo also depicts the north-south orientated 42" diameter sewer force main (left) approximately 4.7 ft. bgs. (Photo Taken 6/14/2022).

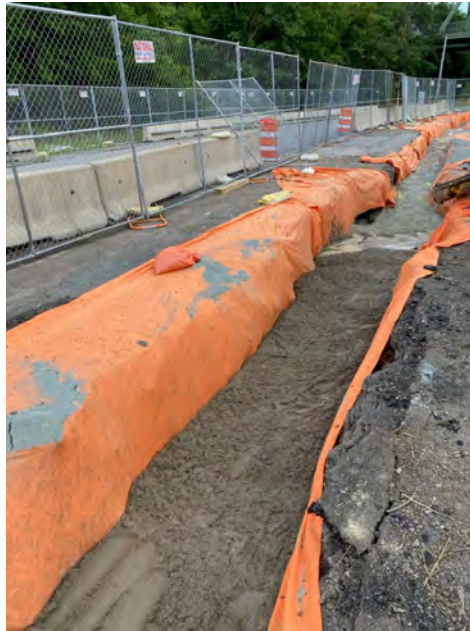
Photograph #47 – View looking southeast. Placement of flowable fill over bedding sand on Area 2 (vicinity of Sta. 11+00). (Photo Taken 7/21/2022).

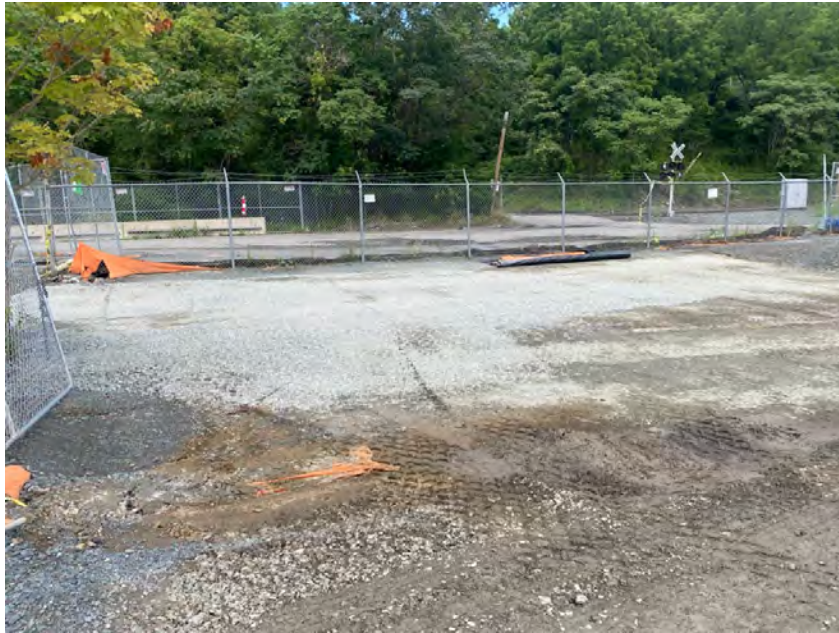
Photograph #49 – View looking east. Final site cover restoration over newly installed gas transmission line on Area 3 (vicinity of Sta. 13+00). (Photo Taken 7/28/2022).

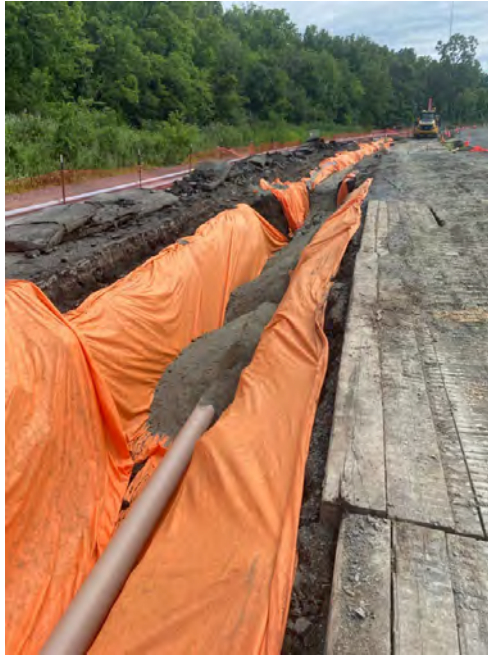
Photograph #56 – View looking southeast. Installation of non-woven, orange-colored geotextile fabric within the trench on CSX property. White line is approximately 10 feet north of last visual observation of tar-like material. LLDPE liner, sandwiched between non-woven, orange-colored geotextile fabric, was installed within the trench up to at least that line (approx. Sta. 23+32) from approx. Sta. 24+78. (Photo Taken 8/5/2022).

- Due to the presence of tar-like material along the trench sidewalls (refer to Section 2.3), from Station 24+78 to Station 23+32 (146-foot length of trench on CSX property), prior to backfilling, the trench sidewalls and bottom were lined with 20-mil thick linear low-density polyethylene (LLDPE) sandwiched between two layers of non-woven geotextile fabric (4 ounces per square yard and orange in color). The inclusion of the geosynthetics within this section of the trench line was discussed with CSX and approved by the NYSDEC in an email dated August 2, 2022. Refer to Photograph 54 in Attachment B. In addition, from Station 23+32 to Station 21+97 (135-foot length of trench), a single layer of non-woven geotextile fabric (4 ounces per square yard and orange in color) was installed along the trench sidewalls and bottom although no tar-like material was encountered within this stretch.

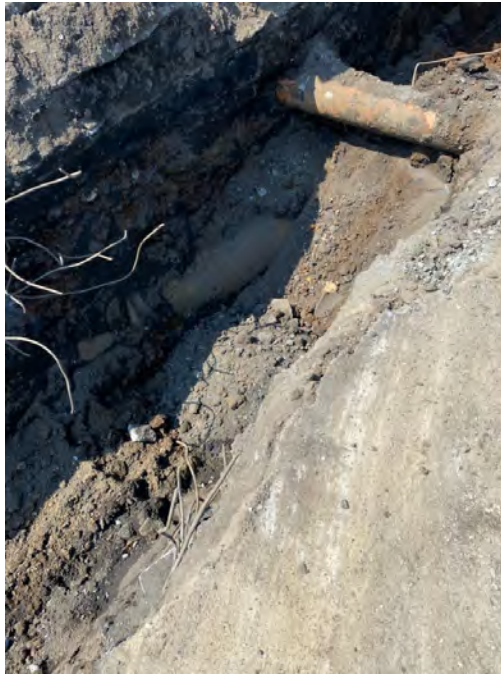
Photograph #59 – View looking northwest. Photo depicts approx. 30" bell-spigot pipe (oriented north-south) encountered at approximately 5.5 ft. bgs on Area 2 (vicinity of Sta. 4+00). Pipe is at a slight northeast to southwest angle and will intercept the trench excavation from approximately Sta. 4+30 to 4+50. Additional east-west oriented pipes also shown in the photo. (Photo Taken 8/25/2022).

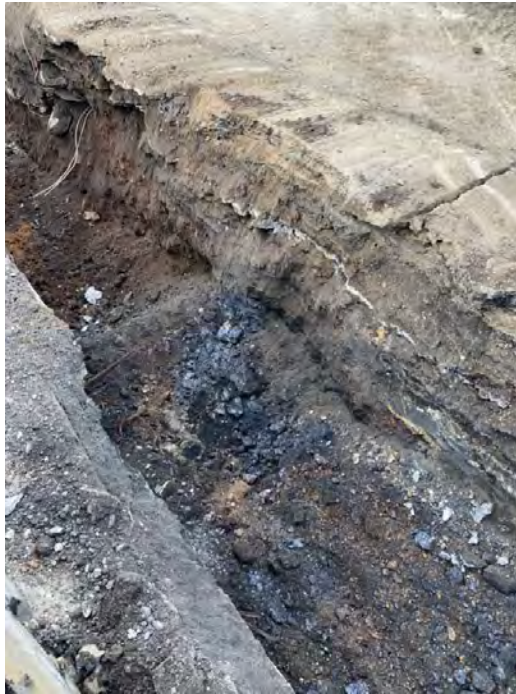
Photograph #61 – View looking east. Excavation and encountered hardened tar-like material at approximately Sta. 3+70 on Area 2. (Photo Taken 8/29/2022).

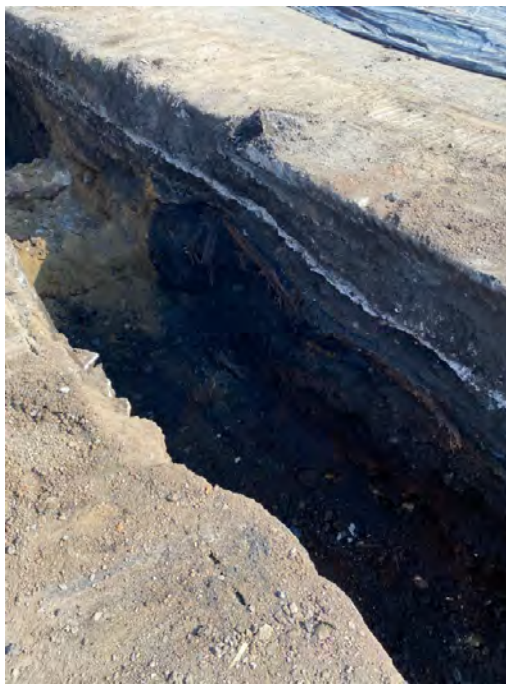
Photograph #62 – View looking east. Excavation and east-west oriented historical pipes encountered within trench at approximately Sta. 3+60 on Area 2. Four 12-inch steel pipes were encountered. All pipes were evaluated, determined to be empty and were removed from the trench and plugged. (Photo Taken 8/29/2022).

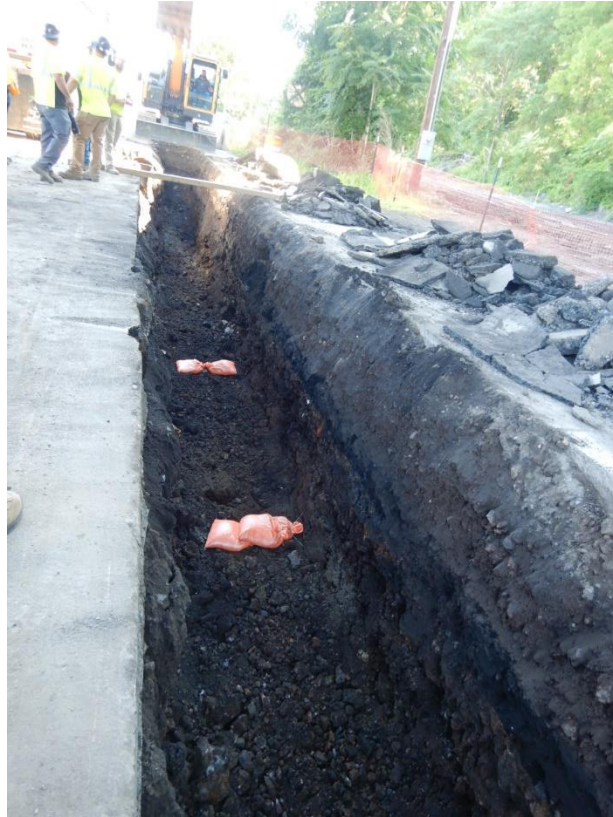
Following the April 2022 Archeological Monitoring Plan for the PL E-20 Project, an archeological monitor from Hartgen was either present or was on-call for trench excavation (Photo 1) in three segments of the Project, as indicated in Table 1, below.

Photo 1. Typical trench excavation, near Station 16+50. The orange sand bags will support the new gas pipeline once lowered into the trench. View facing north northeast.

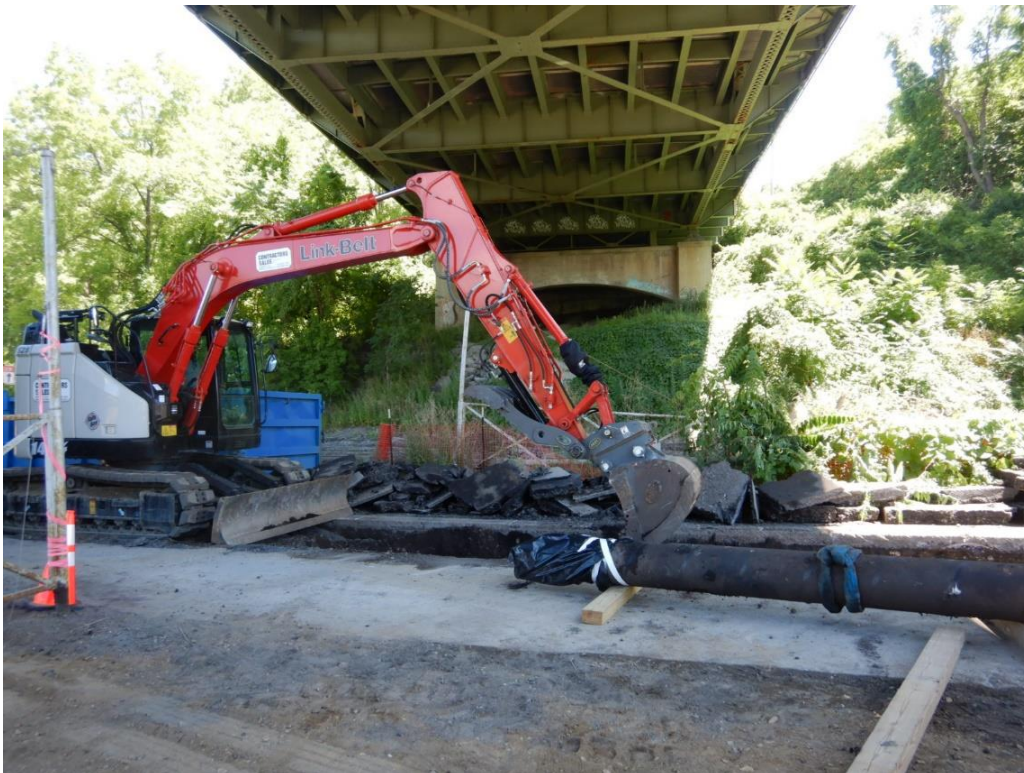
Typical equipment used was a tracked backhoe with a toothed, 3-foot wide bucket (Photo 2).

The Troy-Menands Bridge (NY Route 378) over the Hudson River is roughly at the boundary between Segments B and C (Photo 2).

Photo 2. Menands-Troy Bridge (NY Route 378) over the Hudson River, and over River Road and the Project on the east shore of the Hudson River. View facing east.

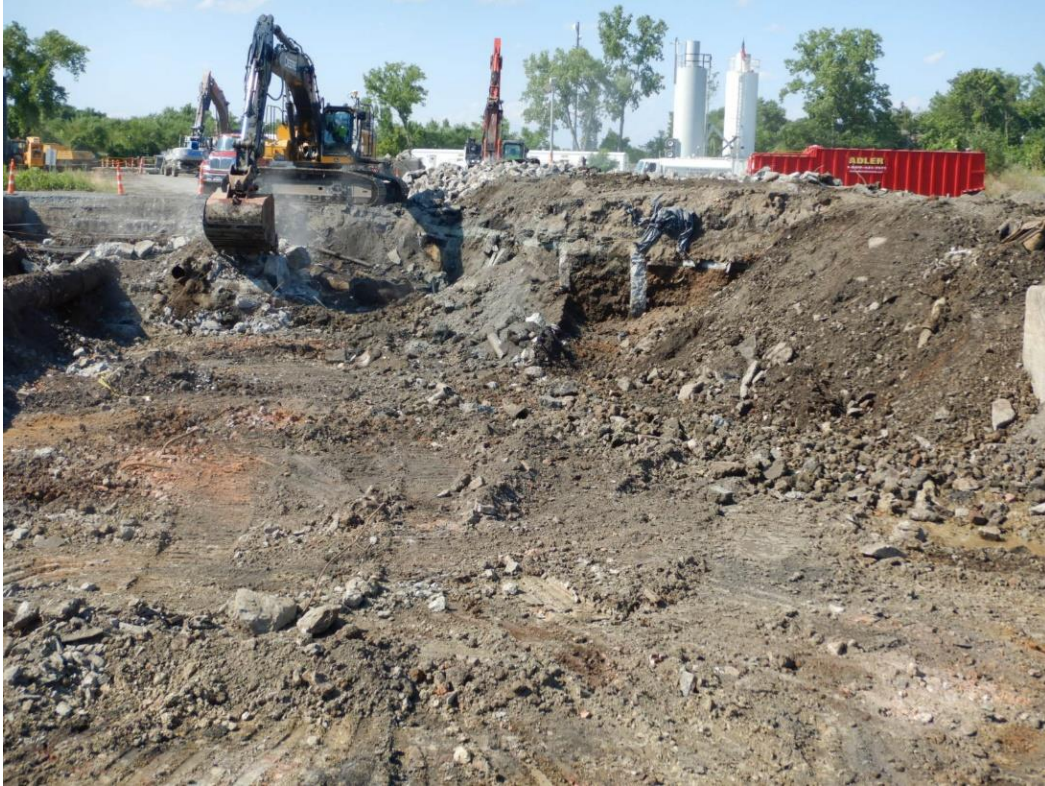
Trench excavation in Segment A was conducted from July 18 to August 25, 2022. The initial excavations between Stations 5+25 and 6+65, however, were done between July 11 and July 29, 2022 as part of the concurrent remediation activities at Area 2 of the Troy (Water Street) Site (Photo 3).

Photo 3. Remediation excavation at the Area 2 location, to approximately 10 feet below surface. View facing north.

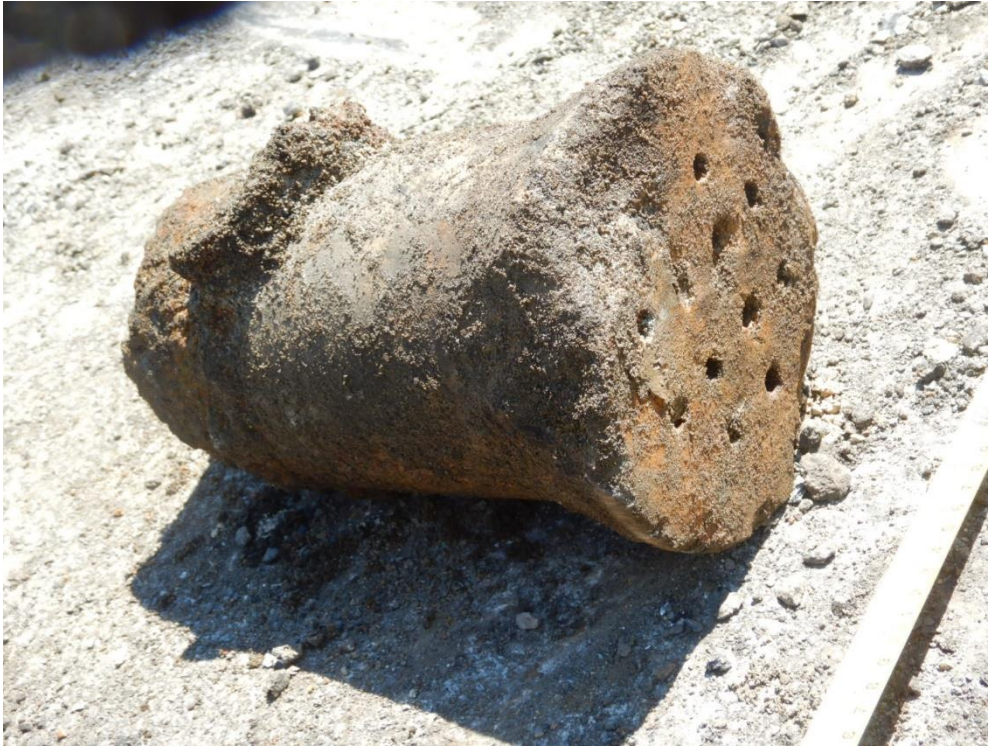
Scores of ceramic tuyeres were noted at the project (Photo 12). A *tuyère* can be any system for bringing air or other gases into an enclosed space, especially a furnace. The tuyeres found at the Project appeared similar to the bottom ends of the tuyeres illustrated for steel converting vessels.

Photo 12. *Tuyère* variety found south of Station 15+80 and in Area 3. It has 12 holes, measures about 8 inches in diameter at its widest, and is 9 inches long.
