PHASE I
ENVIRONMENTAL SITE ASSESSMENT
OF

DAMBROSE CLEANERS
1517 VAN VRANKEN AVENUE
SCHENECTADY, NEW YORK

October 1997

CHA Project No. 6833.07.01

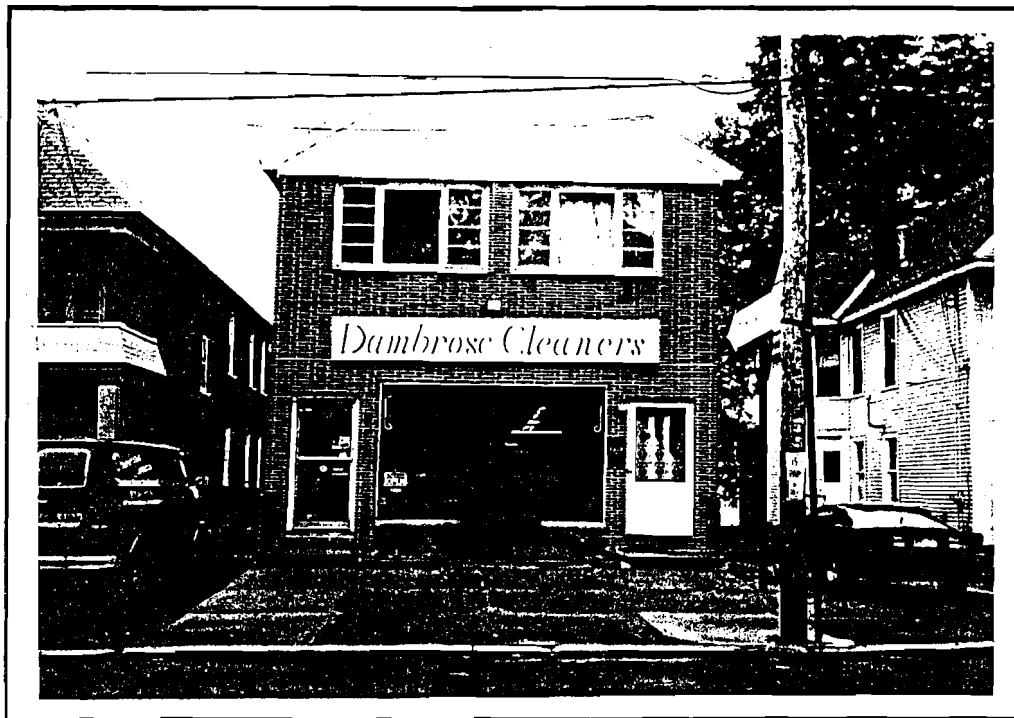
PHOTO #1

The subject site is a rectangular parcel of land measuring 34' x 143' fronting on the western side of Van Vranken Avenue. The majority of the subject site is occupied by a two-story wood frame and masonry building (Photo 1) used for dry cleaning purposes on the first floor and residential purposes on the second floor. The lay-out of the first floor consists of a customer counter at the entrance to the cleaners, clothing racks in the center portion of the floor, and the dry cleaning machine and associated equipment located in the rear portion of the building. The second floor consists of a typical apartment lay-out with kitchen, bedroom, bath, and living areas. The building is underlain by a full basement which is used for storage of miscellaneous supplies and equipment. The entire structure is heated via an oil-fired boiler system located in the basement of the building. ^{CONCRETE BLOCK} A small wood frame garage is located adjacent to the southwestern corner of the main building. The remaining portions of the subject site not encompassed by structures are covered by either concrete or asphalt paved surfaces. A Site Plan has been included as Figure 2.

FRONT VIEW OF SITE BUILDING

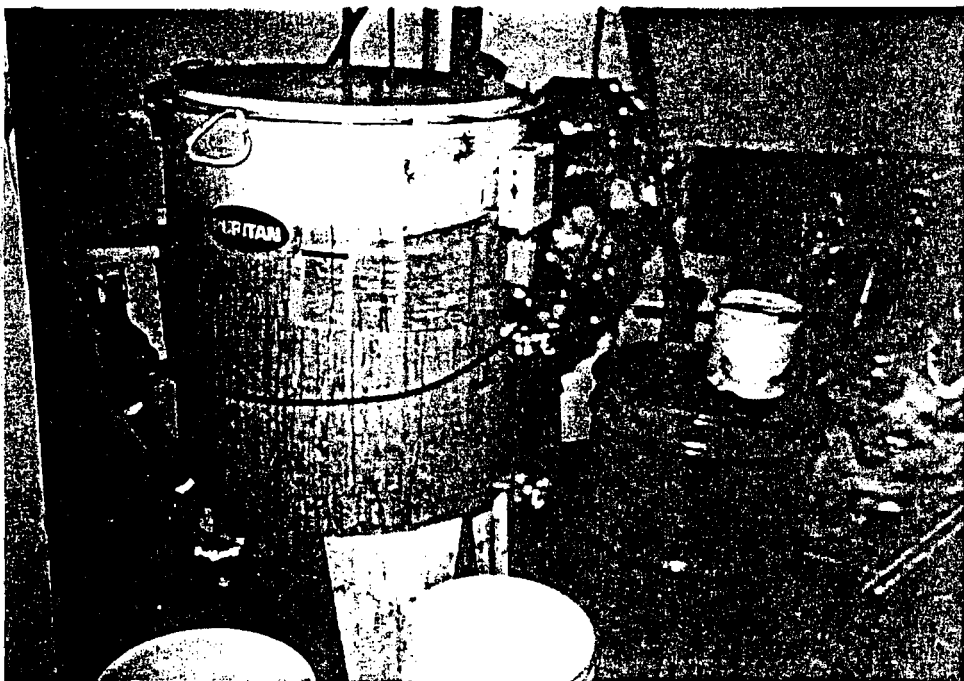
PHOTO #6

distillation tank is located in the southwestern portion of the first floor (Photo 6). Reclaimed solvent is collected in an open plastic five-gallon buscket (Photo 7) and manually dumped back into the cleaning machine tanks. Distillation condensate is collected in an open plastic five-gallon bucket (Photo 8) which is then manually transferred into a "Mist-It" filter unit (Photo 9). The "Mist-It" filter unit further removes any solvent from the condensate water. Condensate from the "Mist-It" unit is collected in an open plastic five-gallon bucket (Photo 10) and dumped to the municipal sewer system via the toilet. Prior to use of the filter unit, condensate was supposedly dumped, via the toilet, directly to the municipal sewer system. The condensate was, reportedly, never accumulated into drums, piped to a storage tank, or discharged to the exterior of the building.

DISTILLATION TANK

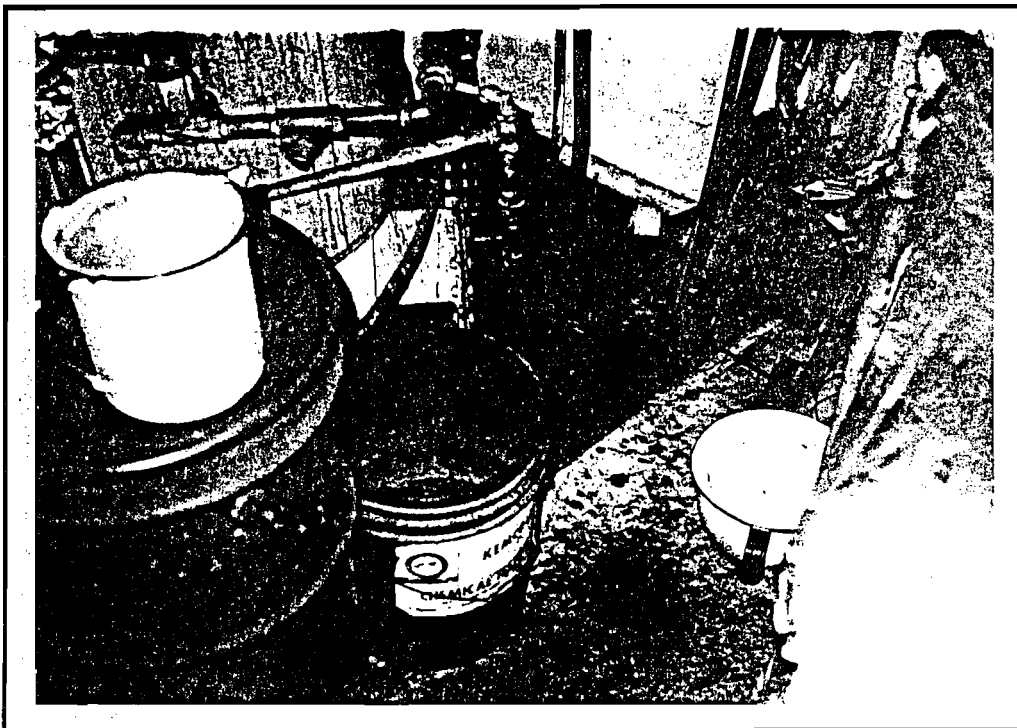
PHOTO #8 5.1.2

DISTILLATION CONDENSATE
COLLECTION VESSEL

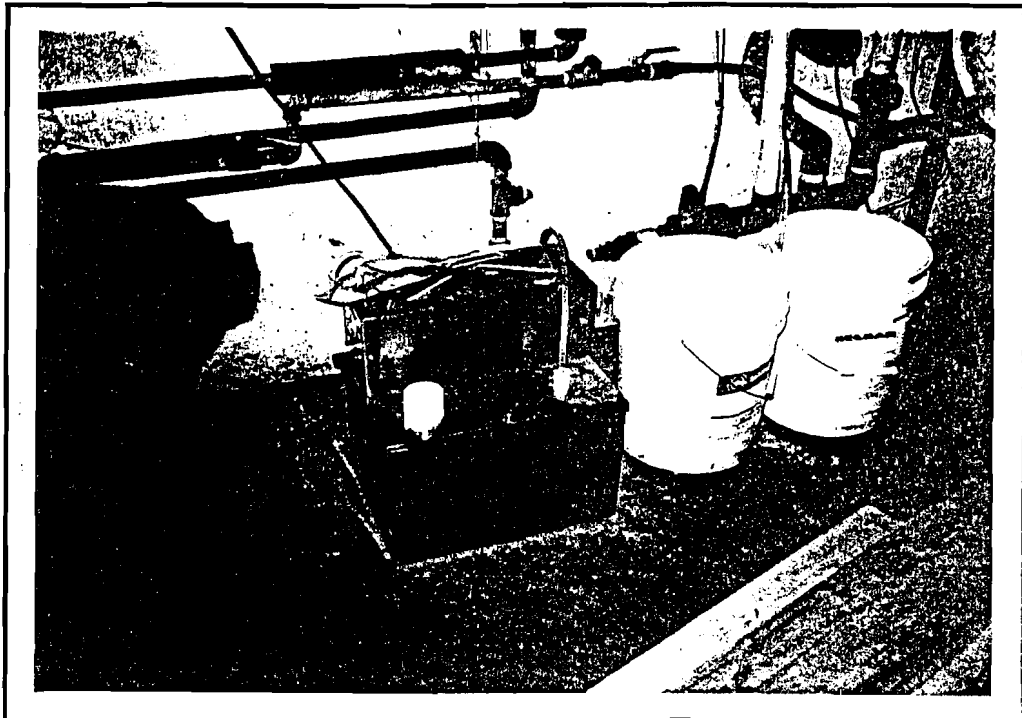
PHOTO #9

MIST-IT UNIT

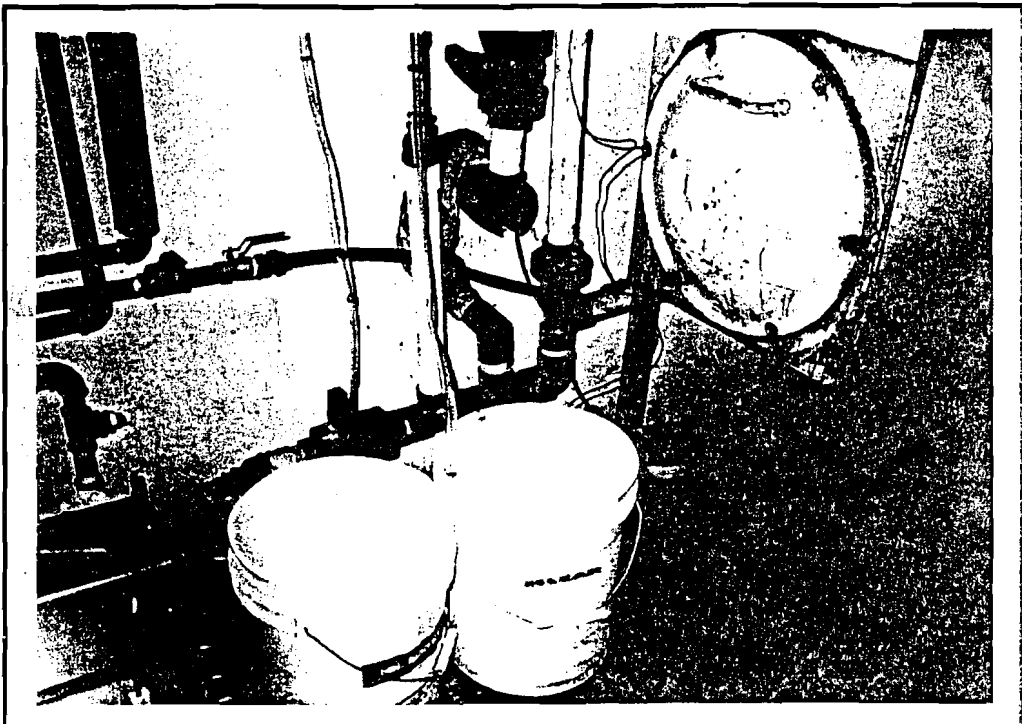
PHOTO #10

WATER COLLECTION
FROM MIST-IT UNIT
