Subject: **Mechanicville Site Management  
Annual Status Report  
Site #: 546033  
NYSEG – Mechanicville Central Avenue Former MGP Site**

On behalf of New York State Electric and Gas Corporation (NYSEG), AECOM has prepared this letter to describe events associated with site management activities at the Mechanicville Central Avenue Former Manufactured Gas Plant (Site) in Mechanicville, NY. The report summarizes the annual activities performed at the Site in 2018 in accordance with the site management plan (SMP) approved by the New York State Department of Environmental Conservation (NYSDEC) in April 2011 as well as the periodic review report (PRR) approved by the NYSDEC in August 2016.

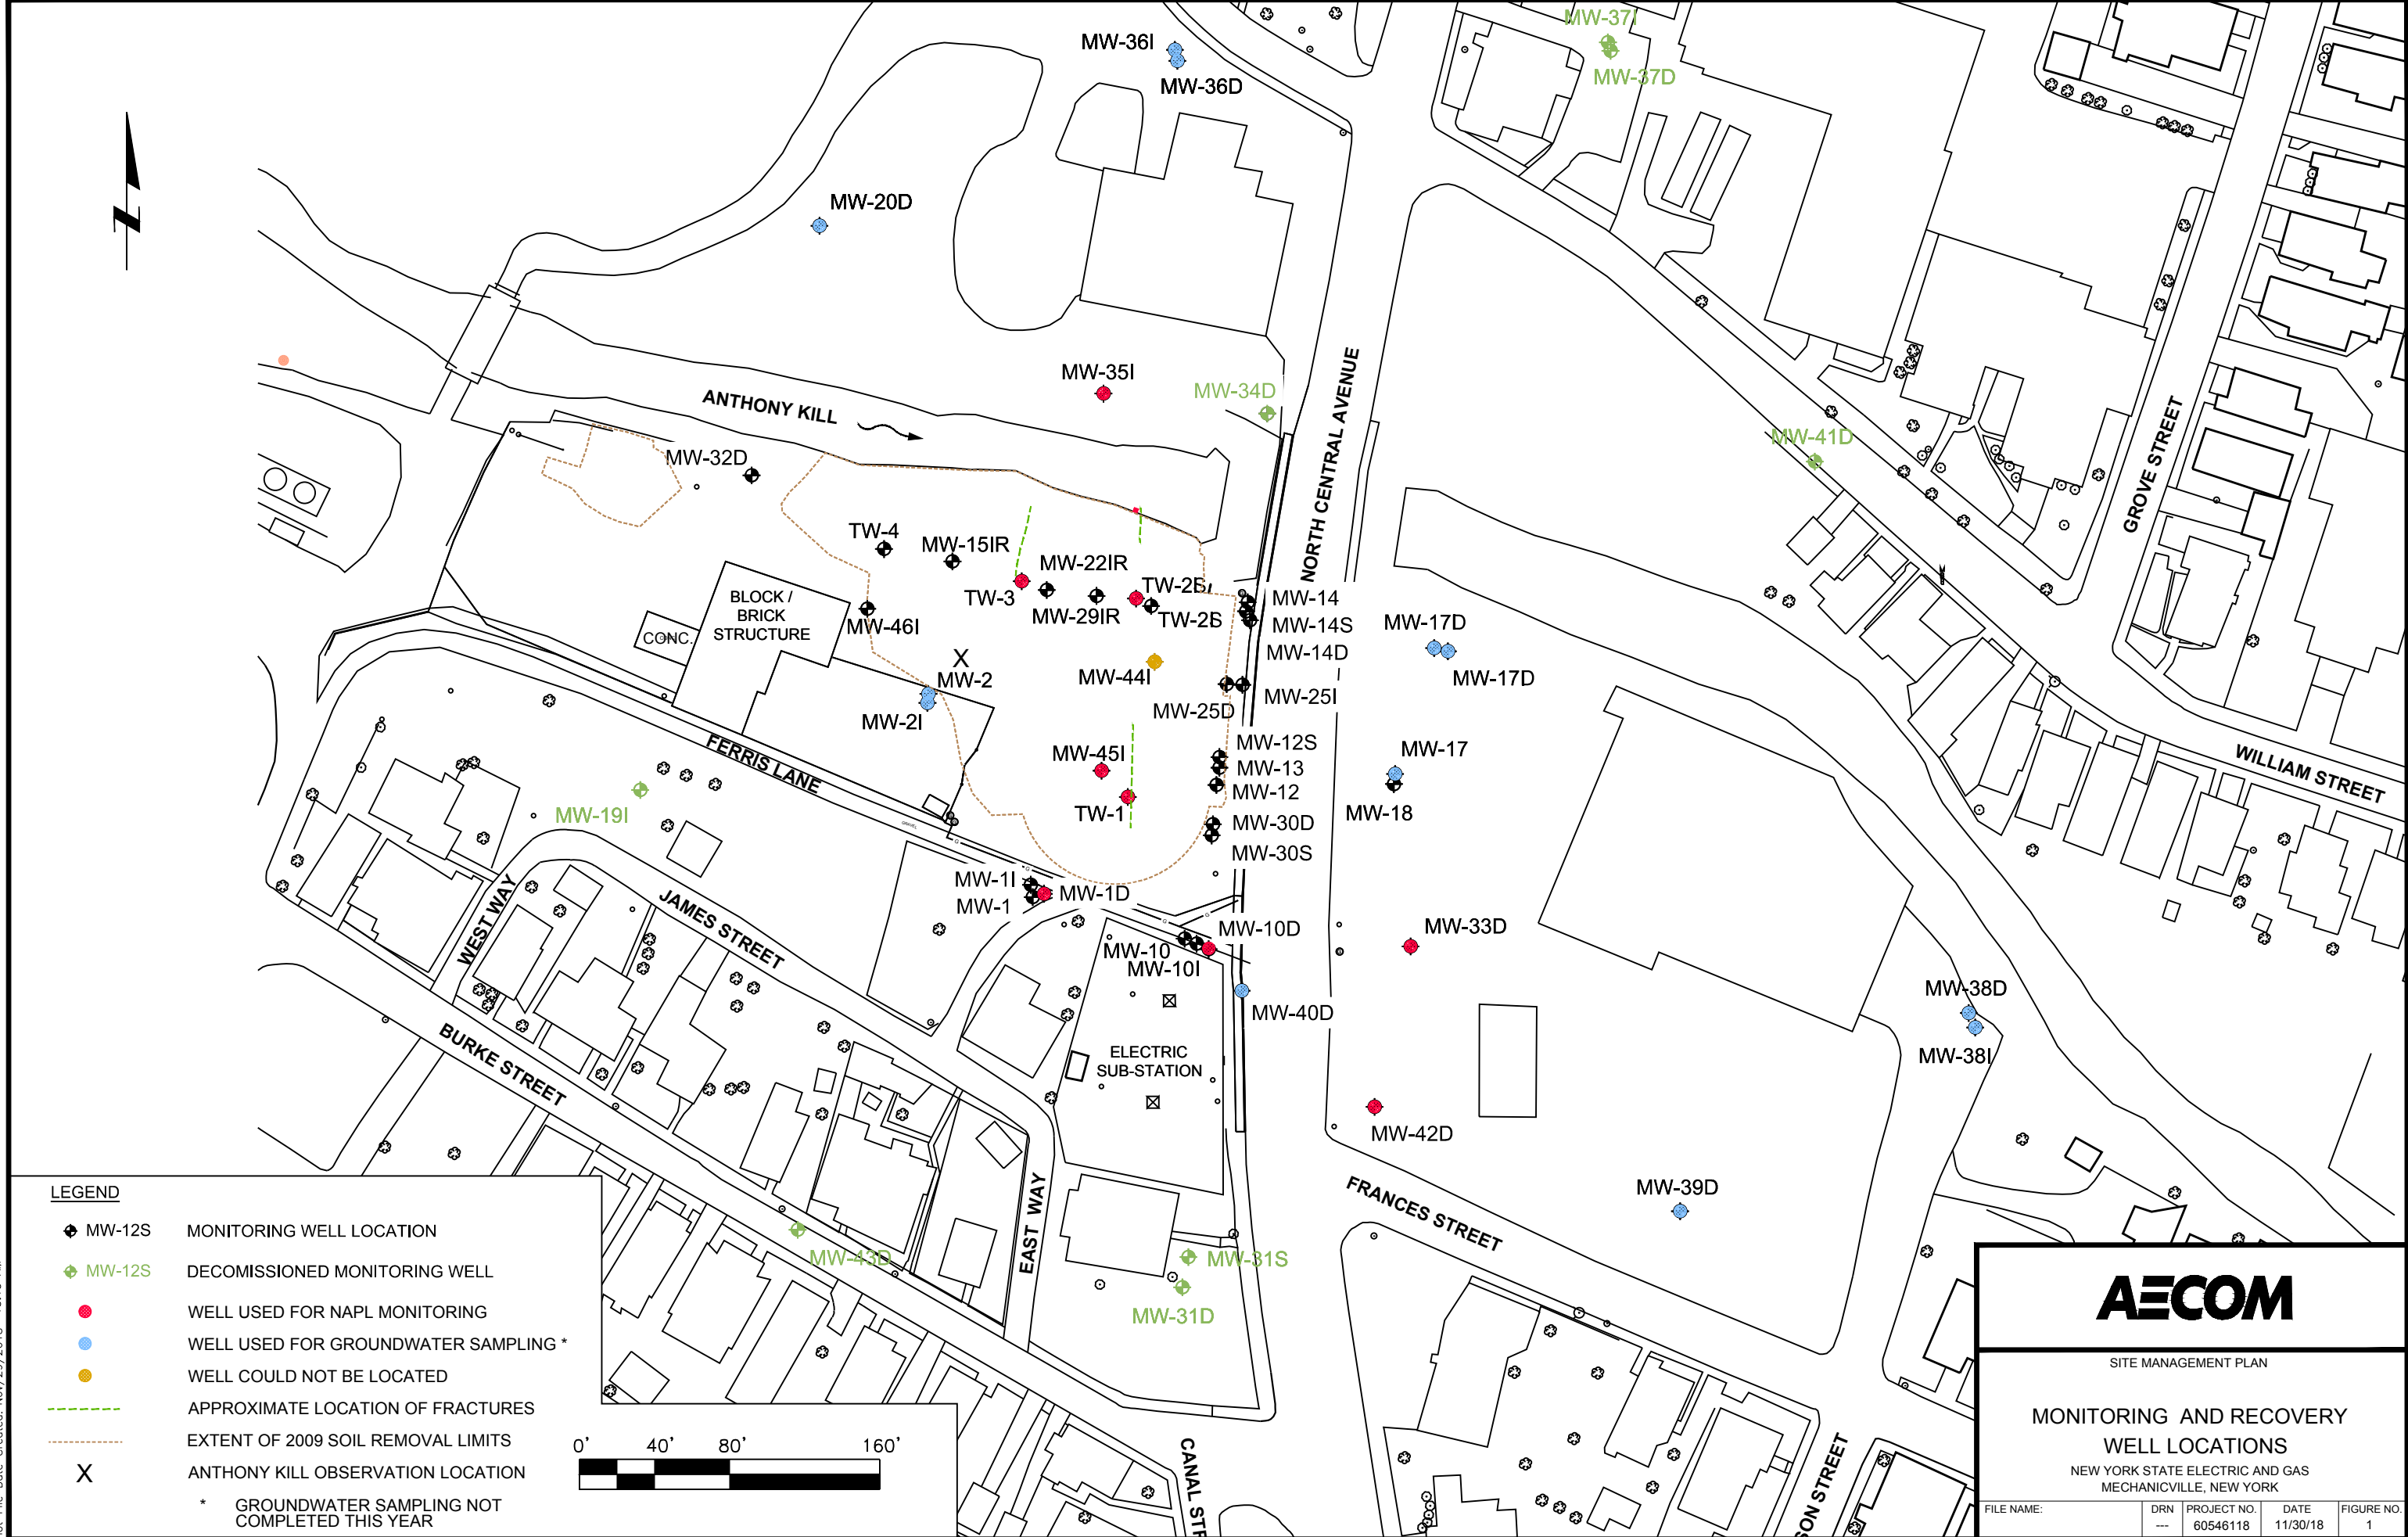
On August 31, 2018, wells TW-1, TW-2, TW-3, MW-1D, MW-10D, MW-33D, MW-42D and MW-45I were monitored to measure the presence of NAPL in each well. The well locations are depicted in Figure 1. To measure NAPL, a weighted cotton string was lowered down the monitoring well casing until the bottom of the monitoring well was reached. The string was then removed from the well and the length of NAPL present on the string was measured. Well MW-34D was decommissioned during

the Anthony Kill Bridge replacement activities in 2014 and therefore not gauged. Missing bolts from some of the well covers were replaced during this visit.

A metal detector was used to successfully locate MW-1D, which was covered by stones. The metal detector as well as the survey equipment was used to successfully locate MW-35I in the overgrown area on the car repair property. However a boat and a trailer were parked over it, making the well inaccessible for gauging. Well cover for MW-44I was identified, but there was no sign of well under it. Area around the empty cover was also scanned with the metal detector and the stones were moved in an attempt to locate the well, but MW-44I was not found. Damage to MW-44I was also recorded during the 2016 semi-annual visit and it was noted that the well cover was removed and the top of the well was covered with stone from the recent paving activities at the site. Pictures of the well MW-35I and empty well cover in the general area of MW-44I are included in the photo log (Attachment 1). Based on the observations and failed attempts to locate the well MW-44I, we would request for it to be considered abandoned, and be removed from the NAPL monitoring list.

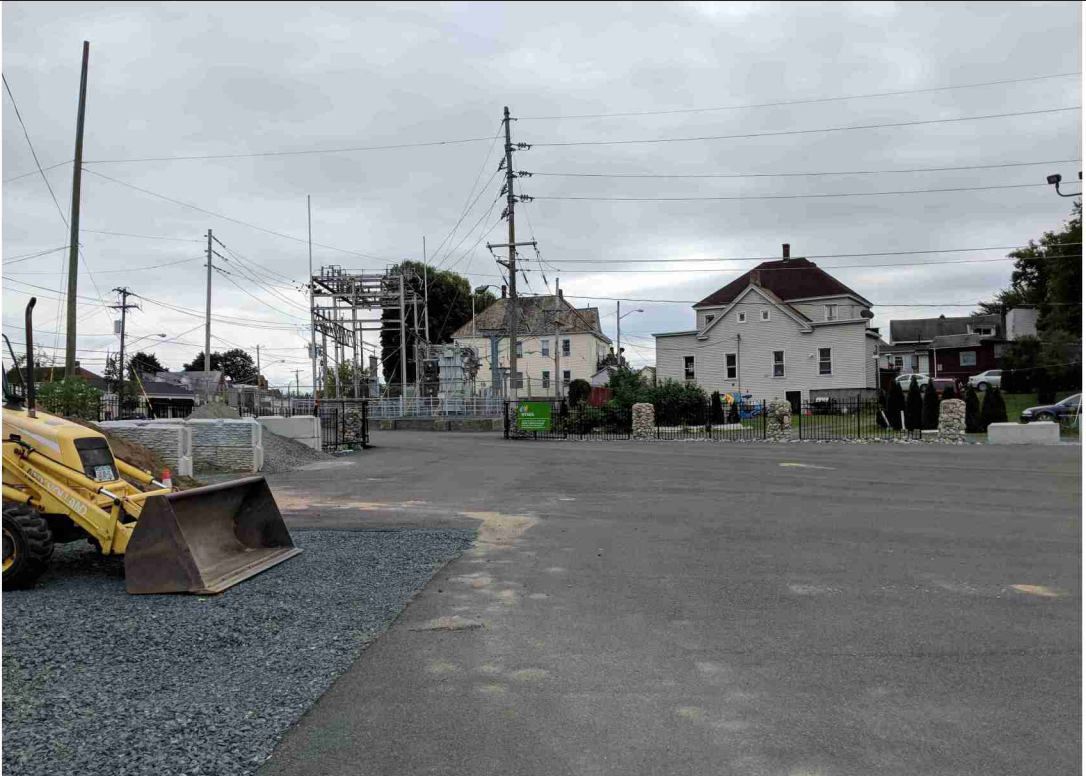
| <b>Photo No.</b><br>3 | <b>Date:</b><br>8/31/18 | | |

| <b>Description:</b><br><br>View of the General Site Area. | | | |
