Re: 2024 Annual Monitoring Report
NYSEG - Mechanicville Central Ave. MGP
Central Avenue, Mechanicville
Saratoga County
Site No.: 546033

Re: NYSEG Mechanicville Central Avenue MGP Site
2024 Annual Monitoring Report

Mechanicville Central Avenue Former MGP
NYSDEC Site No. 546003
2021 PRR & 2023 MW Rehabilitation Recommendation Checklist
For Report:
2024 Annual Monitoring Report prepared by Arcadis

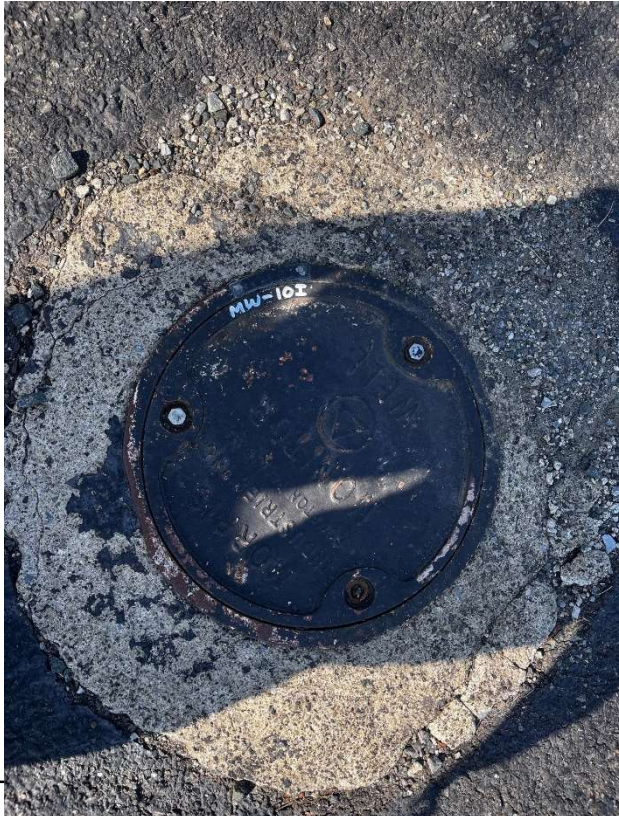
Date: 10/8/2024		
Direction Photo Taken: Downward Description: MW-10I

10/09/2023	15.05		90.84	9.28	81.56	N	0	Well in good condition
	9/27/2022	14.78			3.09	87.75	N	0	--
MW-11	10/07/2024	47.42	45 - 75^A	91.26	10.34	80.92	Y	Trace	NAPL not measurable.
	10/09/2023	--		90.62	9.93	80.69	--	--	Obstruction at 51.34, possible pump apparatus in well.
	9/27/2022	72.90			9.35	81.27	Y	102	8.5 ft of Saturated NAPL, 58 ft of suspended NAPL; 35.8 gallons of NAPL/water mixture removed.
	7/26/2021	--			9.16	81.46	Y	96	2021 Well Inspections - Well uncovered under crushed stone 9/29/21 and gauged; Well in good condition.
MW-10	10/07/2024	6.93	8.7 - 19.5	92.38	Dry	--	N	0	Could not advance beyond 6.93'.
	10/09/2023	--		91.66	--	--	N	0	Obstruction at 6.79 ft bgs.
	9/27/2022	--			--	--	N	0	Not Measured. Obstruction at approximately 6.5 ft bgs. No J-Plug.
	9/27/2021	91.66			Dry	--	N	0	PVC noted to be crushed at approx. 6.89 ft below surface.
MW-10I	10/08/2024	41.86	22 - 43^A	92.91	12.43	80.48	N	0	Missing one bolt.

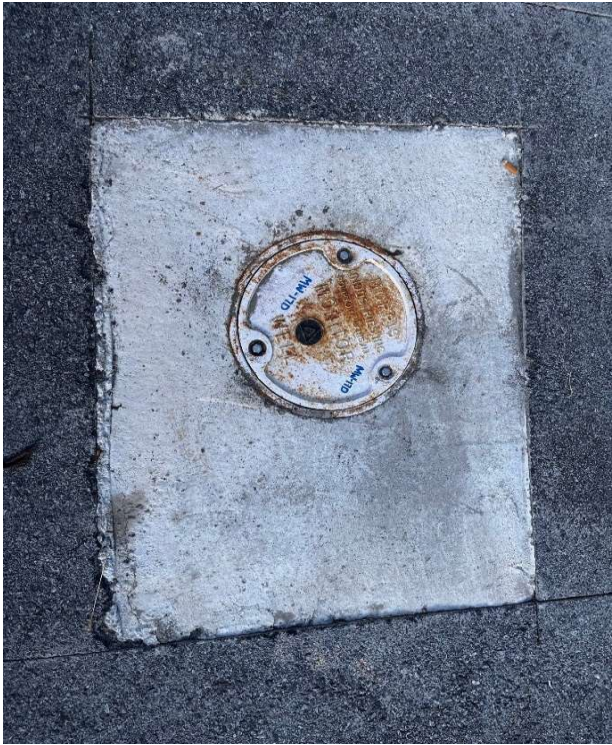
Date: 10/7/2024	
Direction Photo Taken: Downward	
Description: MW-17D

Well ID	Date Gauged	Total Depth (ft bTOC)	Screen Interval/Open Hole (ft bTOC)	Reference Elevation (TOC)	Depth to Water (ft bTOC)	Groundwater Elevation	NAPL Observed (Y/N)	NAPL Thickness (in)	Notes
MW-17D	10/07/2024	138.29	121 - 142.5 ^A	92.76	8.32	84.44	N	0	Good condition.
	10/09/2023	138.88		93.29	3.31	89.98*	N	0	Not bolted, no J-plug, and tubing inside.
	9/27/2022	139.04			0.20	93.09	N	0	Flooded. Flush mount top doesn't fit on casing. 2" PVC loose in 6" steel casing. No J-plug. No bolts. Well depth reduced from initial installation depth - requires rehabilitation (incl. pumping to remove sedimentation).
	9/27/2021	138.85			8.40	84.89	N	0	Flush mount top doesn't fit on casing. 2" PVC loose in 6" steel casing. No bolts. Well depth reduced from initial installation depth - requires rehabilitation (incl. pumping to remove sedimentation). No odor or sheen noted.
	7/26/2021	140.50			8.63	84.66	N	0	2021 Well Inspections - Flush mount top doesn't fit on casing. 2" PVC loose in 6" steel casing. No bolts. Well depth reduced from initial installation depth - requires rehabilitation (incl. pumping to remove sedimentation).

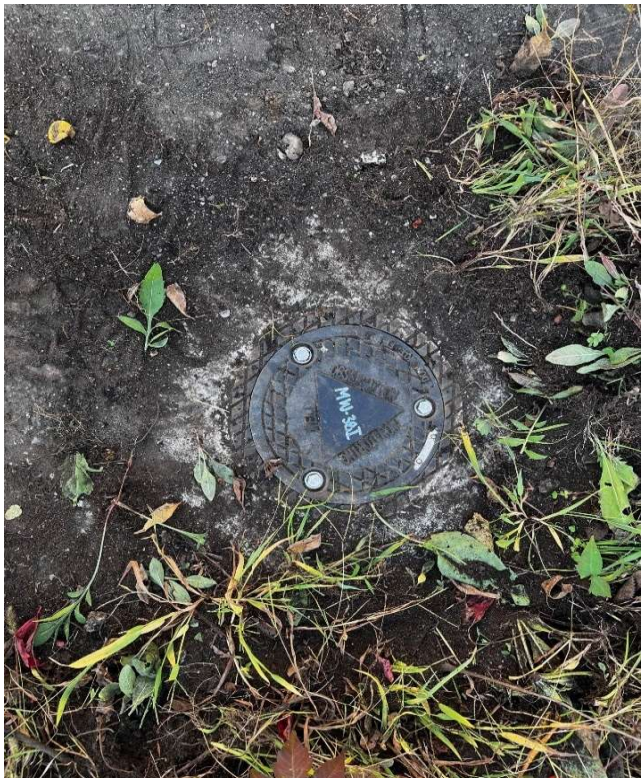
Date: 10/7/2024	
Direction Photo Taken: Downward	
Description: MW-38I

6/29/2017	>150			10.73	83.49	N	0	No odor or sheen noted.
MW-38I	10/07/2024	119.52	90 - 120 ^A	79.07	6.48	72.59	N	0	Good condition.
	10/09/2023	97.42		78.66	3.89	74.77	N	0	No curb box, no J-plug, hole filled with dirt.
	9/27/2022	100.39			6.50	72.16	N	0	No casing cover or J-plug on PVC. No odor or sheen noted.
	9/27/2021	100.50			5.50	73.16	N	0	No casing cover or J-plug on PVC. Well depth reduced from initial installation depth - requires rehabilitation (incl. pumping to remove sedimentation). No odor or sheen noted.
	6/26/2021	100.30			5.88	72.78	N	0	2021 Well Inspections - No casing cover or J-plug on PVC. Well depth reduced from initial installation depth - requires rehabilitation (incl. pumping to remove sedimentation).
	9/10/2019	174.42			6.65	72.01	N	0	Petroleum odor, no sheen observed.
	6/29/2017	100.61			6.21	72.45	N	0	Slight - moderate sulfuric odor, no sheen noted.
MW-38D	10/07/2024	169.89	150 - 170.1 ^A	79.35	6.54	72.81	N	0	No bolts.

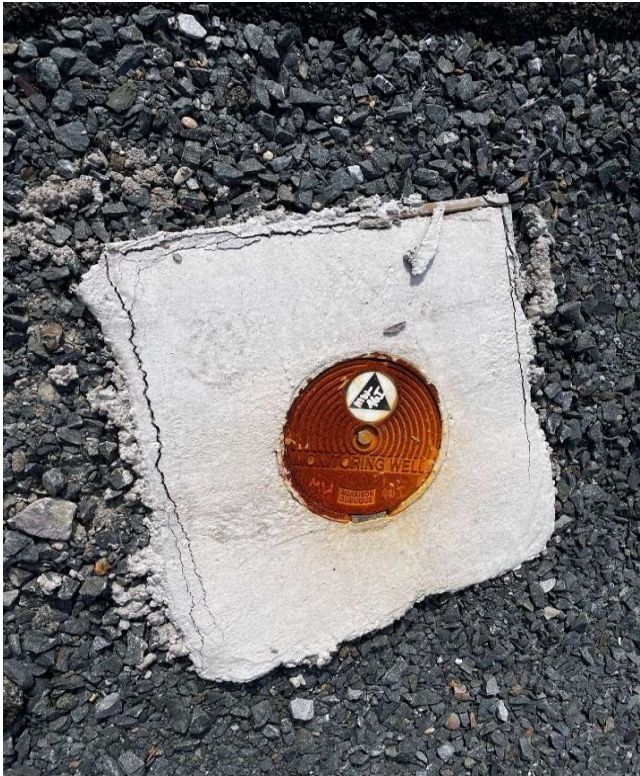
Date: 10/7/2024	
Direction Photo Taken: Downward Description: MW-461

MW-46I	10/07/2024	71.12			16.5 - 75^A	90.17	12.02	78.15	N
	10/09/2023	--	--	--		--	--	Well is buried in either gravel or paved over (unable to be gauged).	
	9/27/2022	--	--	--		--	--	Well is buried in either gravel or paved over (unable to be gauged).	
	9/27/2021	--	--	--		--	--	Well buried under approximately 15 inches of gravel and was blocked (unable to be gauged). A temporary road box was placed over the well for protection. Not gauged or sampled in September 2021.	
	9/10/2019	74.84	9.10	78.83		N	0	No odor or sheen noted.	
	6/29/2017	--	--	--		--	--	--	
	Additional Locations - Gauged 2021-2024								
TW-4	10/07/2024	73.52	15-75^A	87.846	9.73	78.116	N	0	Well in good condition
	10/09/2023	73.19		87.17	9.06	78.11	N	0	Well in good condition.
	9/27/2022	76.18			9.30	77.87	N	0	Well in good condition
	7/26/2021	74.01			8.54	78.63	N	0	2021 Well Inspections - Well in good condition.
MW-1	10/07/2024	15.93	11.6 - 16.85	91.56	9.63	81.93	N	0	Well in good condition.
