# **INTERIM REMEDIAL MEASURE Soil Removal Summary Report**

**Saratoga Tree Nursery  
Inactive Hazardous Waste Site**

**Route 50 Facility  
Saratoga County, N.Y.  
Site No. 5-46-043**

February 1996

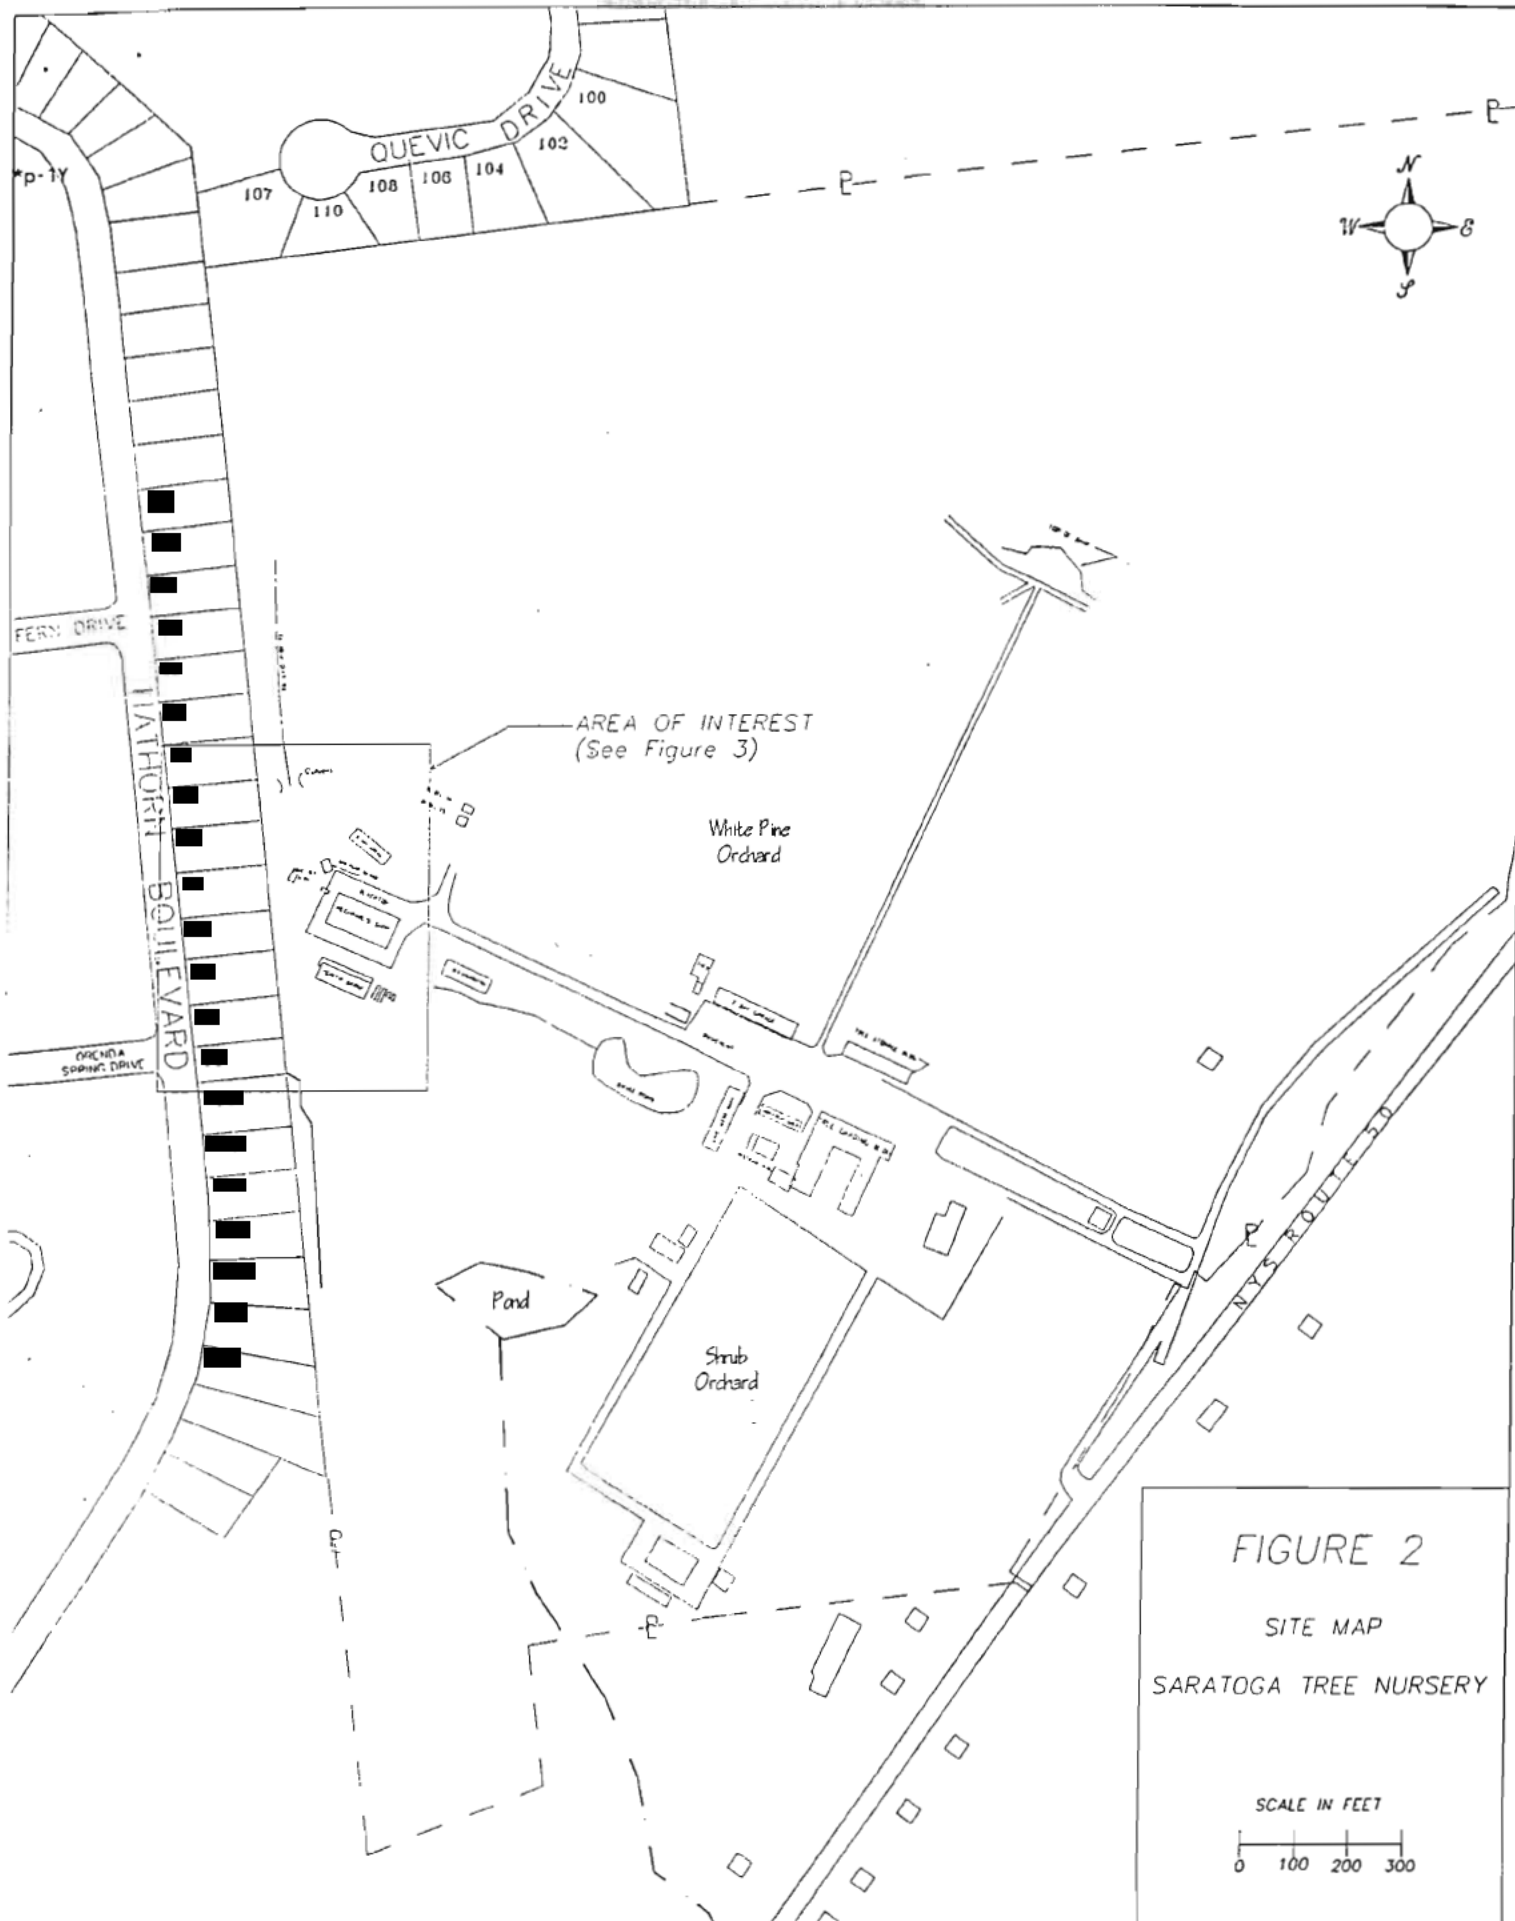
FIGURE 2  
SITE MAP  
SARATOGA TREE NURSERY

Excavated soil was stockpiled on the Nursery property, west of the Loading Dock, in the central portion of the Nursery (ref. Figure 2). The stockpile area was defined by placement of wood timbers. Contaminated soil was placed on landscape fabric. The soil stockpile was covered with an impermeable, UV resistant plastic. The plastic was placed to preclude dust generation and infiltration of precipitation. The stockpiled soil was covered with the plastic following daily operations. The edges of the plastic were weighted down to keep the plastic in place. The pile was shaped with a Bobcat to prevent ponding of water. The contaminated soil will be stockpiled on nursery property until the remedial work associated with on-site contamination is complete. Weekly inspections of the stockpile will be conducted to detect and repair any damage to the cover.

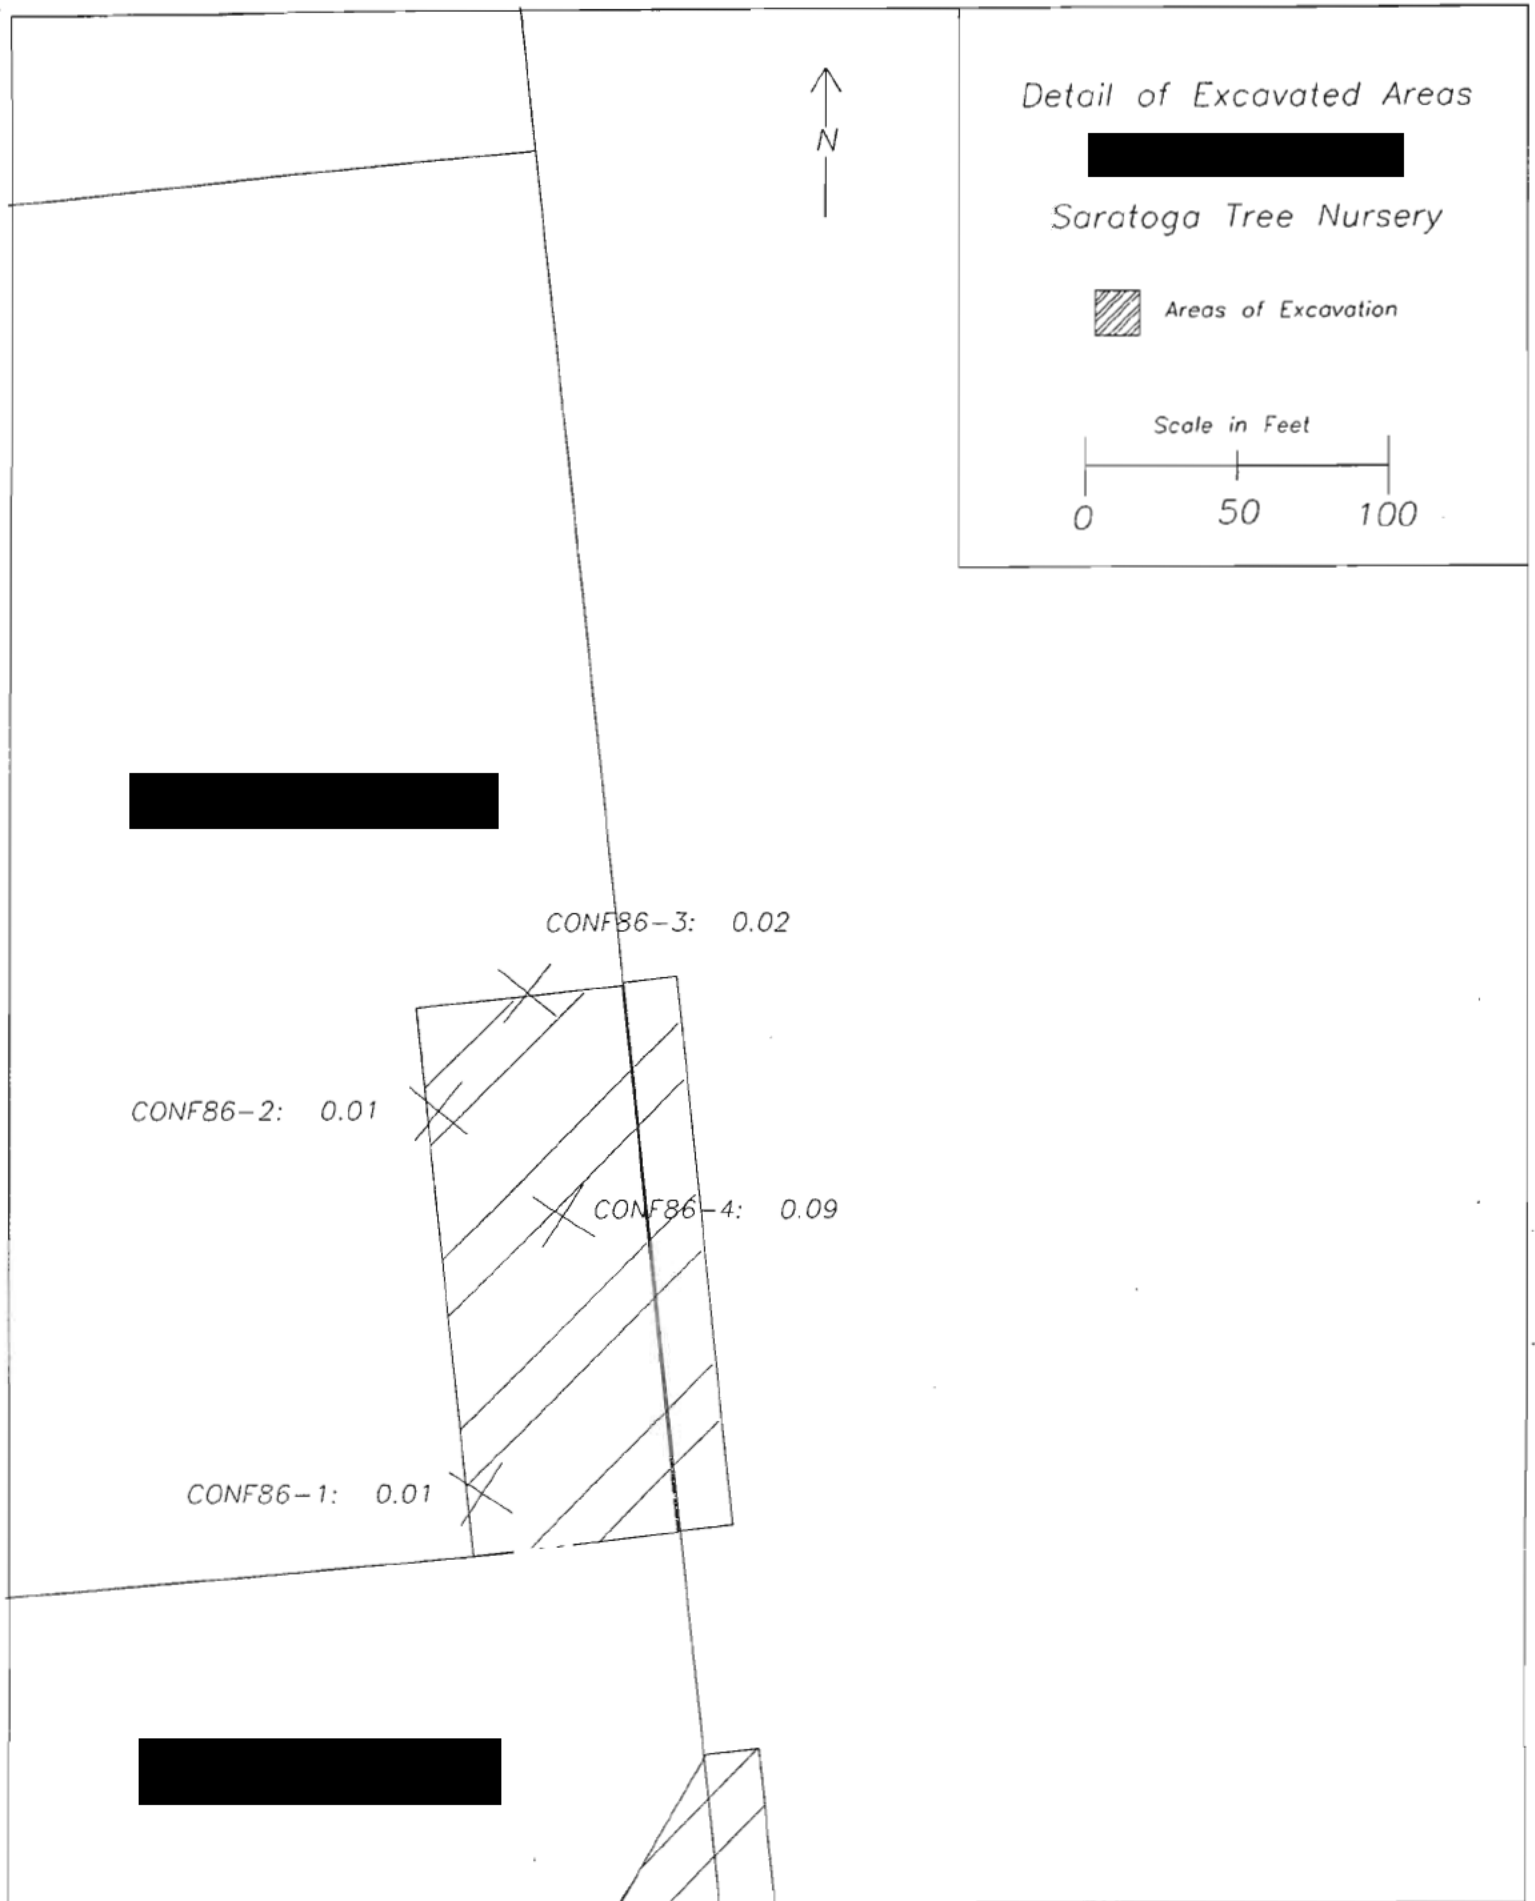
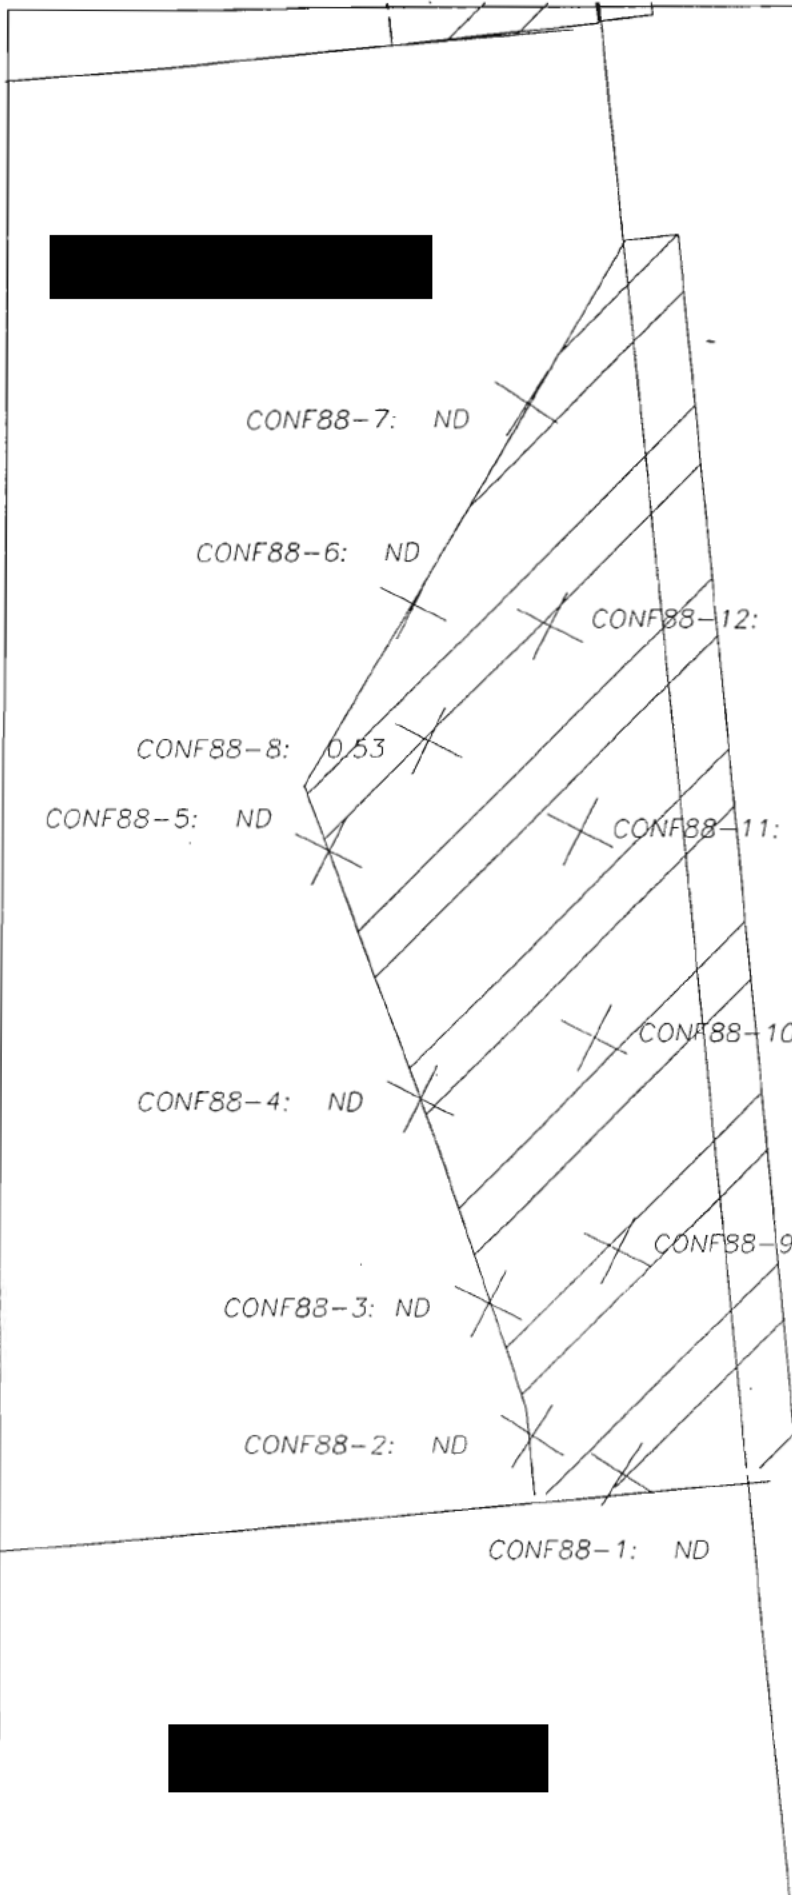
Detail of Excavated Areas

The limits of the excavations, confirmatory sample locations, and the sample results are included in Appendix A.
