**Re: Site Photo Logs  
Former Matt/Grace Petroleum  
201 Leland Avenue  
Utica, New York (Oneida County)  
NYSDEC Spill# 88-09026**

**Photo Logs**

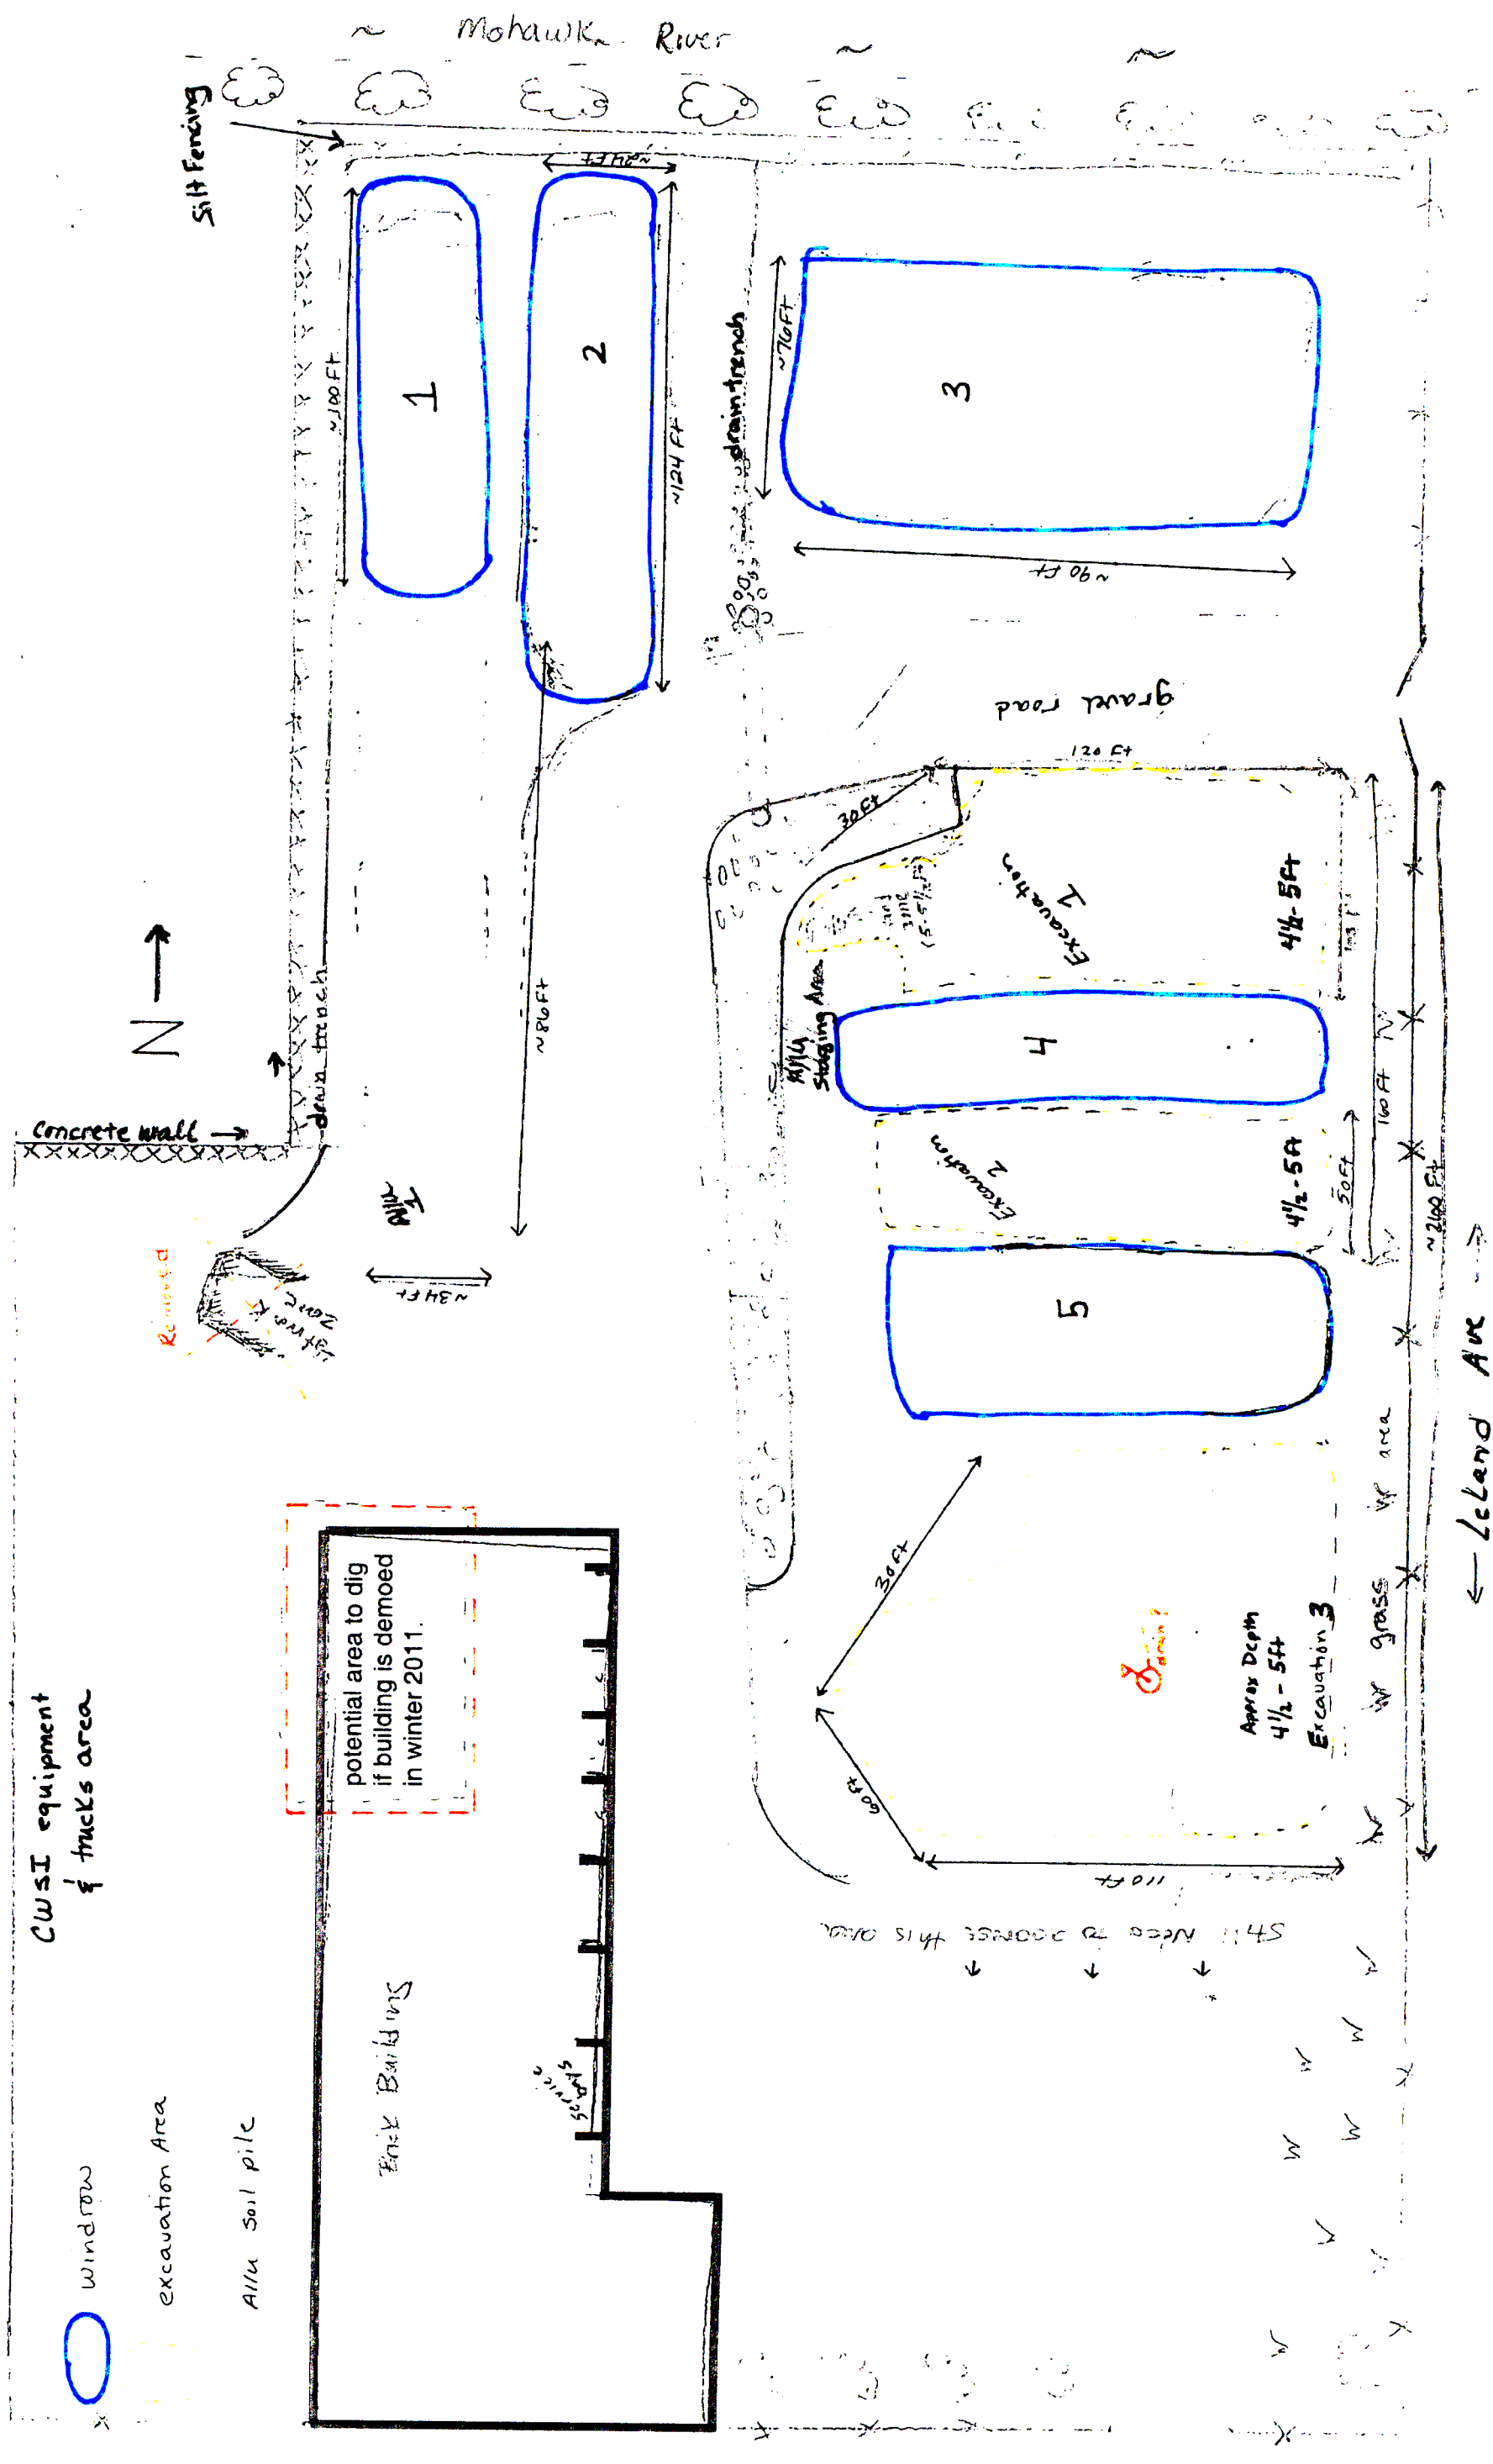
Photo #54: November 1, 2011 –Phase I: Winterization of windrows with plastic sheeting and sand bags to reduce potential run off.
