# Dvirka and Bartilucci

Re: Pre-Design Investigation  
Work Assignment No. D003600-39  
American Cleaners Site, Site No. 7-04-030  
D&B No. 2216

AMERICAN CLEANERS SITE REMEDIAL DESIGN  
BINGHAMTON, NEW YORK

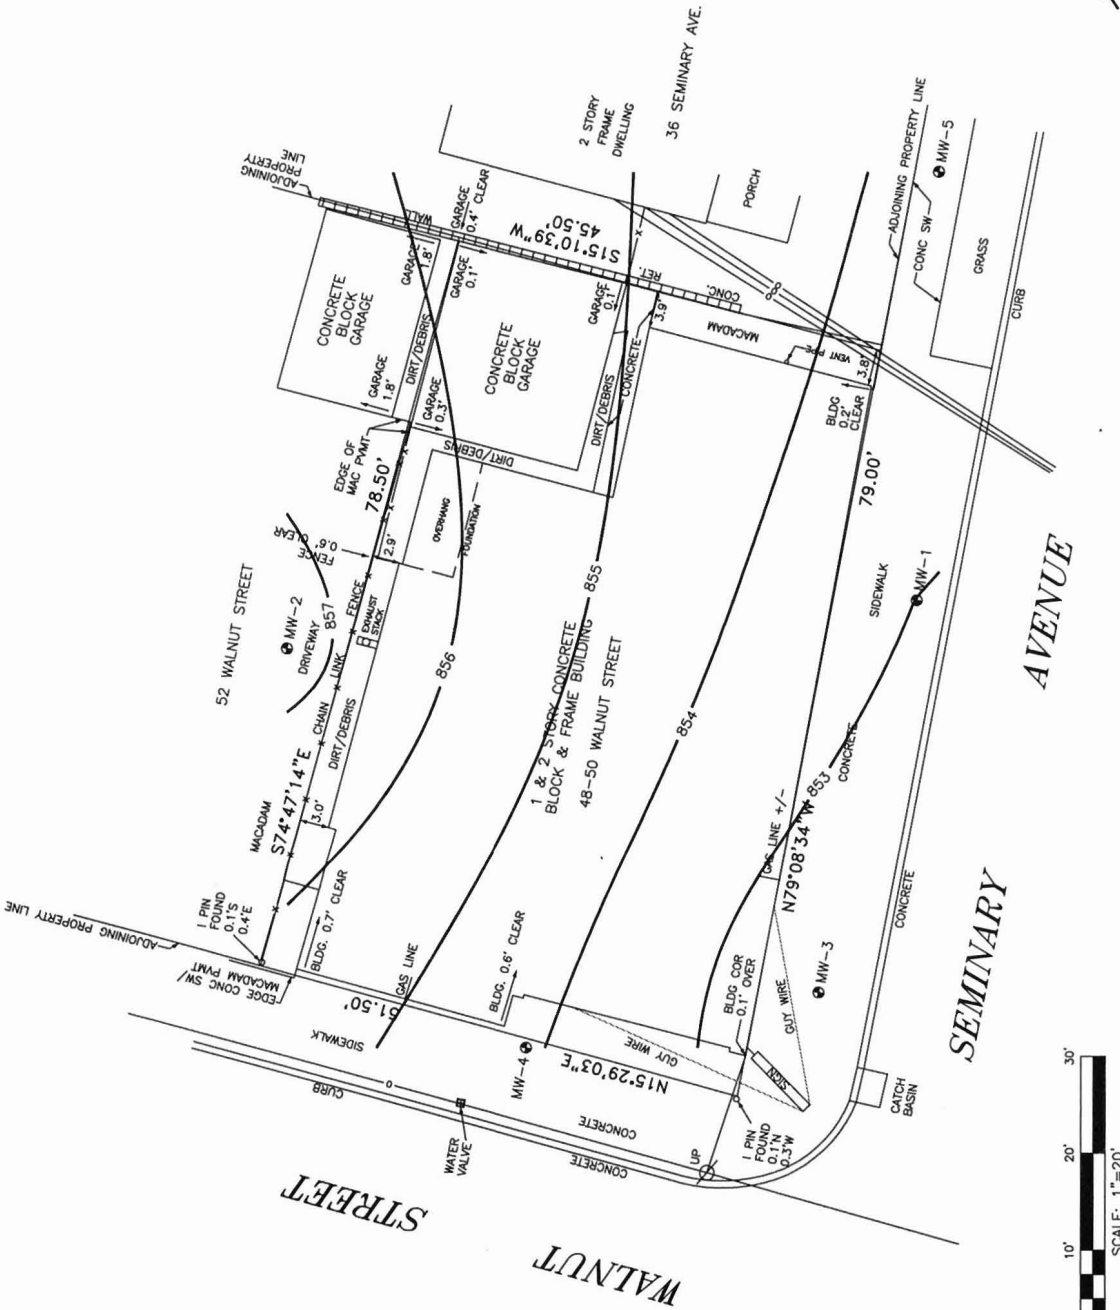
Water levels were measured on July 19, 2004, August 27, 2004 and September 14, 2004, using an electronic water level indicator. Depth to groundwater measurements were used to calculate groundwater elevations at the site (Table 3, Attachment B). Water table elevation contour maps (Figures 3, 4 and 5, Attachment A) were constructed using the water level measurements for each of the three days. Based on the results of each of the three water table measurement events, the direction of groundwater flow at the site is to the north-northeast.

WATER TABLE ELEVATION CONTOUR MAP - AUGUST 27, 2004  
A Division of William F. Cosulich Associates, P.C.

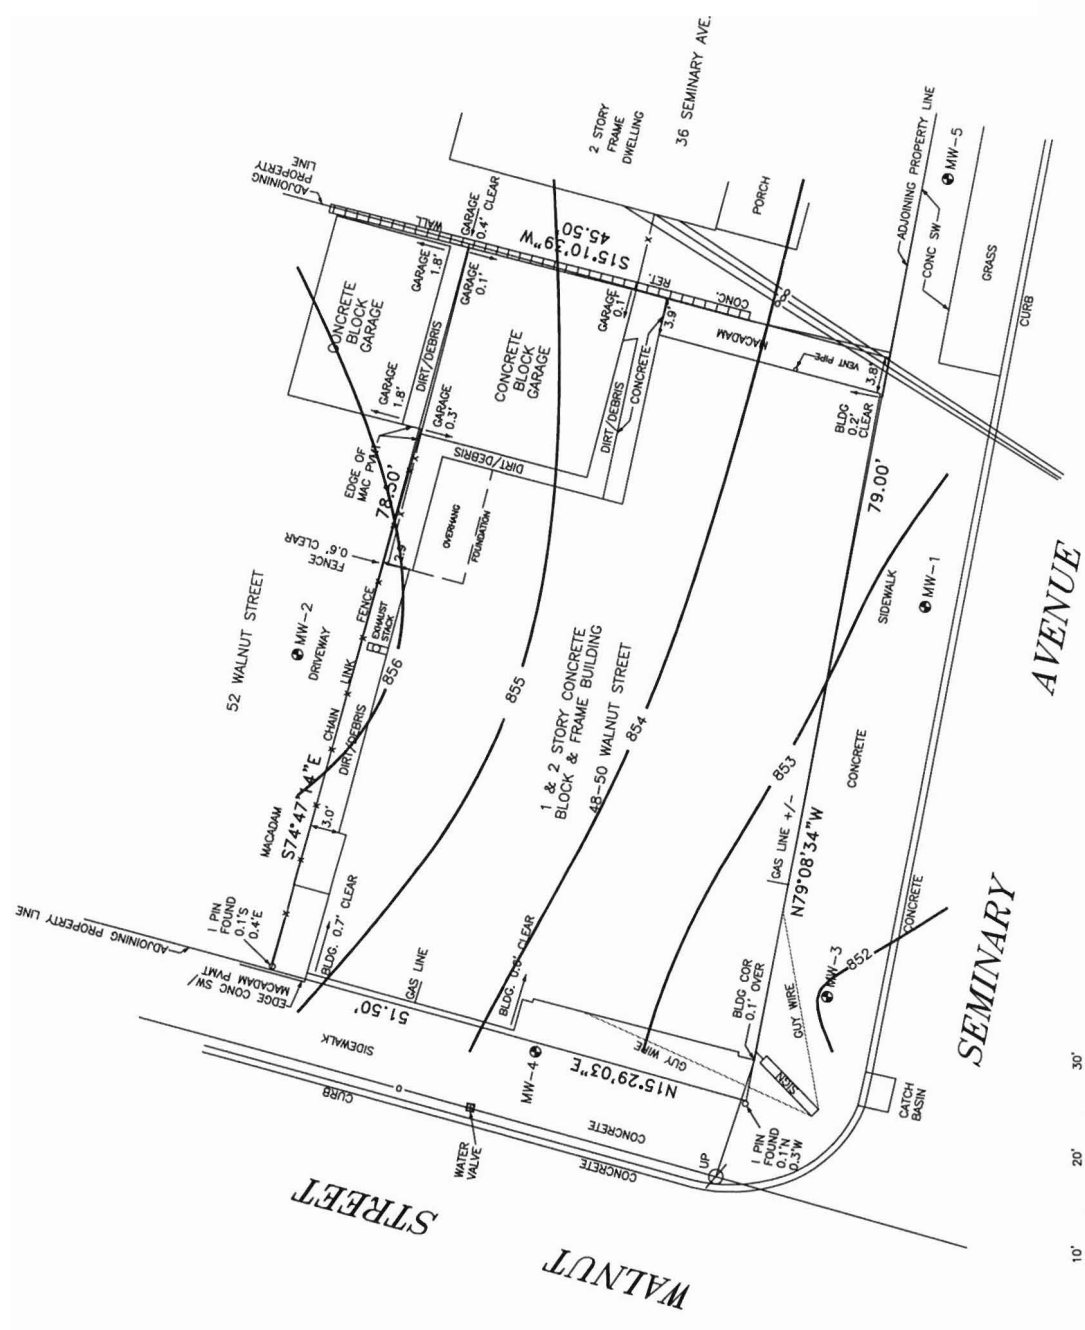
WATER TABLE ELEVATION CONTOUR MAP - SEPTEMBER 14, 2004
