2023 Transloading Area – Qualitative Site Inspection
NYSEG Binghamton Court Street Former Manufactured Gas Plant Site
NYSDEC Site No. 7-04-031

June 27, 2023

2023 Qualitative Site Inspection

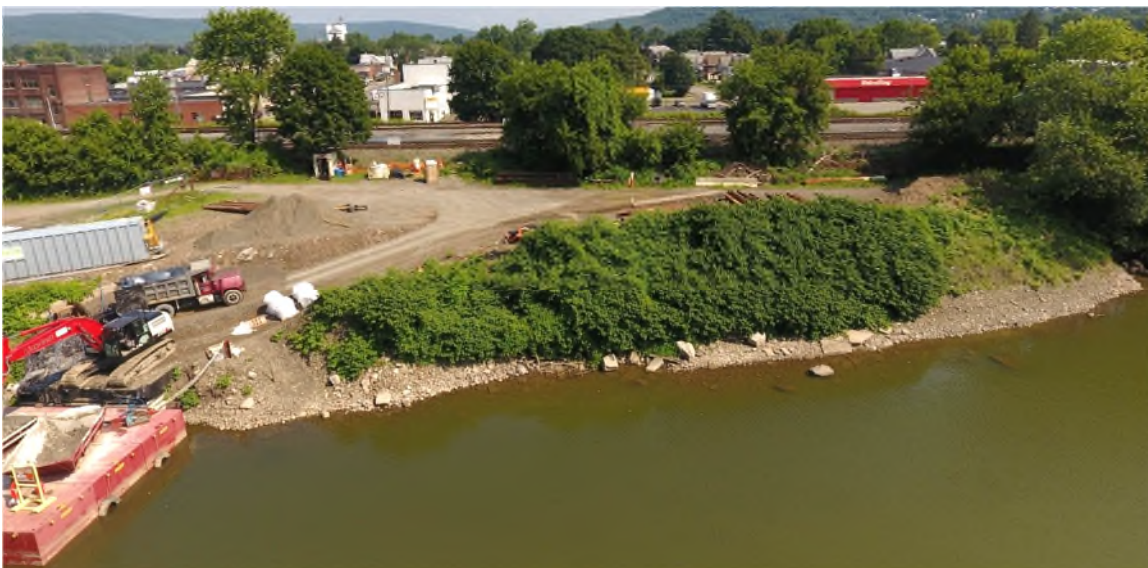
In accordance with the restoration plan, corrective actions to control the aggressive encroachment of Japanese knotweed (*Polygonum cuspidatum*) and other invasive species (e.g., spotted knapweed) or nuisance species had been performed during the 2020, 2021, and 2022 growing seasons using foliar application of a glyphosate-based herbicide (specifically AquaNeat) using backpack sprayers. Prior to the restoration of the Transloading Area, the bank area was largely a monoculture of Japanese knotweed (as shown in the inset photograph below from July 30, 2019 during the construction period).
