CERTIFICATION OF COMPLETION

**FINAL CORRECTIVE MEASURES ADDRESSING
SOIL AND SEWER CONTAMINATION**

FORMER BORDEN RESIN FACILITY – BAINBRIDGE, NEW YORK

September 2001

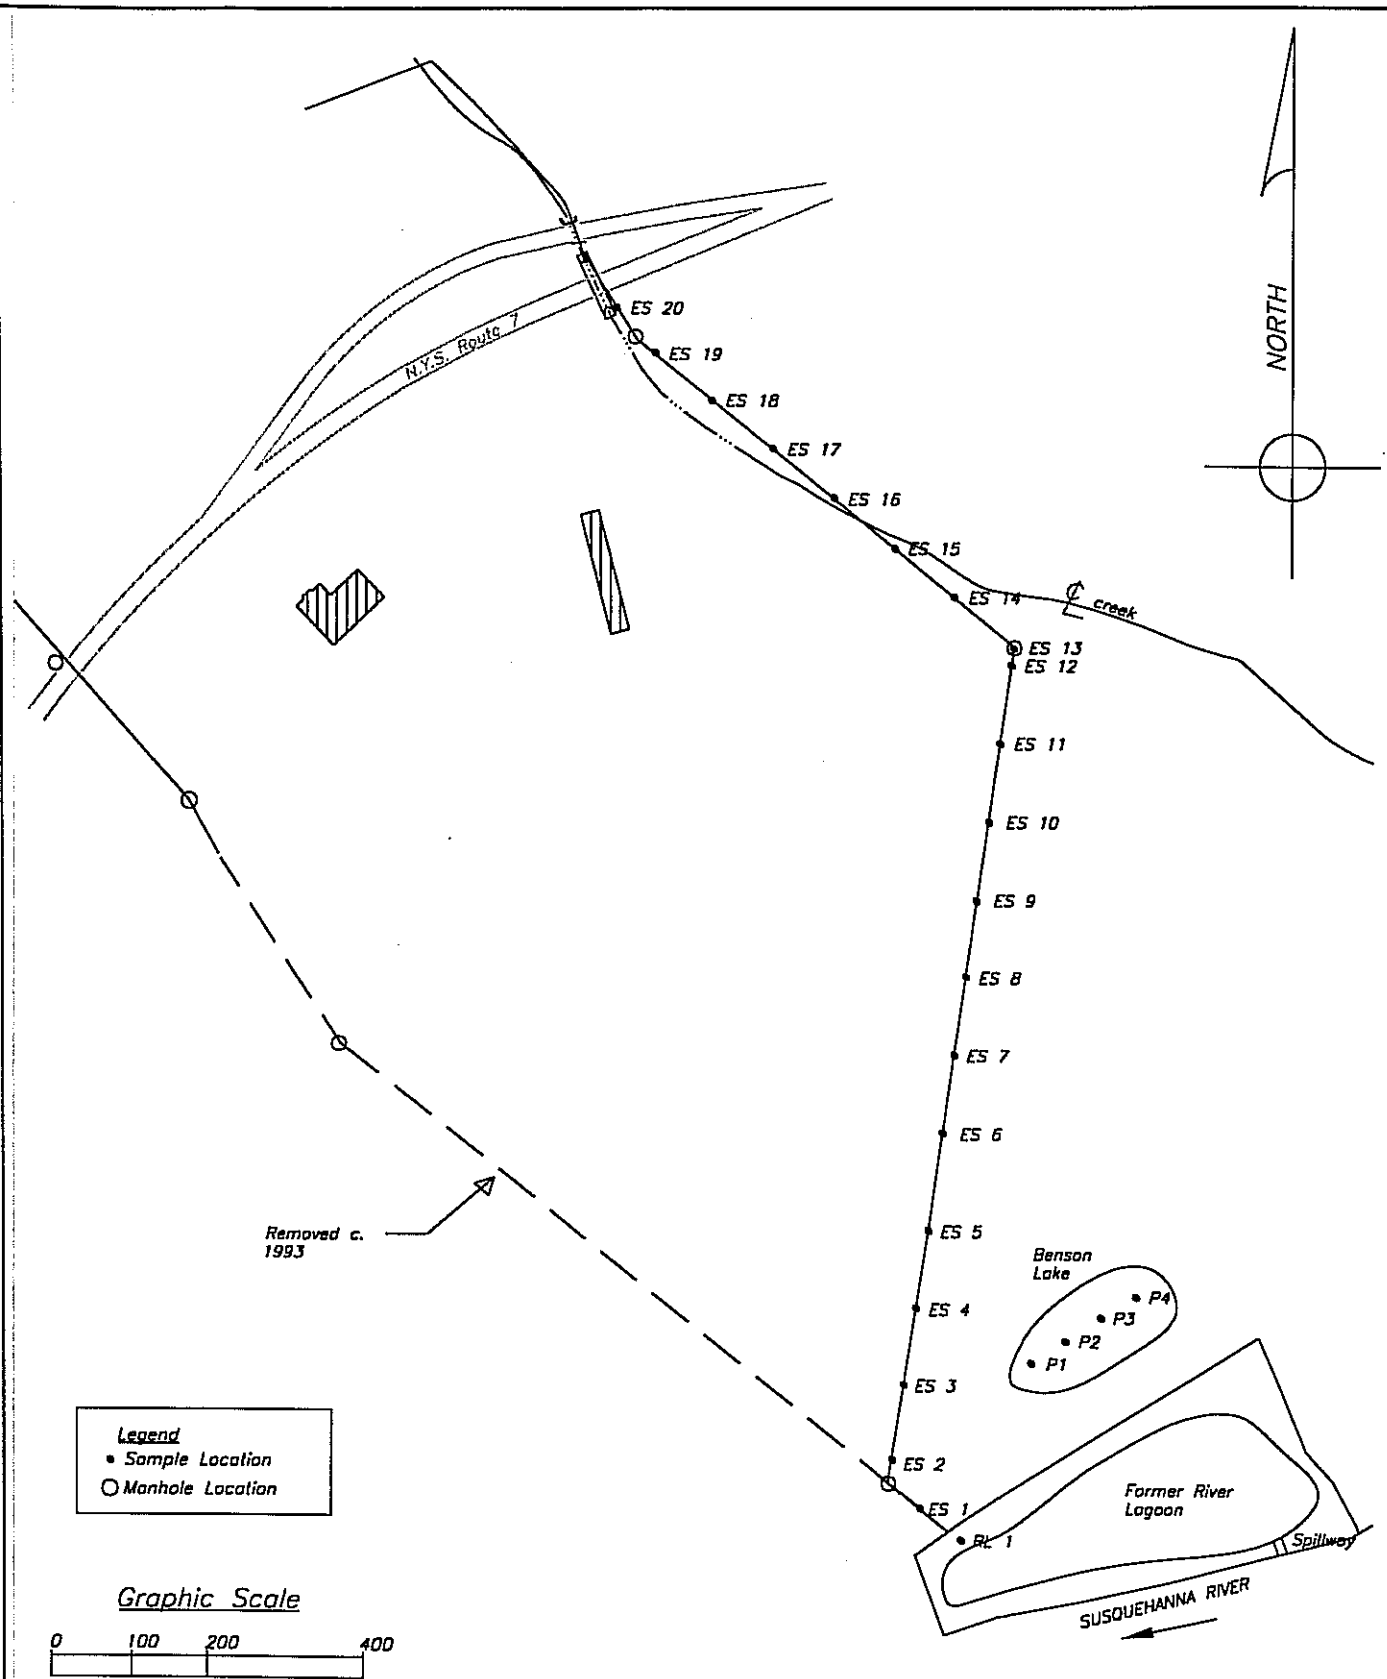
Former Borden Resin Facility - Bainbridge, New York
 Figure 14
 Eastern Sewer - South of Route 7

Segment E. Sewer Segment E ran from approximately 25 feet south of Route 7 culvert to the former River Lagoon (Figure 14). Approximately 700 feet of the sewer run was under the Beatty Creek stream bed. Approximately 1,300 feet of the sewer length ran diagonally across a farm field ("Benson's Field") to the River Lagoon. Segment E included three manholes.

In 2000, MACTEC excavated the entire Segment E sewer run, including sludge, pipe, and manholes. After excavation was completed, verification samples were collected at 100-foot intervals from the bedding beneath the pipe. The verification sample locations are illustrated on Figure 14, and verification results are summarized in Table 7. Note that at two locations, re-excavation of one-foot increments was required due to slightly elevated PCB concentrations in the bedding material. Verification samples collected after re-excavation demonstrated that the clean-up criterion (one mg/kg PCBs) was achieved along the entire reach of sewer removal.

topographic low area (Figure 14), and NYSDEC raised the concern of PCB accumulation in this low area. Although previous sampling performed for the RCRA Facility Investigation indicated non-detectable levels of PCBs in water and sediments from this ephemeral pool, additional sediment samples were collected during the final remediation phase from the locations illustrated on Figure 14. Sample results, summarized in Table 7, confirm non-detectable concentrations of PCBs. Therefore, no corrective measures were required to address the "Benson Lake" area.
