## TECHNICAL MEMORANDUM

**Re:** Drum Inventory and Location Survey

This technical memorandum describes the work efforts completed during the drum inventory and location survey for the property located on the southwest side of the Rosen Site, which is owned by the City of Cortland.

CITY OF CORTLAND PROPERTY  
DRUM INVENTORY AND LOCATION SURVEY  
CORTLAND, NEW YORK

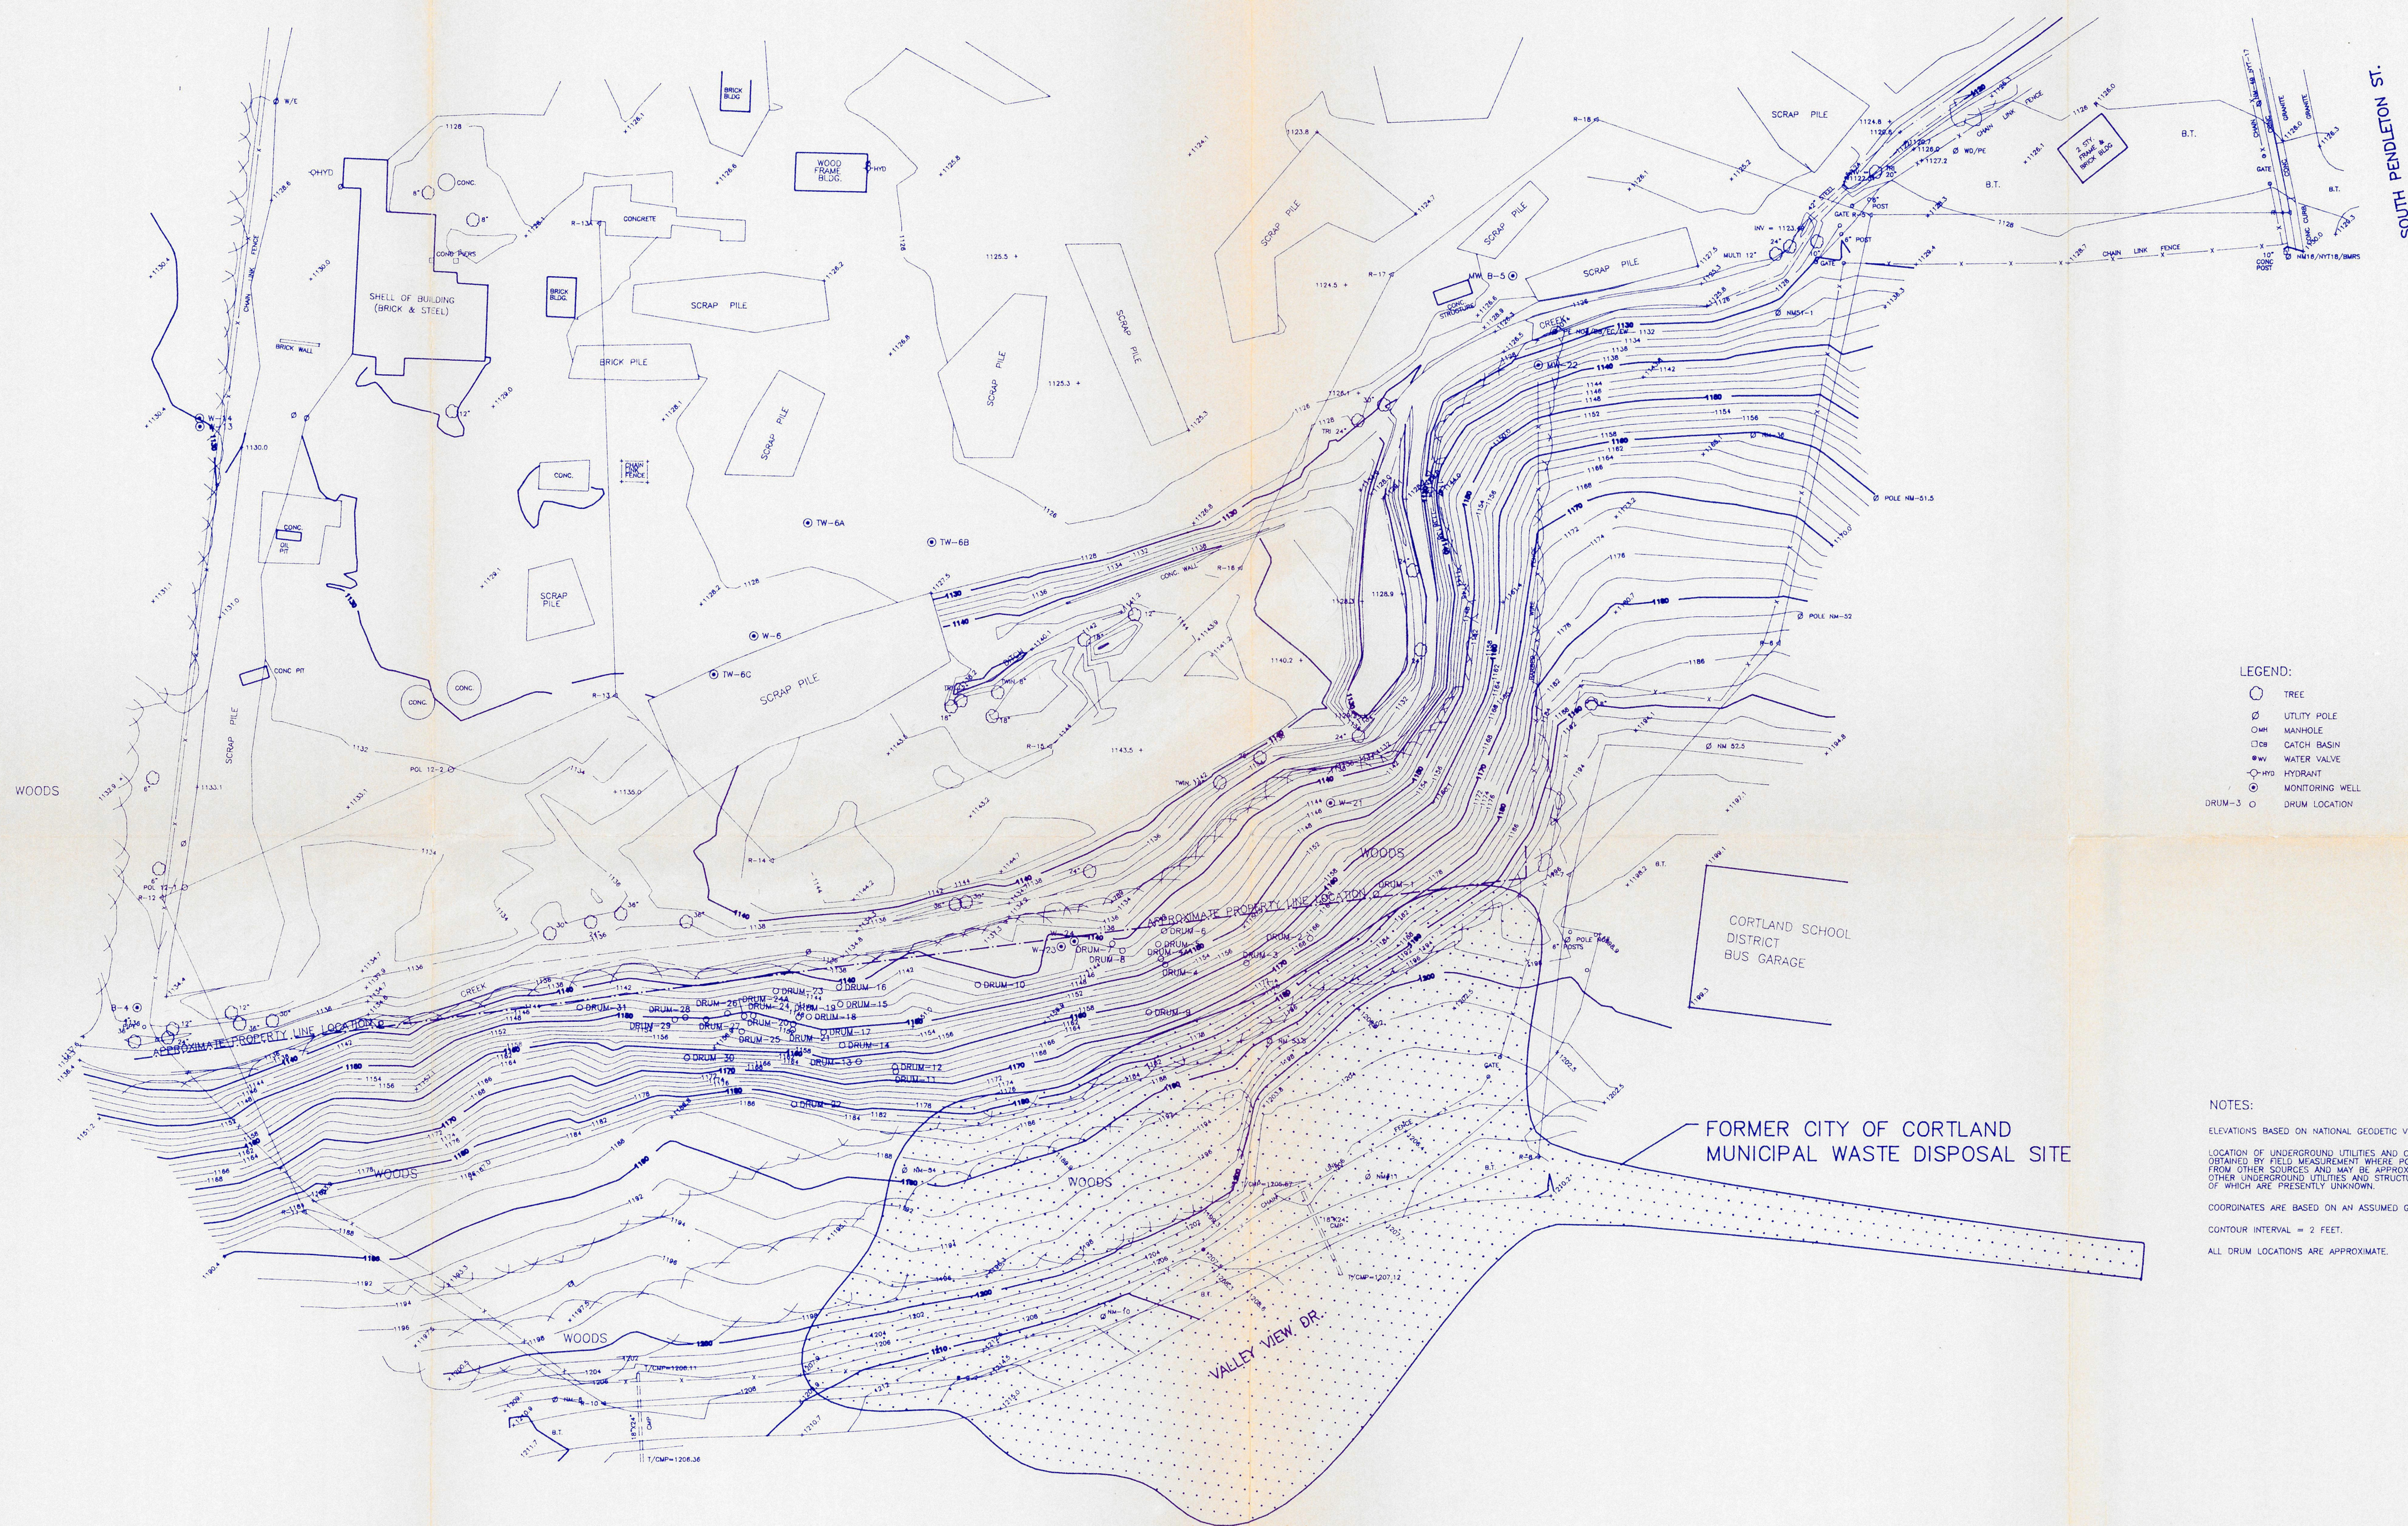
ROSEN PRP GROUP  
**FIGURE 1**  
**DRUM LOCATION MAP**

Field personnel walked along the southern boundary of the Rosen Site adjacent to the Perplexity Creek tributary from the southeast corner to the southwest corner. A total of 33 drums or drum fragments were visible either to the naked eye or through the binoculars. The drums or drum fragments were located on the hillside south of the Perplexity Creek tributary and west of monitoring well W-21. Figure 1 presents the locations of the visible drums or drum fragments. The locations of visible drums or drum fragments are approximate only. The angular and distance measurements were taken with a Topcon Total Station Instrument. These measurements were further supplemented with estimated distances and angular corrections from the approximate property line to each individual drum or drum fragment. The measurements recorded by the survey team are a combination of the above methods. Drums 4A and 24A were discovered on April 7, 1995 after the instrument survey and the locations presented on Figure 1 are estimated distances from Drum #4 and Drum #24, respectively.

The visible drums or drum fragments appeared very rusted and no labels, lettering, or other markings were observed except on Drum #20 and Drum #24. Drum #20 has the lettering "STC" inscribed on one end. Drum #24 has the following lettering inscribed on one end "DPS5636A". Drum #27 is rusted, severely crushed, and contains a white powder substance, which had leaked out one end. A summary table of the drum or drum fragment number designation and a description of each drum or drum fragment is presented as Table 1. The designations on this table correspond to the drums or drum fragments located on Figure 1.
