Date: July 10, 2023  
Our Ref: 30169483  
Subject: 2023 Qualitative Site Inspection  
NYSEG Cortland-Homer Former MGP Site  
Site No. 7-12-005

On behalf of the New York State Electric & Gas Corporation (NYSEG), this Site Inspection Letter has been prepared for the Cortland-Homer Former Manufactured Gas Plant (MGP) site, Operable Unit No. 2 (OU-2) located in Homer, New York (the site). This letter presents the results of the 2023 qualitative monitoring event including, adaptive management and corrective action recommendations to support meeting the Year 1 performance criteria and has been prepared in accordance with the Preliminary Monitoring and Maintenance plan included as Appendix G to the April 2020 Remedial Design Report (Remedial Design).

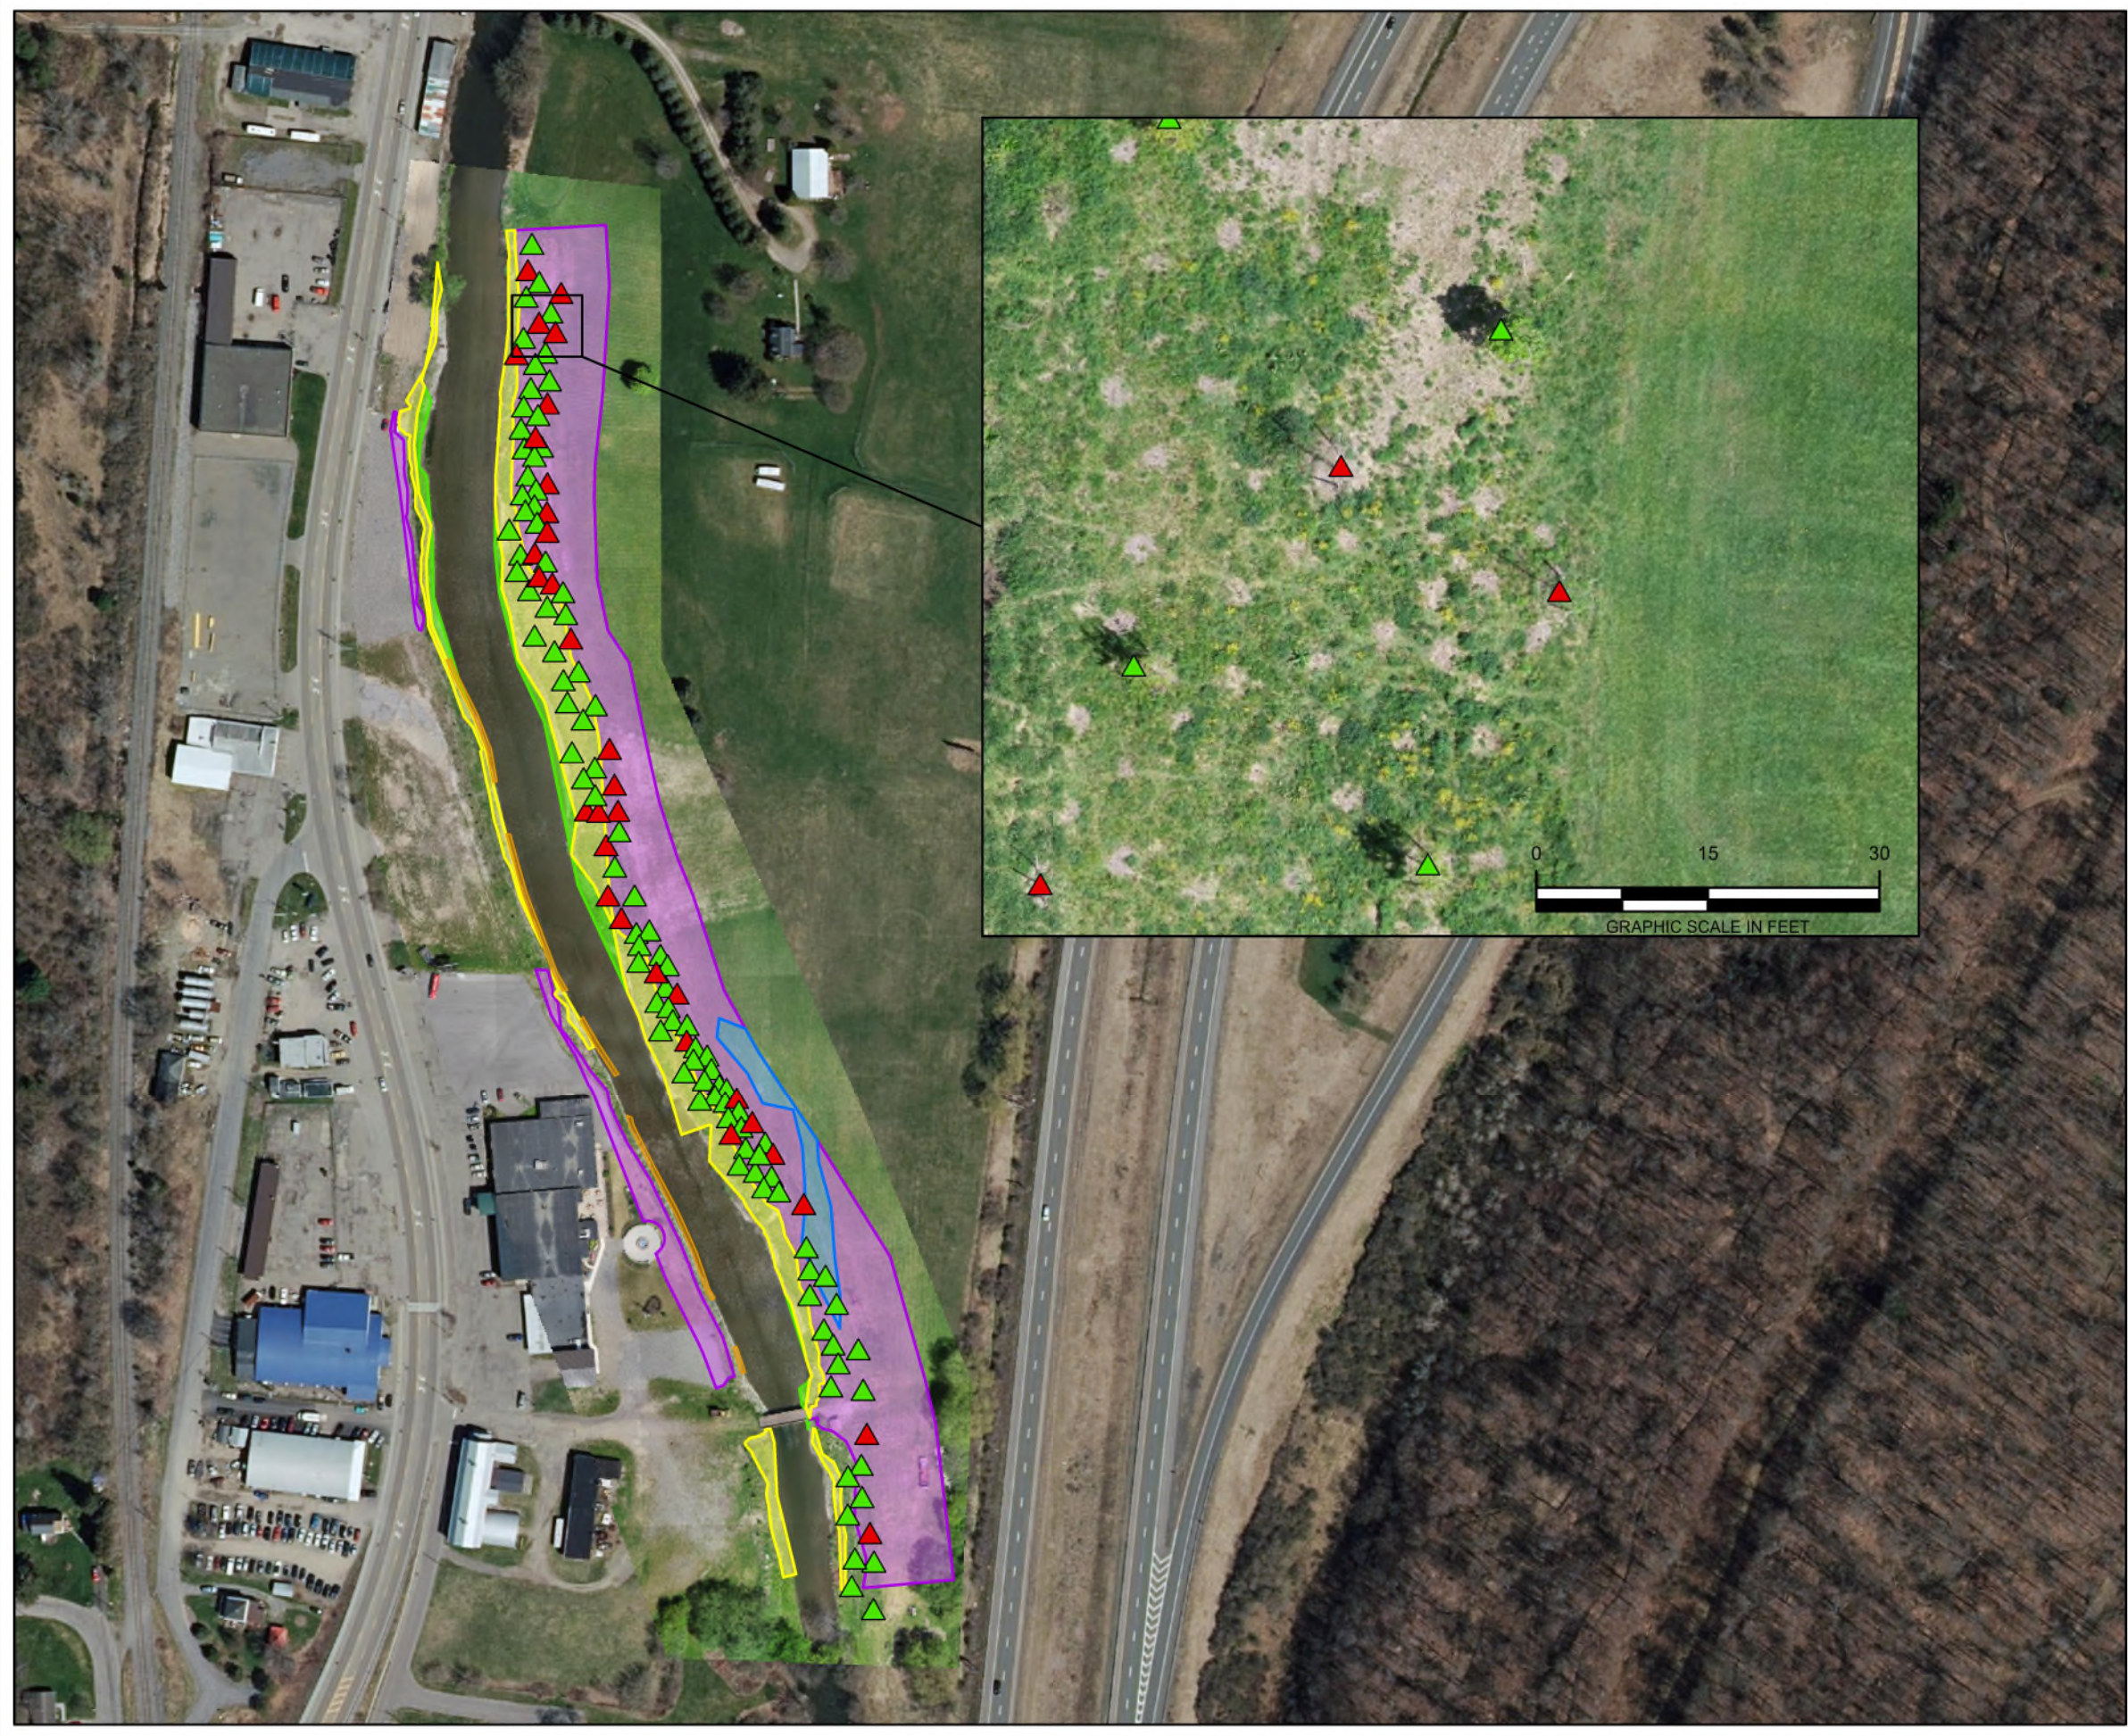
Path: T:\env\nyseg\Cortland-Homer-VegetationMonitoring\_2023\vegMonitoring\_2023.aprx\Figure 3 Area 1 Eastern Shoreline Aerial Analysis Last Saved By: ldrum 6/13/2023

Aerial analysis of the eastern shoreline indicated that none of the planting areas can be reliably estimated at over 85% vegetative cover. Cover was estimated using a VARI index (Figure 6), which classes relative vegetative vigor by using the ratio of intensities of different discrete bands of visible imagery (Green - Red) / (Green + Red - Blue). The ratio emphasizes green reflectance while accounting for objects which may reflect highly across the whole visible spectrum (i.e. bare rock or concrete). Inspection of the imagery confirmed that areas with a VARI score greater than zero appeared to indicate vegetation, while those with VARI scores of zero or less indicated rock, bare dirt, water, or pavement. The VARI image was accordingly classified as vegetation versus non-vegetation, and each planting area was assessed for percentage of vegetative cover. Estimated percent cover ranged from 11% in the West Bank area to 80% in the Floodplain Planting area. True percentages may vary from the

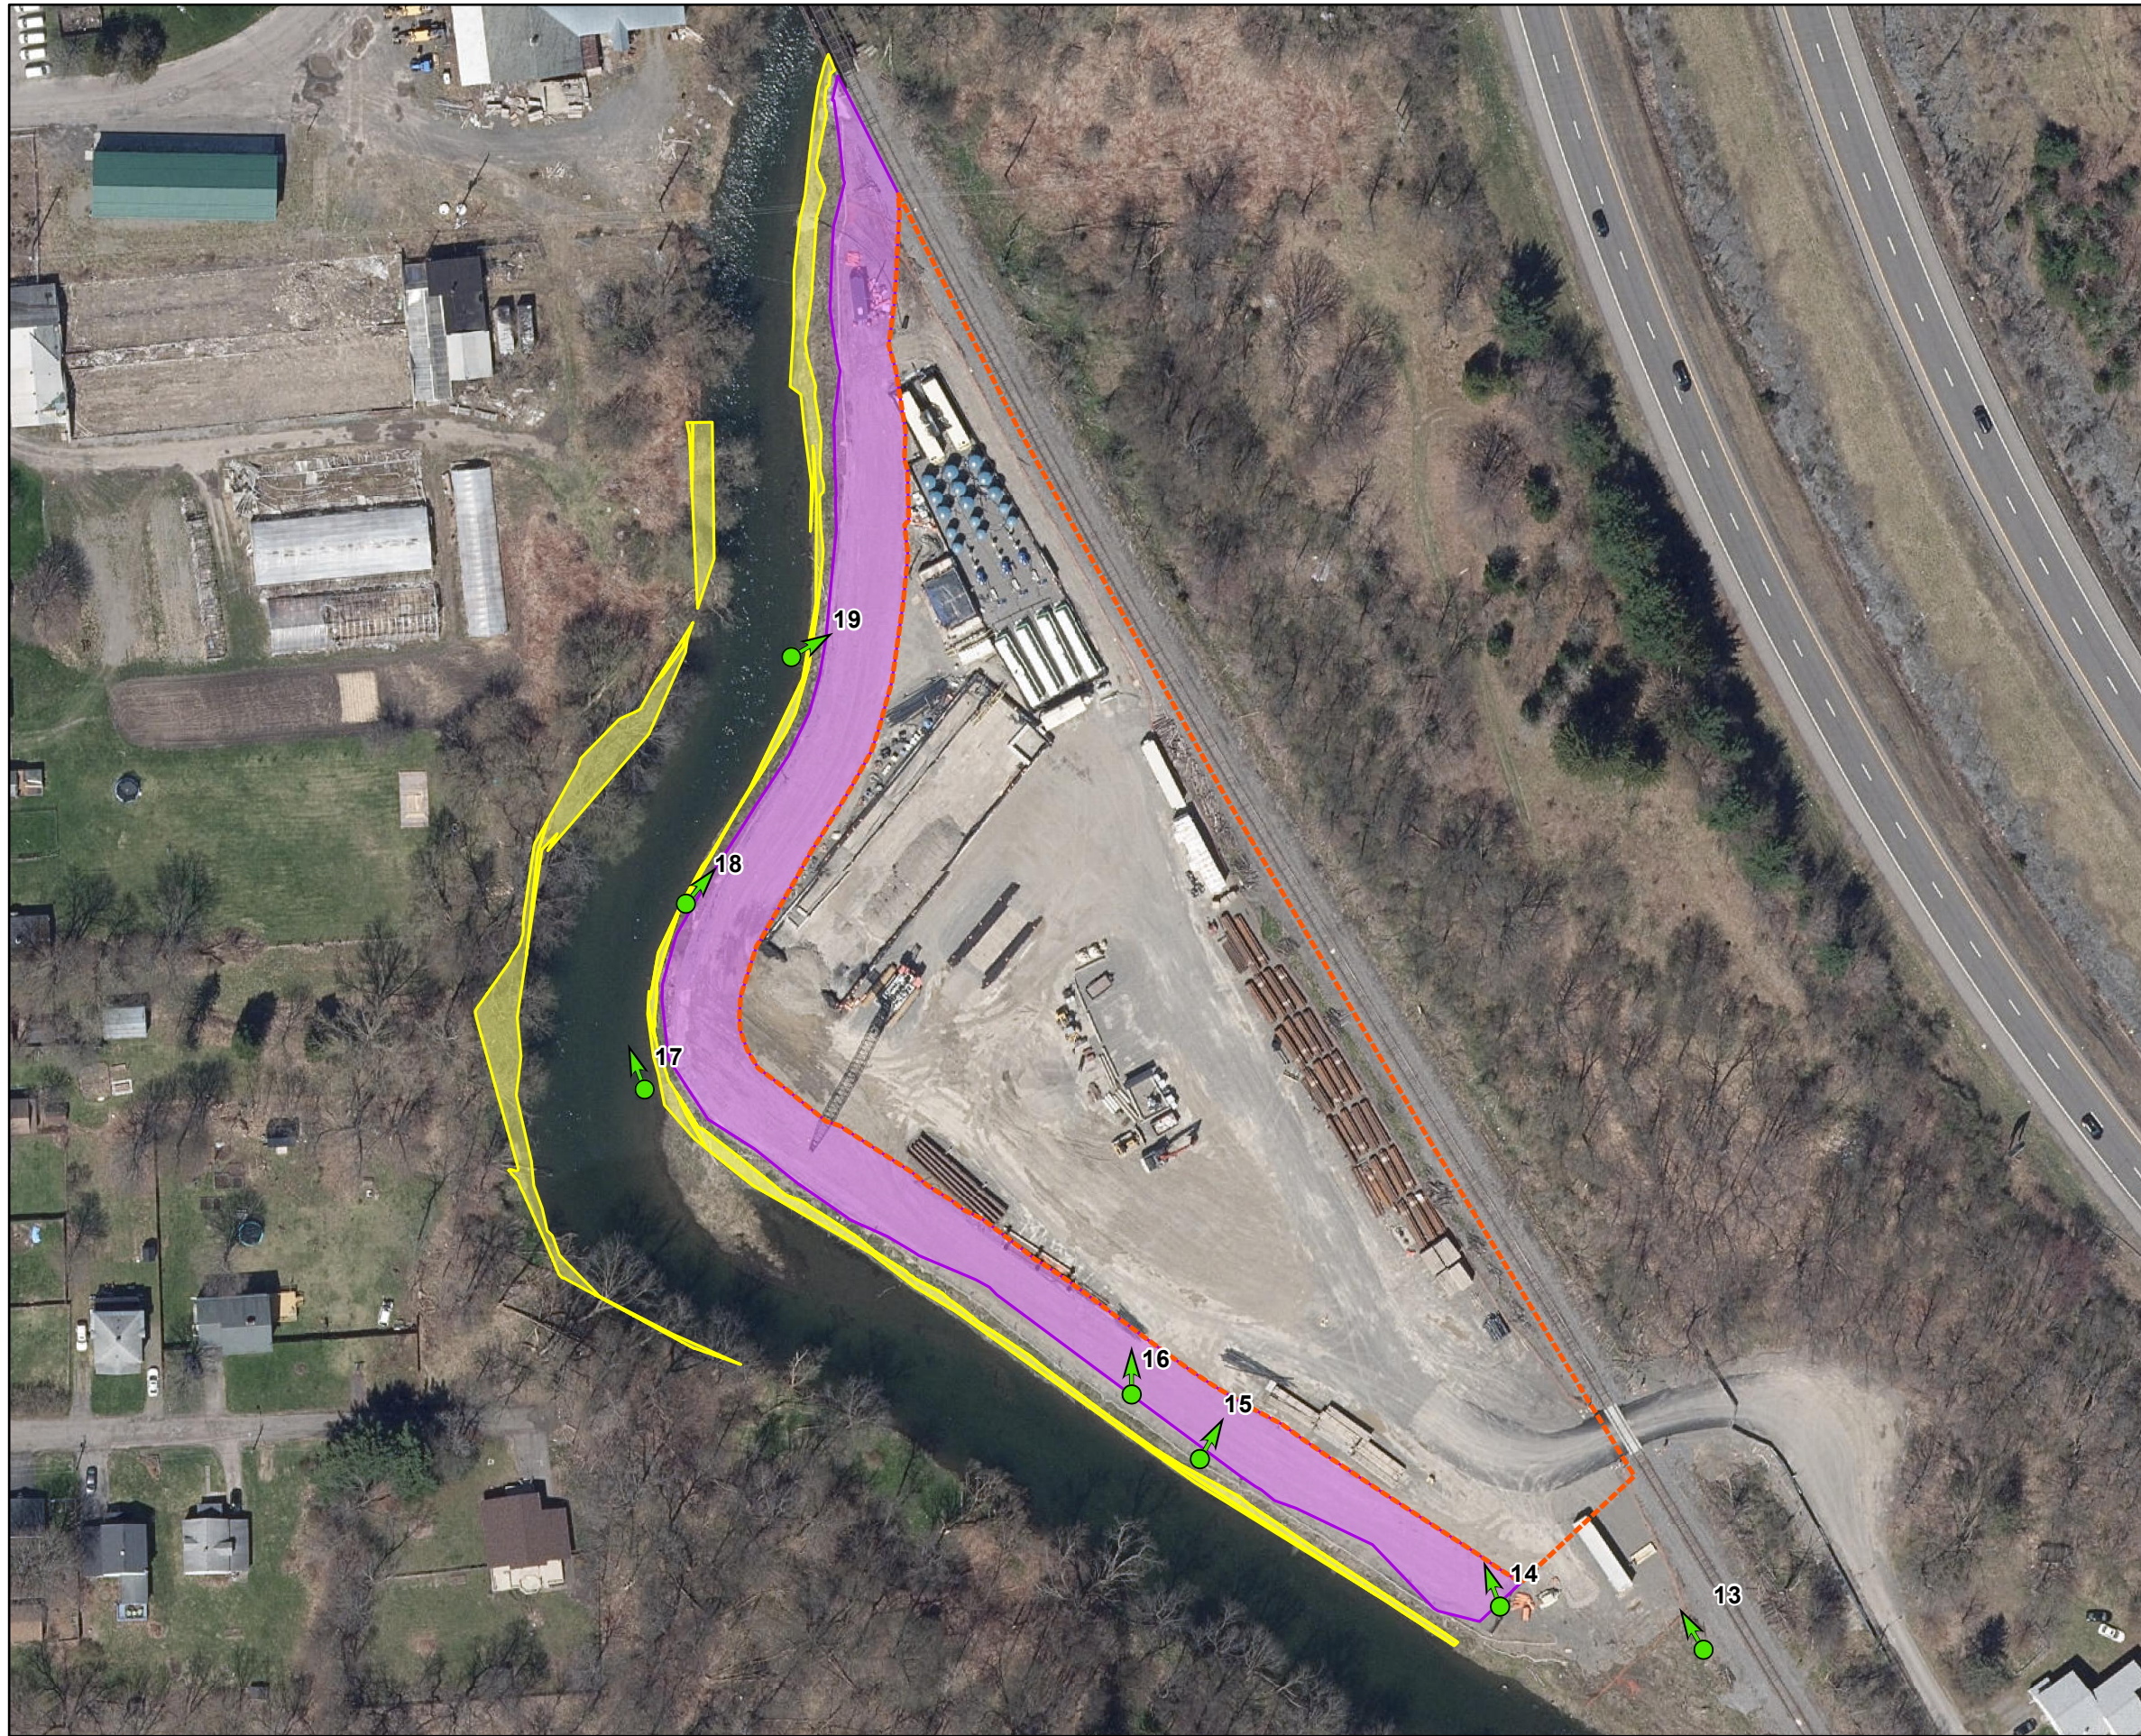
FIGURE  
**5**

Photographs to assess the restored areas for both Area 1 and 2 were established at fixed assessment points with predetermined cardinal directions at 12 of the targeted 20 locations for Area 1 and all 17 targeted locations for Area 2 (Figures 1 and 2, respectively), fixed assessment point photos are provided as Attachment 1A. Within the eastern shoreline and floodplain area for Area 1, the current drone aerial imagery has been georeferenced to detail current conditions and is shown on Figure 1. During the quantitative monitoring event later this year, the remaining eight fixed assessment point photographs at Area 1 will be taken to document current conditions. Additional photographs were collected at any identified problem areas (e.g., presence of nuisance or invasive plant species, bank sloughing, etc.) (Attachment 1B) and locations for potential corrective action needs were noted and mapped on Figures 4 and 5.

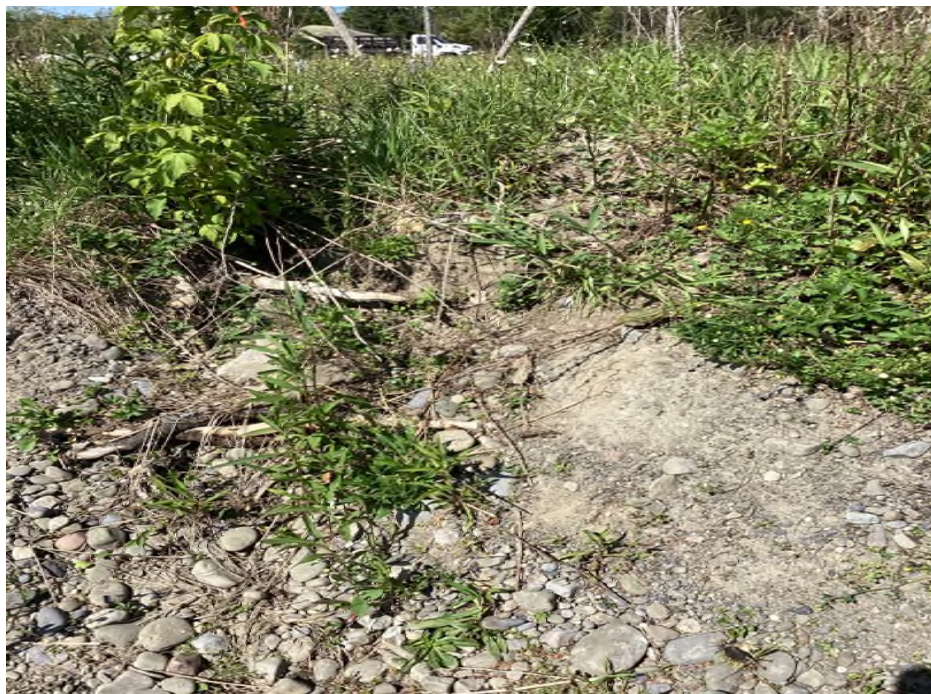
**Photo: 4**

As-built conditions for Area 1 included 244 trees, 2,201 shrubs, and 453 live stakes. Trees and shrubs along the western shoreline generally appeared to be in good health with little mortality observed. Herbivore damage was evident along the western and eastern shoreline and floodplain (Attachment 1B, Photos 3 and 11, respectively). Analysis of drone images identified approximately 32 dead tree plantings on the eastern shoreline of restoration Area 1 (Figure 3). Despite the observed mortality within the eastern shoreline, one example of natural recruitment was observed, as a maple sapling was present and healthy. A formal tree and shrub mortality census will be performed as part of the quantitative monitoring effort planned for August/September 2023.

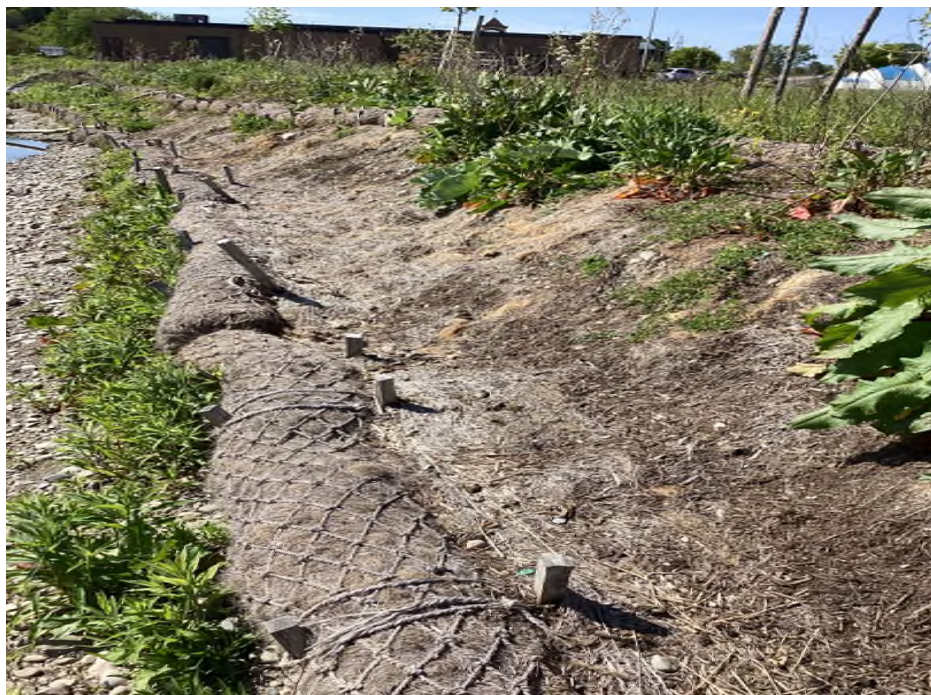
**Photo: 5**

As-built conditions for Area 1 included the seeding of herbaceous cover. Habitat-specific seed mixes were sowed to re-establish vegetative species within the wet meadow, floodplain, bank, and maintained grass planting areas. Approximately 1,400 emergent plugs were installed, comprised of two species, Arrow arum (*Peltandra virginica*) and American bur-reed (*Sparganium americanum*), to restore this emergent vegetative community found in the near-shore inundated planting areas. Overall herbaceous cover appeared in good condition with wildflowers beginning to bloom on the upper banks and into the floodplain along most of the western shoreline. Two areas lacking vegetative cover were identified, one on the western bank and one along the eastern shoreline (Attachment 1B, Photos 5 and 10, respectively). Some bare spots were noted within the restored areas of the western shoreline.

- Herbaceous cover – Herbaceous planting areas will likely not meet the performance criteria (85% cover). Fall reseeded of these areas is recommended.
- Emergent vegetation and live stakes – Observations indicate the need to monitor their establishment, as loss was evident during this inspection. Recommendations will be determined following the quantitative inspection.

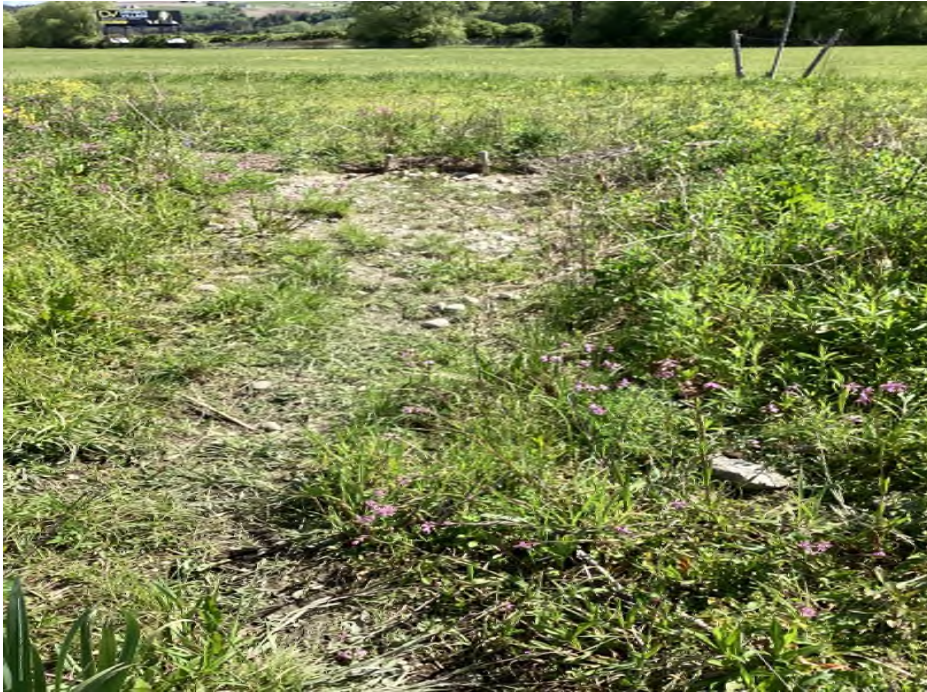
**Photo: 9**

**Notes:**  
Facing East.

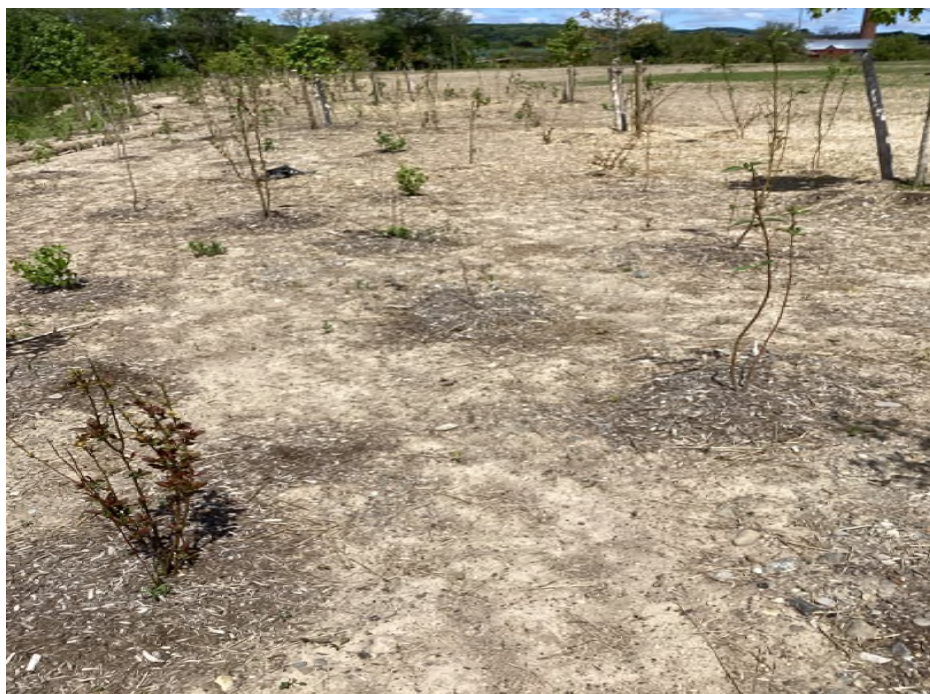
**Photo: 14**

**Notes:**  
Facing Northeast.

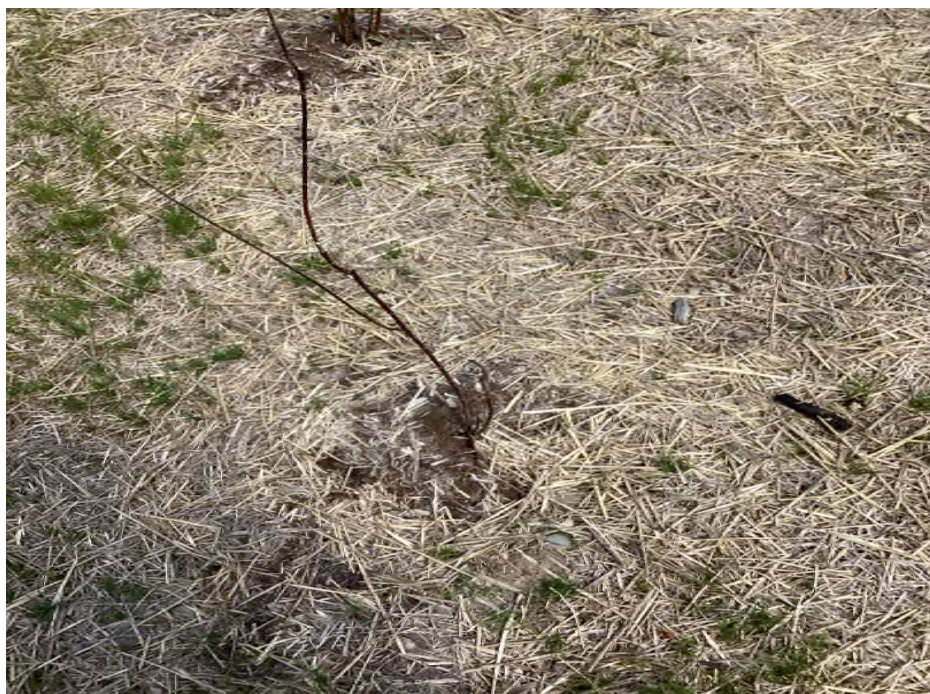
**Photo: 16**

**Notes:**  
Facing North.

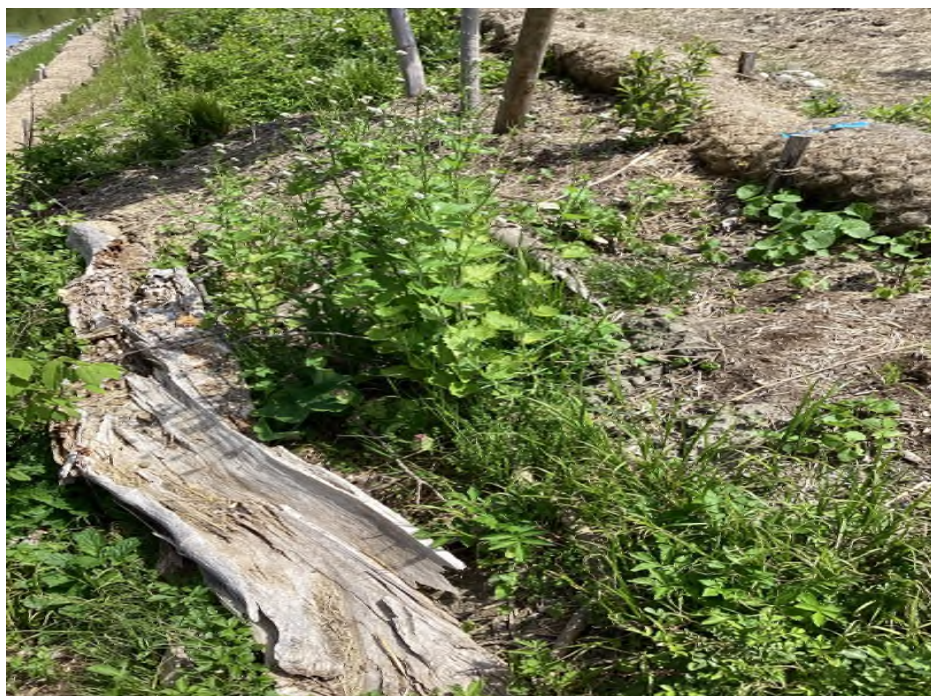
**Photo: 18**

One invasive species was identified in Area 2 during the inspection, as garlic mustard (*Alliaria petiolata*) (Attachment 1B, Photo 18).
