Date: June 17, 2025 Our Ref: 30229726 Subject: Response to Comments – 2024 Restoration Monitoring Report NYSEG Cortland-Homer Former MGP Site NYSDEC Site No. 7-12-005 Arcadis of New York, Inc. One Lincoln Center 110 West Fayette Street Suite 300 Syracuse, NY 13202 United States Phone: 315 446 9120 Fax: 315 449 0017 www.arcadis.com

NYSEG - CORTLAND-HOMER FORMER MGP SITE HOMER, NEW YORK 2024 RESTORATION MONITORING REPORT

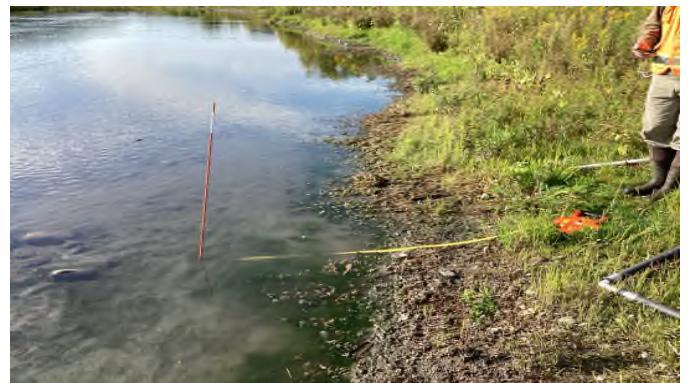
Monitoring Location : EV-01Q1				
Habital Type : Emergent Vegetation				
Survey Date : 09/09/2024				
Staff: Jason Vogel				
Aerial Cover				
Dimensions	1	meters		
	Opiewijije News	Alto a luta O aura 0/	Nativity (native, non	N/
Common Name	Scientific Name	Absolute Cover %	native, weed)	vigor
Trees

Other Species Observed					
Common Name	Scientific Name	Notes			
Tree Strata	N/A	0			
Shrub Strata	N/A	0			
Herb Strata	N/A	45%

Total Vegetative Cover (%)	45	
Total Species Cover (%)	60	
Native Cover (%)	24	
Invasive/Target Weed (%)	1

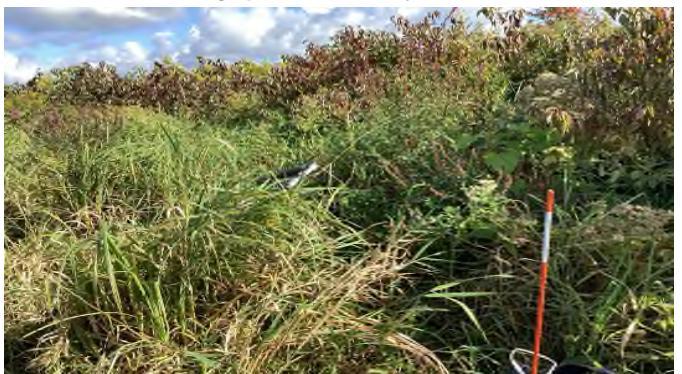
Monitoring Location : EV-04

Other Species Observed				
Common Name	Scientific Name	Notes		
Tree Strata	N/A	1%		
Shrub Strata	N/A	30%		
Herb Strata	N/A	60%

Shrubs				
Red-Osier Dogwood	Cornus sericea	10	Native	N/A
Herbs				
Swamp Milkweed	Asclepias incarnata	15	Native	N/A
Spotted Touch-Me-Not	Impatiens capensis	15	Native	N/A
Lurid Sedge	Carex lurida	55	Native	N/A
Reed Canary Grass	Phalaris arundinacea	10	Non-Native	N/A
Mad Dog Skullcap	Scutellaria lateriflora	5	Native	N/A
Water Forget-Me-Not	Myosotis scorpioides	7	Non-Native	N/A

Total Vegetative Cover (%)	98	
Total Species Cover (%)	117	
Native Cover (%)	90	
Invasive/Target Weed (%)	10

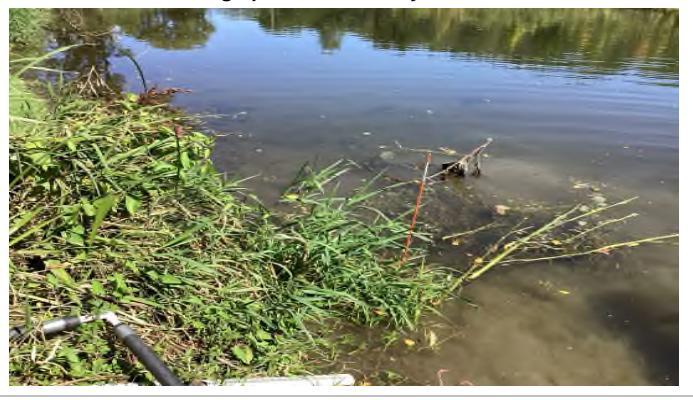
Monitoring Location :	EV-05
-----------------------	-------

Survival					
Radial Dimensions	0.01 acres				
Common Name	Scientific Name	Alive (Installed)	Alive (Recruited)	Dead (Installed)	Survival (%)
Canadian Waterweed	Elodea canadensis	0	0	0	0
Grass-leaved Pondweed	Potamogeton gramineus	0	0	0	0
Pond Water Starwort	Callitriche stagnalis	0	0	0	0
Water Speedwell	Veronica anagallis-aquatica	0	0	0	0
Rice Cut Grass	Leersia oryzoides	0	0	0	0
Reed Canary Grass	Phalaris arundinacea	0	0	0	0
				Stems per acre	0
				Total % Survival	NA
Note: N/A

State Species Observed						
Common Name	Scientific Name	Notes				
Herb Strata	N/A	60%				
Tree Strata	N/A	0				
Shrub Strata	N/A	0

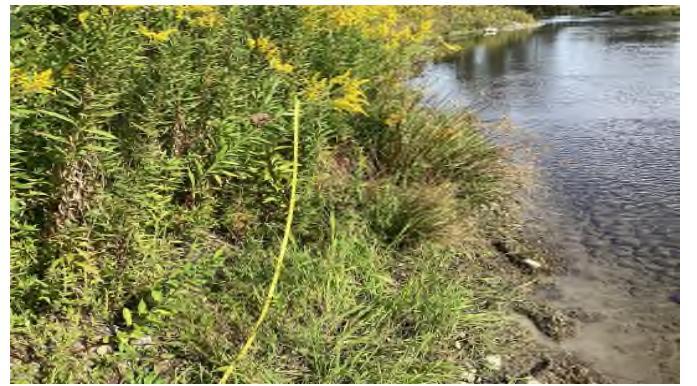
Monitoring Location: IS-02	
Habital Type: Inundated Shoreline	
Survey Date: 09/09/2024	
Staff: Jason Vogel

Survival Radial Dimensions 0.01 acres Alive (Recruited) Common Name Scientific Name Alive (Installed) Dead (Installed) Survival (%) Staghorn sumac Rhus typhina 0 0 3 0 Pussy Willow Salix discolor 0 4 0 NA Stems per acre 361 Total % Survival NA Note: N/A

· · · · · · · · · · · · · · · · · · ·		
Common Name	Scientific Name	Notes
Tree Strata	N/A	5%
Shrub Strata	N/A	20%
Herb Strata	N/A	70%

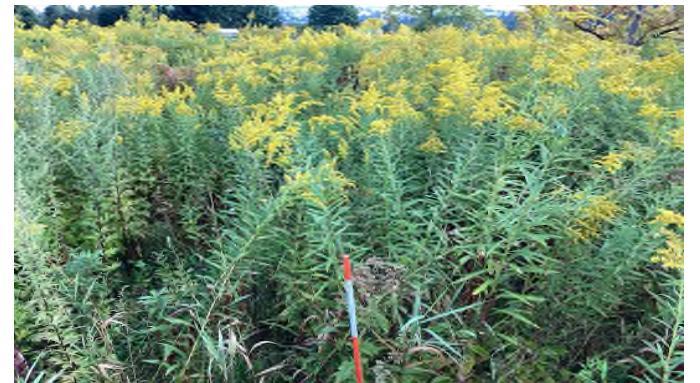
Aonitoring Location: IS-07
łabital Type: Inundated Shoreline
Survey Date: 09/10/2024
staff: Jason Vogel

Survival					
Radial Dimensions	0.1 acres				
Common Name	Scientific Name	Alive (Installed)	Alive (Recruited)	Dead (Installed)	Survival (%)
Eastern Cottonwood	Populus deltoides	0	2	0	0
Tall goldenrod	Solidago altissima	0	0	0	0
Purple-Stemmed Aster	Symphyotrichum puniceum	0	0	0	0
Common Wormwood	Artemisia vulgaris	0	0	0	0
Red-Osier Dogwood	Cornus sericea	7	0	0	100
Silky Dogwood	Cornus amomum	7	0	0	100
Silver Maple	Acer saccharinum	3	0	0	100
Sugar Maple	Acer saccharum	1	0	0	100
Northern White Oak	Quercus alba	1	0	0	100
Northern Red Oak	Quercus rubra	1	0	0	100
				Stems per acre	1133
				Total % Survival	100
Note: N/A

Other Species Observed					
Common Name	Scientific Name	Notes			
Tree Strata	N/A	18%			
Shrub Strata	N/A	10			
Herb Strata	N/A	95%

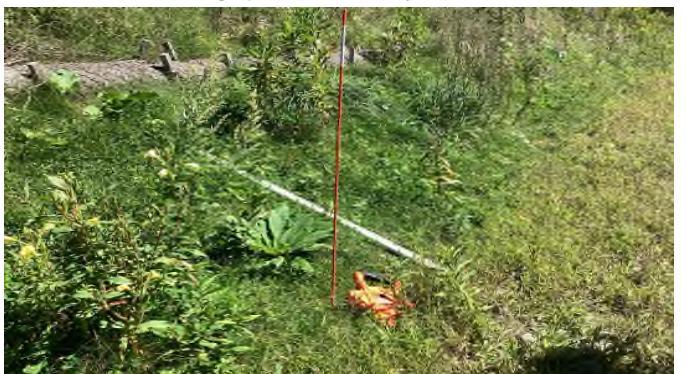
Nonitoring Location: IS-10
Habital Type: Inundated Shoreline
Survey Date: 09/10/2024
Staff: Jason Vogel

Survival					
Radial Dimensions	0.01 acres				
Common Name	Scientific Name	Alive (Installed)	Alive (Recruited)	Dead (Installed)	Survival (%)
Red Fescue	Festuca rubra	0	0	0	0
Fall Panic Grass	Panicum dichotomiflorum	0	0	0	0
Red Clover	Trifolium pratense	0	0	0	0
Perennial Rye Grass	Lolium perenne	0	0	0	0
				Stems per acre	0
				Total % Survival	NA
Note: N/A

Other Species Observed					
Common Name	Scientific Name	Notes			
Tree Strata	N/A	0			
Herb Strata	N/A	55%			
Shrub Strata	N/A	0

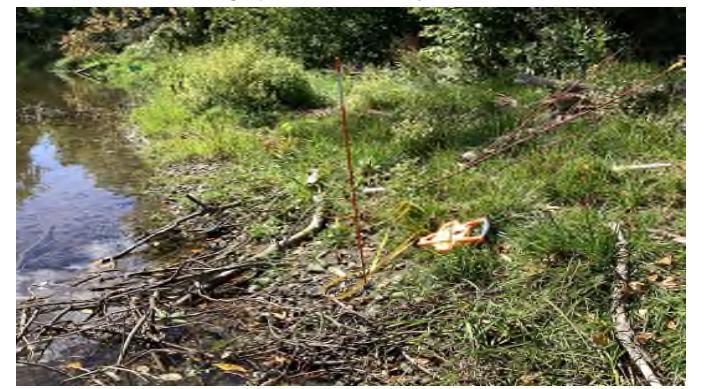
Monitoring Location: IS-13	
Habital Type: Inundated Shoreline	
Survey Date: 09/10/2024	
Staff: Jason Vogel

Survival					
Radial Dimensions	0.01 acres				
Common Name	Scientific Name	Alive (Installed)	Alive (Recruited)	Dead (Installed)	Survival (%)
Red-Osier Dogwood	Cornus sericea	1	0	0	100
Virginia Sweetspire	Itea virginica	1	0	0	100
Arrowwood	Viburnum dentatum	1	0	0	100
				Stems per acre	155
				Total % Survival	100
Note: N/A

Other Species Observed						
Common Name	Scientific Name	Notes				
Tree Strata	N/A	0				
Shrub Strata	N/A	3%				
Herb Strata	N/A	40%
