**FINAL
FIELD ACTIVITIES REPORT
GROUNDWATER MONITORING WELL INSTALLATION
AND LANDFILL INSPECTION
SOUTH HILL DUMP
SITE NO. 712009**

WORK ASSIGNMENT NO. D007619-16

**New York State Department of Environmental Conservation
Division of Environmental Remediation
Remedial Bureau E
Albany, New York**

AUGUST 2014

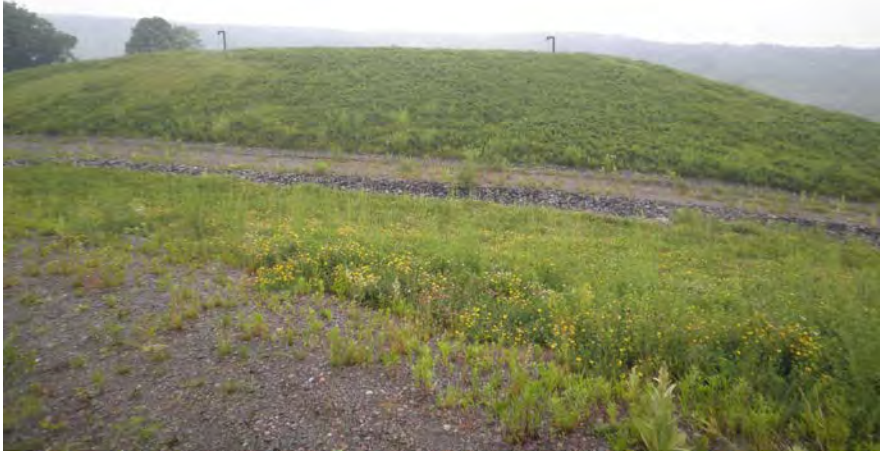
<p>Photo 208</p> <p><u>Description:</u> Erosion gully cutting into the southwest branch of the perimeter road beginning downgradient of the end of the west drainage swale downgradient of culvert C-3.</p> <p><u>Source:</u> MACTEC, July 2014 Site Inspection</p>
