**RE: Submission of the 2019 Periodic Review Report  
South Hill Dump, Town of Cortlandville, New York  
CHA Project No.: 34236  
NYSDEC Site No.: 712009**

# 2019 PERIODIC REVIEW REPORT

**South Hill Dump  
Sommerville Road  
Cortlandville, New York**

**NYSDEC Site Number: 712009**

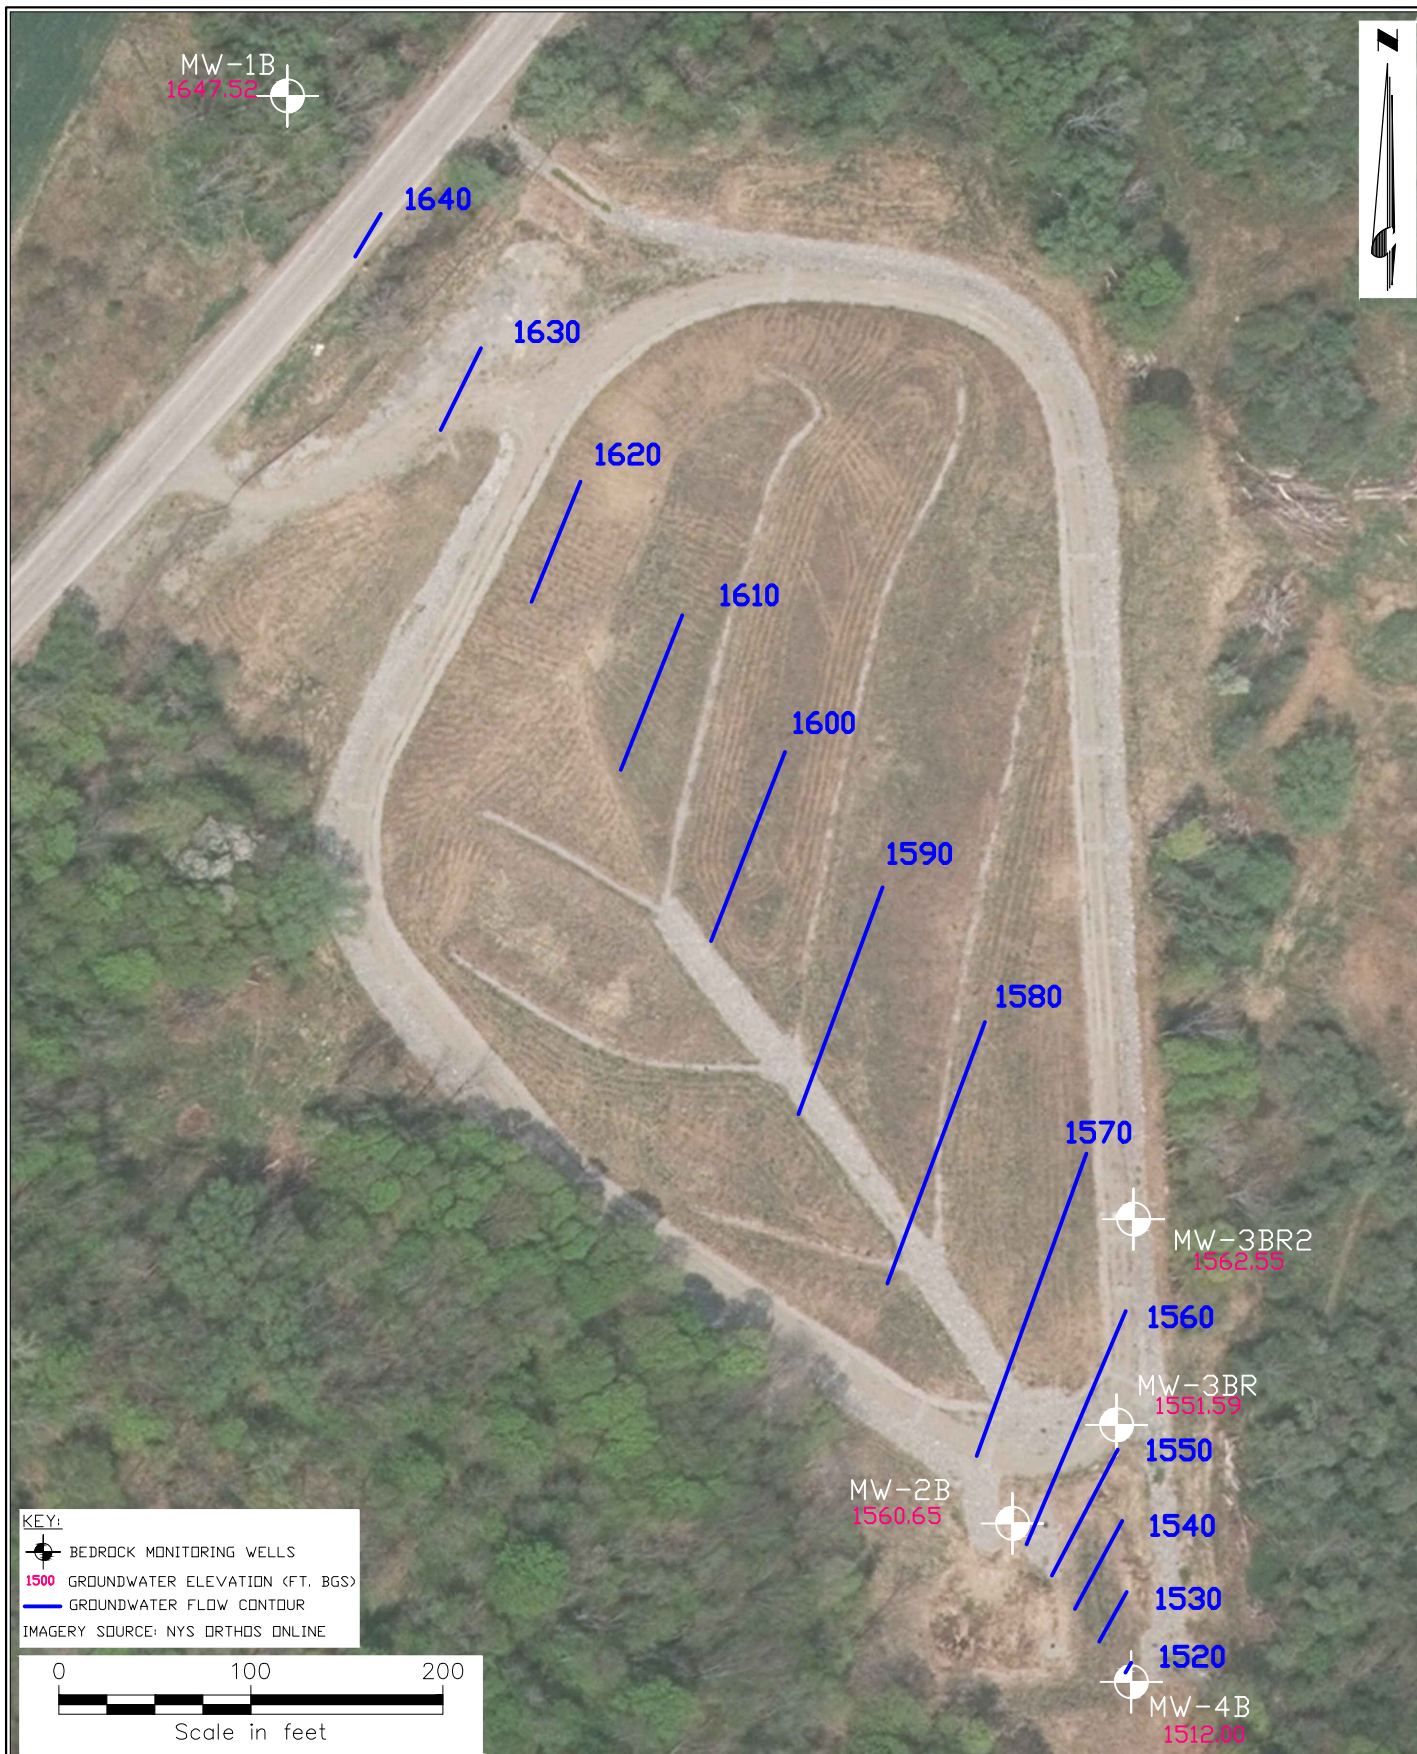
Groundwater water level measurements were collected from each of the 11 groundwater monitoring wells shown on Figure 2 and are presented in Table 1. Groundwater levels in most wells were generally lower when compared to the 2018 monitoring event. The groundwater flow direction for the overburden and bedrock wells are depicted on the Groundwater Potentiometric Maps included as Figures 3 and 4, respectively. Groundwater at the Site generally flows to the southeast.

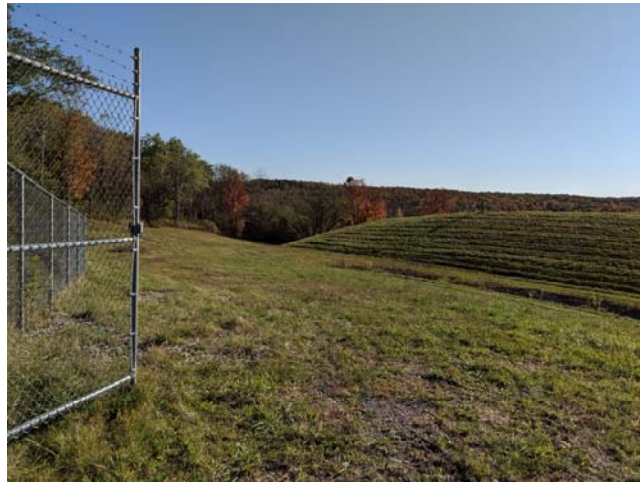
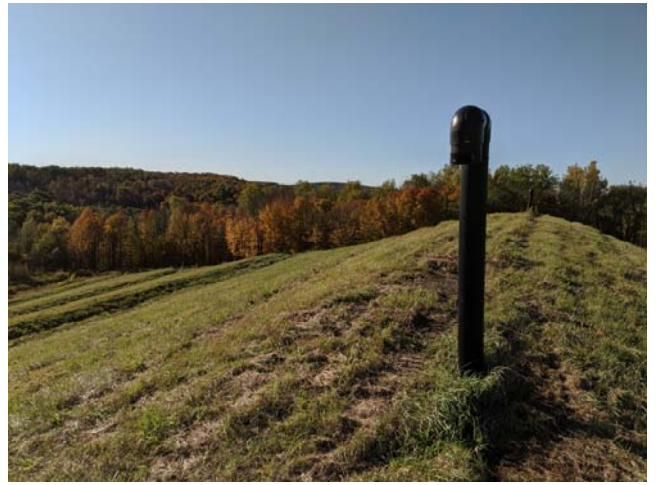
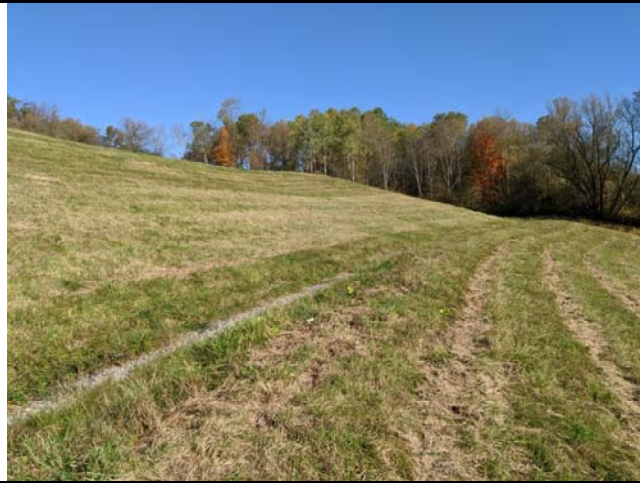
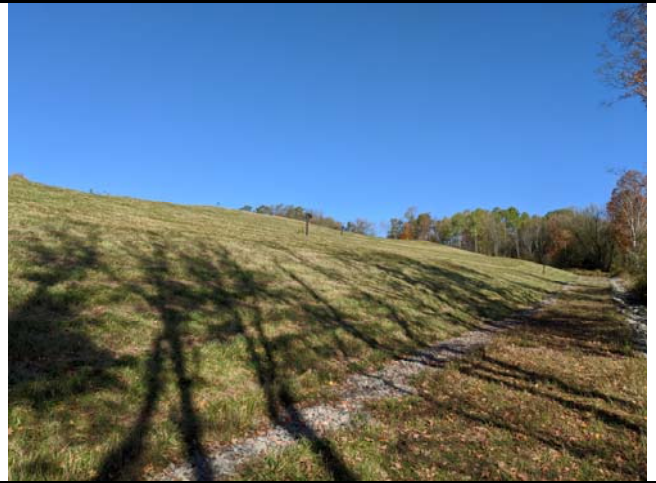
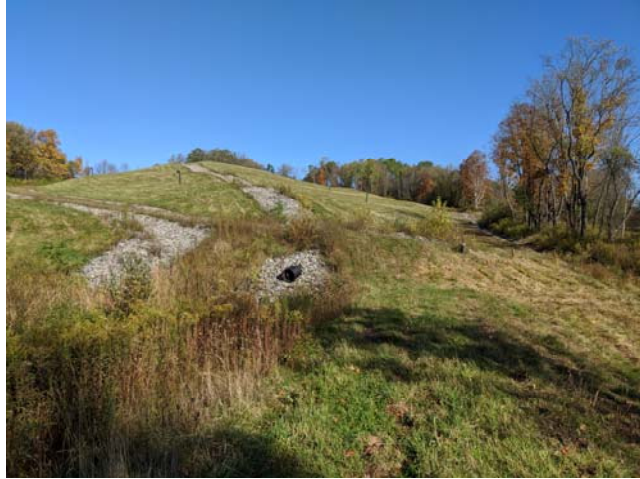
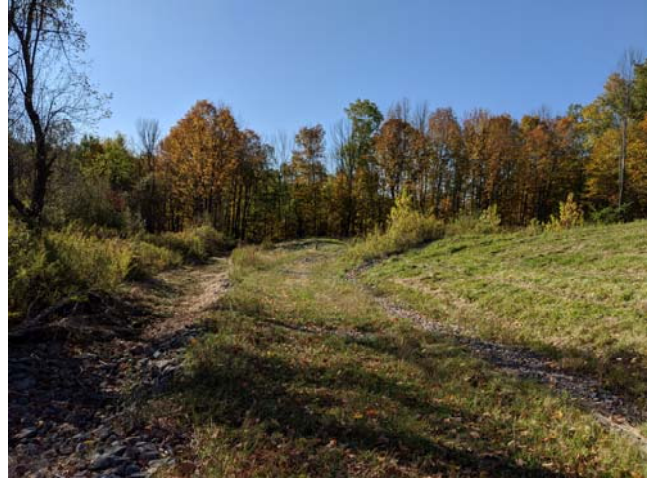
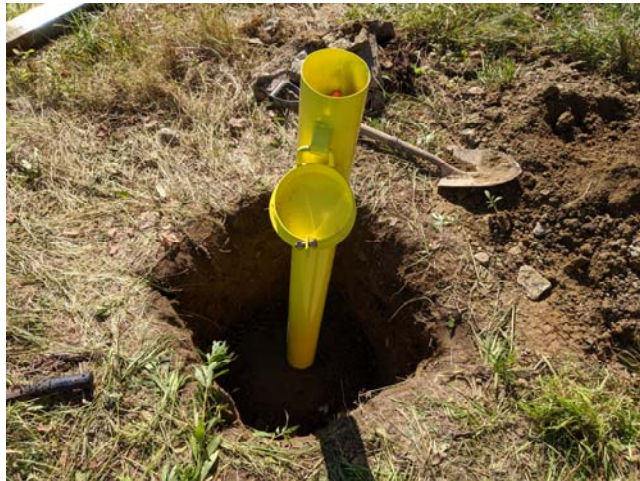
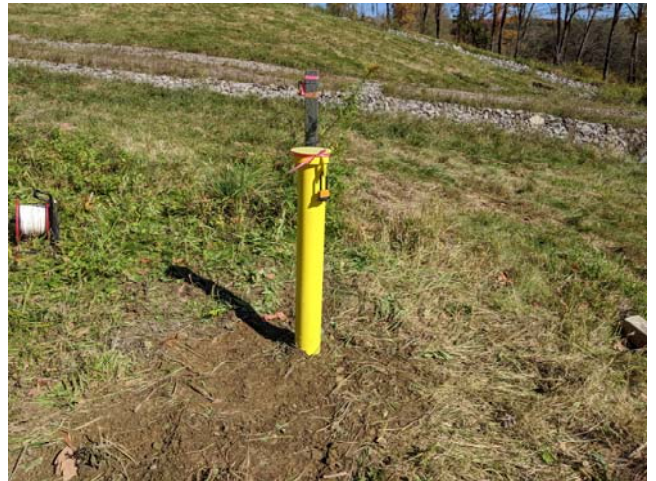
**ADDITIONAL NOTES & OBSERVATIONS**

ITEM/CONDITION	YES	NO	NA	COMMENTS
Are the monitoring wells in generally good condition?	<input type="checkbox"/>	<input checked="" type="checkbox"/>	<input type="checkbox"/>	See additional notes & observations
Are well caps installed on the wells?	<input checked="" type="checkbox"/>	<input type="checkbox"/>	<input type="checkbox"/>	
Are locks present and secured?	<input checked="" type="checkbox"/>	<input type="checkbox"/>	<input type="checkbox"/>	
<b>VECTOR INSPECTION</b>
