Subject: Carrier Corporation, Thompson Road Facility, Syracuse, New York
Corrective Action Order — Index CO 7-20051118-4
Site Registry No.: 734043
Interim Corrective Measure Construction Completion Report
TR-8 Floor Vault Sealing

**TR-8 Floor Vault Sealing
Interim Corrective Measure
Carrier Corporation Site
ONONDAGO COUNTY, NEW YORK**

Construction Completion Report

NYSDEC Site Number: 734043

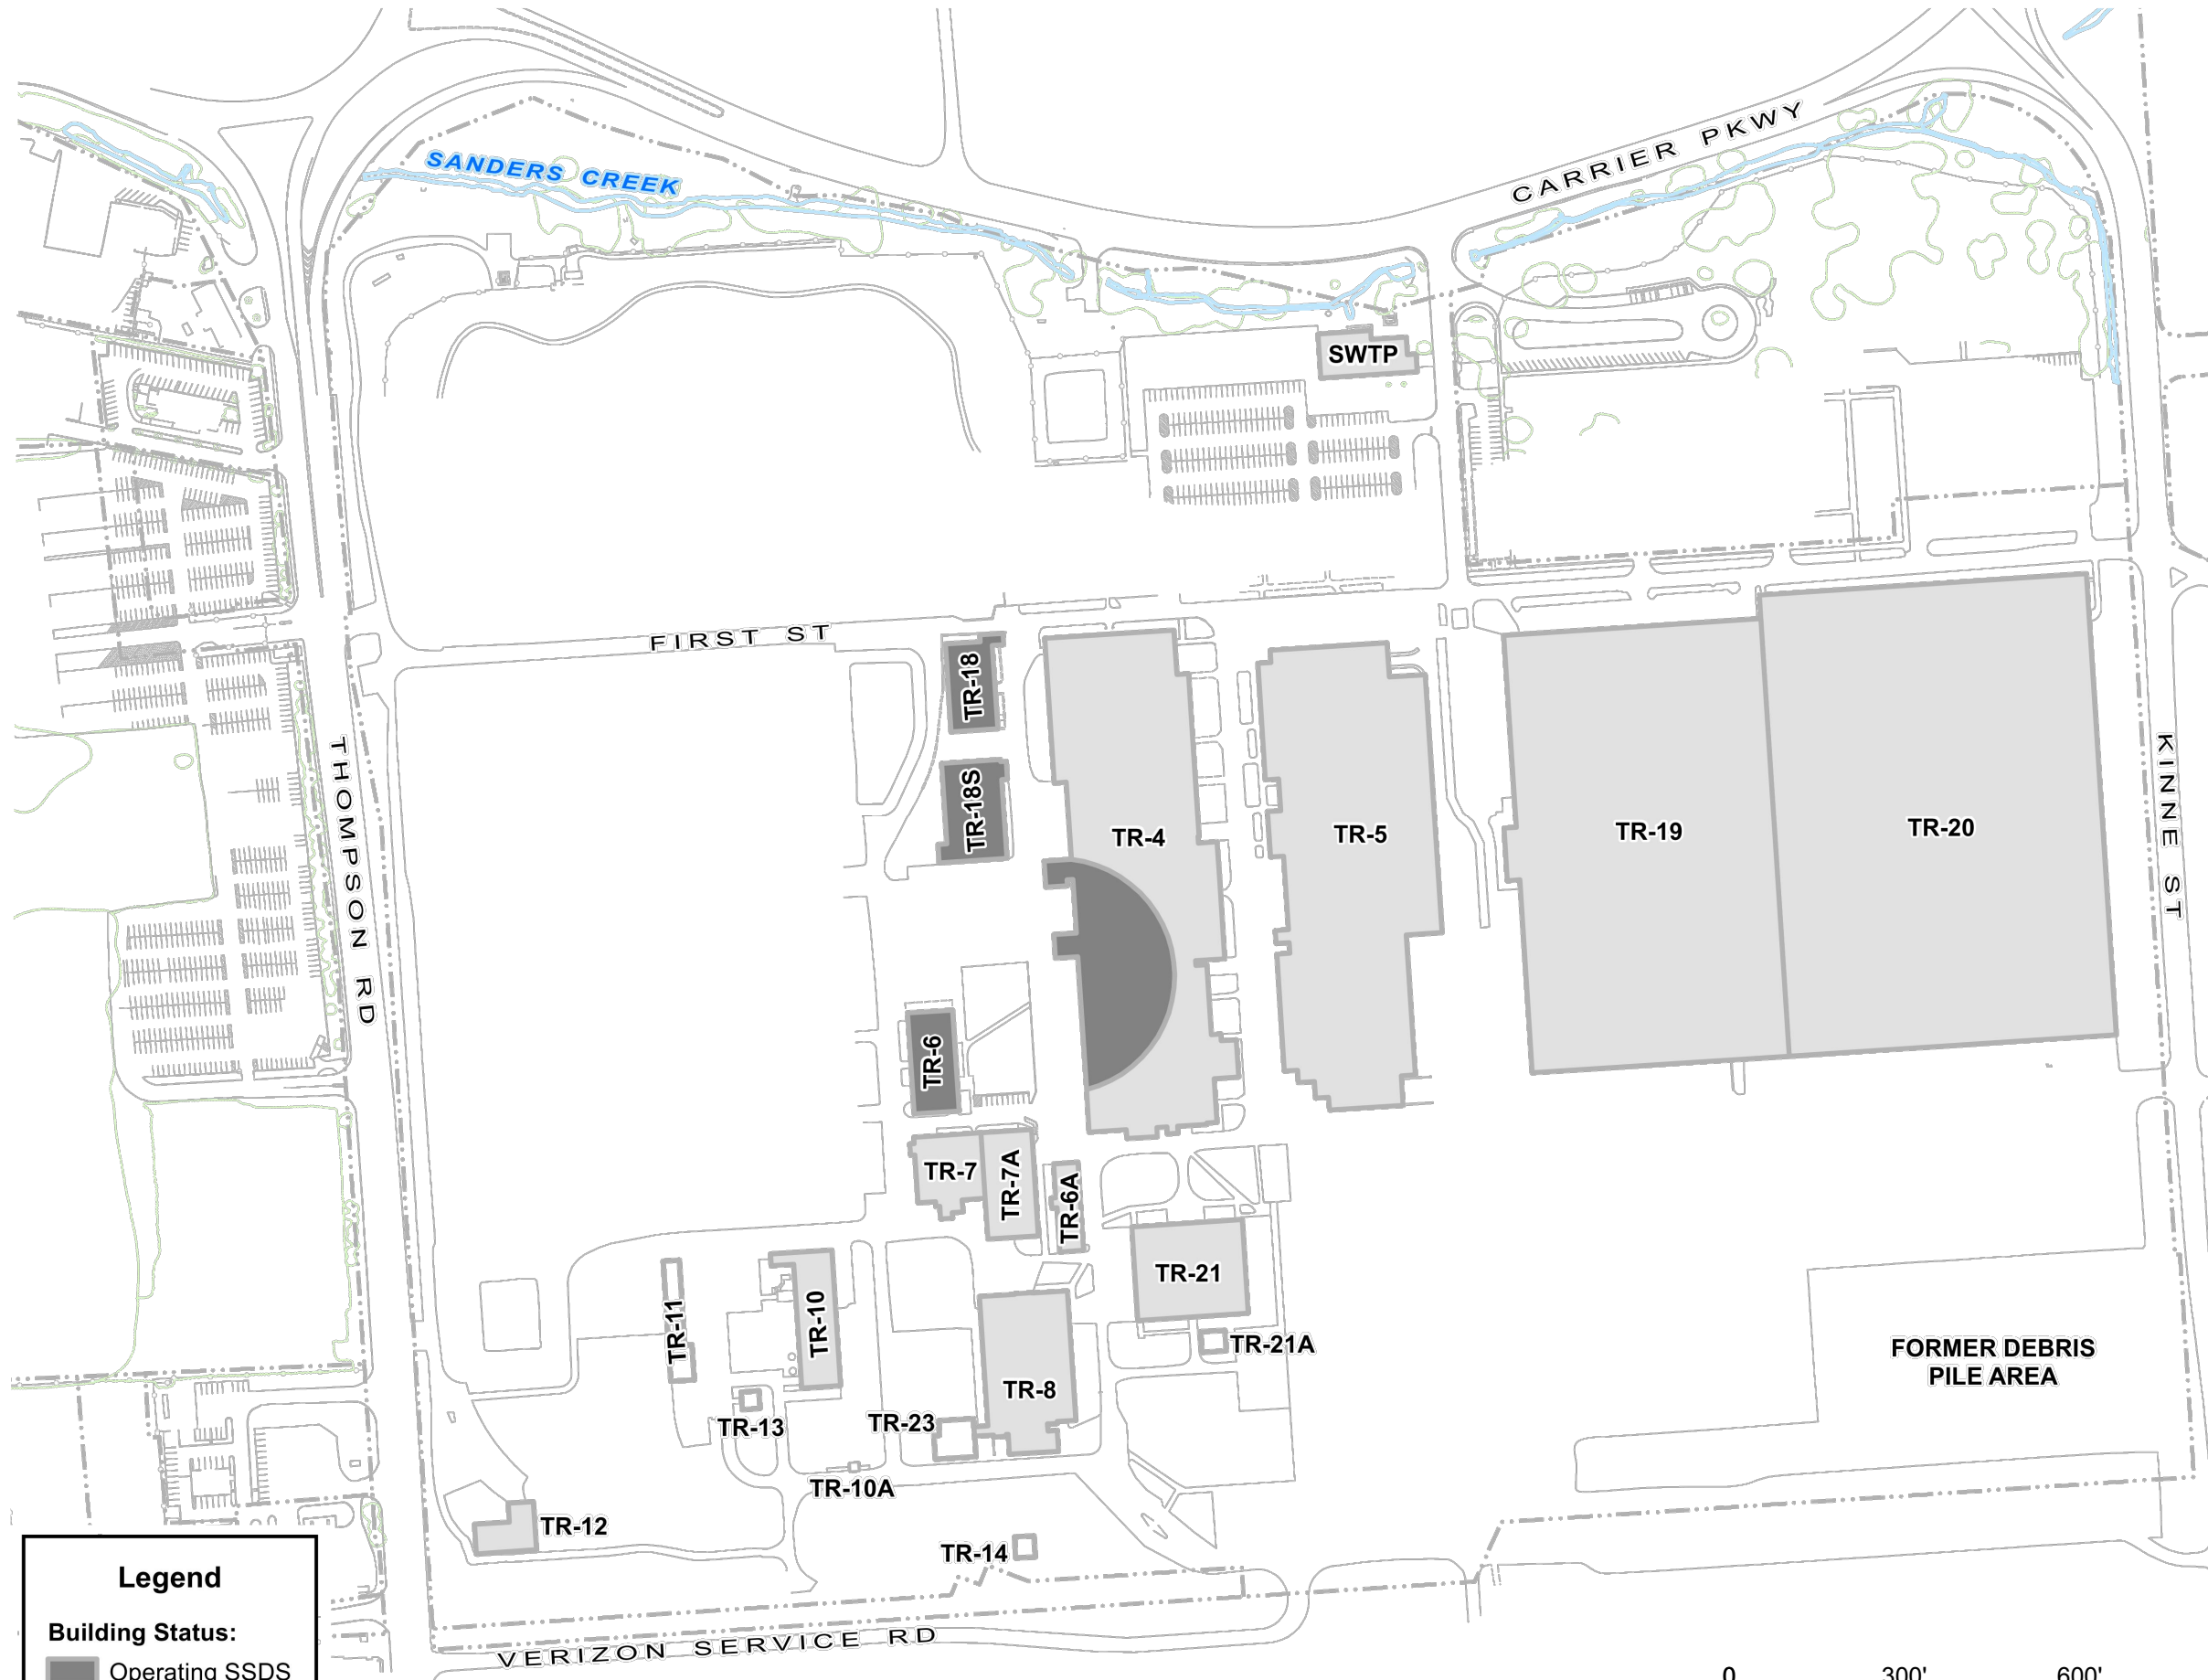
Figure 2 – TR-8 Floor Vault Sealing

In addition to the vaults, four floor drains were identified and sealed. The approximate locations of the vaults and floor drains are shown in **Figure 2**.
