Re: Annual Landfill Inspection Report (Year 15)
Syracuse China Landfill
Town of Salina, Onondaga County, New York
NYSDEC Site Number 7-34-053

Rocterra, LLC (Rocterra), on behalf of TPC-York Inc. (TPC-York), has prepared this letter report to summarize the required monitoring and maintenance activities completed at the Syracuse China Landfill site located in the Town of Salina, Onondaga County, New York (Site No. 7-34-053). In accordance with New York State Department of Environmental Conservation (NYSDEC) requirements, activities for the fifteenth year of Operation, Monitoring and Maintenance (OM&M) were performed at the site. In accordance with the OM&M Plan prepared by Remedial Engineering, PC dated September 25, 2003 and the schedule approved by NYSDEC, the following activities were performed:

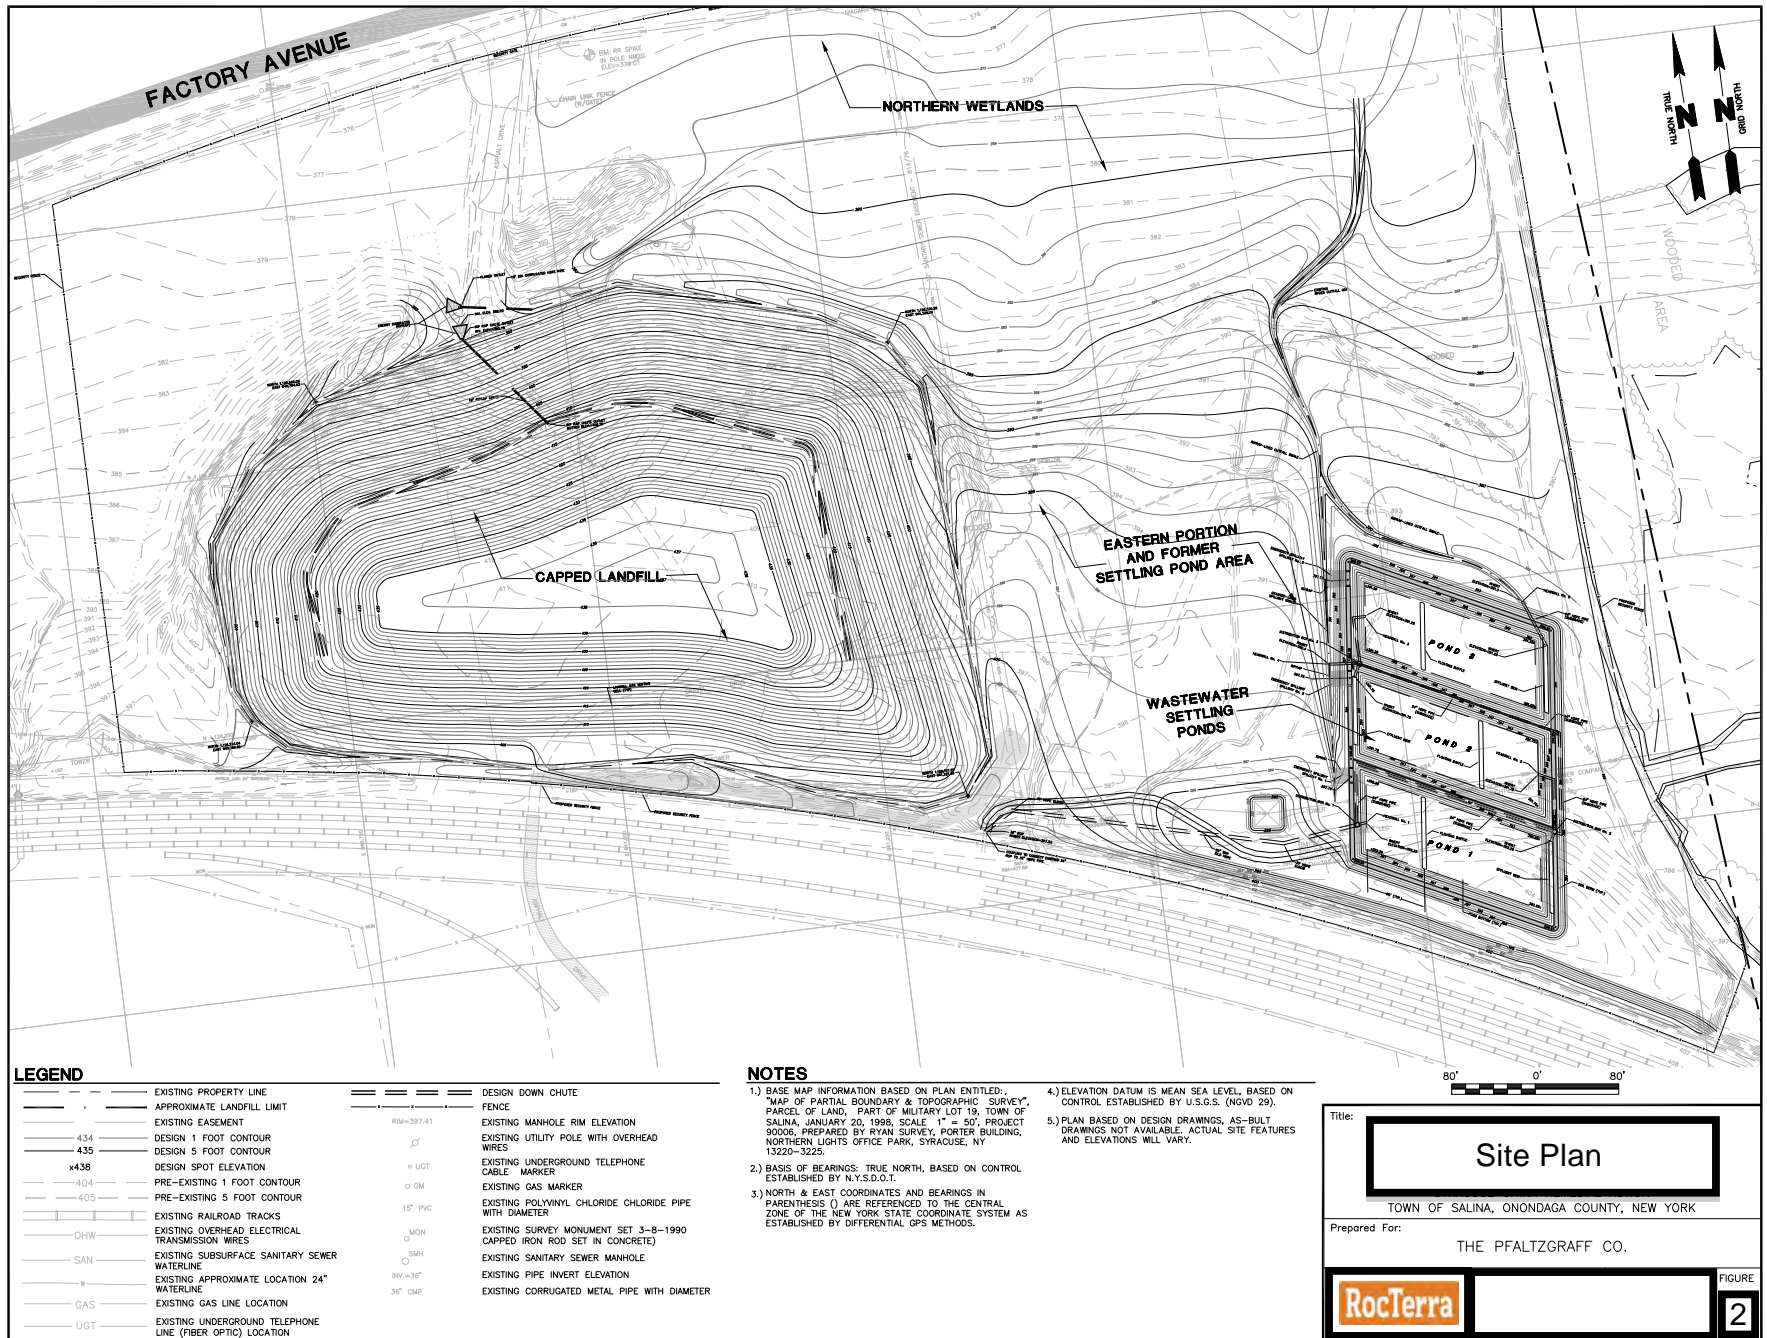
Site Feature Location Plan

Approximately 100 feet of fencing along the northern border/Factory Ave has begun to deteriorate due to oxidation of the support posts. Fencing contractors have been contacted and warranty-repair is being coordinated with the contractor. An additional, approximately 150 feet of fencing along the northern border/Factory Ave have been damaged. Damage appears to have been caused by a vehicle accident. Broken pieces of autobody parts/plastic/debris were scattered throughout this area of damaged fencing. Repair of this area will occur concurrently with the warranty repair work. Figure 2 identifies the approximate locations of these two areas.

A culvert that runs beneath the CSX railroad tracks and exits along the southern border of the site has lost integrity due to erosion. There is approximately 40 feet of fencing in the vicinity of the culvert that is in danger of being destabilized as a result of the culvert deterioration (pictures have been included within Appendix B). Ownership of the culvert is being determined so that the appropriate party can be contacted to undertake the necessary repairs. As an alternative approach, an evaluation is being made of the feasibility of relocating the fence away from the culvert. However, relocation would either need to avoid the adjacent CSX railroad right-of-way or permission from CSX would need to
