April 6, 2022

Re: Annual Landfill Inspection Report (Year 18)
Syracuse China Landfill
Town of Salina, Onondaga County, New York
NYSDEC Site Number 7-34-053

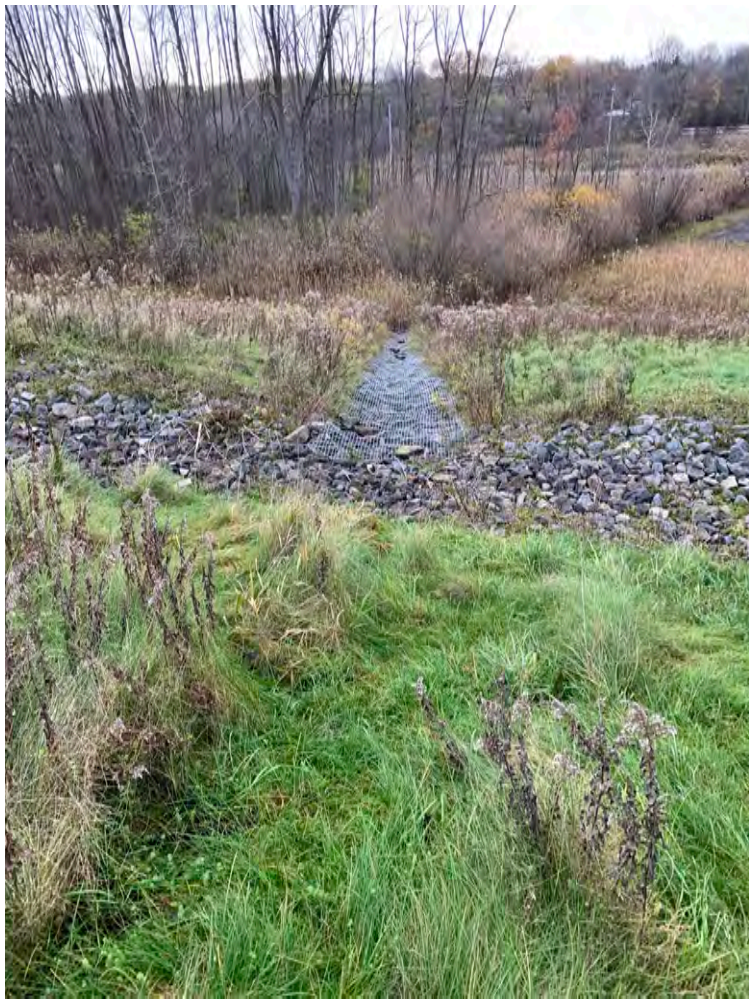
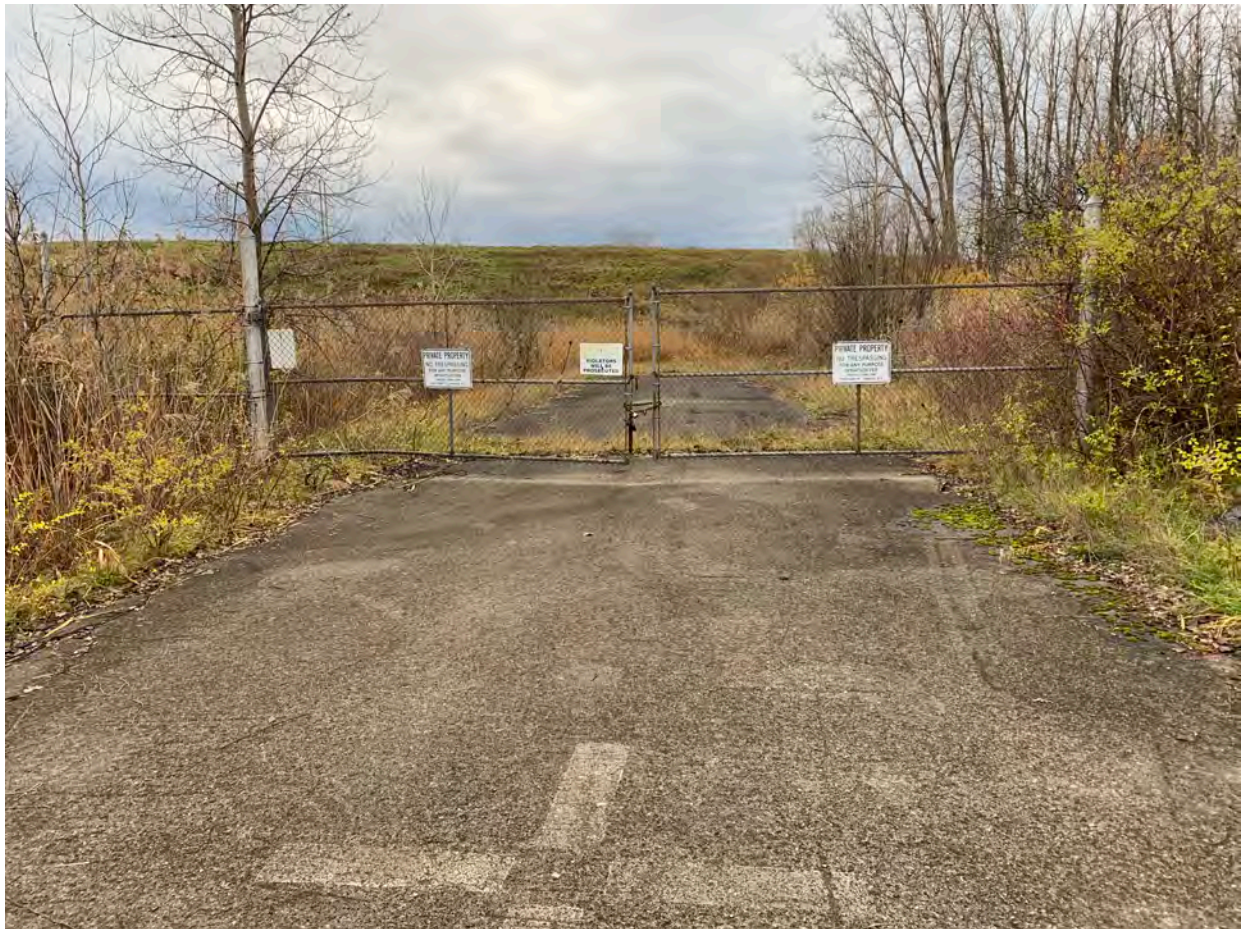
Culvert Area

An area of fencing at the west side of the culvert area has also been compromised. Stone was piled against the fencing, bending the support post and creating a large gap in the fencing. Figure 3 identifies the approximate locations of these areas. It is recommended that Onondaga County, CSX, NYSDEC and Rocterra representatives meet on site to discuss the fencing/culvert/failed slope area. Photographs are included within Appendix B.

A culvert that runs beneath the CSX railroad tracks and exits along the southern border of the site has lost integrity due to erosion. There is approximately 40 feet of fencing in the vicinity of the culvert that is in danger of being destabilized as a result of the culvert deterioration (pictures have been included within Appendix B). Upon review of as-built documents and evaluating the area in-person, the feasibility of relocating the fence
