**Storm Sewer Rehabilitation IRM
Former Inland Fisher Guide Facility
Syracuse, New York
(Site No. 7-34-057)**

General Motors Corporation
Syracuse, New York

October 2002

O'BRIEN & GERE
ENGINEERS, INC.

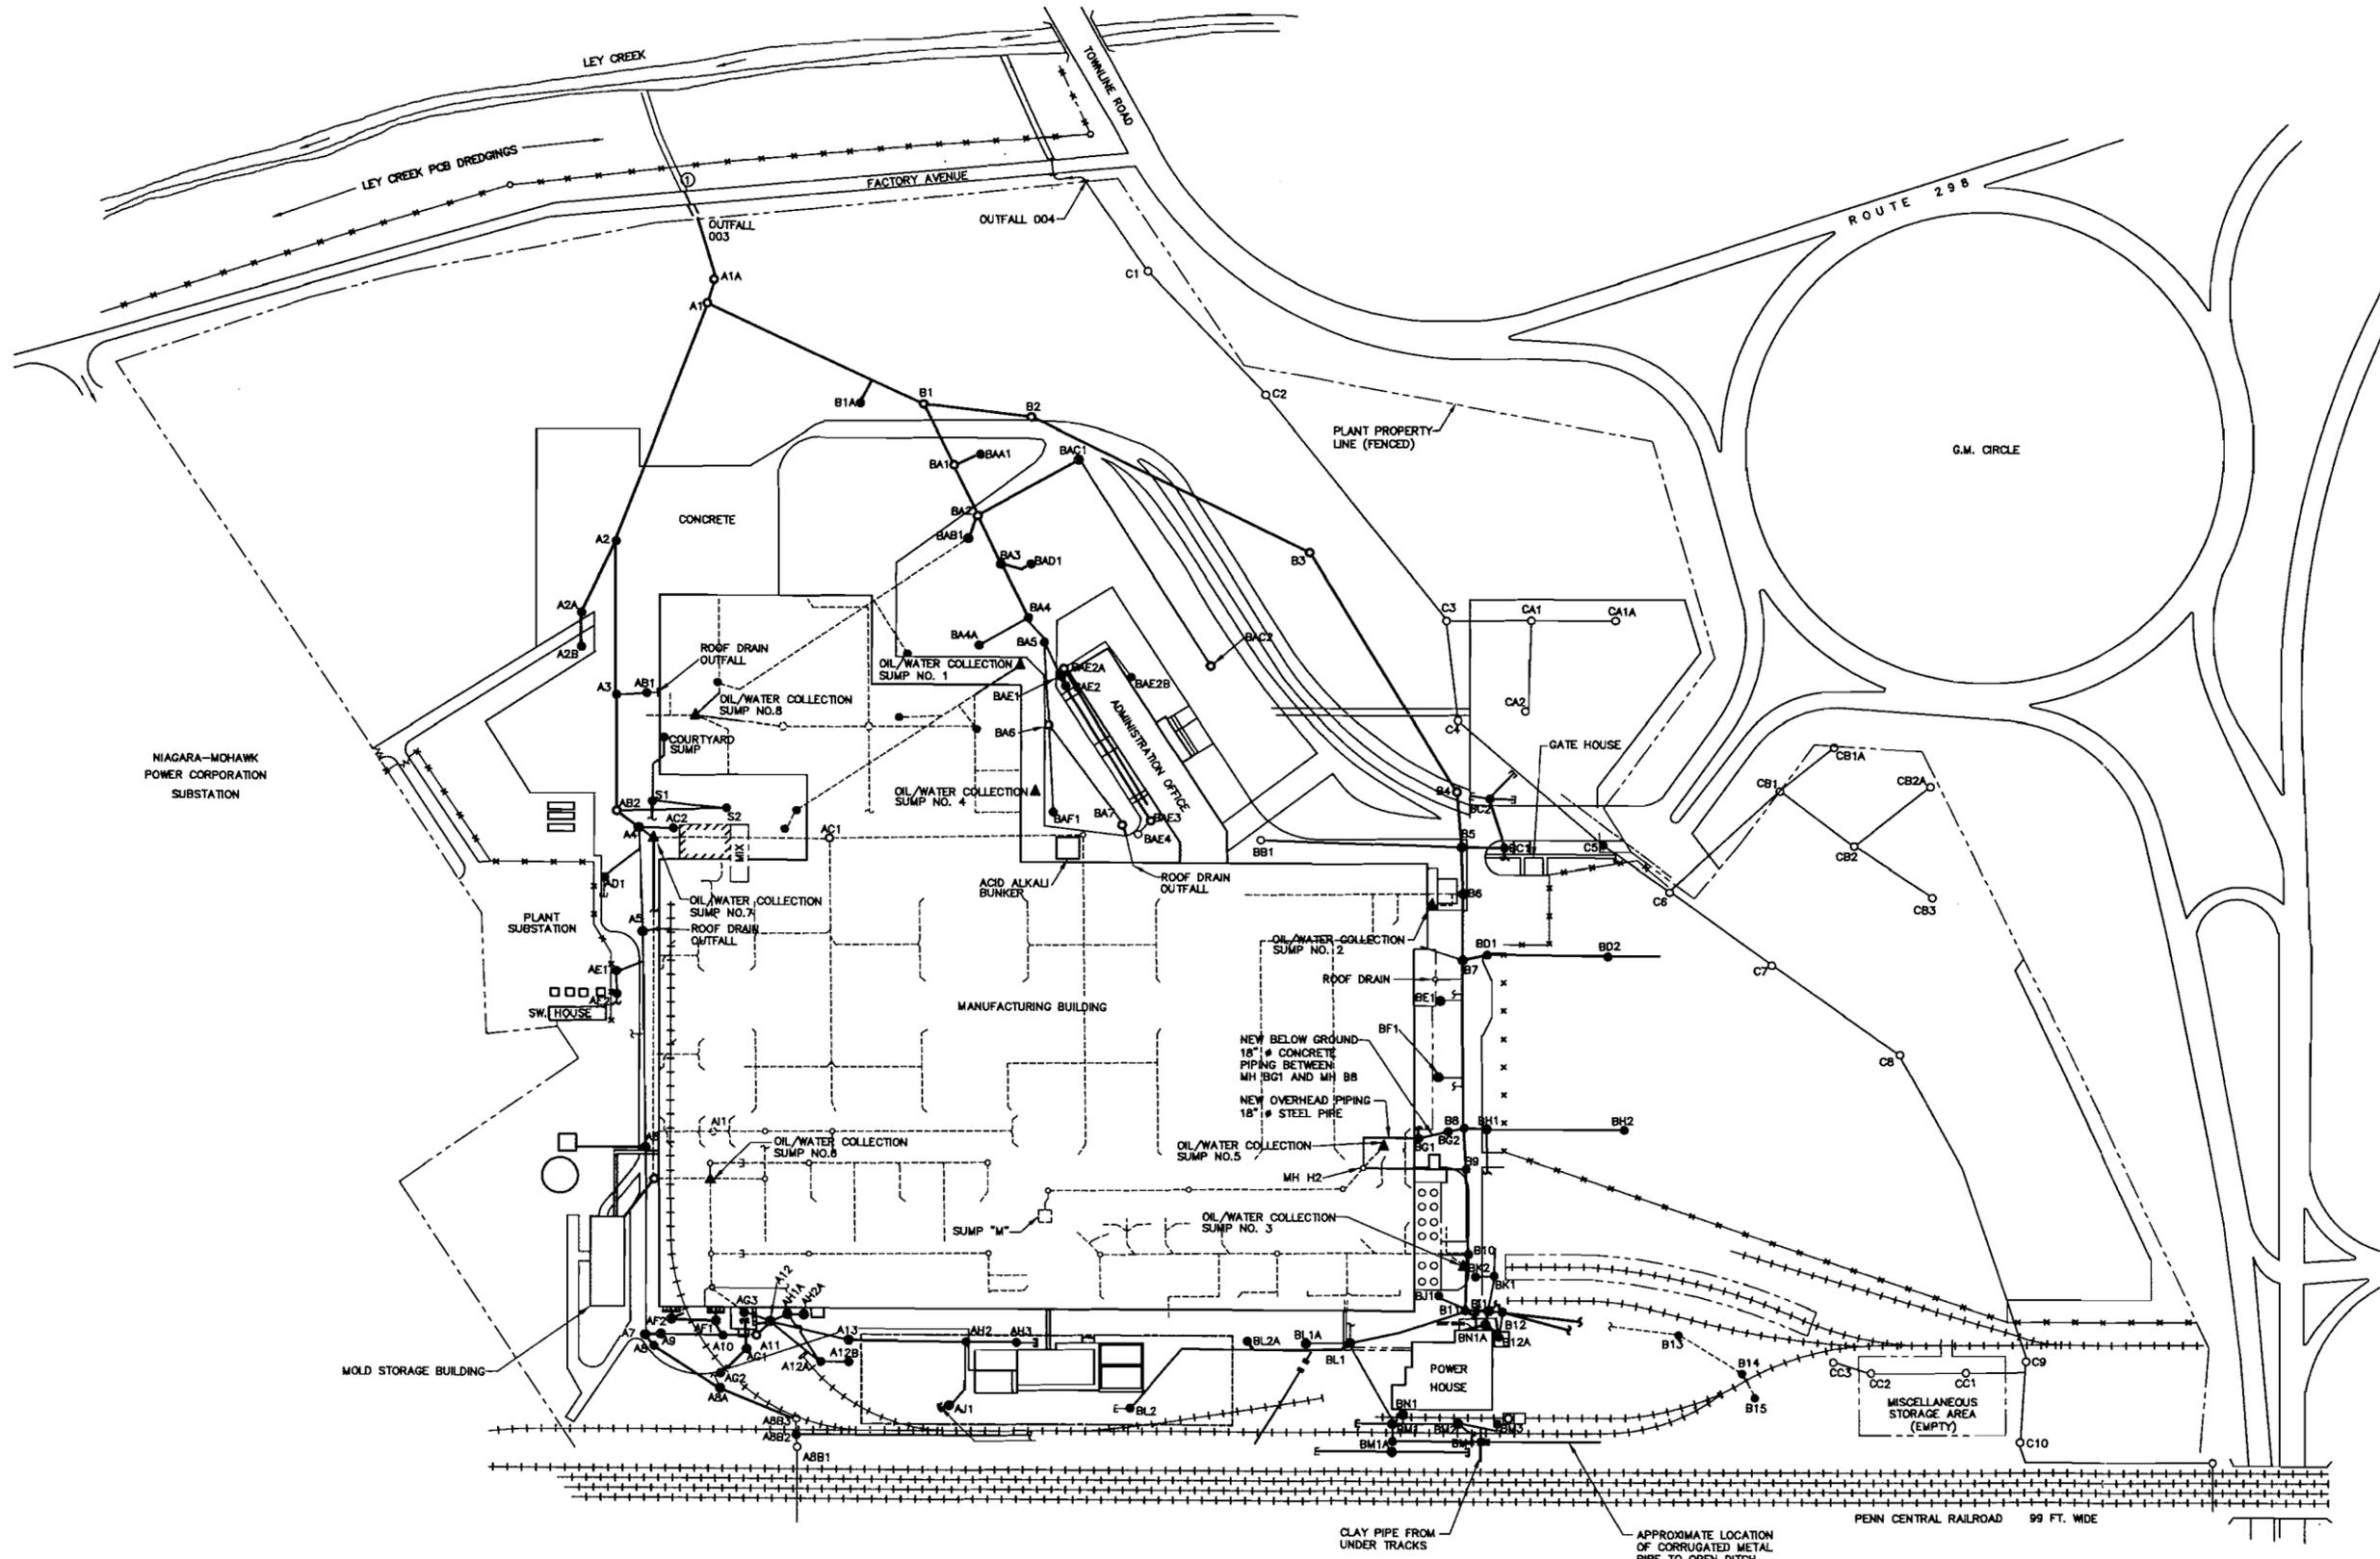
FIGURE 1

Based on the results of the storm sewer cleaning and televising activities, the subsequent sampling program, and observations made during implementation, storm sewer rehabilitation activities were performed using various techniques, as summarized in Table 2-1. Storm sewer rehabilitation activities are depicted on Figure 1. Storm sewer rehabilitation was performed from June 2001 through November 2001.

rehabilitation activities. Manhole rehabilitation activities are also depicted on Figure 1. Manhole rehabilitation activities were performed from June 2001 through November 2001. Additional rehabilitation activities were performed in May 2002.

The pipe between S1 and the courtyard sump and the piping between S2 and S1 was abandoned; Catch Basin S2 was replaced; and a new storm sewer pipe from S2 to AB2 was installed. With this configuration, the surface water collected in this area flows to the main storm sewer line leading to Outfall 003. These improvements to the western courtyard are shown on Figure 1.

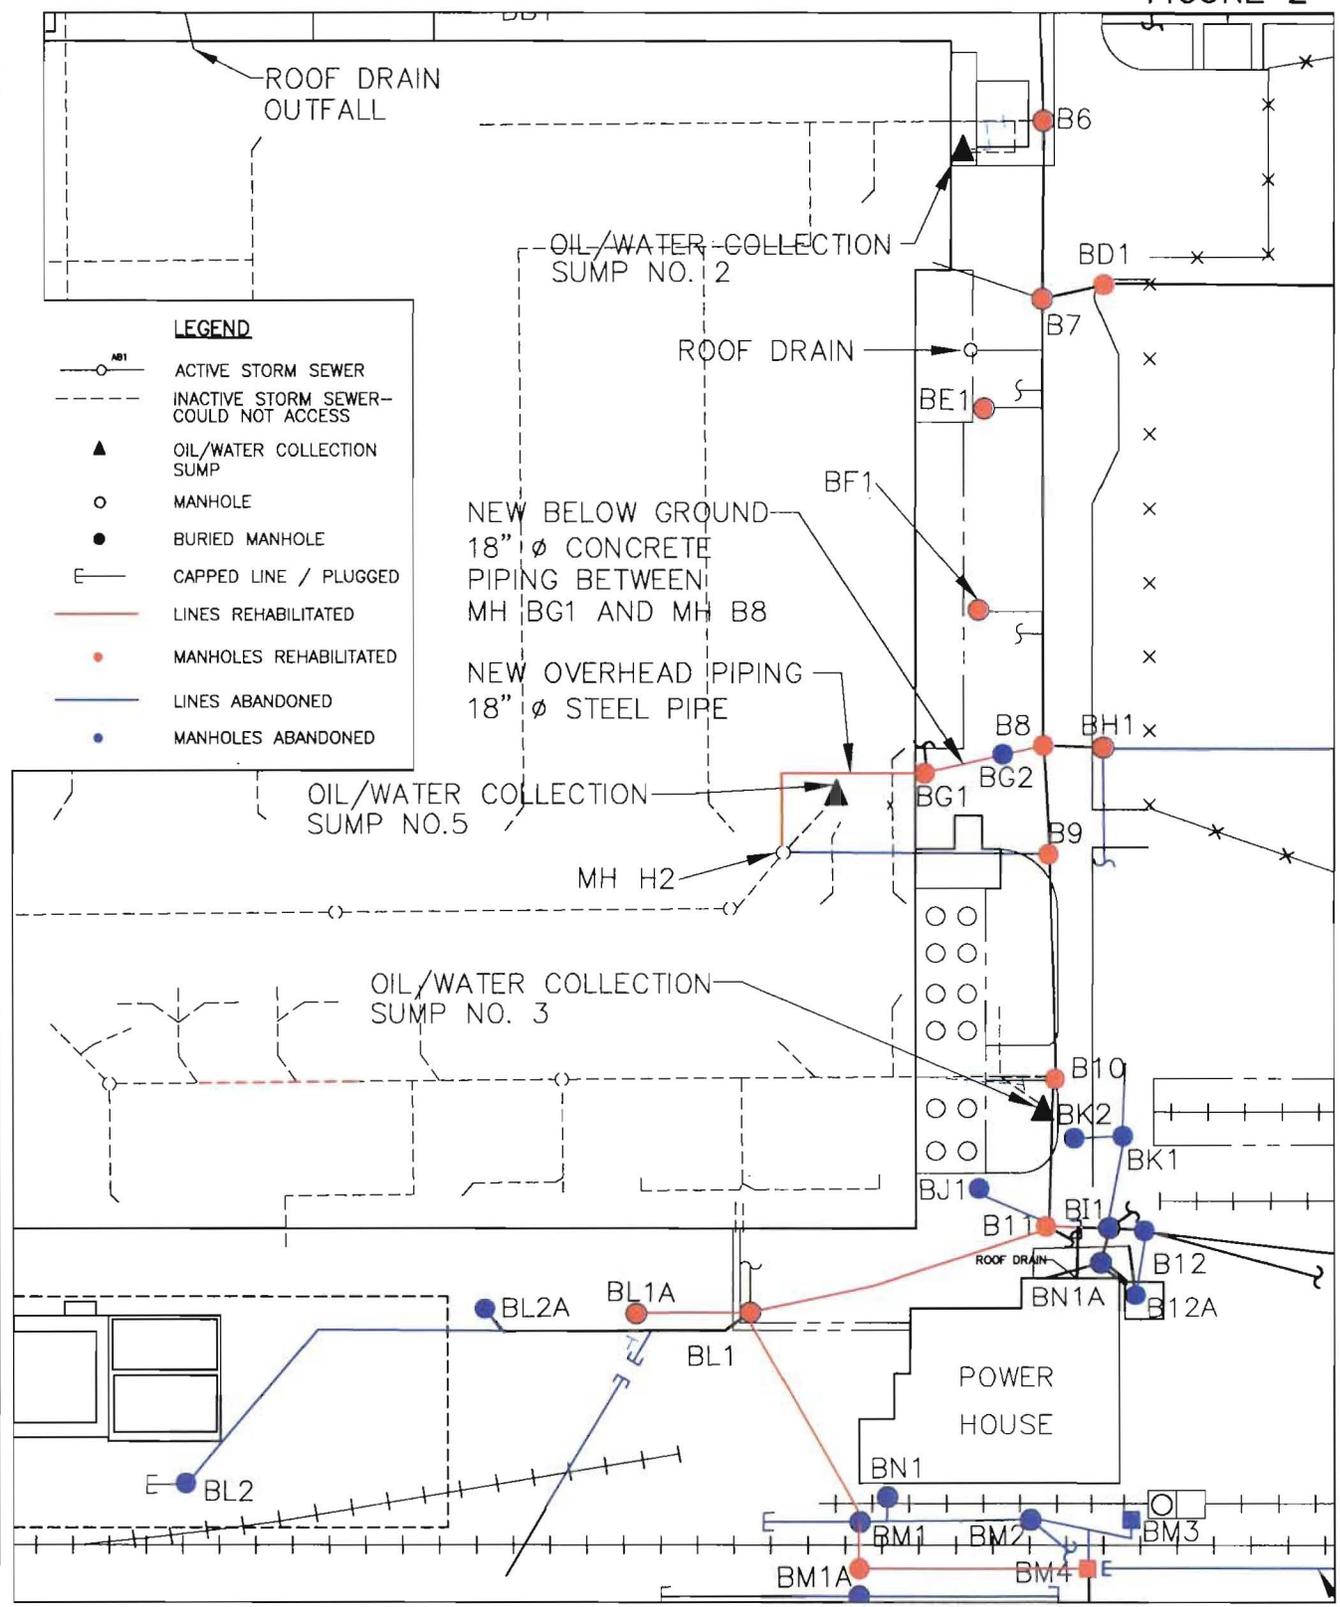
FIGURE 2

The roof drain that directs water collected from the southeastern portion of the roof to manhole B9 was rerouted due to concentrations of PCBs detected in H2 and the poor condition of pipe between H2 and B9. The roof drain discharged to manhole H2 located inside the facility in Bay H2. The roof drain was rerouted as shown on Figure 2. Activities associated with rerouting the roof drain were performed from September 6, 2001 through October 30, 2001. Activities associated with rerouting the roof drain included the addition of approximately 145 ft of new 18-inch, steel overhead piping, connection of the overhead piping to replaced manhole BG1 (outside), and replacement of the underground storm sewer piping between manholes BG1 and B8. Following installation of the new piping, the old underground piping from manhole H2 was plugged where it entered manhole B9. The June 2001 Storm Sewer Rehabilitation IRM Work Plan (O'Brien & Gere 2001c) specified that the underground piping would be plugged at both H2 and B9; however, the underground piping from H2 toward B9 was not plugged because manhole H2 is not accessible (i.e., cannot be accessed due to lack of steps to enter the manhole).

Connection to manhole BG1 was accomplished by excavating inside the building and through the foundation wall to replacement manhole BG1. Replacement of the underground storm sewer between manholes BG1 and B8 was accomplished by excavating a trench, approximately 60 ft long by 3 ft wide. The soil was managed as described in Section 4. An

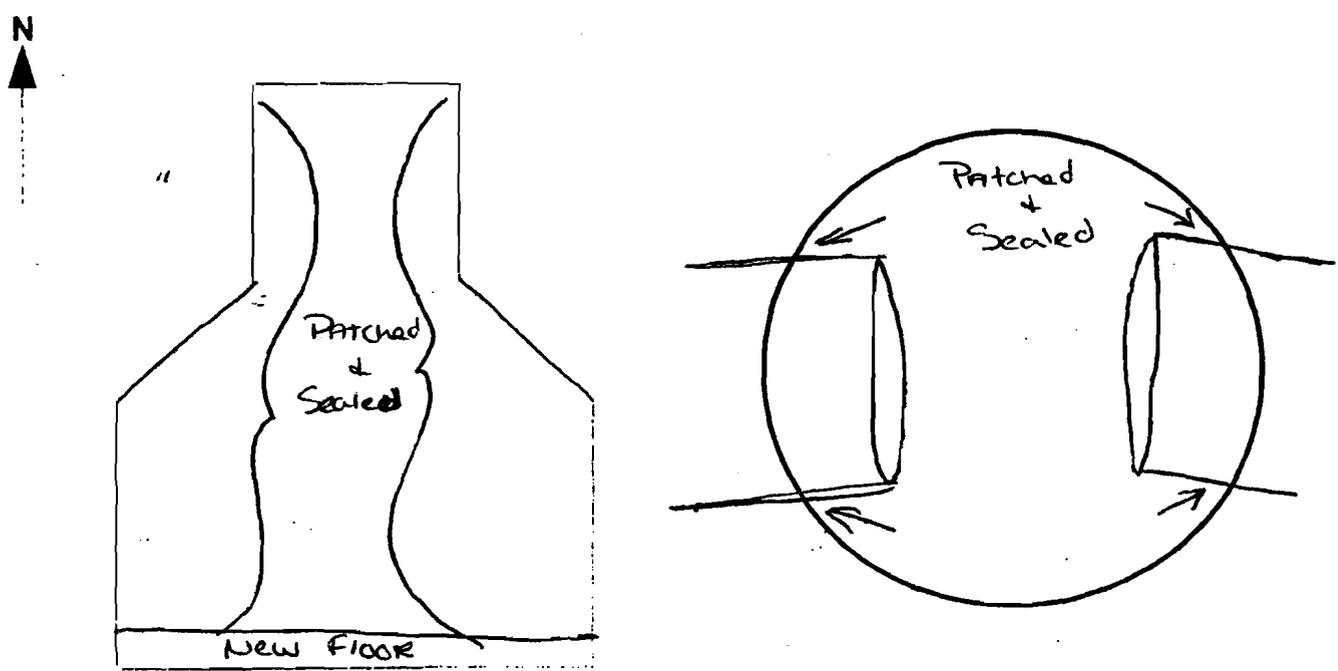
Manhole #: A13 Sewer Branch: Western Date: _____

* A12B	Complete	Eliminate infiltration	Abandon	Inspection performed
A13	Incomplete; no further action required due to construction of a storm water treatment system.	Eliminate infiltration	Grout (patch) walls of manhole. Seal entire basin. Install new floor in basin.	Inspection performed; infiltration observed around effluent pipe.

Description of Repairs Made: Entire Basin was Patched & Sealed
AND A NEW FLOOR WAS PAURED RAISING THE FLOOR
BY 3"
