**PROJECT:** Former Carlyle Compressor Site

NYSDEC Site Code - 734068

Periodic Review Report, 2019

# Periodic Review Report September 30, 2019

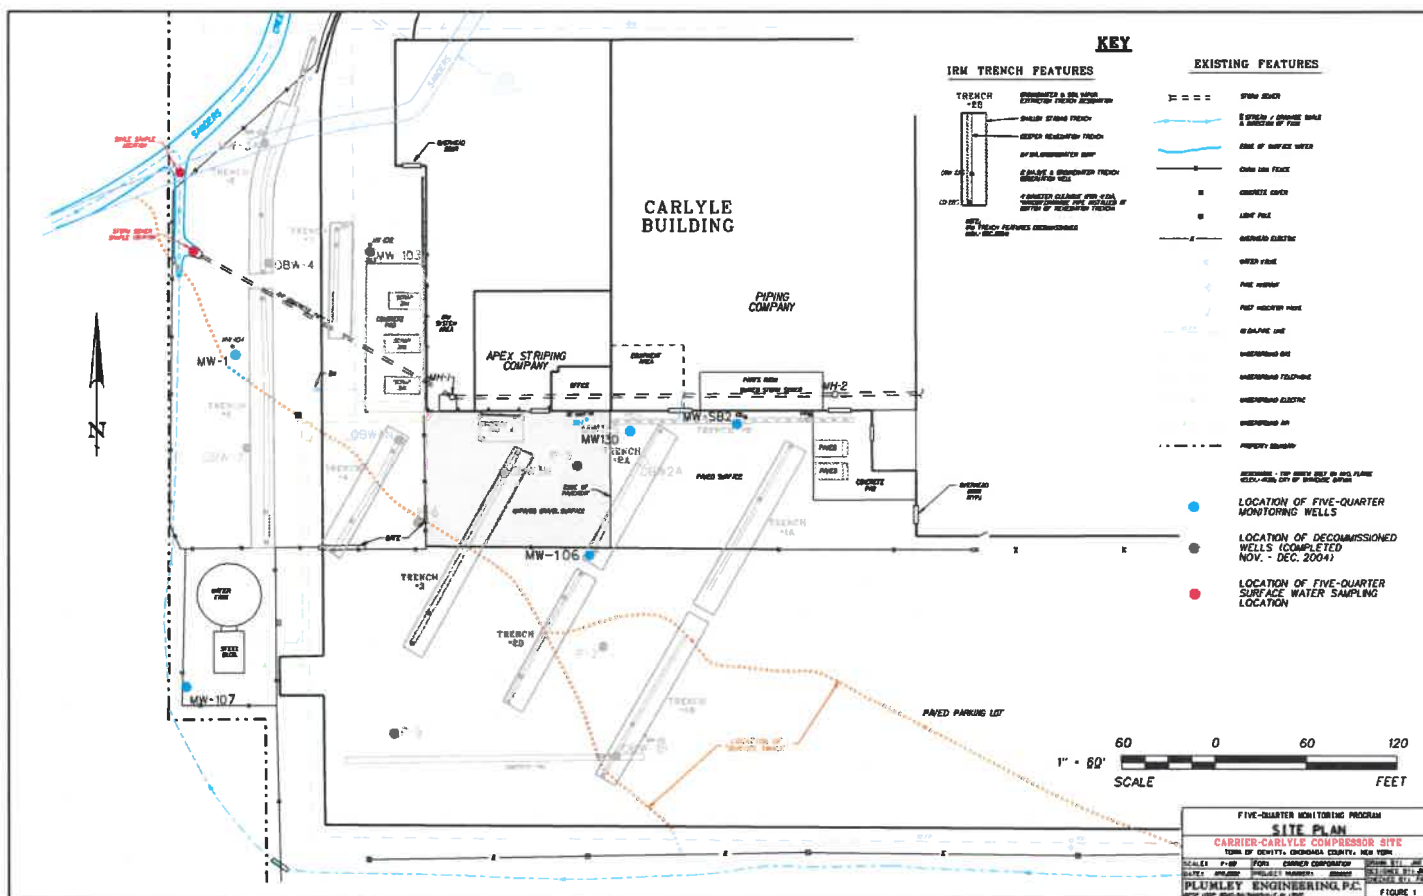
**Figure 1**  
**Site Plan**

The media sampling and analysis program includes sampling groundwater from five monitoring wells and collecting two surface water samples associated with the drainage swale and storm sewer outfall (Figure 1). The latest sampling event was completed on September 27, 2018 and included:
