TIOGA CASTING FACILITY, 754012 Monitoring Well Inventory, 04/01/2009

Photos with Notes

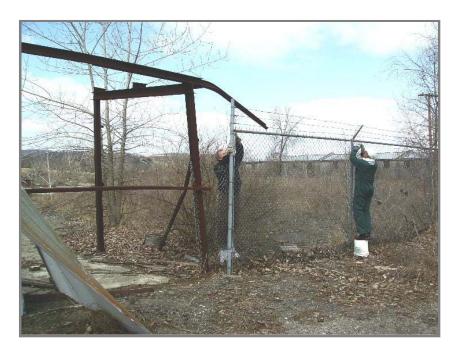
We snipped aluminum fasteners, un-bolted clamps and cut the fence fabric where we had to. Will Welling had brought a bolt cutter which was perfect for the job. Using a generator we ran a recipricating saw to cut brush and trees up to five inches in diameter. A chain saw might have been better for the large trees but the electric saw worked out well.

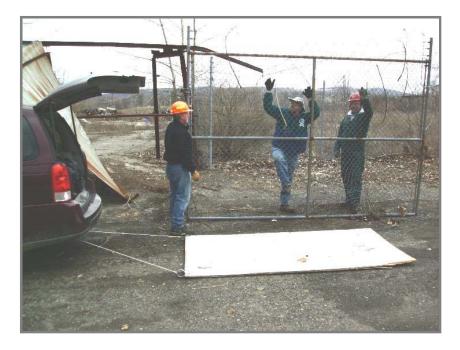
The gates were cumbersome. We dragged the rolled up fence fabric on an improvised sled made of the deteriorated construction sign.

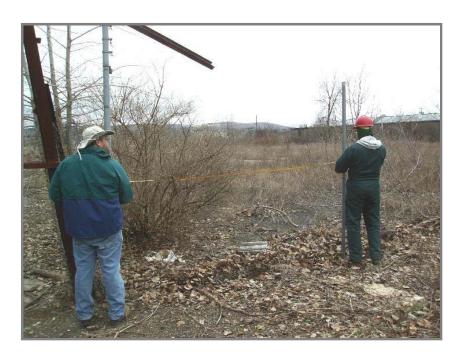
Payson (left) and carl (right) measure the distance between fence poles. They counted fence poles and calculated that we left 900 feet of fence to be removed by a call-out contractor.

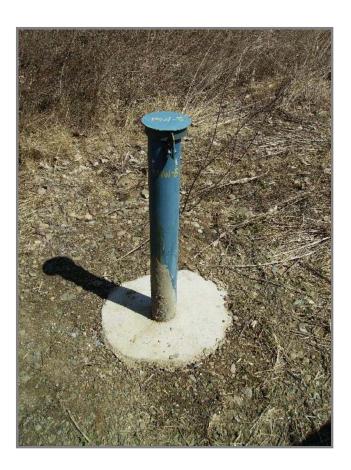
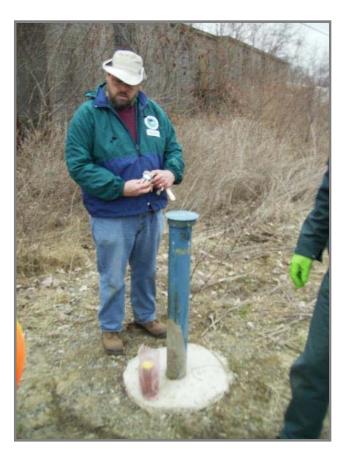
MW-8	
NYTM-X:	NYTM-Y:
395045	4662277

Over-the-head shot of Will and Payson at MW-4.

At MW-8. Drizzle was falling.

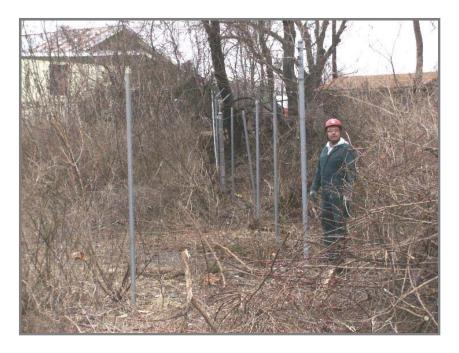
Telephoto shot of Carl standing among the fence poles. The village agreed to pull the poles and take away the fence parts.

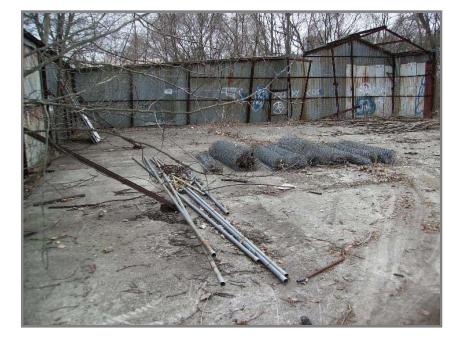
Staged metal fence. "Suck my COC" is written on the back fence. "COC" of course means "certificate of completion."

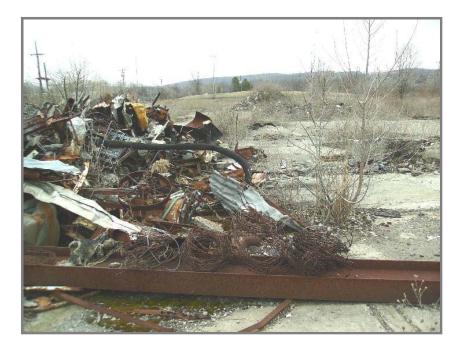
We placed the coiled barbed wire on the metals pile back inside the central area.

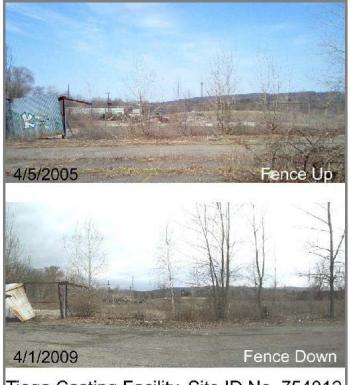
Fence is gone in the lower image. In three years there was quite a lot of tree growth.
