Tioga Castings Site Quarterly Report Third Quarter 2015

NYSDEC Site Number 7-54-012

January 2016

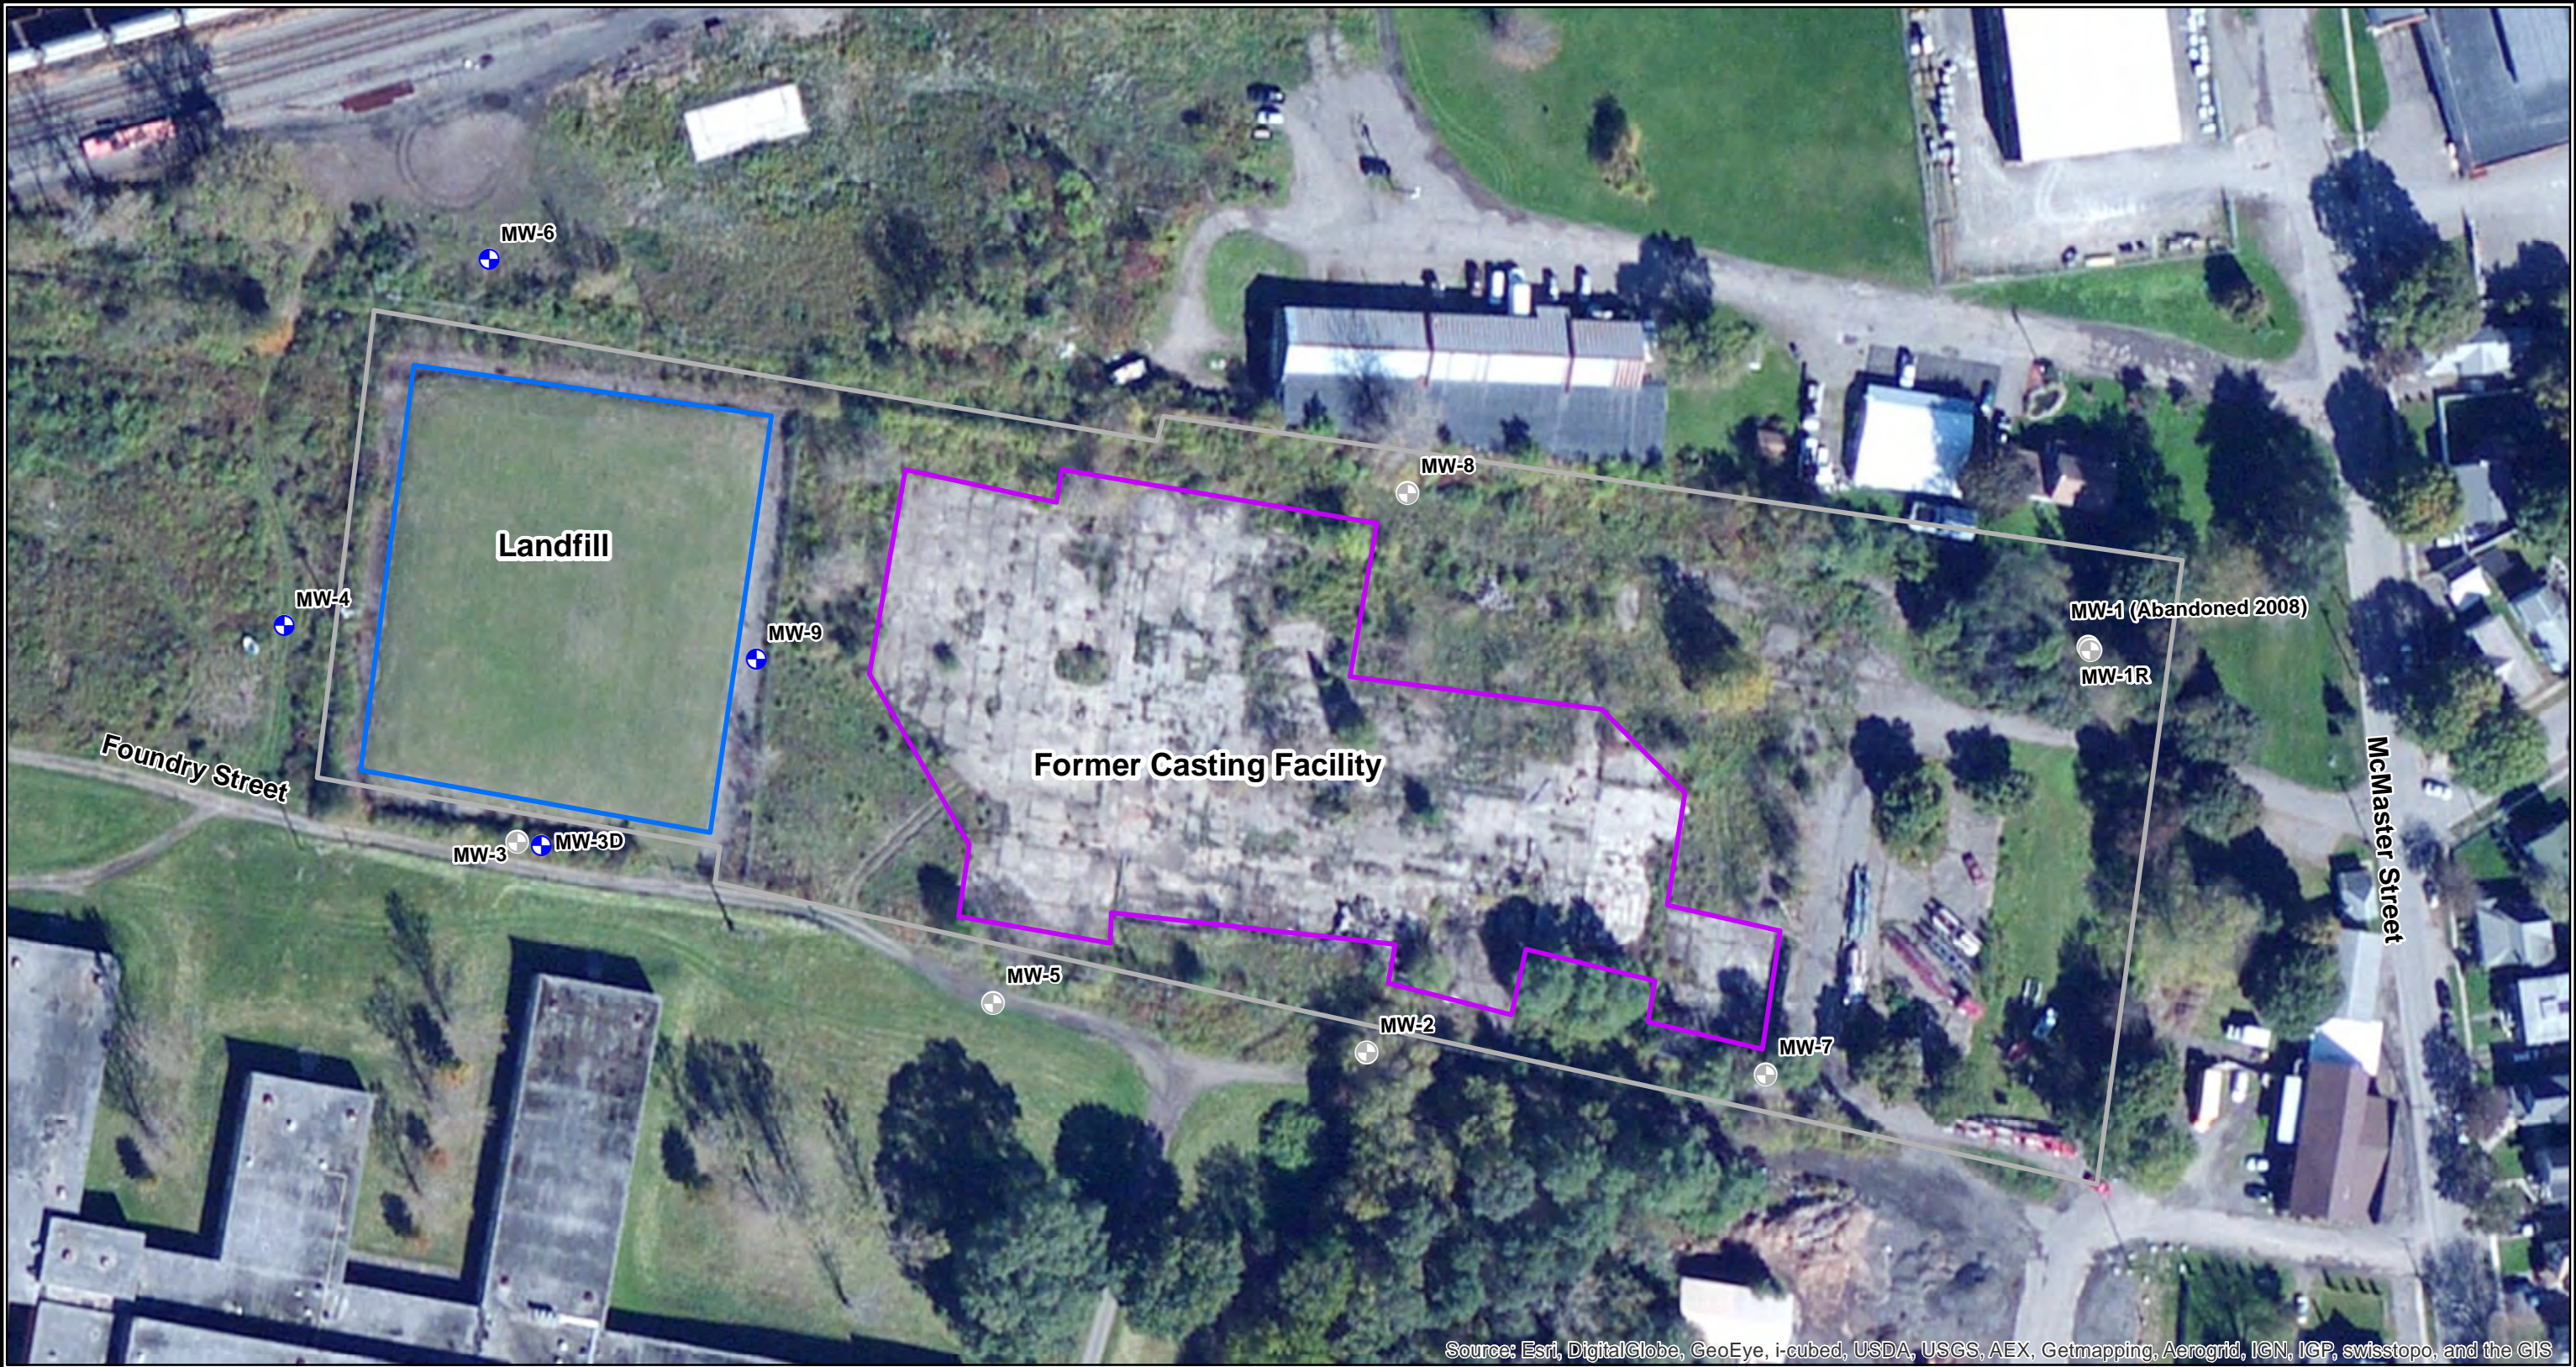
FIGURE
2-2

The Tioga Castings site is located on Foundry Street, Owego, Broome County, New York (Figure 2-1). The site currently consists of an approximately one acre capped, closed landfill. In August 2011, the boundaries of the site (originally encompassing approximately seven acres) were reduced by the NYSDEC to only include the landfill (Figure 2-2).
