Re: Former Jarl Extrusions Site 2020 Periodic Progress Report Site No. 828-005 Pittsford, NY

> Periodic Progress Report Former Jarl Extrusions Site Site No. 828-005 Pittsford, NY File: 784/29706 #2

Asphalt Cover Inspection Photo Log

FORMER JARL EXTRUSIONS SITE

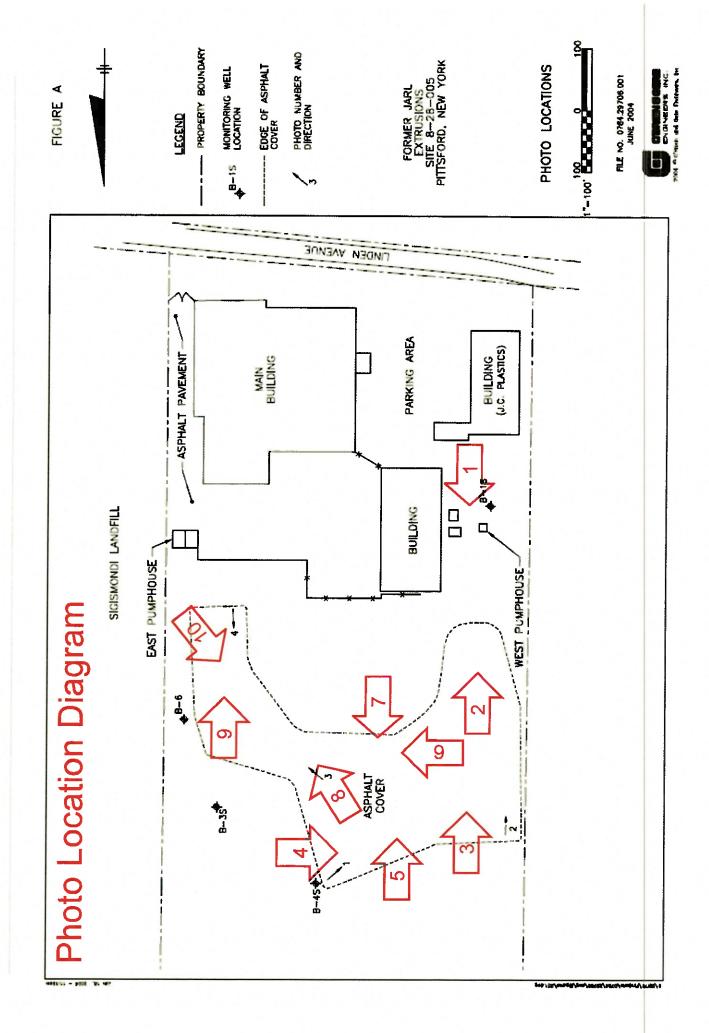
Photo 10: Some surficial cracking observed along pass lines

III. Conclusions and Recommendations – The asphalt cap appears to be performing as intended. Recommendations are to repair surficial cracks and areas of settling and to continue inspections on a biannual basis.
