02-8710-102-PA  
REV. NO. 0

PRELIMINARY ASSESSMENT  
TAYLOR INSTRUMENT/DIVISION OF SYBRON

MARCH 11, 1988

NUS CORPORATION  
SUPERFUND DIVISION

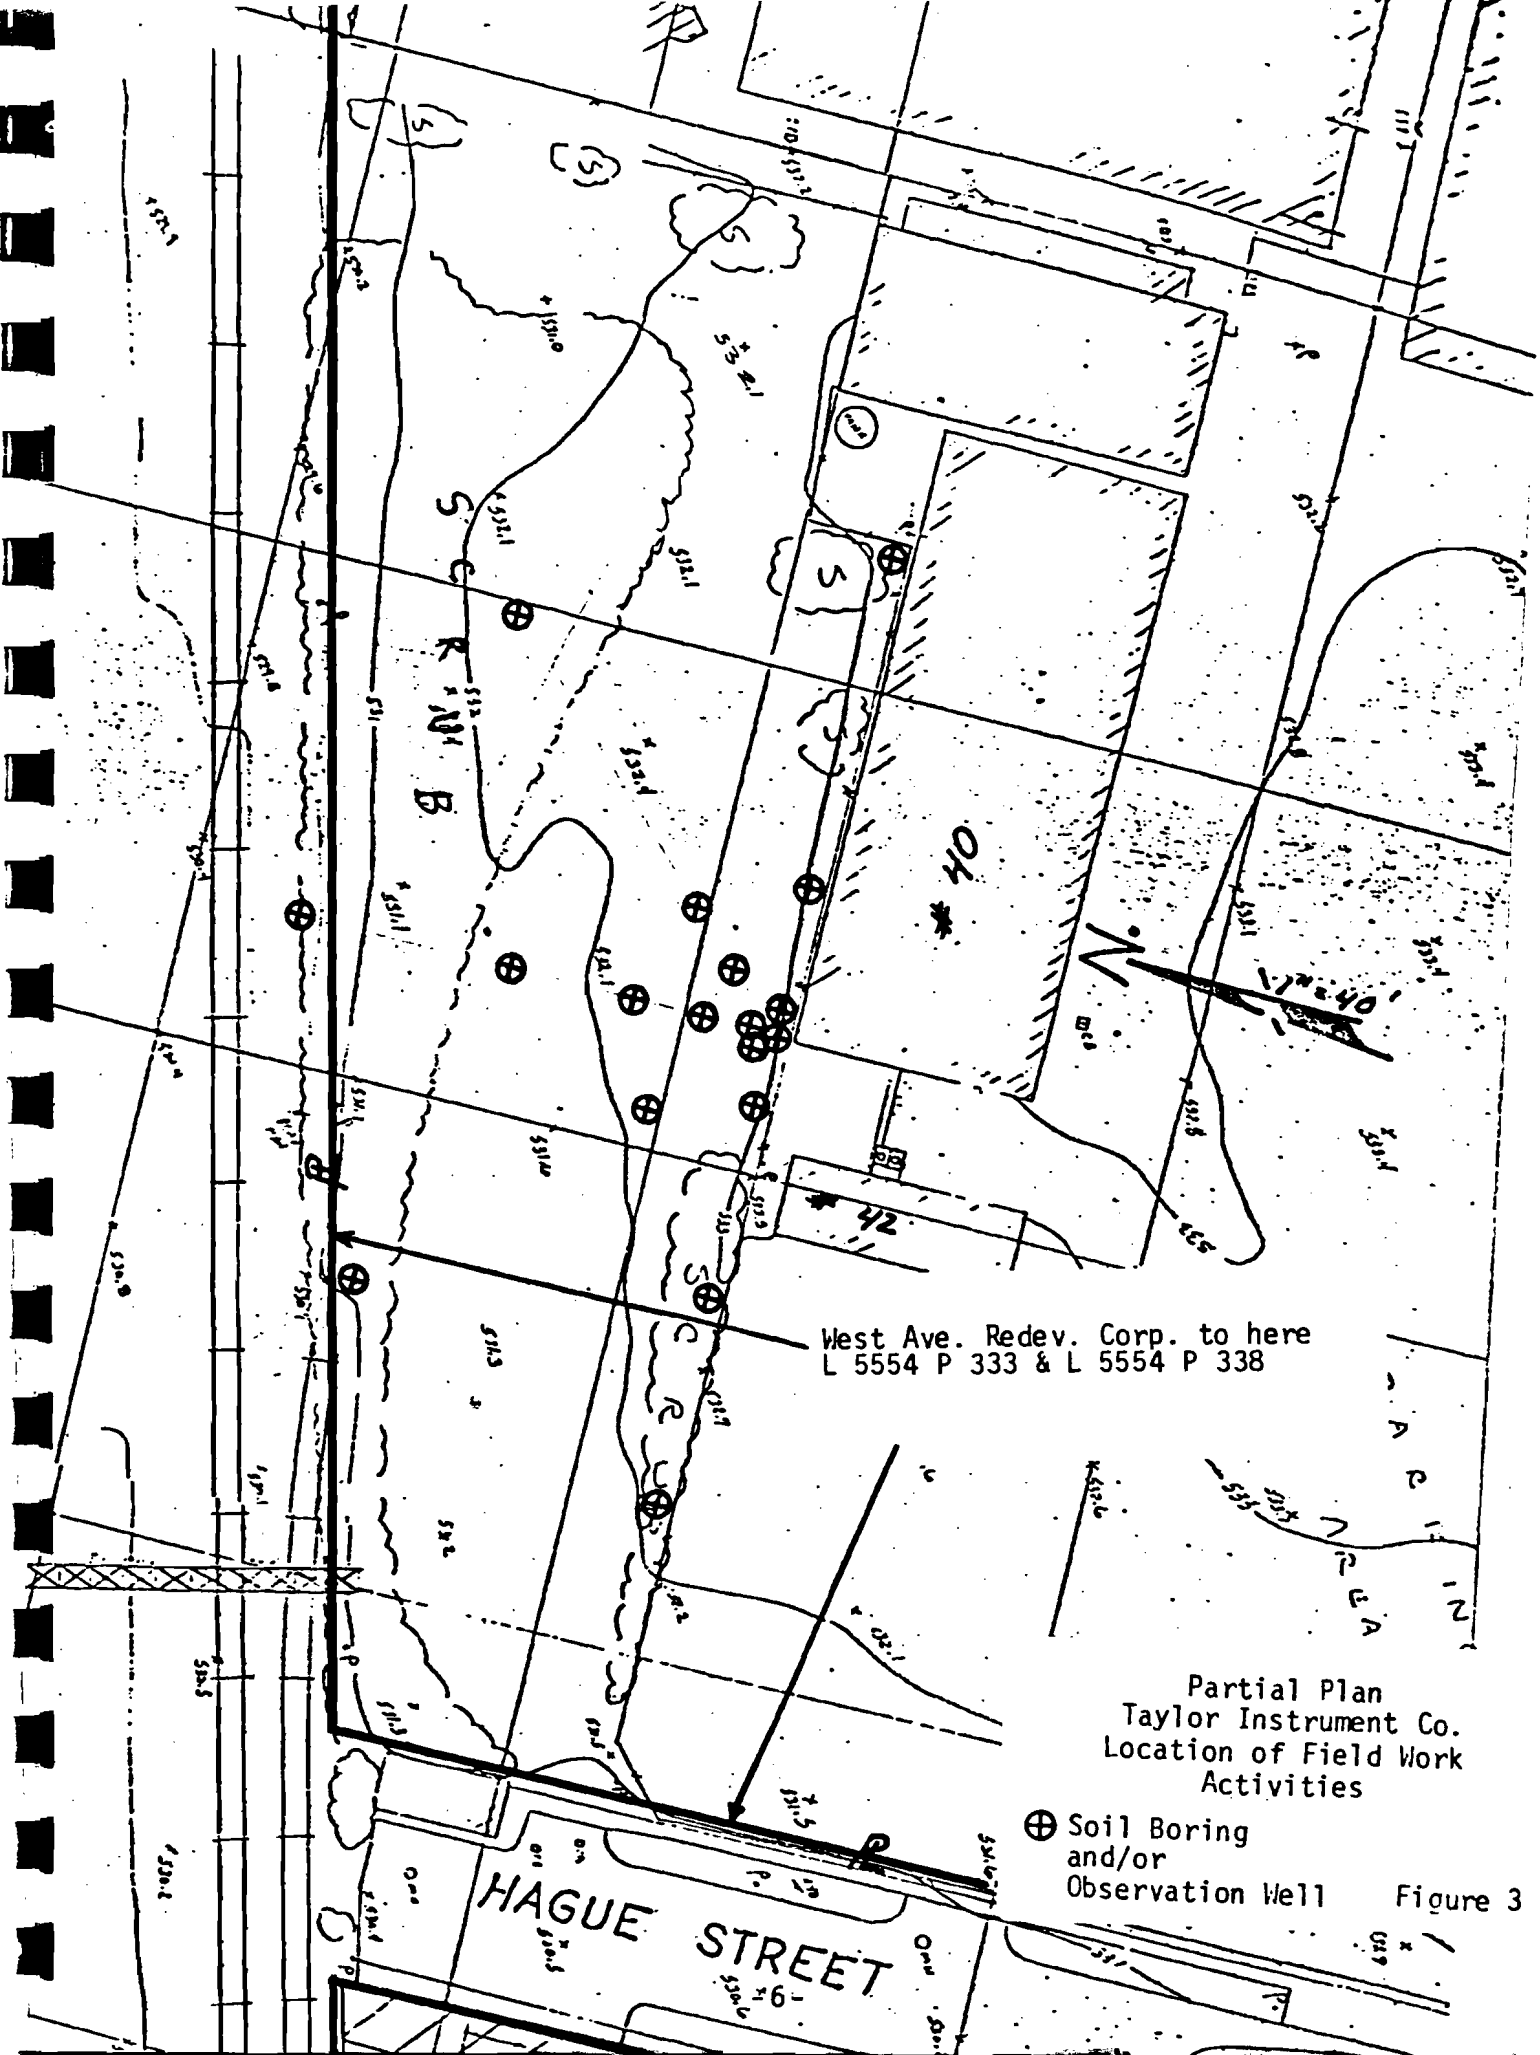
Figure 3

Empire Soils was contracted by Lozier, Inc. to do the field work at the Taylor Instrument site. This field work consisted of boring seventeen (17) holes. Soil samples were withdrawn from sixteen (16) of these holes along the guidelines of the initial proposal and four (4) groundwater observation wells were installed, three (3) of which were in holes from which soil samples were withdrawn. A more representative illustration of the expanse of the field investigations at the subject site can be found on Figures 2 & 3. The actual contract with Empire Soils, Inc. was signed on October 13, 1981 and the initial projection for the start of field work was Thursday, October 15, 1981. Available on-site power difficulties and some equipment difficulties impeded the actual start of the field work, and consequently no significant work began at the Taylor Instrument site until Monday, October 19, 1981. All positions at which Empire Soils conducted drilling work were staked by Lozier, Inc. personnel in the field on October 12, 1981. These positions were laid out logarithmically per the guidelines of the initial proposal and ground elevations were shot at each position where Empire Soils was to perform drilling work. All drilling, soil sample withdrawal and groundwater well installation work was finished by Empire Soils late in the afternoon on Tuesday, October 20, 1981. The drilling logs from the field work performed by Empire Soils can be found in Appendix A. All the soil samples withdrawn from the four (4) different elevations in each of the boring holes were split in the field at the time of withdrawal. Every split soil sample received by Taylor Instrument and Lozier/Camo consisted of

Partial Plan  
Taylor Instrument Co.  
Location of Field Work  
Activities

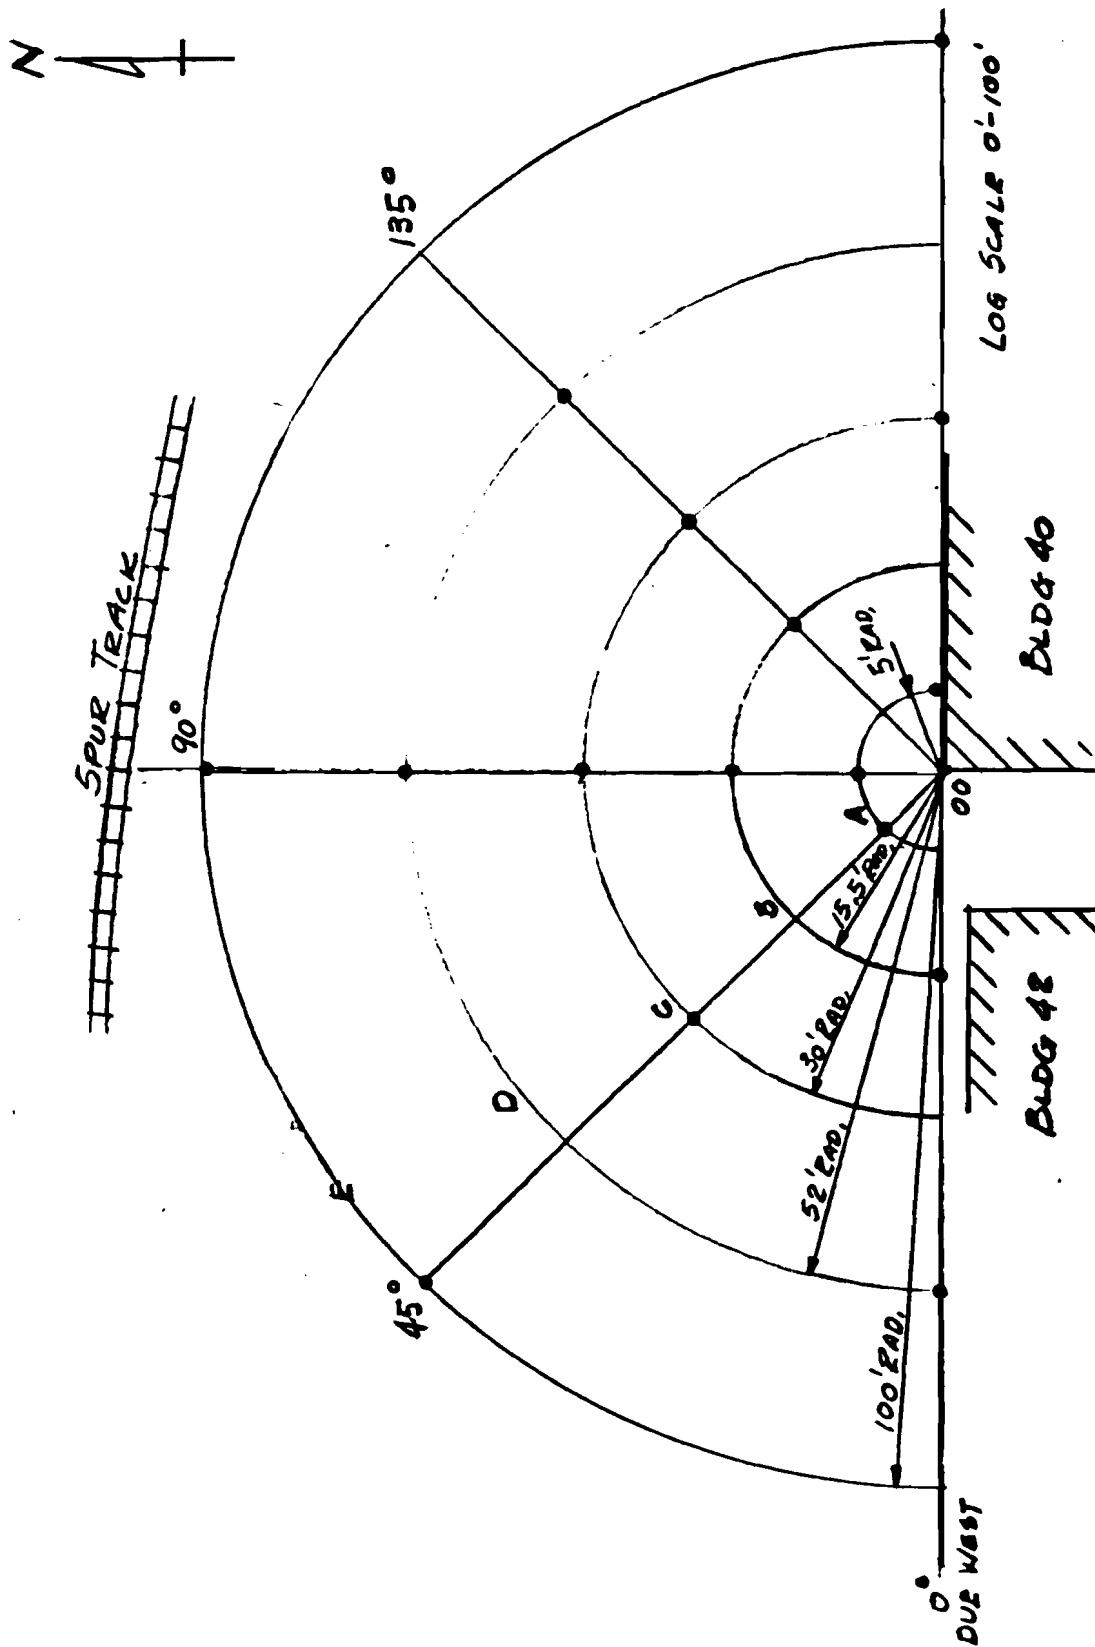
TAYLOR INSTRUMENT CO.  
SAMPLING GRID PATTERN  
FIGURE #2
