MONROE COUNTY  
DEPARTMENT OF HEALTH

Re: Identification and Testing of Chemical Dump Sites

## THE LOWER FALLS

Several chemical seeps have been discharging from the Lower Falls of the Genesee River since the early 1970's. This paper discusses the problem, recent findings, and makes recommendations.

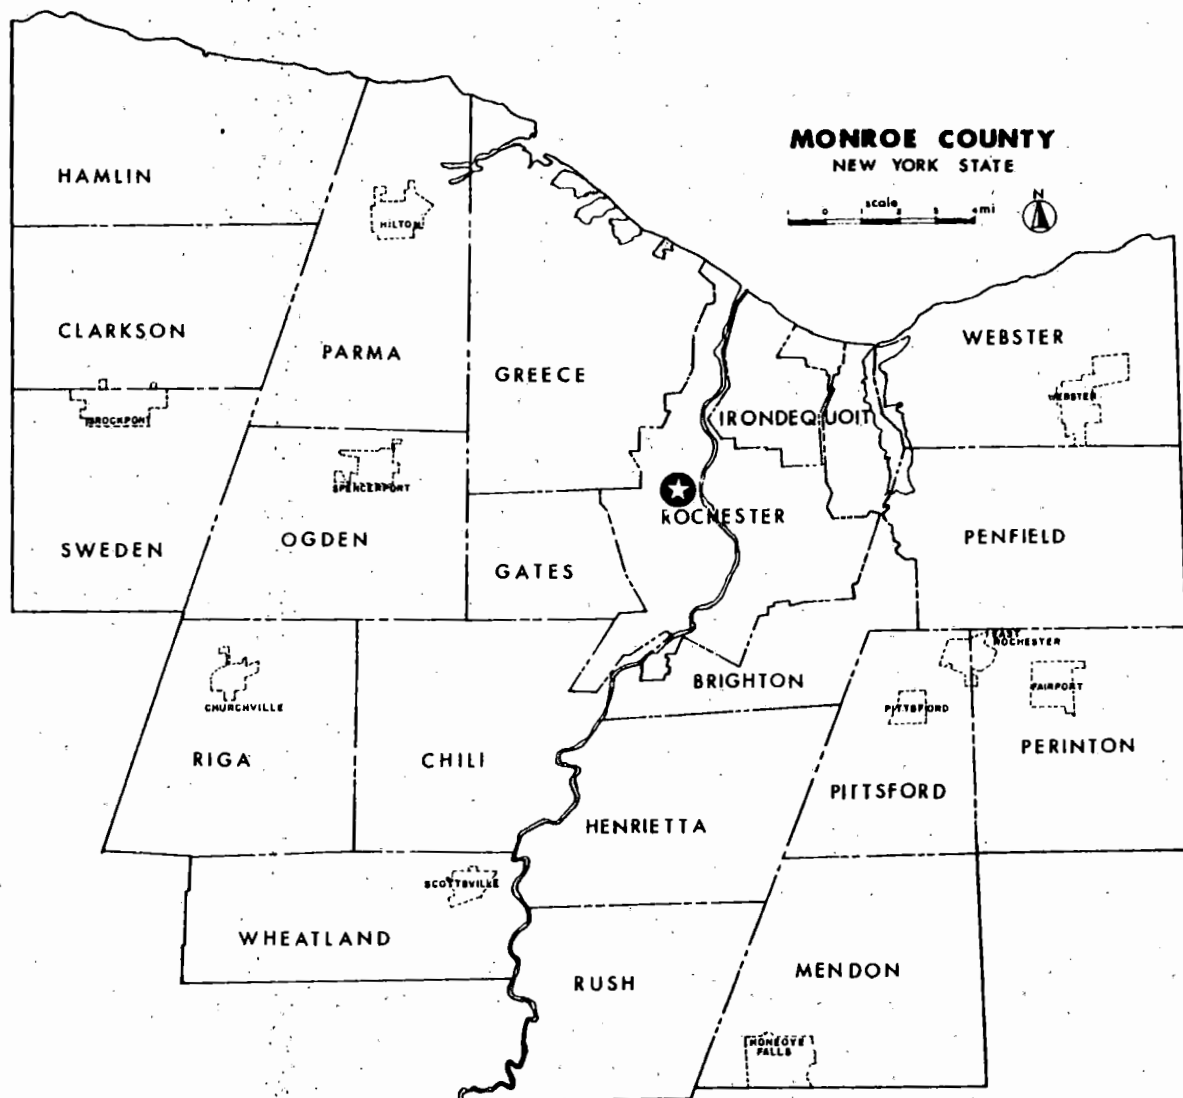
FIGURE 1

★  
Location of Lower Falls  
City of Rochester - Site No. 14

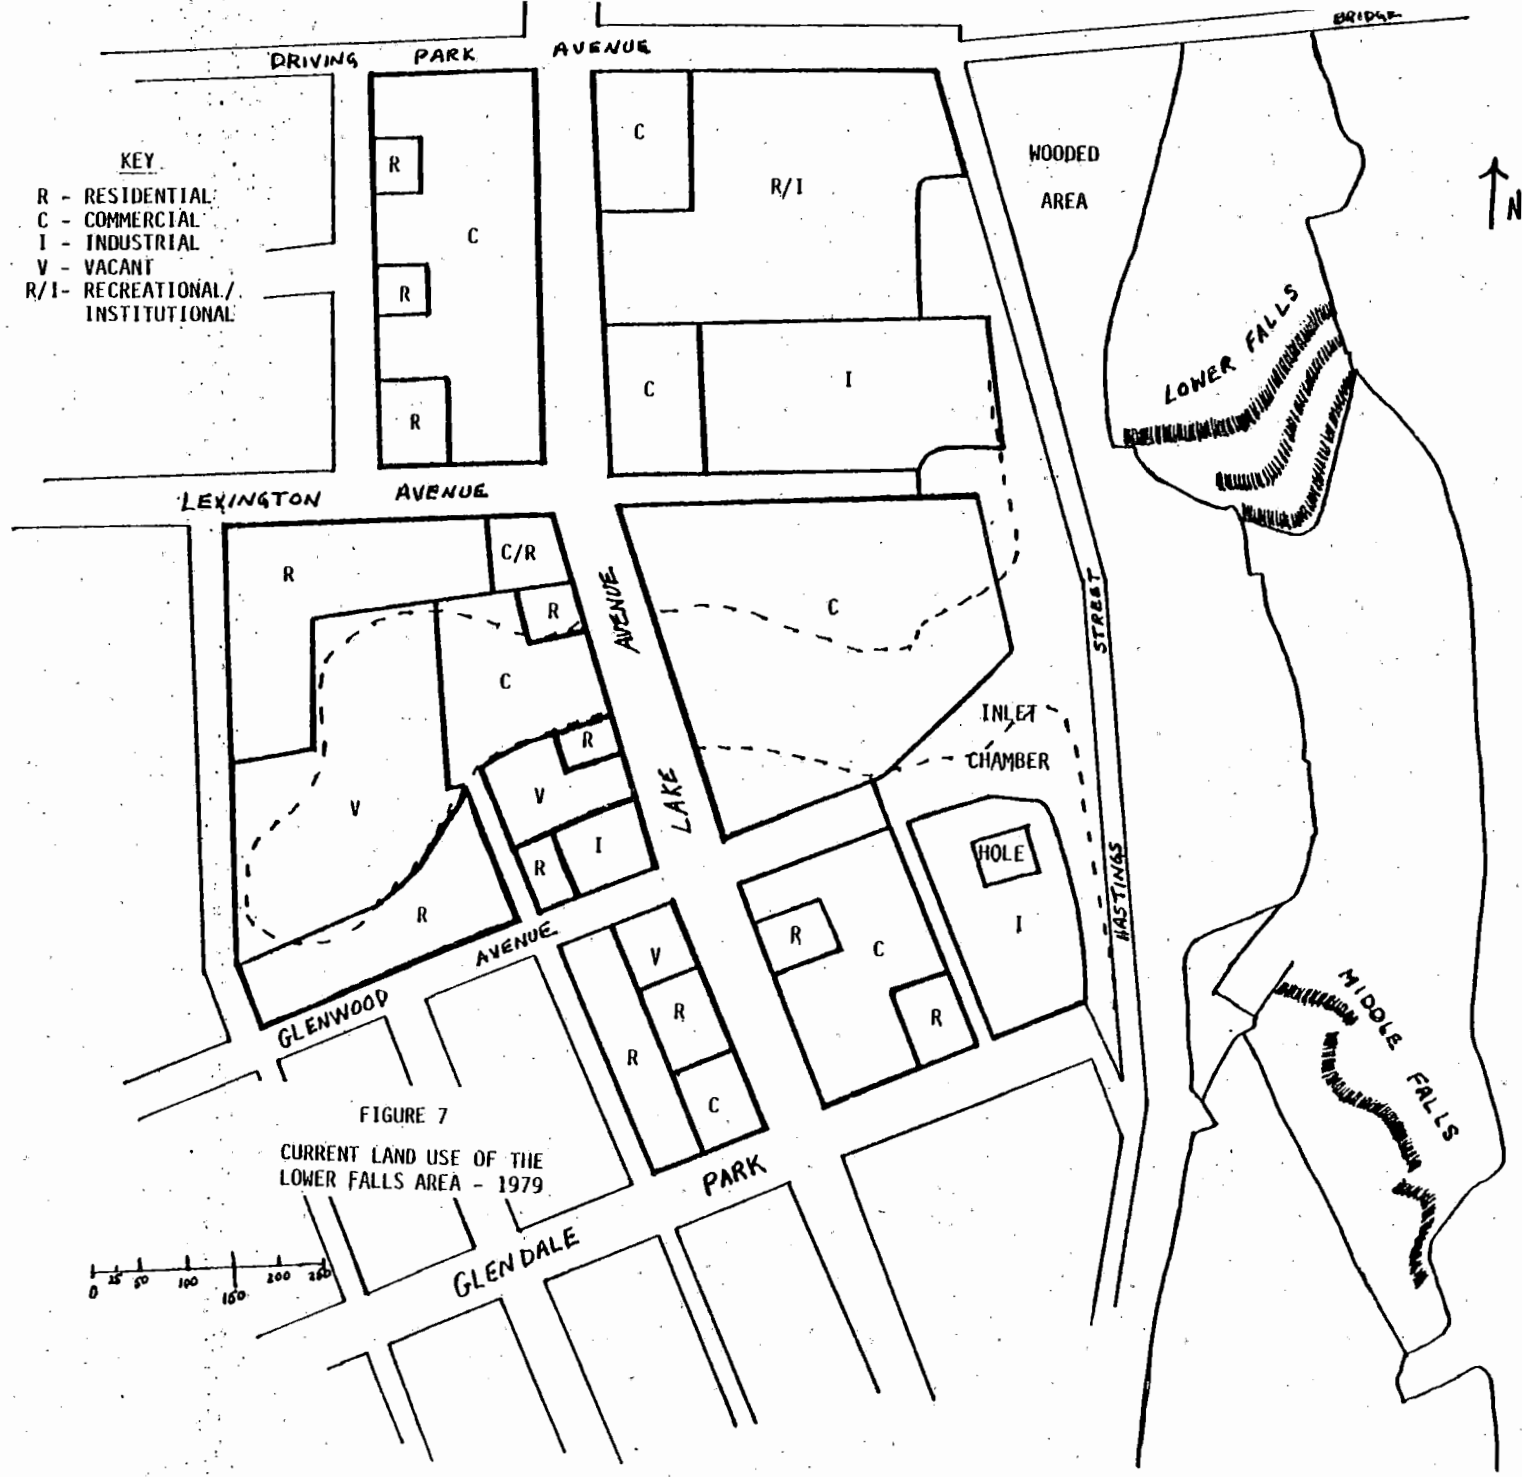
FIGURE 7  
CURRENT LAND USE OF THE  
LOWER FALLS AREA - 1979

Figure 7 indicates present land use of the area. Residential and commercial structures do not appear to be affected by any potential leachate from the dumping area since subsurface movement is toward the river and substantially below any dwelling (Appendix B). Homes in the area are on public water; therefore well contamination is not a consideration.

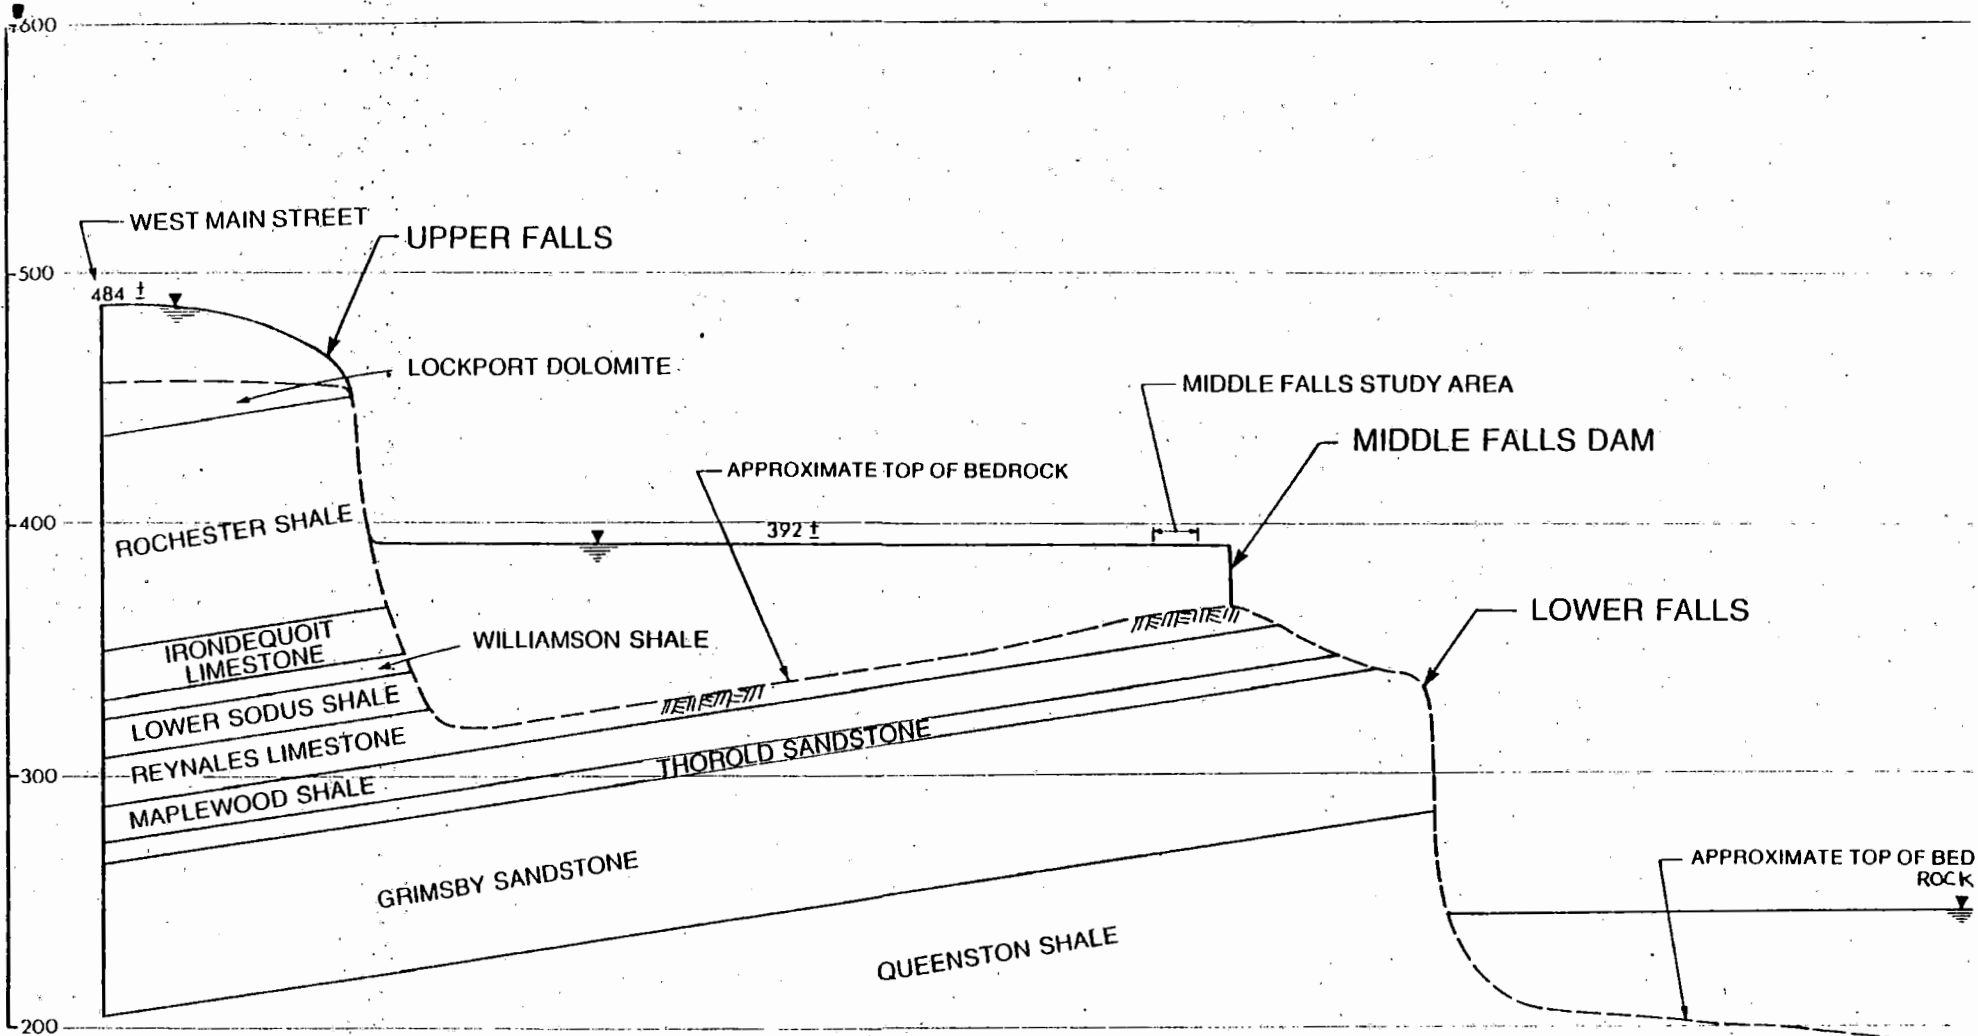
From: Pure Waters  
Wastewater Facilities Plan  
Volume V, Figure 12. 1976

The eroding face of the falls is somewhat irregular and sloping as indicated in the engineering profile accompanying this report (from Rochester Pure Waters, Wastewater Facilities Plan, Vol. V, Fig. 12, 1976). The sloping face of the top of the falls and the chemical seeps of current interest appear to be located near the middle part of the Grimsby Formation (formerly the Medina). This rock formation in the gorge consists of 55 feet of sandstone, shales, and siltstones. The upper 15 feet and lower 20 feet contain coarser, more thickly bedded sandstones with minor shale, whereas the middle 20 feet contain thinner sandy units with more prominent red to greenish shales.
