**2021 Annual Corrective Measures
Implementation Summary Report
Eastman Business Park
Rochester, New York
Site No. 828177**

December 2023

**ECOLOGY AND ENVIRONMENT ENGINEERING AND GEOLOGY, P.C.
40 La Riviere Drive, Suite 320
Buffalo, NY 14202**

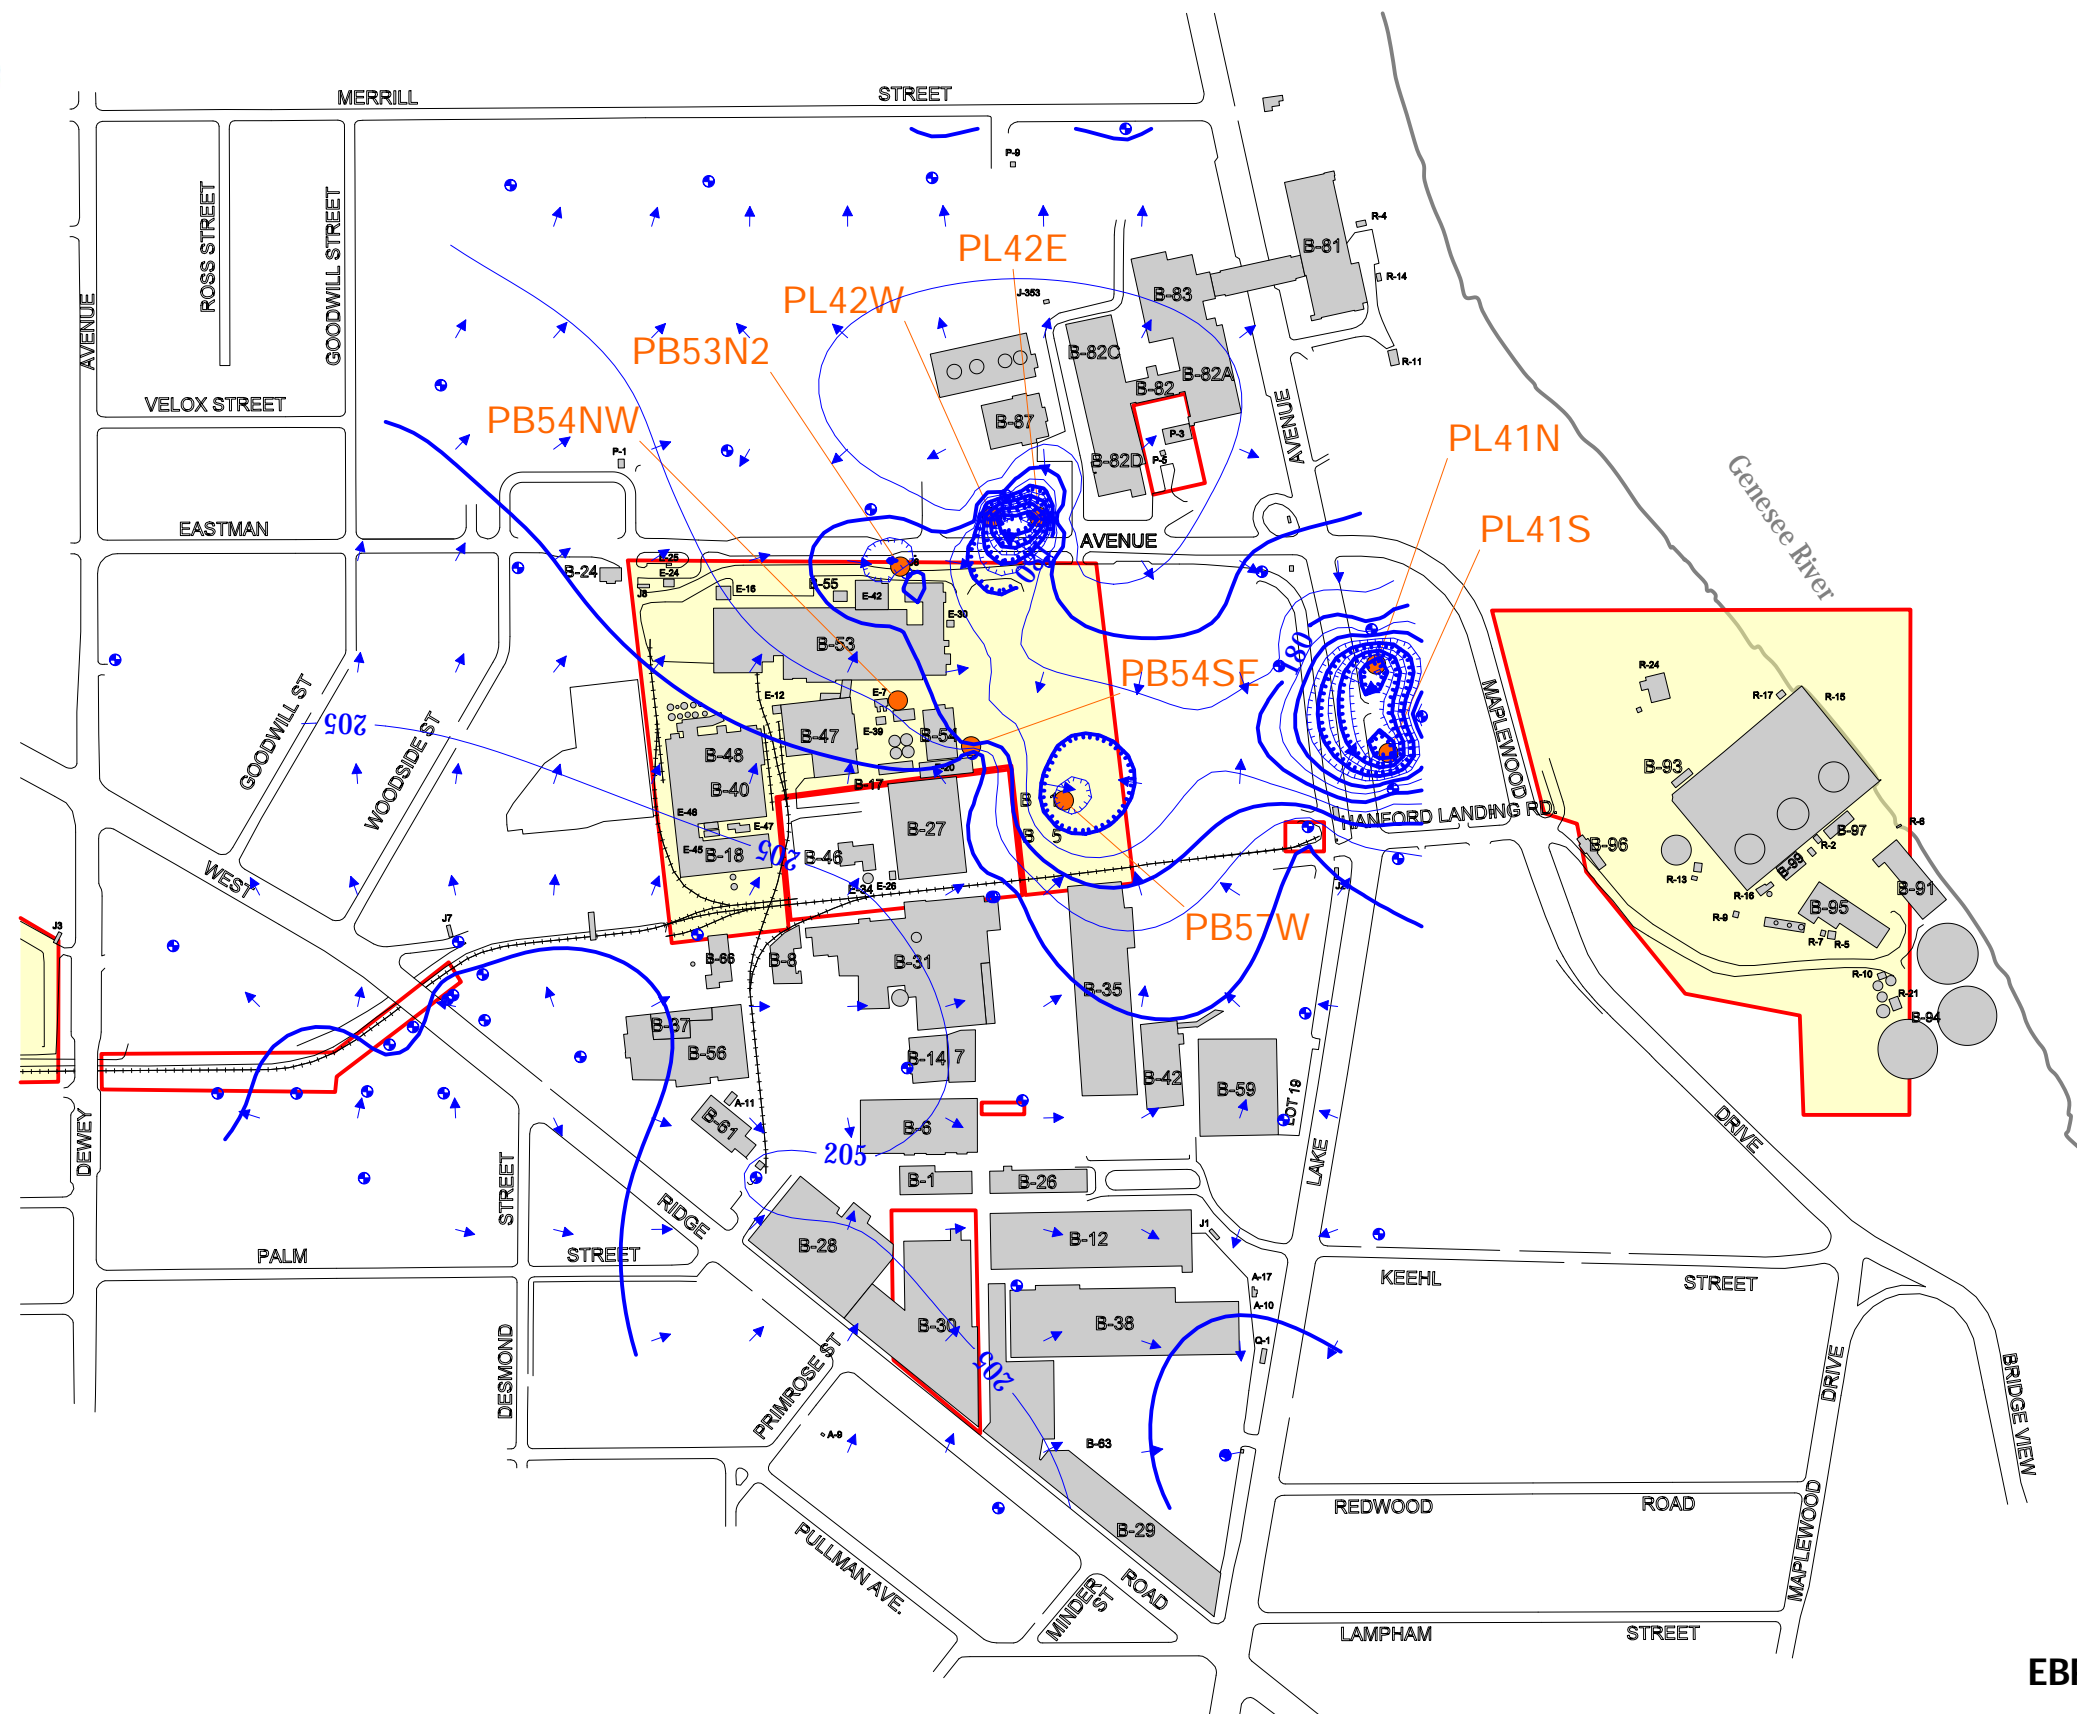
Figure 3
EBP-E 2021 Top of Rock Groundwater
Potentiometric Surface
Eastman Business Park
Rochester, New York

the system is illustrated for the TOR and GQ surfaces in Figures 3 and 4 by the depressions in the contour lines. Within the areas of influence, groundwater flows toward the four pumping wells within the system.

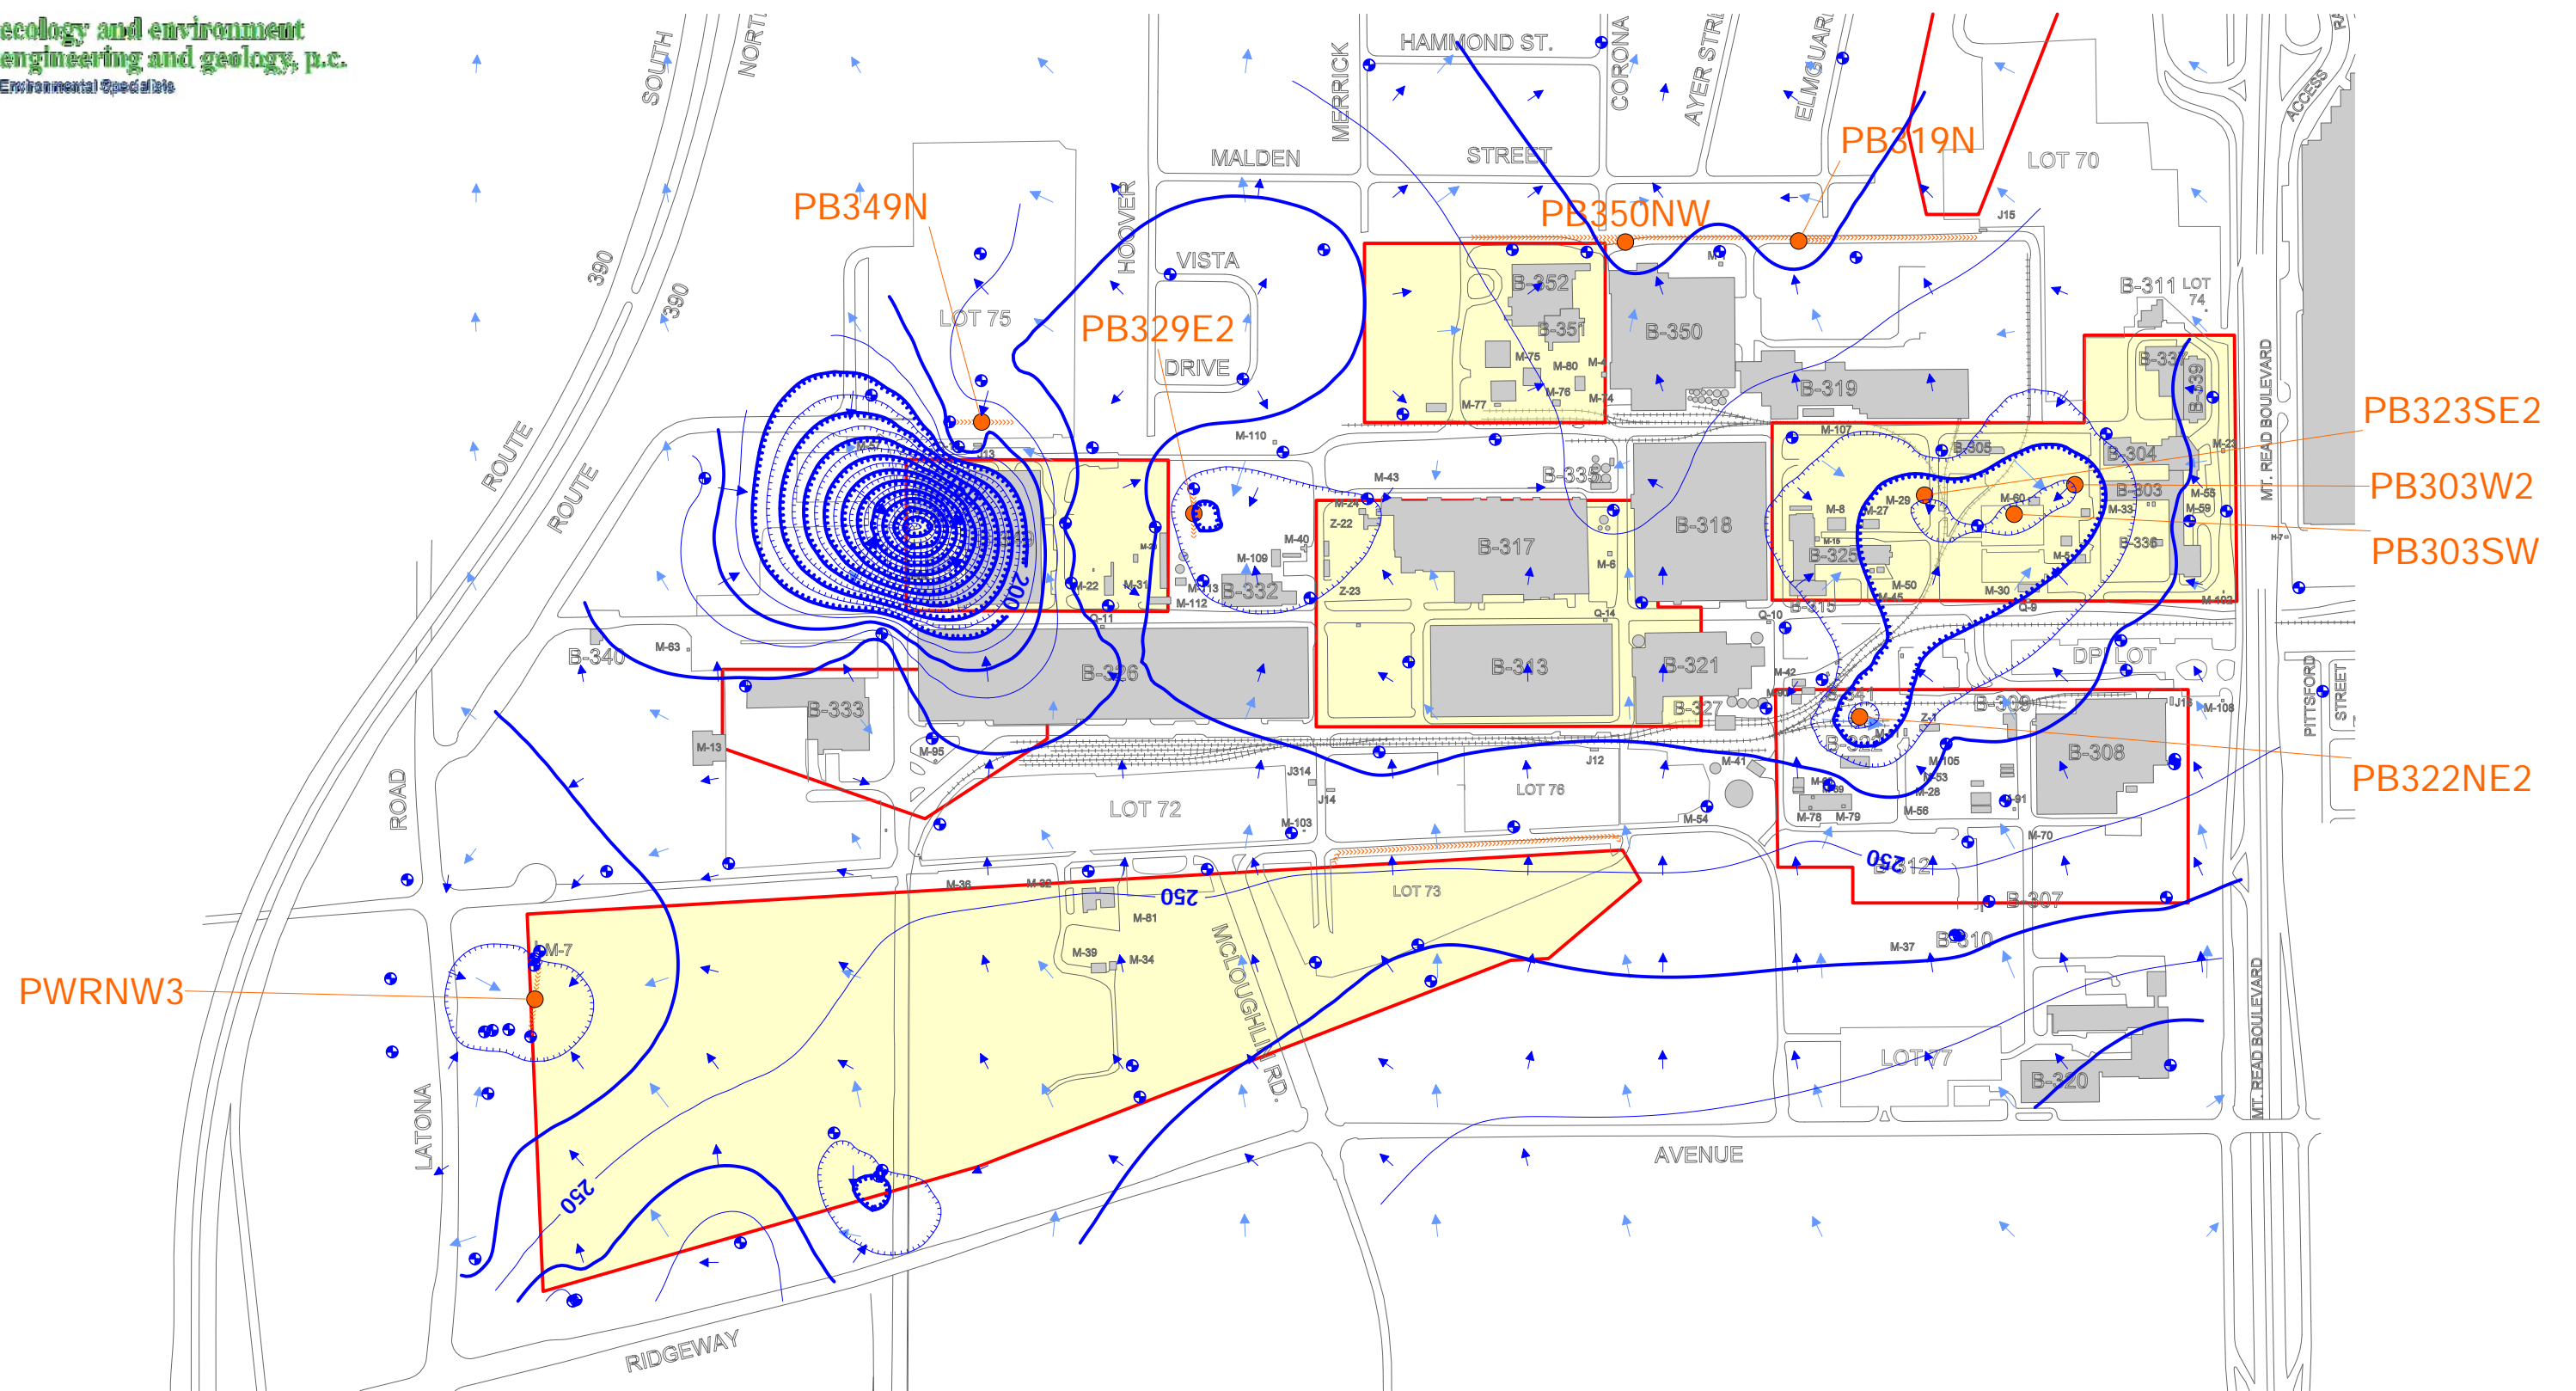
Figure 6
EBP-M 2021 Top of Rock Groundwater
Potentiometric Surface
Eastman Business Park
Rochester, New York

Contours of the overburden, TOR, and GQ groundwater potentiometric surfaces in EBP-M area are presented in Figures 5 through 7. The effect of the Building 329/349 Area Remediation System within the TOR surface is illustrated by the depressions in the contour lines on Figure 6, with groundwater flowing toward the trenches/pumping wells within the system. The system does not appear to have any hydraulic influence within the GQ zone.

Contours of the overburden, TOR, and GQ groundwater potentiometric surfaces in EBP-M area are presented in Figures 5 through 7. The effects of the NEBP-M MCS in the overburden and the TOR surfaces are illustrated by the depressions in the contour lines in Figures 5 and 6. Within the overburden and TOR areas of influence, groundwater flows towards the trench and three pumping wells within the system.

Contours of the overburden, TOR, and GQ groundwater potentiometric surfaces in EBP-M area are presented in Figures 5 through 7. The effects of the MIA-301 Groundwater Remediation System in the overburden and the TOR surfaces are illustrated by depressions in the contour lines on Figures 5 and 6, with groundwater flowing toward the three pumping wells within the system. The system has no influence or hydraulic capture within the GQ zone.

Contours of the overburden, TOR, and GQ groundwater potentiometric surfaces in EBP-M are presented in Figures 5 through 7. The effect of the WRLF Remedial System is illustrated for the TOR zone in Figure 6, with groundwater flowing to the pumping well.

PB136S, as shown in Figure 9. Groundwater in the overburden flow zone is influenced by pumping wells PB307E2, PB307N3, PB322NE2, and PB322NE4, as shown in Figure 5. Groundwater in the TOR flow zone is also influenced by pumping well PB322NE2, as shown in Figure 6.

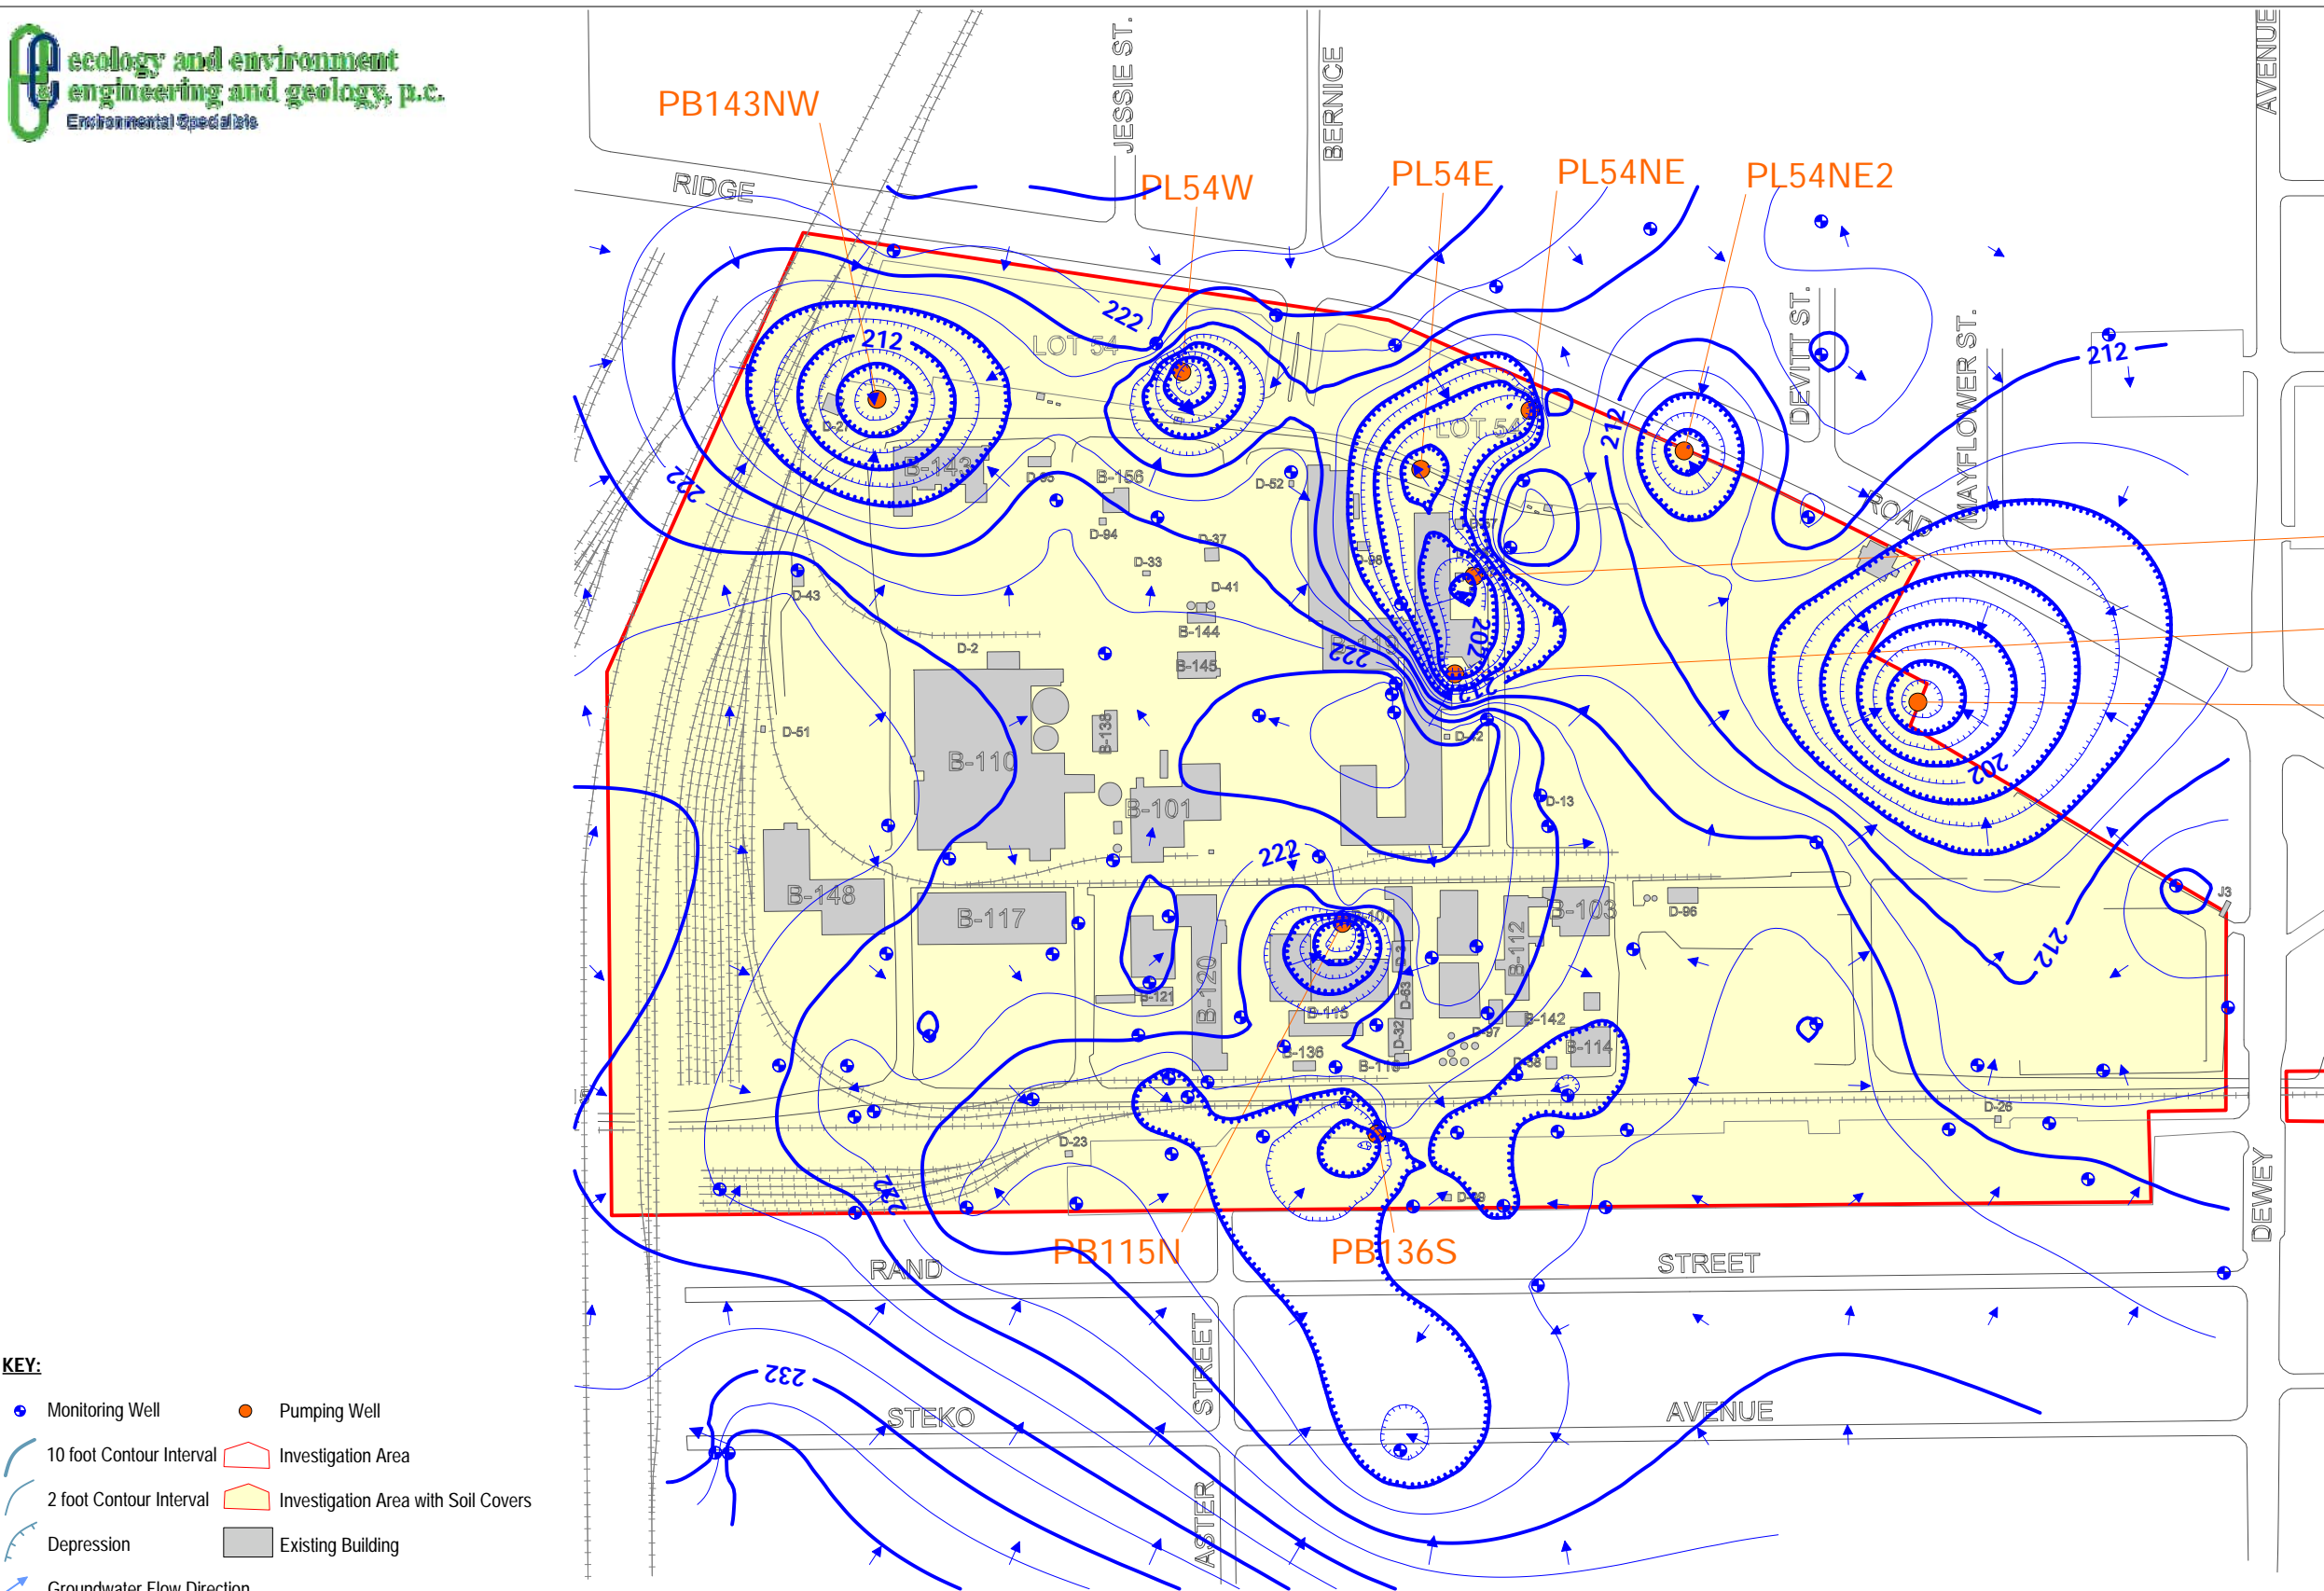
Figure 9
EBP-W 2021 Top of Rock Groundwater
Potentiometric Surface
Eastman Business Park
Rochester, New York

Contours of the overburden, TOR, and GQ groundwater potentiometric surfaces in EBP-E, EBP-M, and EBP-W areas are presented in Figures 2 through 10, respectively. These systems were not designed based on a hydraulic capture zone specification, although groundwater is influenced within the overburden, TOR, and GQ groundwater potentiometric surfaces. Groundwater in the TOR and GQ flow zones is influenced by pumping wells PB53N2, PB54SE, and PB57W, as shown in Figures 3 and 4; groundwater in the GQ flow zone is influenced by pumping well PB54NW, as shown in Figure 4. Groundwater in the overburden and TOR flow zones is influenced by pumping well PB115N, as shown in Figures 8 and 9. Groundwater in the TOR flow zone is influenced by pumping well

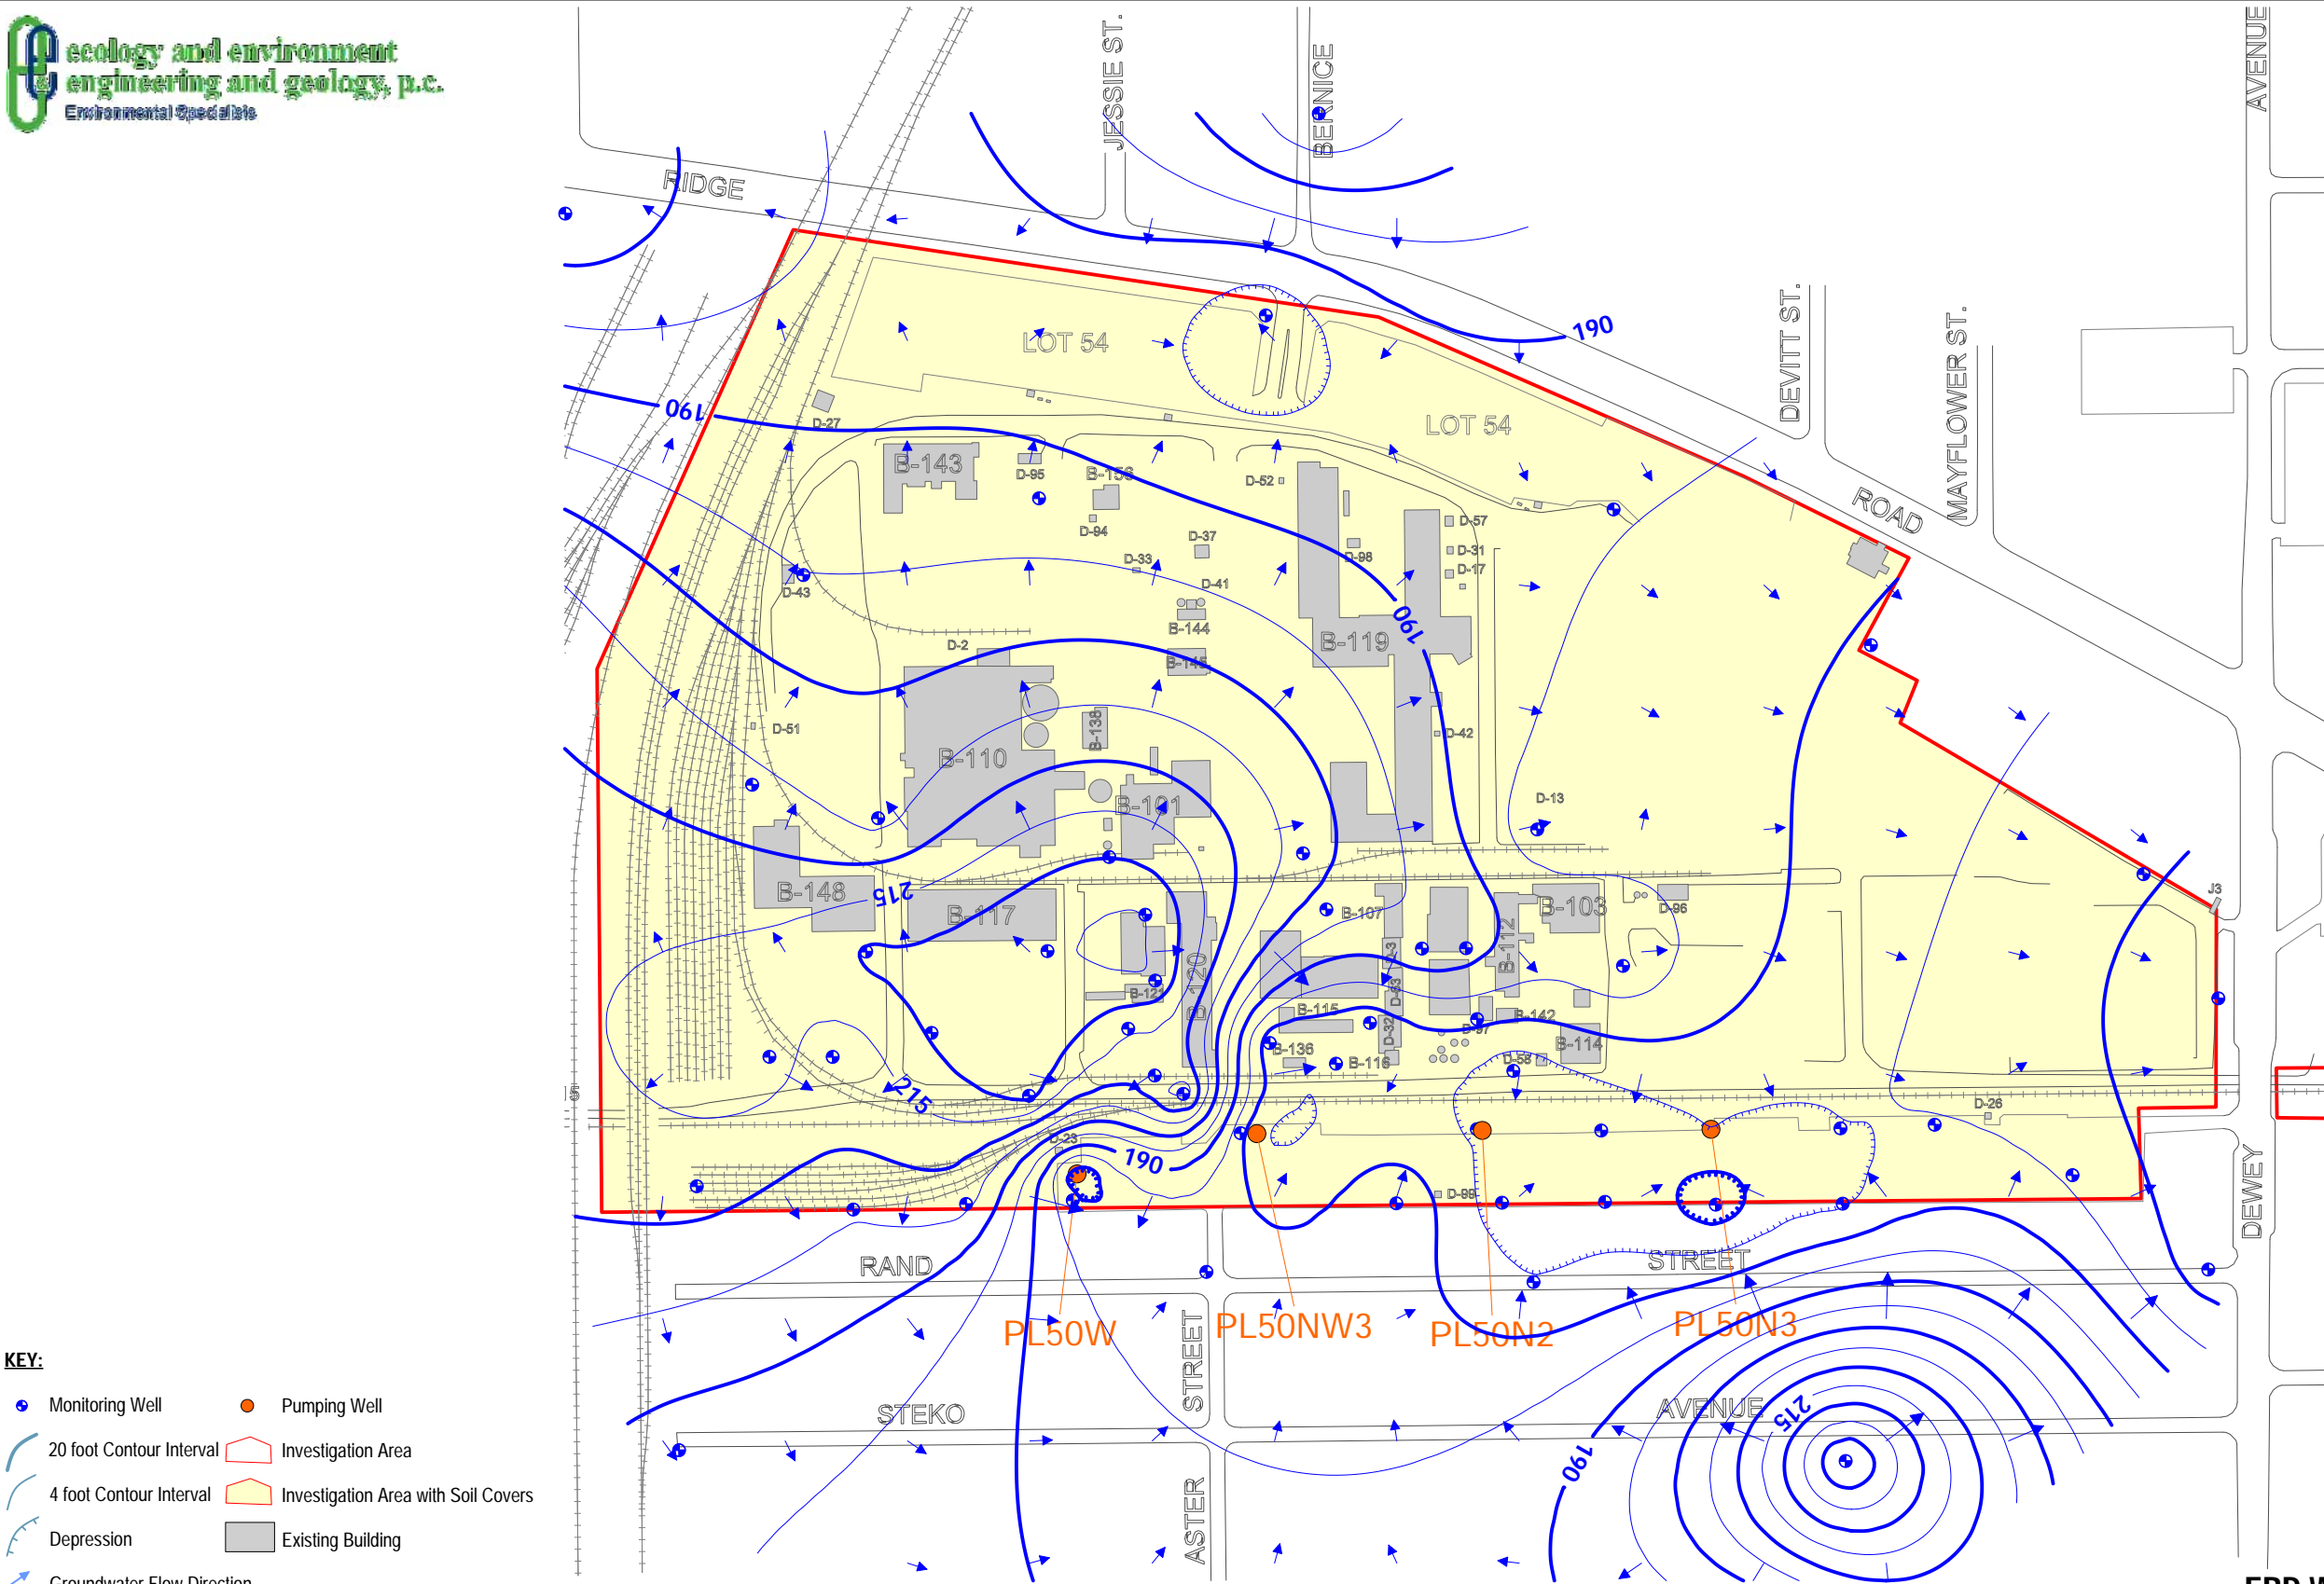
Figure 10
EBP-W 2021 Grimsby-Queenston Groundwater
Potentiometric Surface
Eastman Business Park
Rochester, New York

Contours of the overburden, TOR, and GQ groundwater potentiometric surfaces in EBP-W area are presented in Figures 8 through 10. The effect of the Lot 50 MCS within the GQ flow zone is illustrated in Figure 10 by the depressions in the contour lines. Within this area of influence, groundwater in the overburden, TOR, and GQ flows towards the wells within the Lot 50 MCS. The extent of capture in the GQ zone extends beyond the property boundary to the south, indicating that groundwater is pulled back to the site by this system (see Figure 10).

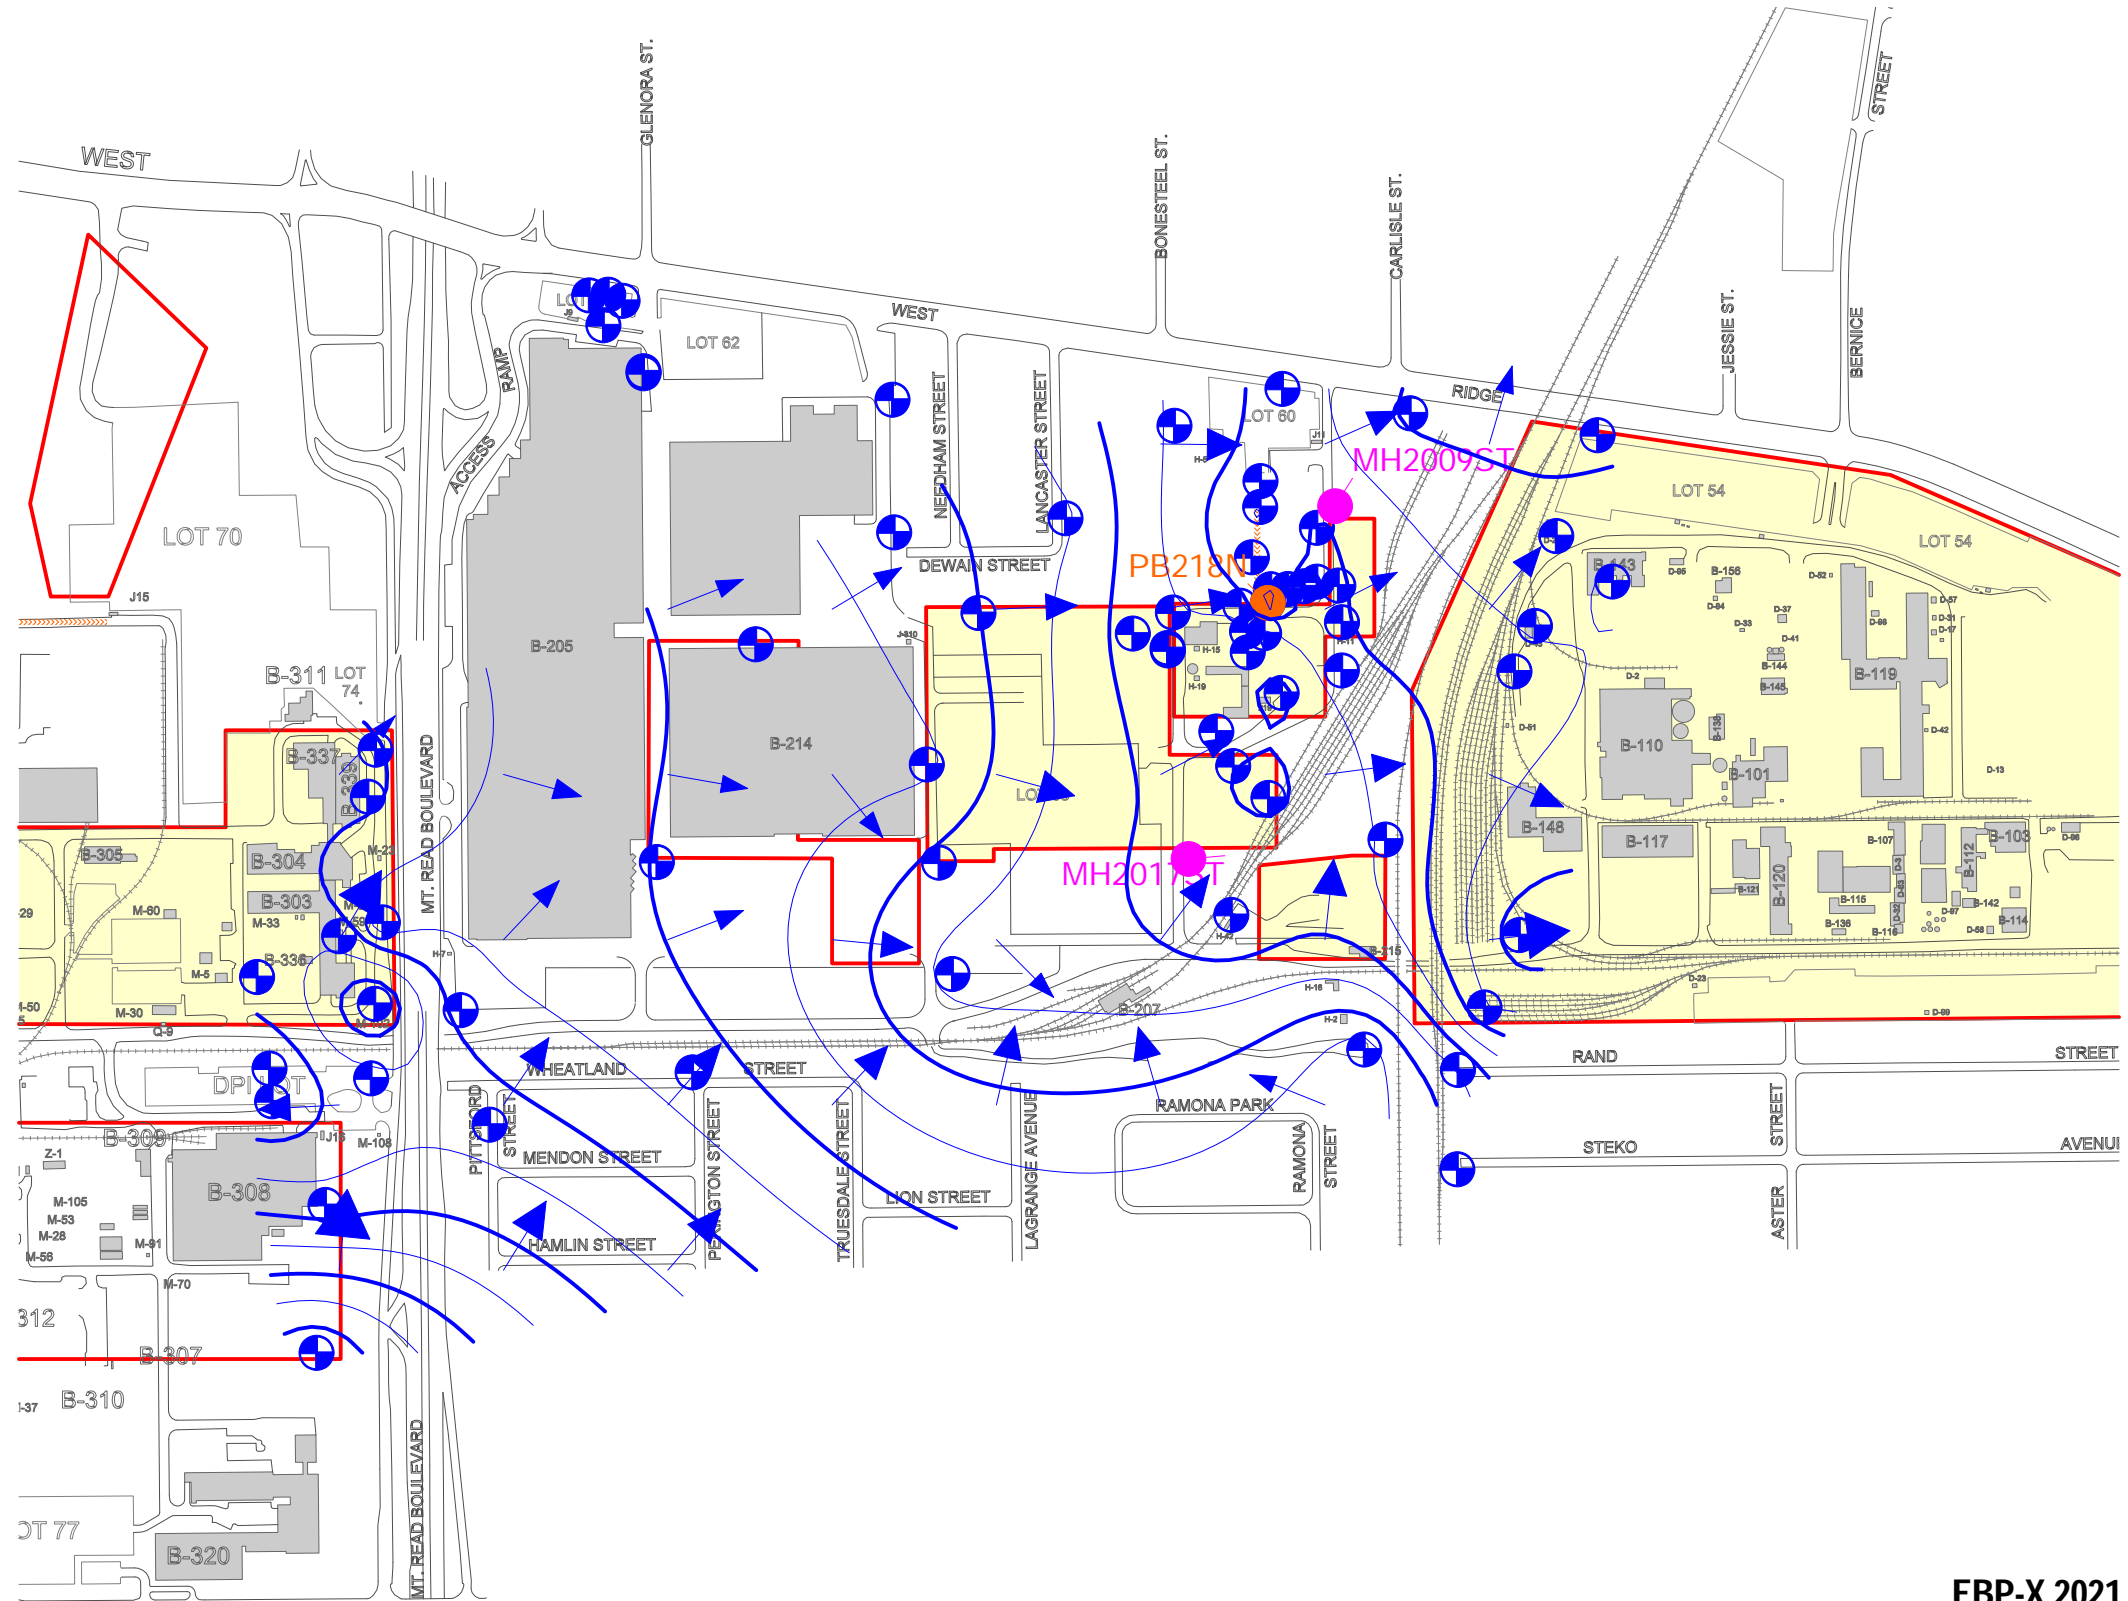
Figure 11
EBP-X 2021 Overburden Groundwater
Potentiometric Surface
Eastman Business Park
Rochester, New York

Contours of the overburden, TOR, and GQ groundwater potentiometric surfaces in the NE-EBPX MCS area are presented in Figures 11 through 13. The effect of pumping well PB218N on the overburden surface is illustrated in Figure 11 by the depressions in the contour lines.

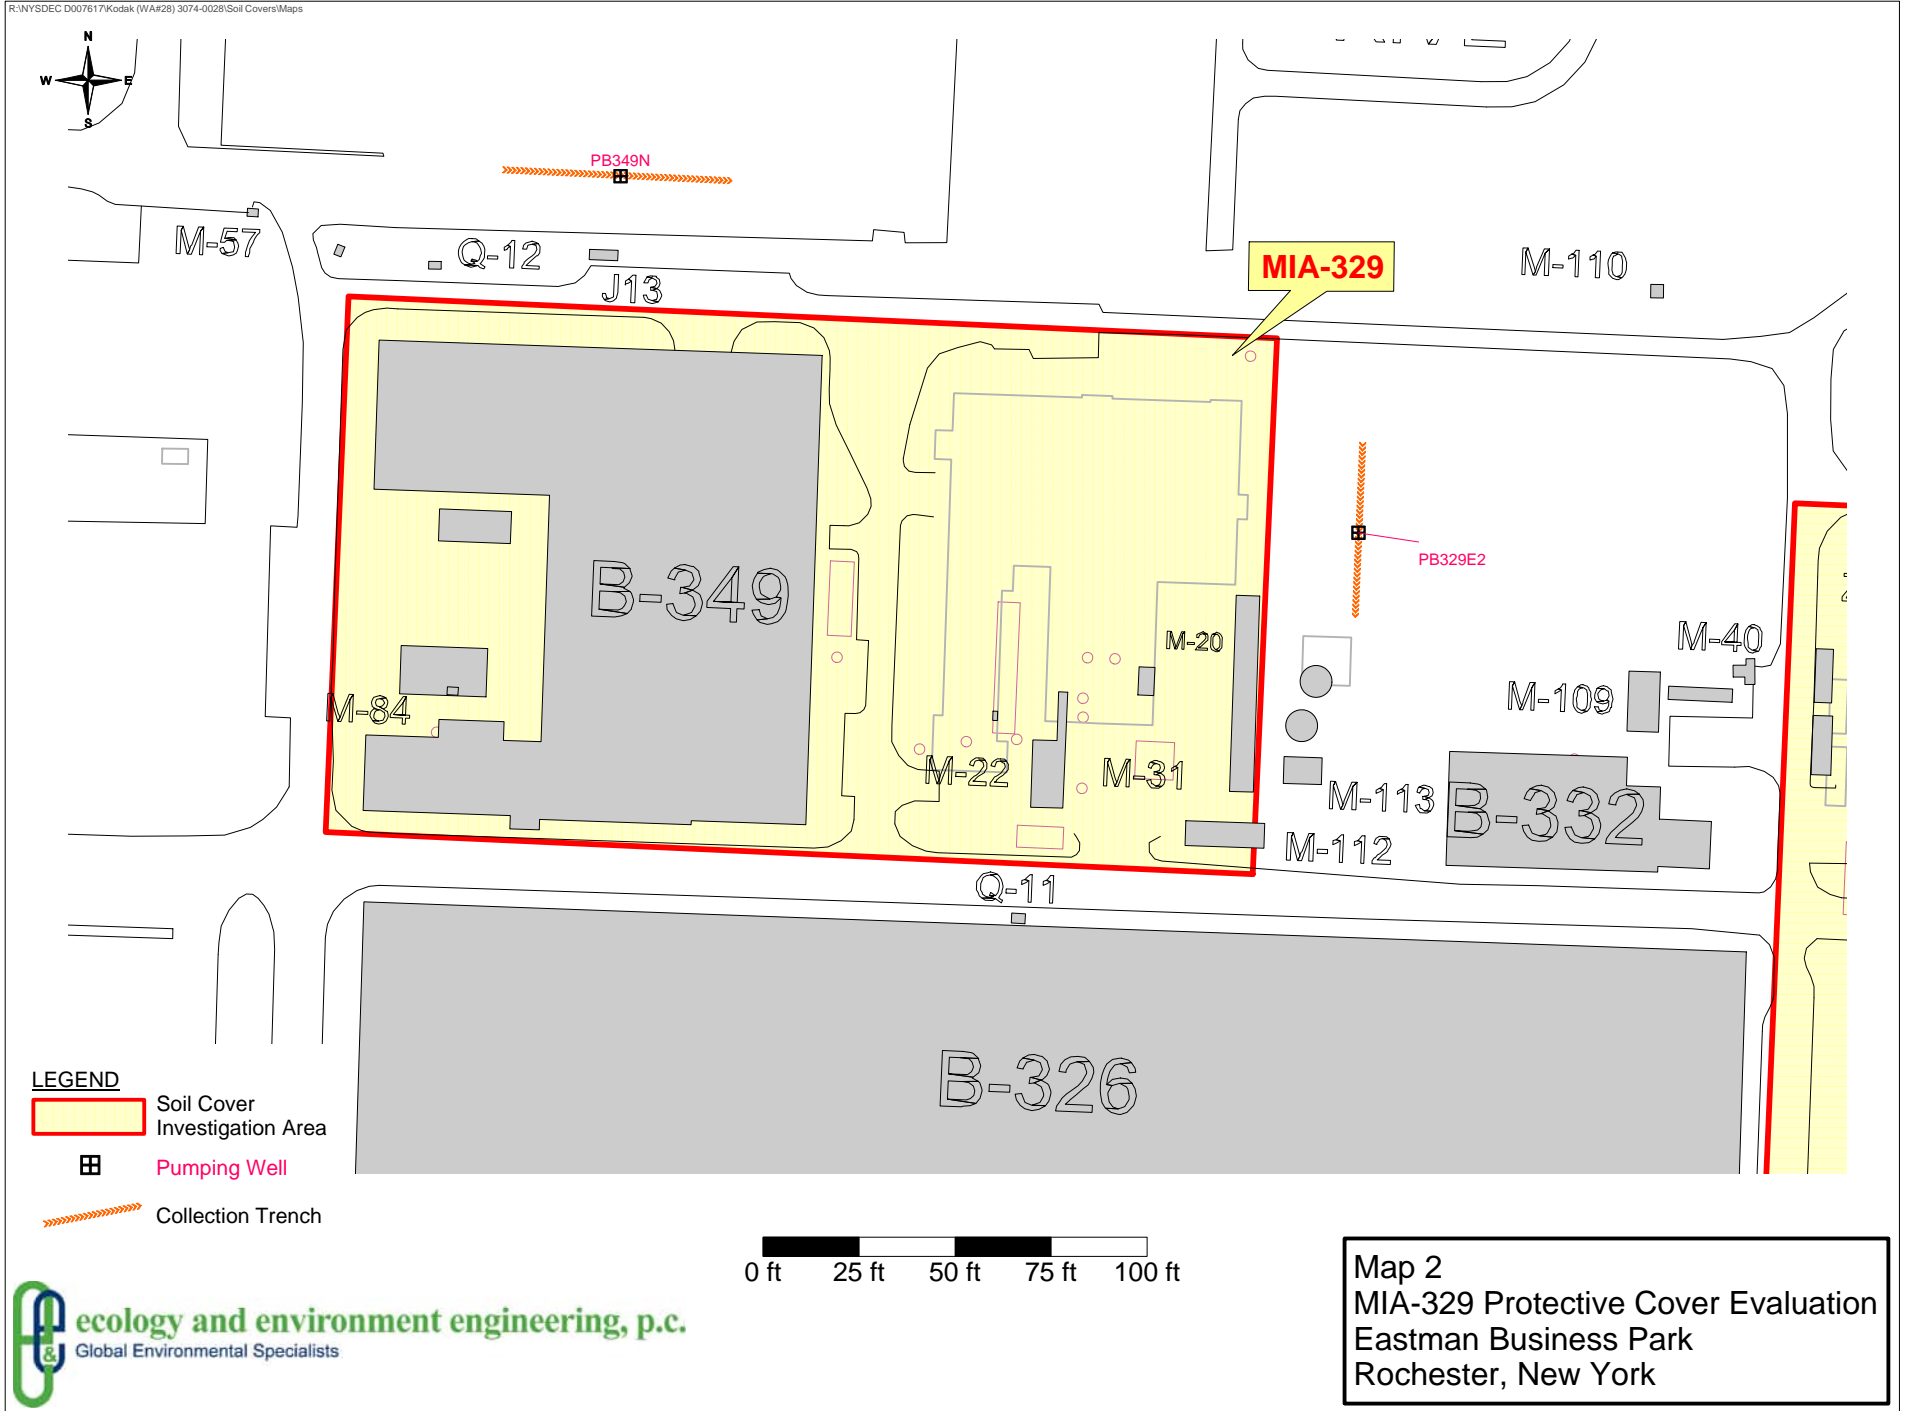
MAP No.	INVESTIGATION AREA	STATUS		NATURE OF DEFICIENCY, IF ANY (add attachments if needed)	ACTION REQUIRED?	
		OK	OTHER		YES	NO
1	MIA-WRL	✓				✓
2	MIA-329	✓				✓
3	MIA-351	✓		- Potholes + cracks present in roadway		✓
4	MIA-317	✓				✓
5	MIA-301	✓				✓
6	XIA-202/208	✓				✓
7	WIA-KPW	✓				✓
8	NE-KPE	✓				✓
9	EIA-KL	✓				✓
10	B-642 Area	✓				✓
