## Outfall Evaluation Report, Former Hampshire Chemical Corp Facility, Waterloo, New York

PREPARED FOR: Jerome Cibrik/Dow Remediation Leader

PREPARED BY: CH2M HILL Project Team

DATE: February 22, 2011

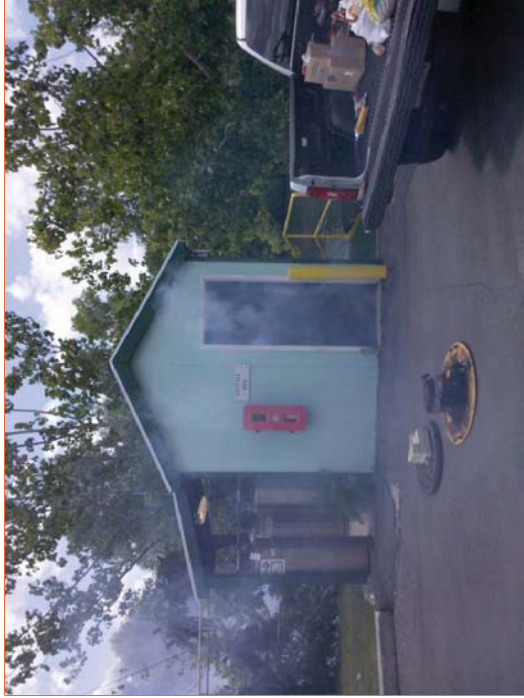
Photo 8. Outfall 004: Smoke observed from Outfall 004: Shed at 004-000A with smoke blower at 004-001

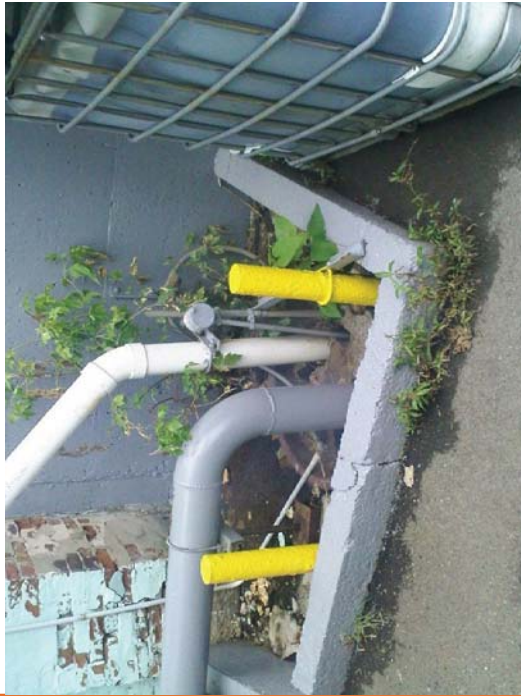
With the smoke blower placed on vertical pipe opening 005-000A, smoke was observed upgradient at nodes 005-001, 005-001A, and 005-001B, and downstream at 005-000. These observations were consistent with site drawings (Attachment 3, Photographs 9 to 14).

Photo 9. Outfall 005: Perforated metal plate at 005-001

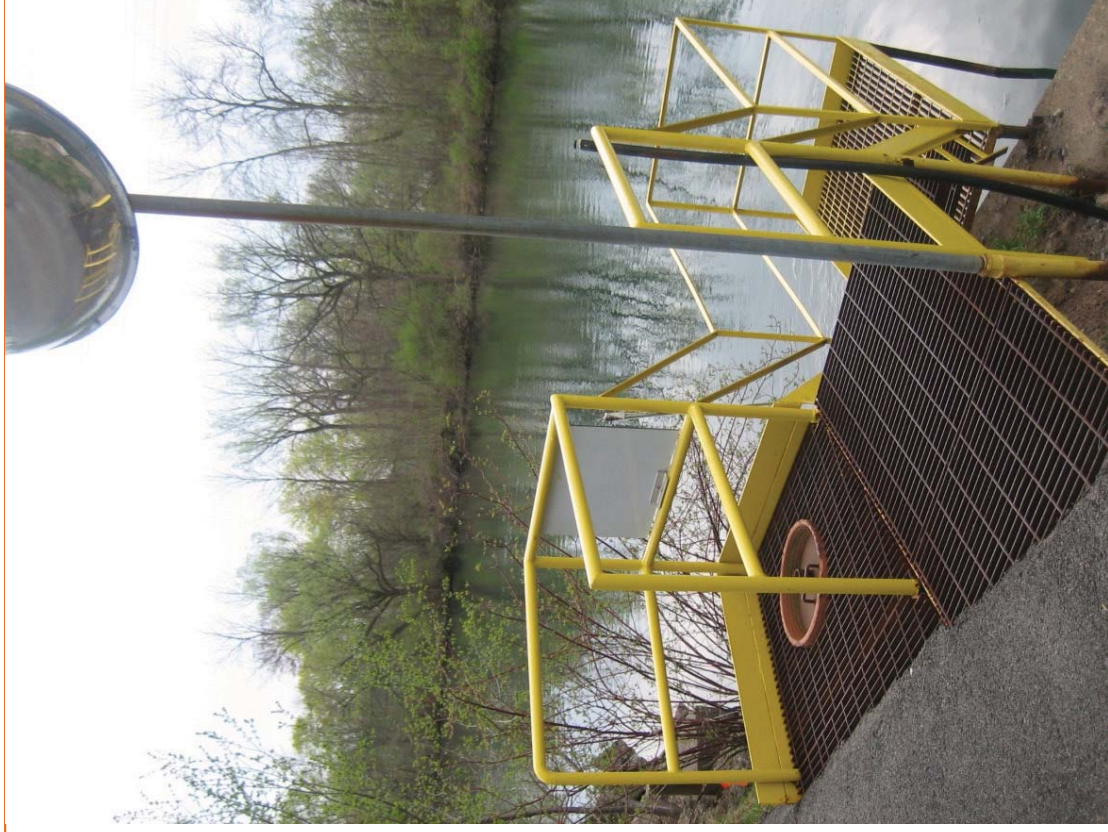
Photo 10. Outfall 005: Location for smoke blower at 005-000A vertical pipe

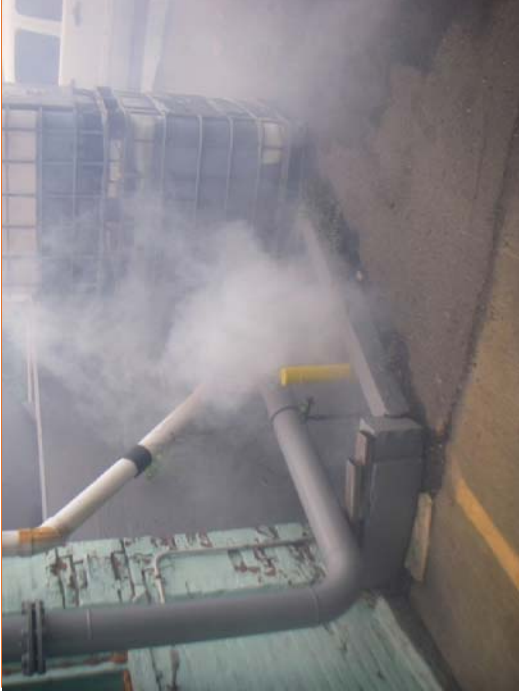
Photo 11. Outfall 005: Smoke observed at perforated metal plate at 005-001

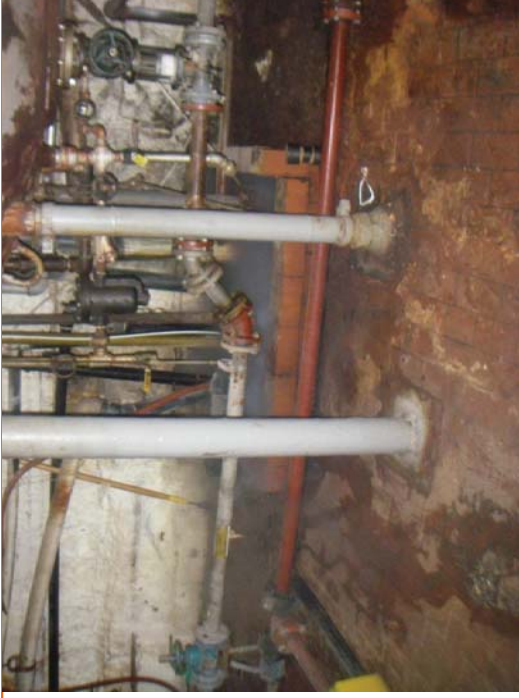
Photo 12. Outfall 005: Smoke observed at 005-001A near former Hotwell 4

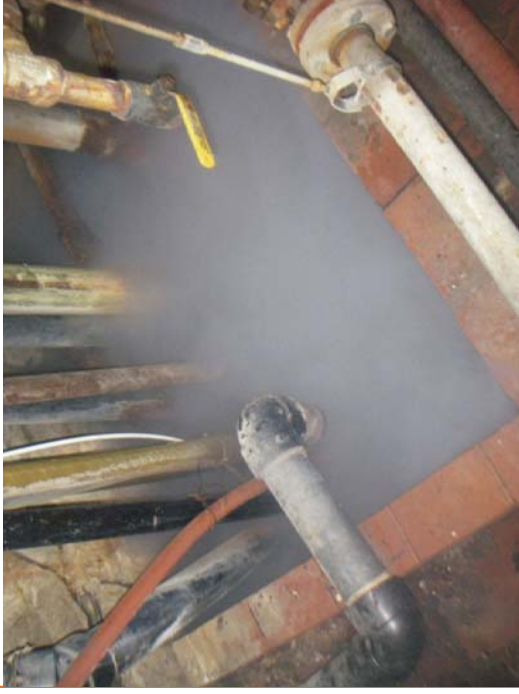
Photo 13. Outfall 005: Smoke observed at 005-001A near former Hotwell 4

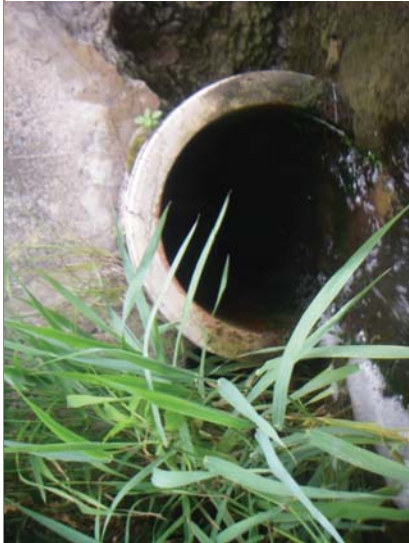
Photo 19. Outfall 001: 12" Diameter discharge point 001-000

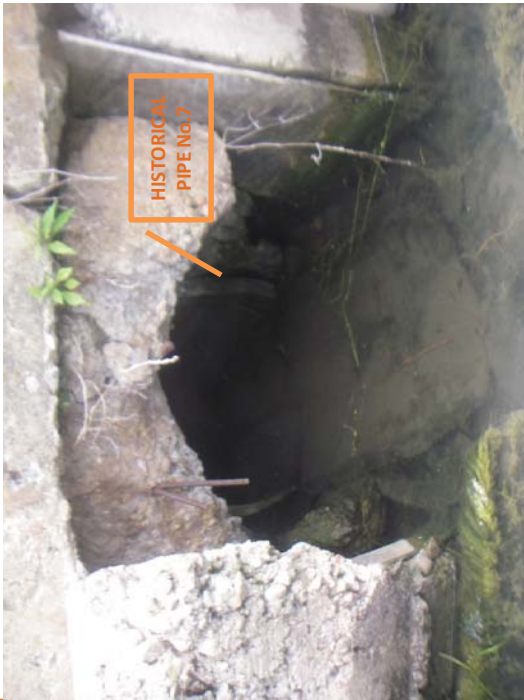
Photo 21. Possible historical pipe No. 7 east of Outfall 002

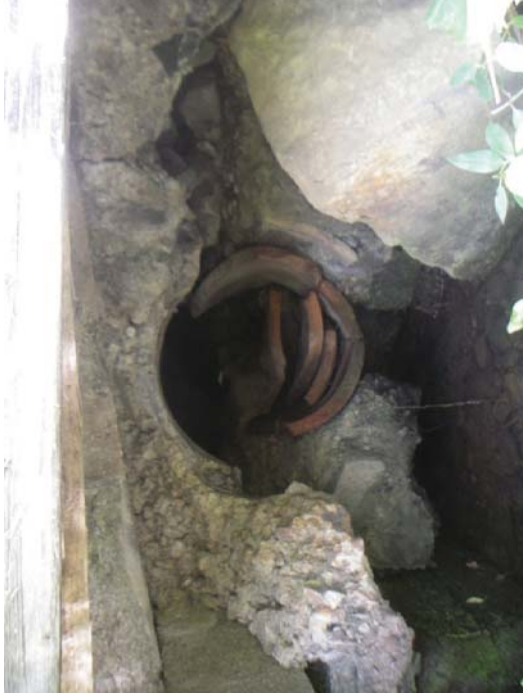
Photo 30. Outfall 006: 15" Diameter abandoned discharge point 006-000 which seems to correspond to historical pipe No. 15

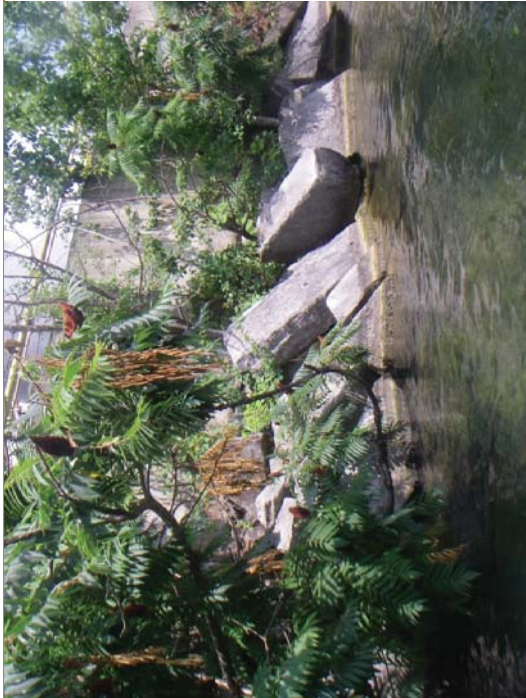
Photo 31. Outfall 007: Could not locate discharge point 007-000. It may underlie area with concrete blocks and vegetation.

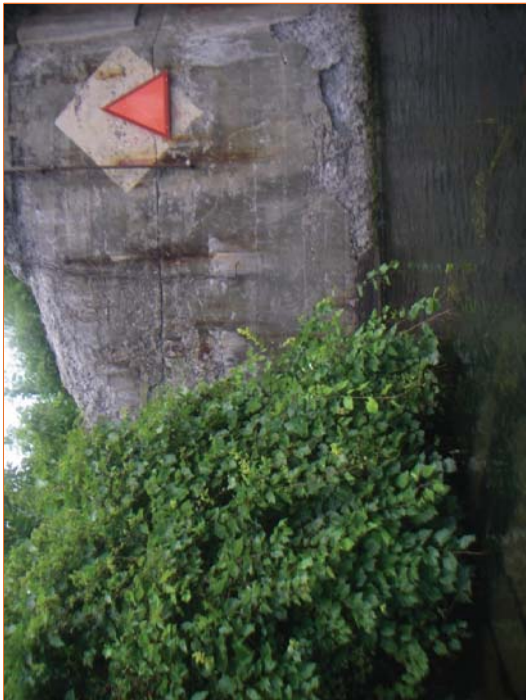
Photo 32. Outfall 007 (Historical pipe No. 18): Could not locate discharge point 007-000. It may underlie area with vegetation.

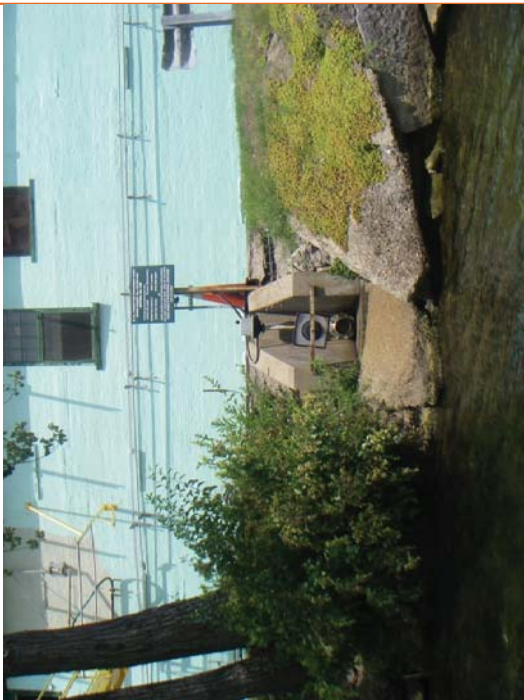
Photo 34. Outfall 009: 6" diameter discharge point 009-000. Pipe above canal water level.

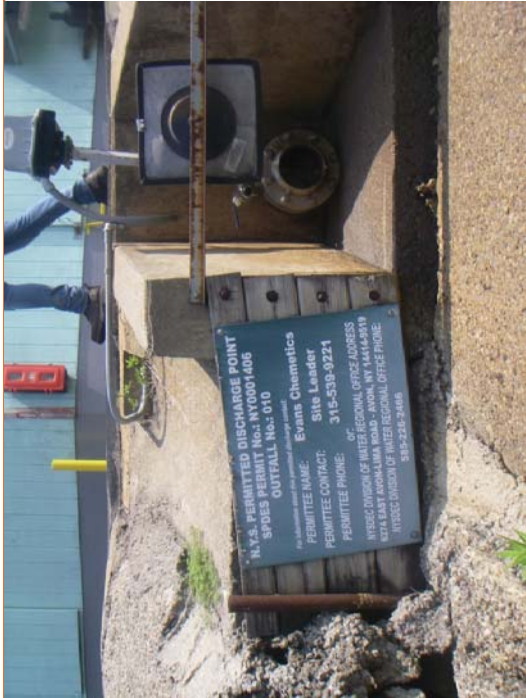
Photo 35. Outfall 010: Discharge point 010-000 above canal water level

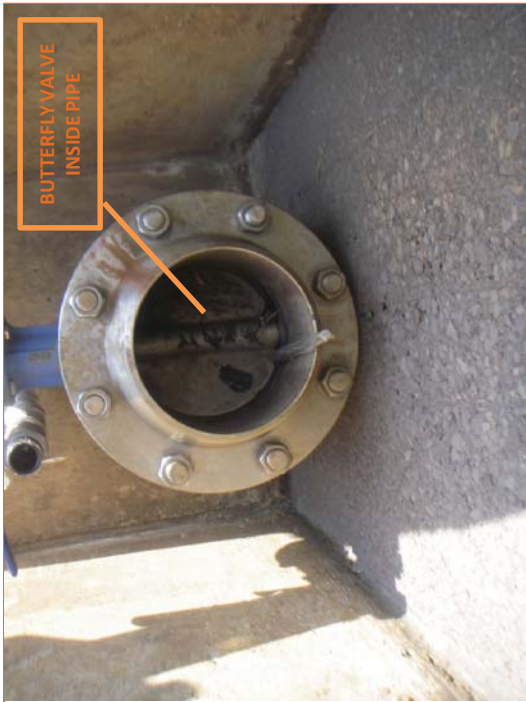
Photo 36. Outfall 010: 6" Diameter discharge point 010-000

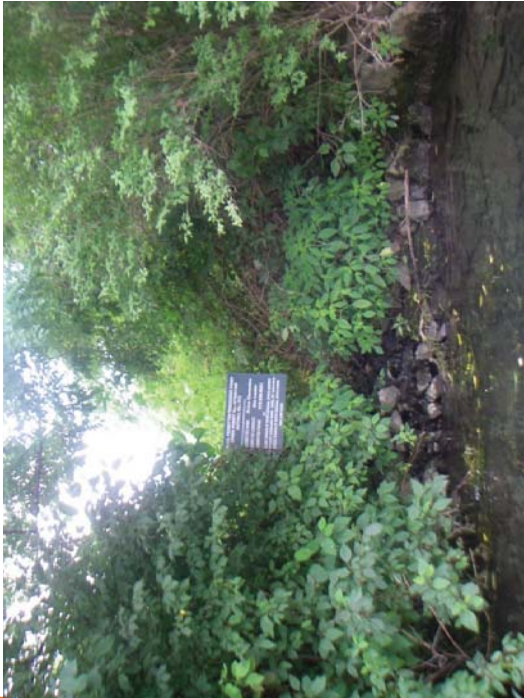
Photo 37. Outfall 012: Discharge point 012-000 on 18" wide cobble stone bed

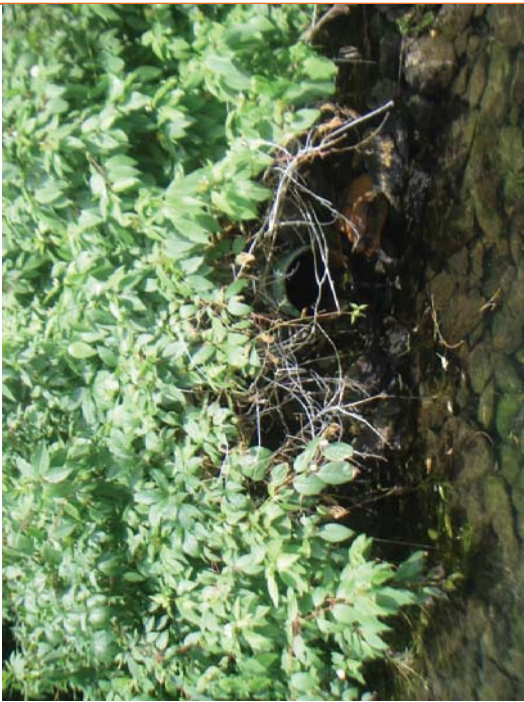
Photo 38. Outfall 013: Discharge point 013-000

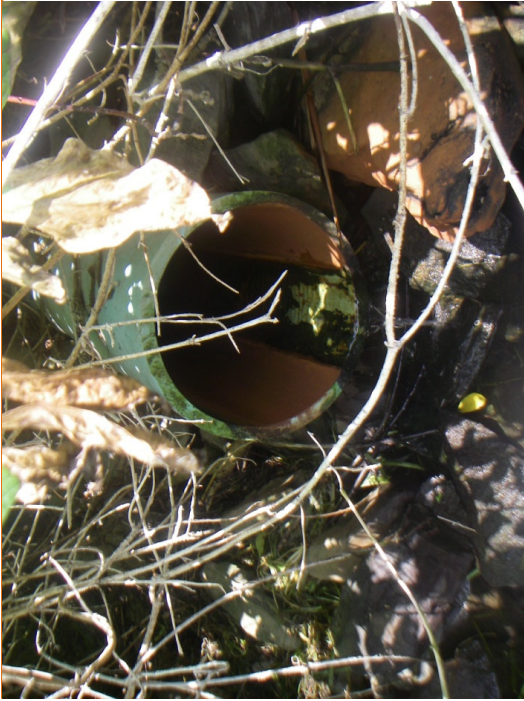
Photo 39. Outfall 013: Discharge point 013-000

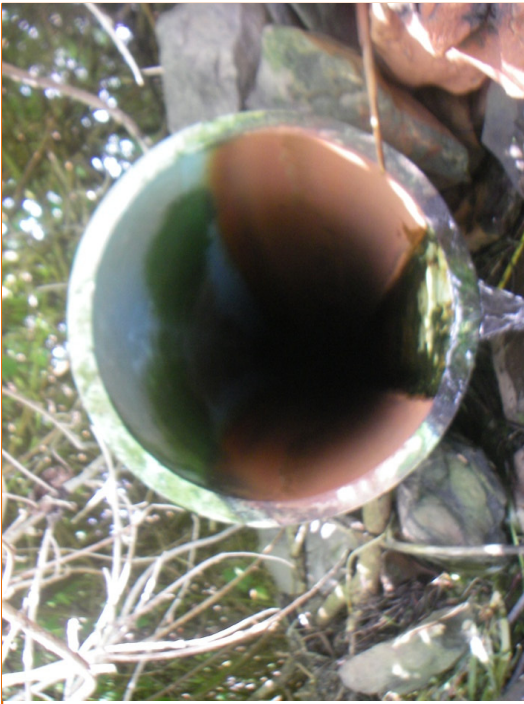
Photo 40. Outfall 013: Interior of 12" diameter discharge point 013-000

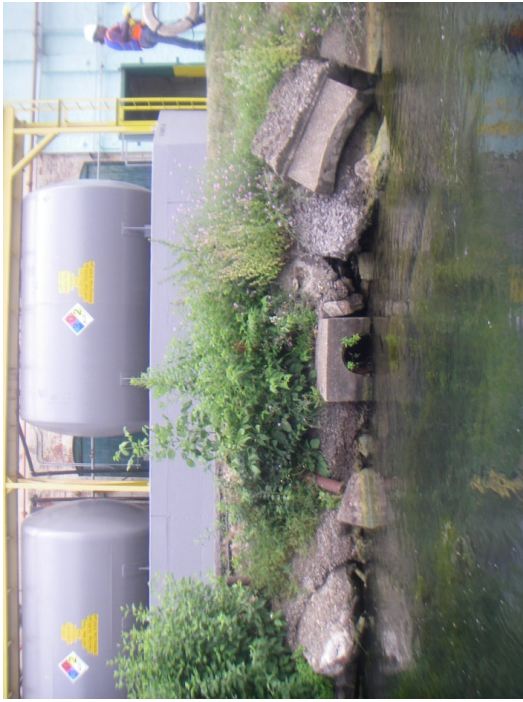
Photo 41. Abandoned historical outfall located approximately 20 ft east of Outfall 005. Seems to correspond to historical pipe No. 10. See Figure 6.

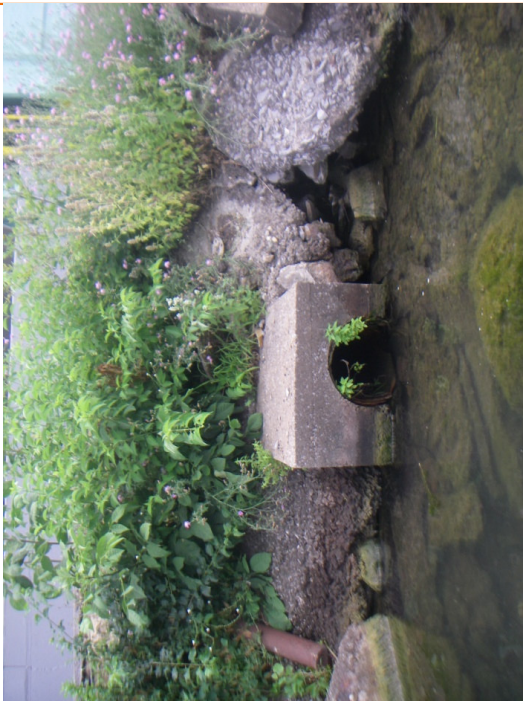
Photo 42. Abandoned historical outfall located approximately 20 ft east of Outfall 005. May correspond to historical pipe No. 10. See Figure 6.

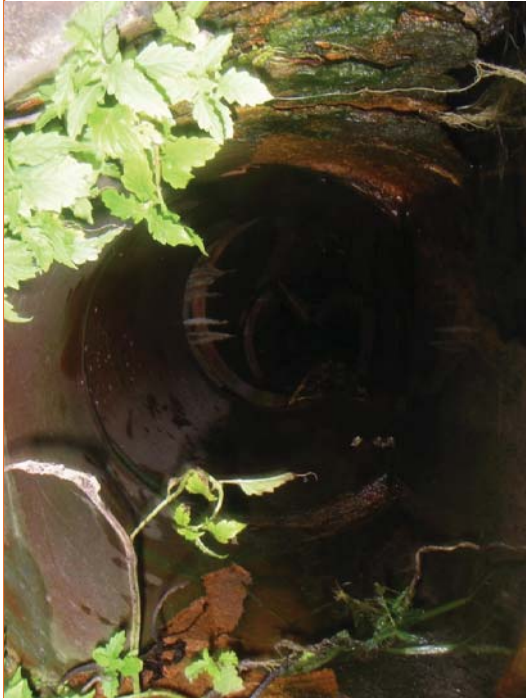
Photo 43. Abandoned historical outfall located approximately 20 ft east of Outfall 005. May correspond to historical pipe No. 10. See Figure 6.

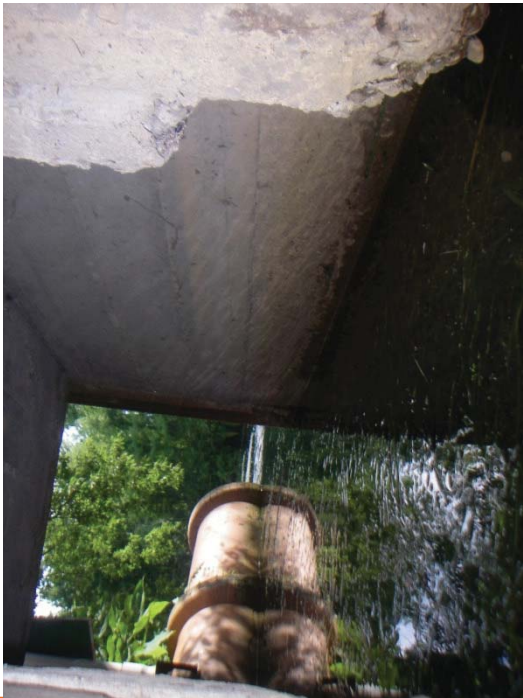
Site personnel opened the manhole upgradient of Outfall 008, which facility personnel had welded shut. This manhole did not connect to Outfall 008, but to a parallel underground conduit. This conduit is west of Building 4, and site personnel informed CH2M HILL that it was connected to a conduit under Building 14 and was used for discharge of noncontact cooling water to the canal. However, its current conditions are unknown (Attachment 3, Photographs 45 to 46).

Photo 45. South view of culvert wall west of Outfall 008

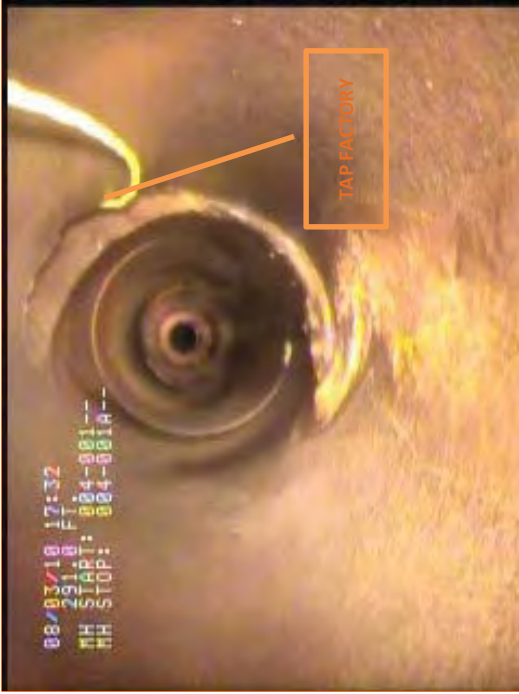
Photo 51. Outfall 004 (004-001A to 004-001): Factory tap to east of 004-001A, south of Building 2-A entrance

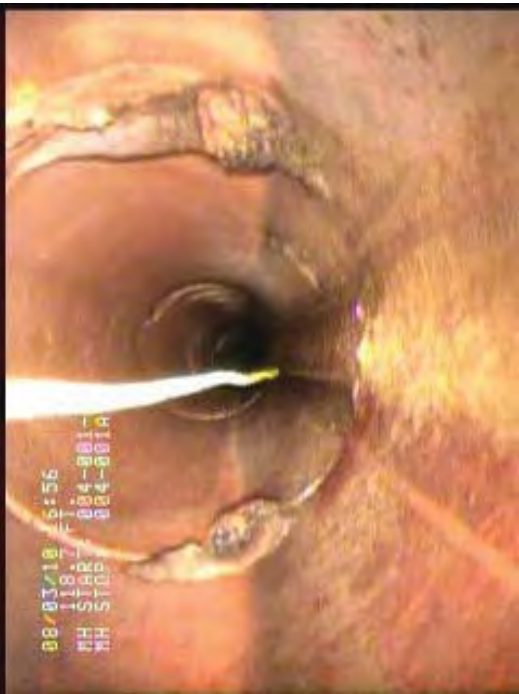
Photo 53. Outfall 004 (004-001A to 004-001): Attached deposits at 121 ft upstream of 004-001

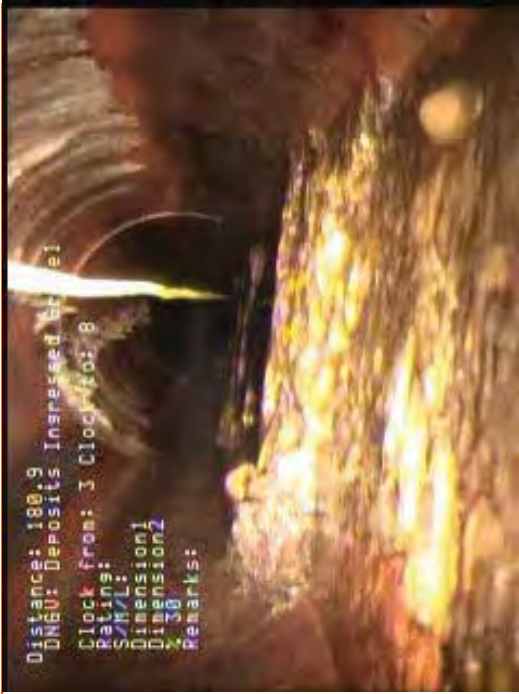
Photo 52. Outfall 004 (004-001A to 004-001): Gravel debris at 194 ft upstream of 004-001

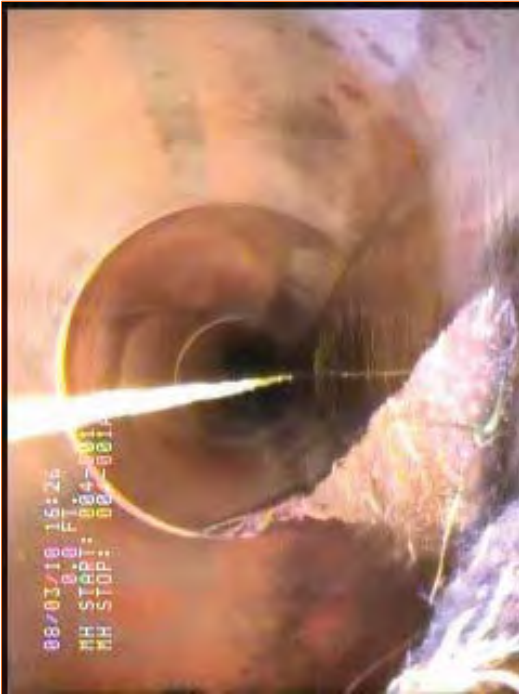
Photo 56. Outfall 004 (004-001 to 004-001A): Facing upstream from 004-001

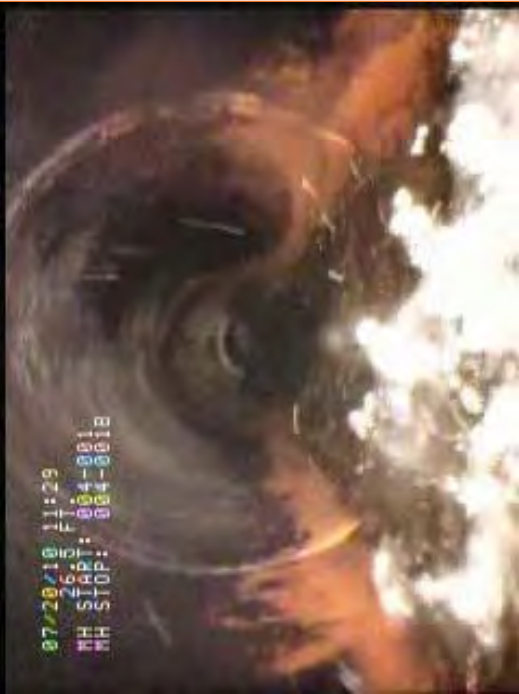
The outfall piping at 006-000 was identified without a plug at the discharge point. The upstream node 004-001B presented a manhole structure that had been paved over. The piping interior was found active and in good condition at the northern end while a concrete plug was present at the southern end. The upstream section of piping 004-001B to 004-001C was not inspected because of the 90-degree angle and smaller piping diameter. Site personnel indicated the outfall piping was rerouted to discharge through Outfall 004 via node 004-001 (Attachment 3, Photographs 57 and 58).

Photo 58. Outfall 004 (004-001B to 004-001): Mid-pipe 004-001B to 004-001

Note: Location of 004-001B corresponds to paved over manhole which was rerouted by site personnel from Outfall 006 to Outfall 004 .

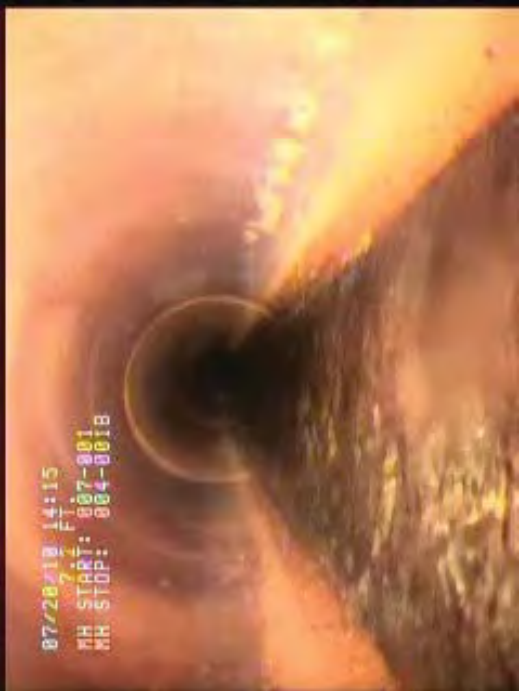
Photo 62. Outfall 004 (007-001 to 004-001B): Facing downstream (west) from 007-001

Note: Location of 004-001B corresponds to paved over manhole which was rerouted by site personnel from Outfall 006 to Outfall 004 and location identified as 007-001 previously discharged through Outfall 007 and was rerouted by site personnel to Outfall 004 by the site.

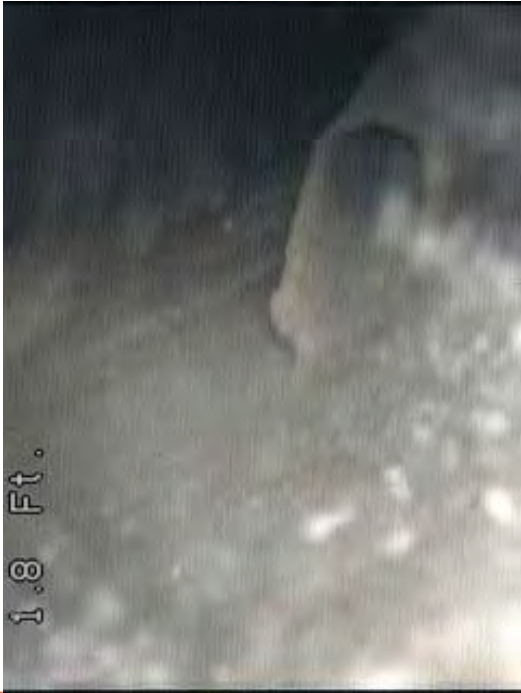
Photo 69. Outfall 005 (005-001A to 005-001): Pipe submerged in noncontact cooling water at 005-001A

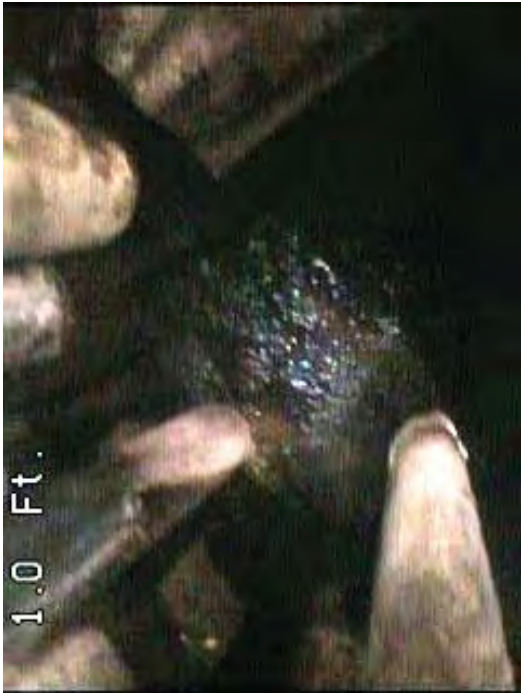
Photo 68. Outfall 005 (005-001A to 005-001): Pipe submerged at 005-001A (former Hot well 4)

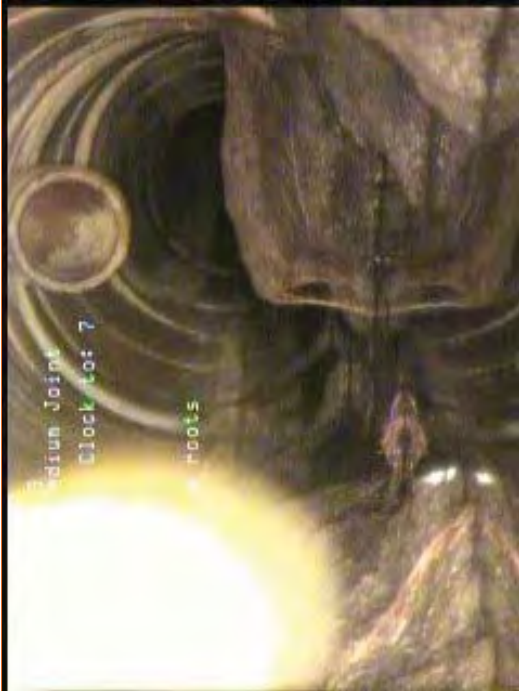
The outfall piping at 008-000 was partially submerged by canal water. Roots and aquatic weeds were present in the joints, a crack was observed at 9 feet upstream of 008-000, and a break-in tap was present at 28 feet upstream of 008-000 (Attachment 3, Photographs 75 to 80). Approximately 28 feet of piping were surveyed from 008-000 to 008-001A.

Photo 75. Outfall 008 (008-001 to 008-000): Break-in tap at 27 ft upstream of 008-000

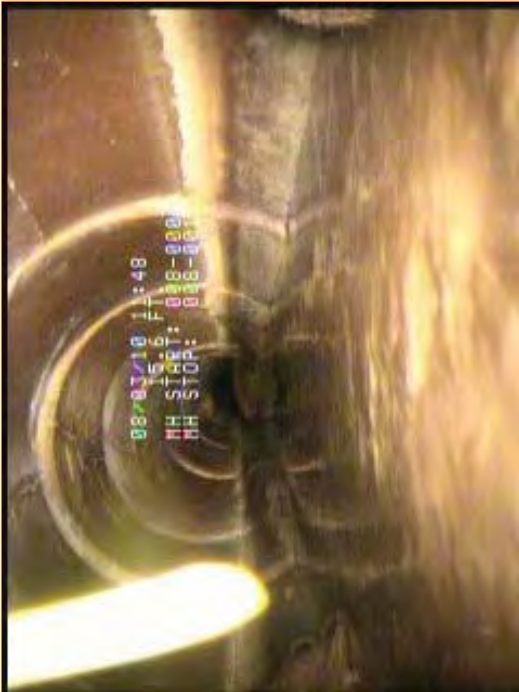
Photo 76. Outfall 008 (008-001 to 008-000): Mid-pipe 008-001 to 008-000

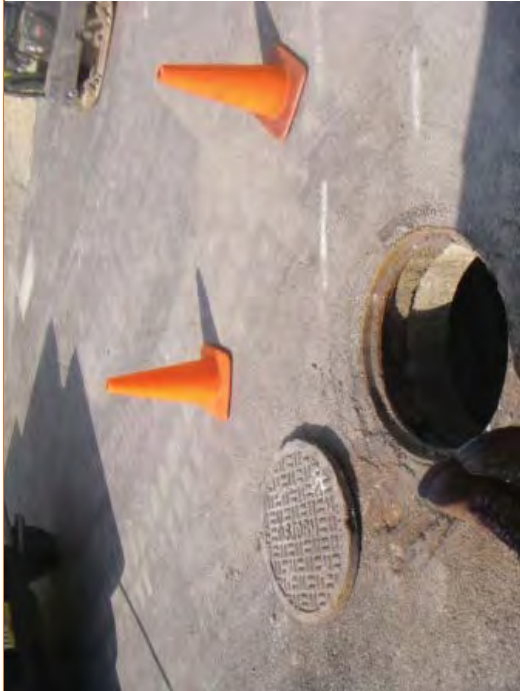
Photo 91. Outfall 001: 001-001 Manhole area

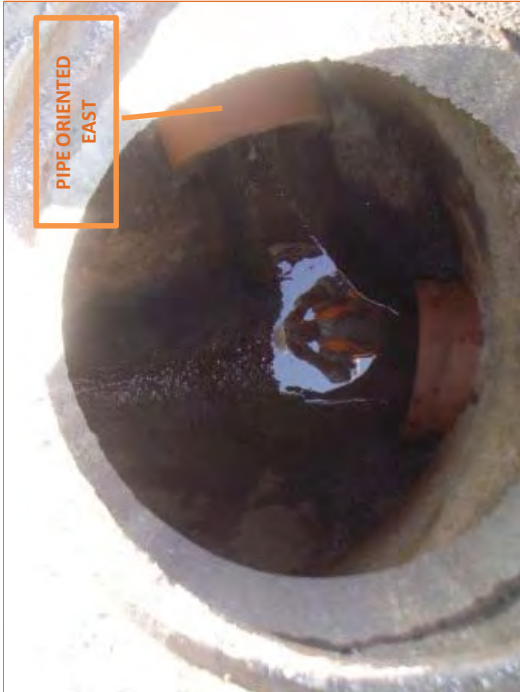
Photo 92. Outfall 001: 001-001 Manhole topside (north up). South and east pipes.

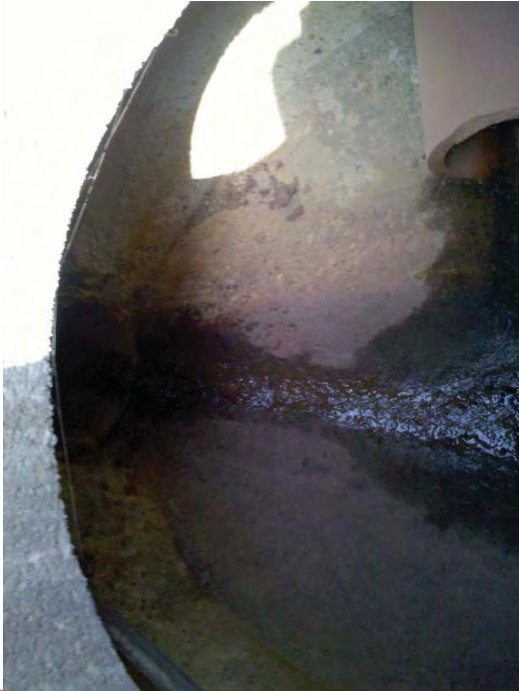
Photo 93. Outfall 001: 001-001 Manhole topside (north up). North and east pipes.

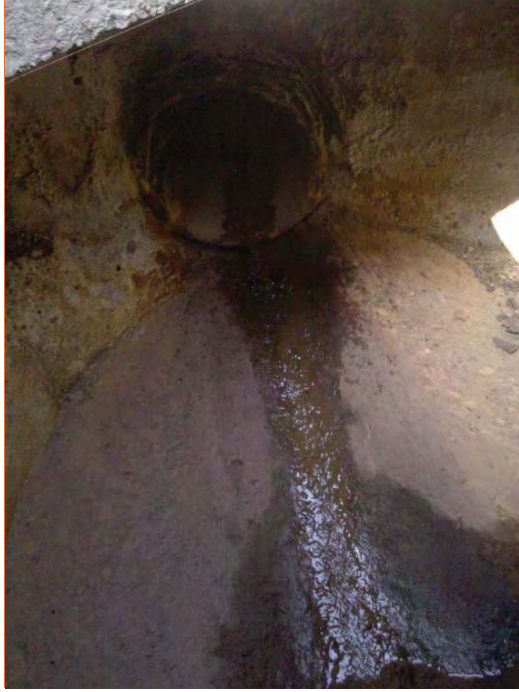
Photo 95. Outfall 001: 001-001 Pipe connections (north pipe)

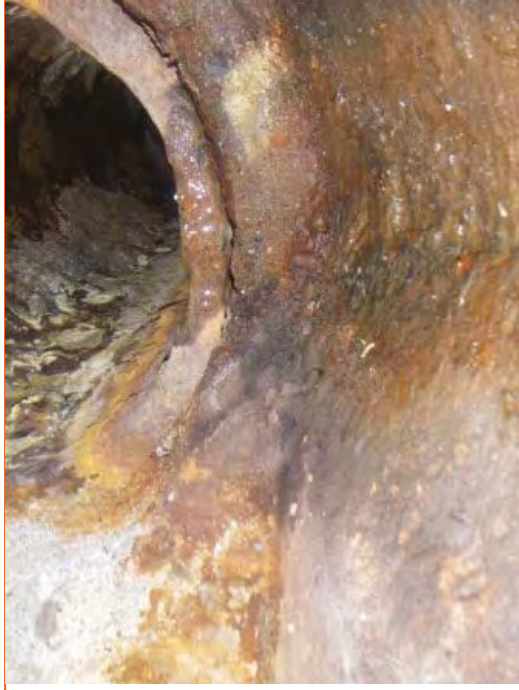
Photo 96. Outfall 001: 001-001 Pipe connections (north pipe)

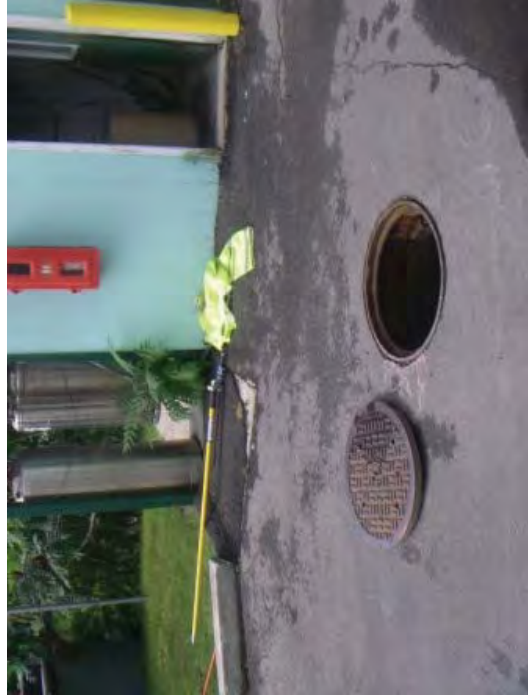
Photo 98. Outfall 004: 004-001 Manhole area

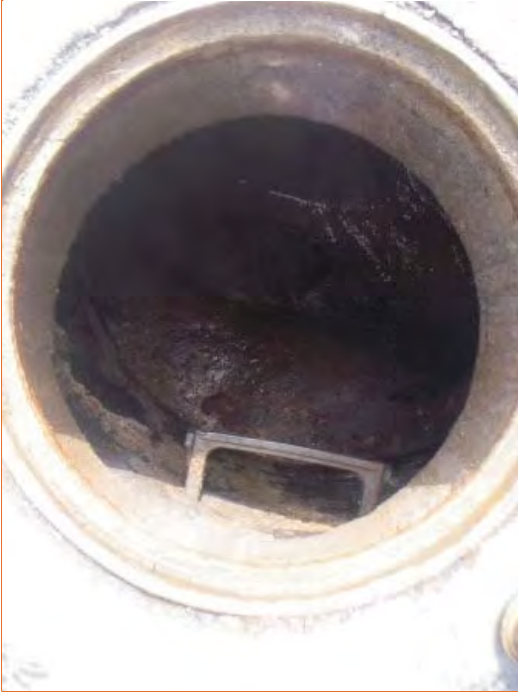
Photo 99. Outfall 004: 004-001 Manhole topside (north up)

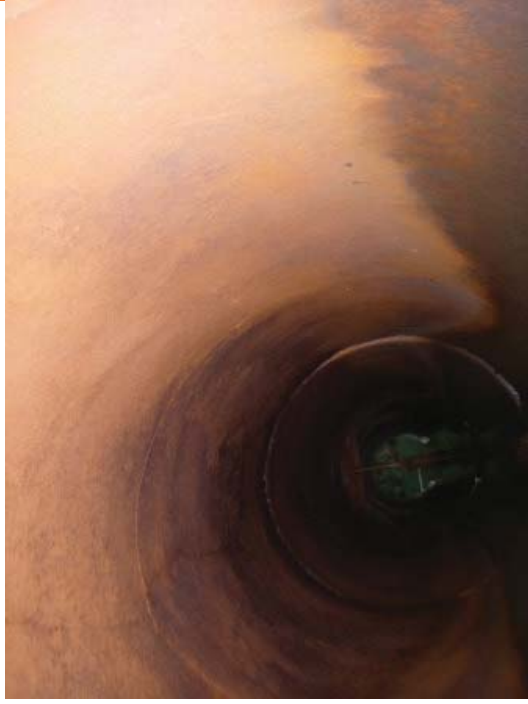
Photo 102. Outfall 004: 004-001 Pipe connections (south pipe)

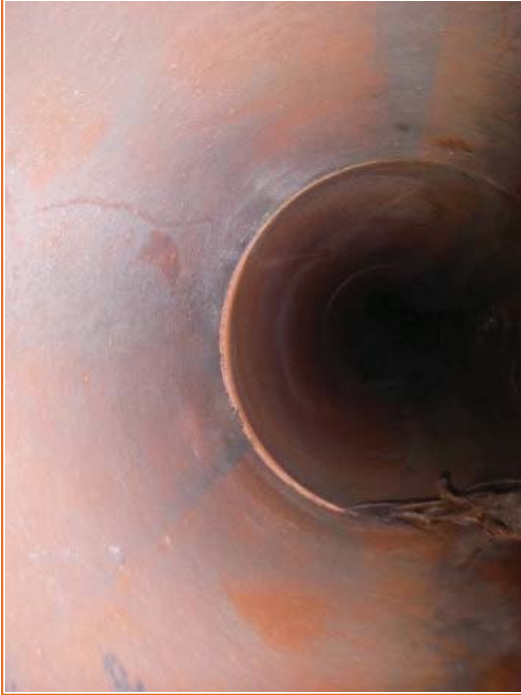
Photo 103. Outfall 004: 004-001 Pipe connections (north pipe)

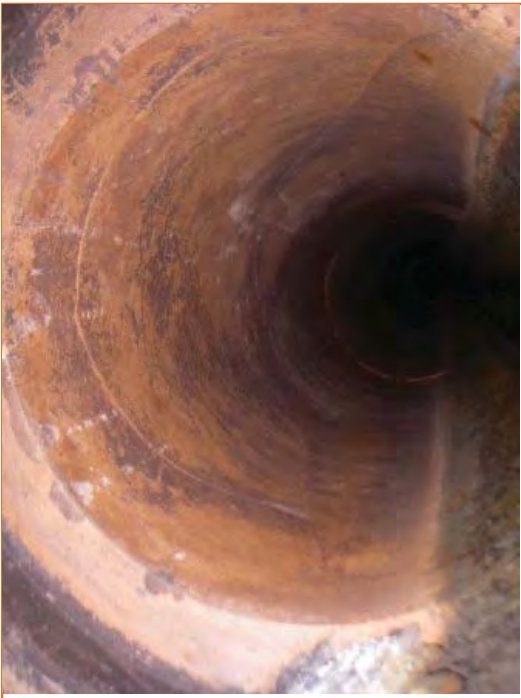
Photo 104. Outfall 004: 004-001 Pipe connections (east pipe)

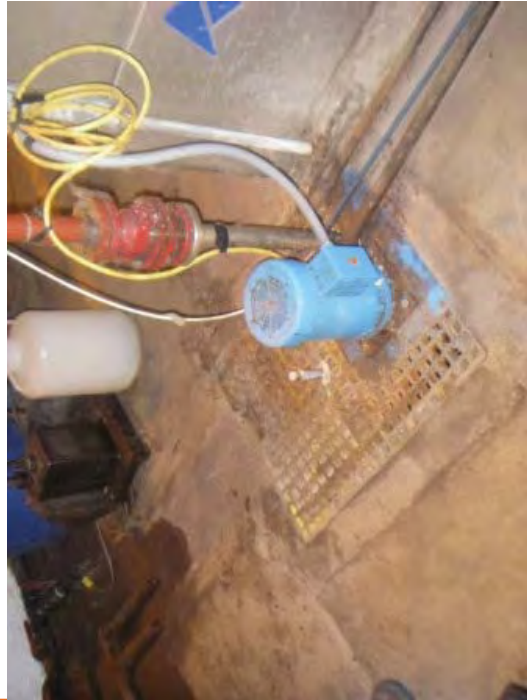
Photo 105. Building 1: 004-002 Floor drain

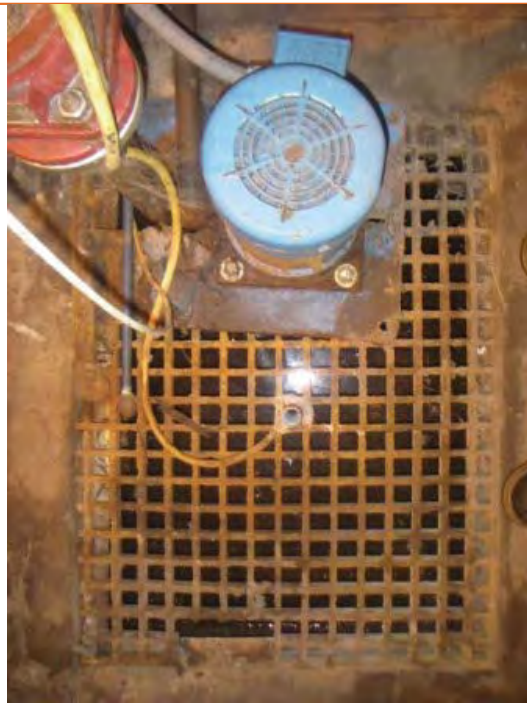
Photo 106. Outfall 004: 004-002 floor drain topside (north up)

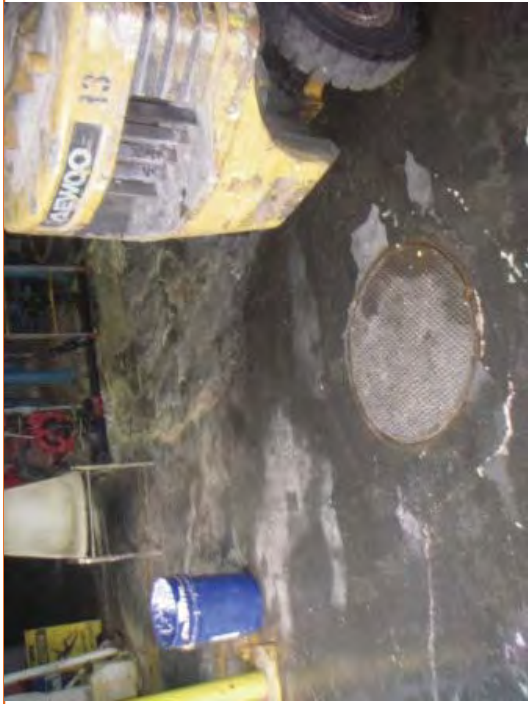
Photo 107. Sanitary sewer: 004-008 Manhole area

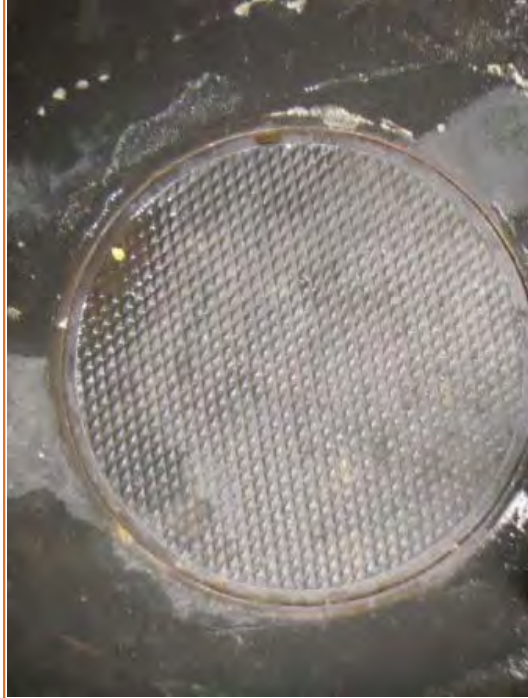
Photo 108. Building 2-A sanitary sewer: 004-008 Manhole cover

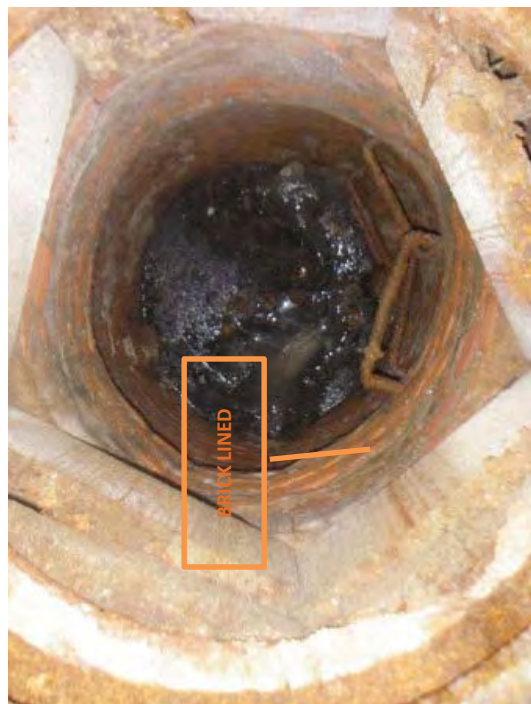
Photo 109. Building 2-A Sanitary sewer: 004-008 Manhole topside (north up)

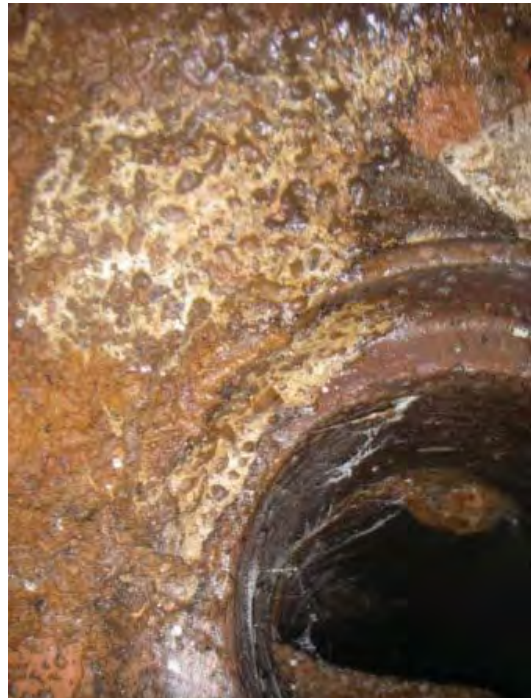
Photo 110. Building 2-A sanitary sewer: 004-008 Pipe connections (east)

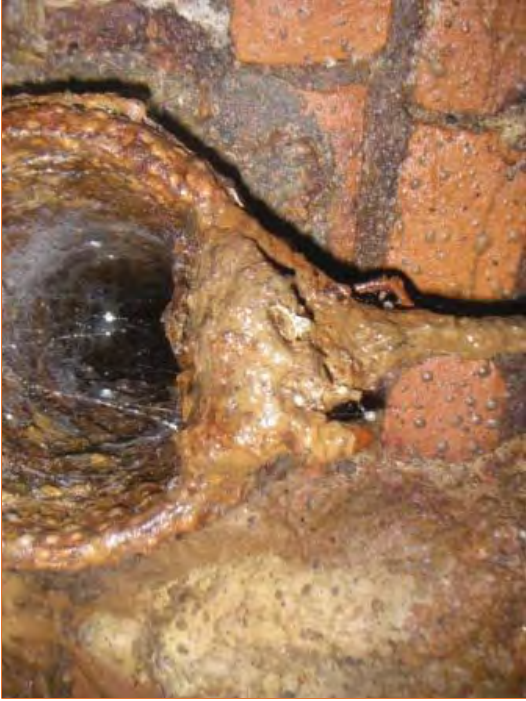
Photo 111. Building 2-A sanitary sewer: 004-008 Pipe connections (south pipe)

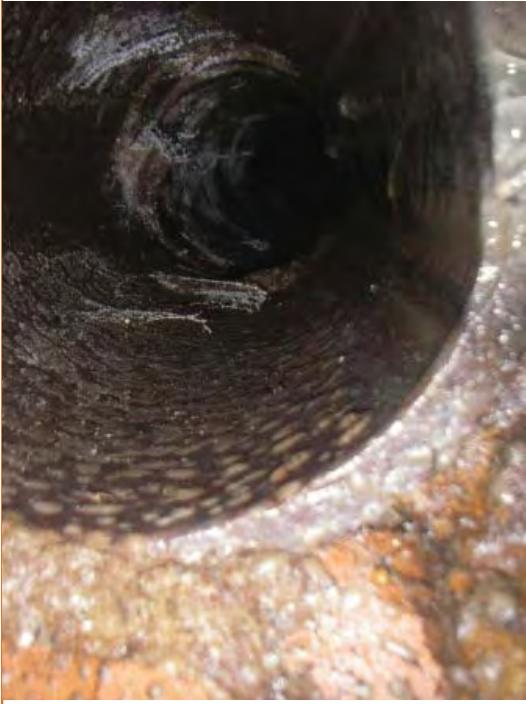
Photo 112. Sanitary sewer: 004-008 Pipe connections (west pipe)

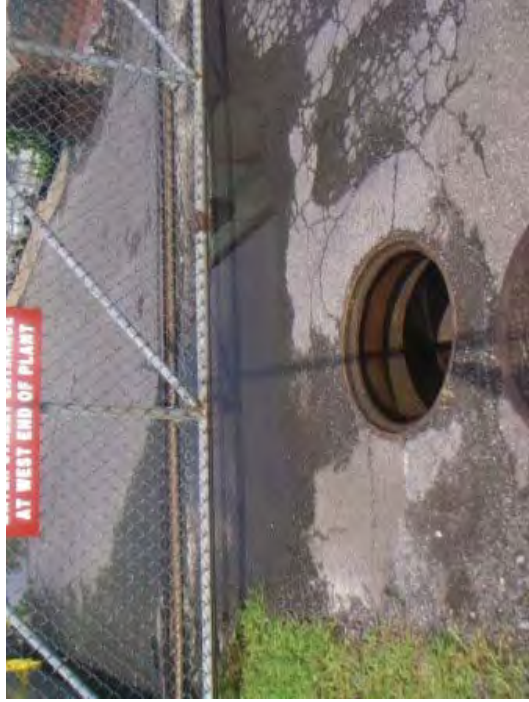
Photo 113. Outfall 007: 007-001 Manhole area

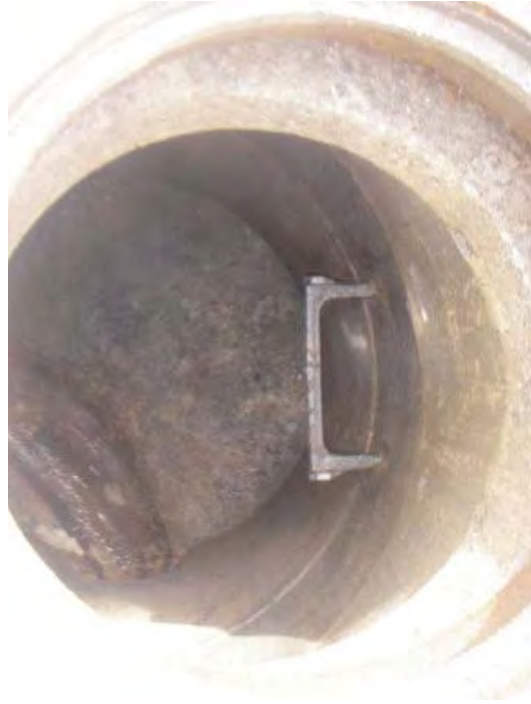
Photo 114. Outfall 007: 007-001 Manhole topside (north up)

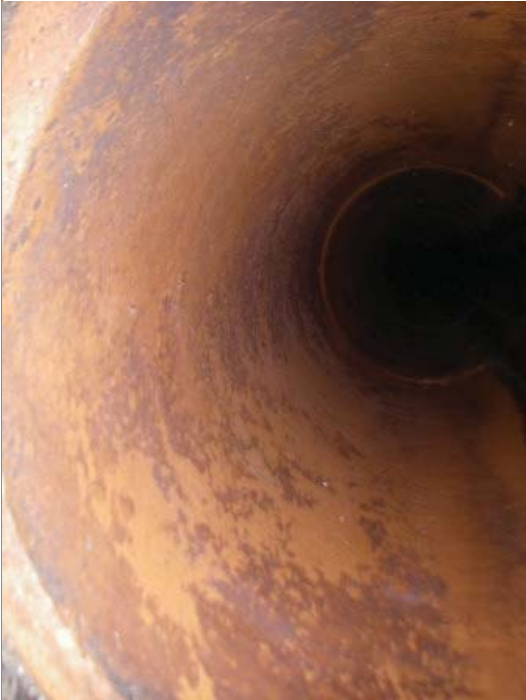
Photo 115. Outfall 007: 007-001 Pipe connections (west pipe)

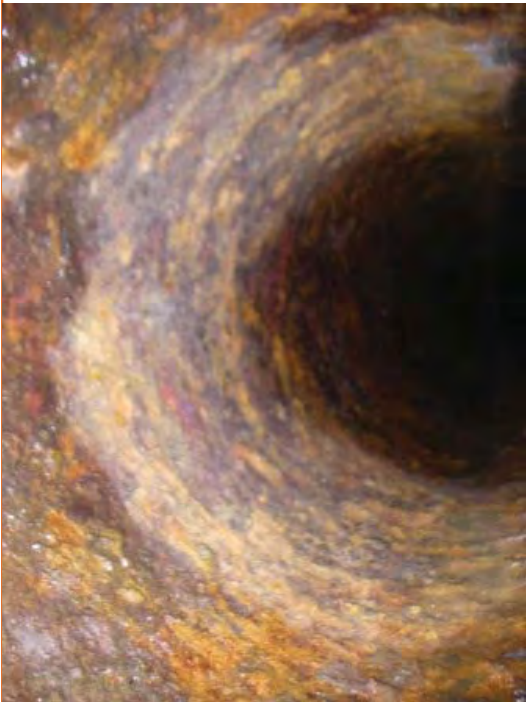
Photo 116. Outfall 007: 007-001 Pipe connections (north pipe)

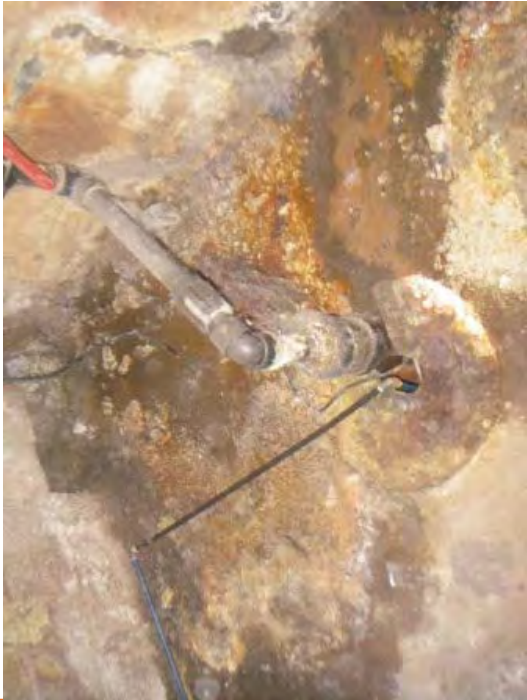
Photo 117. Building 1: 007-003 Floor drain area

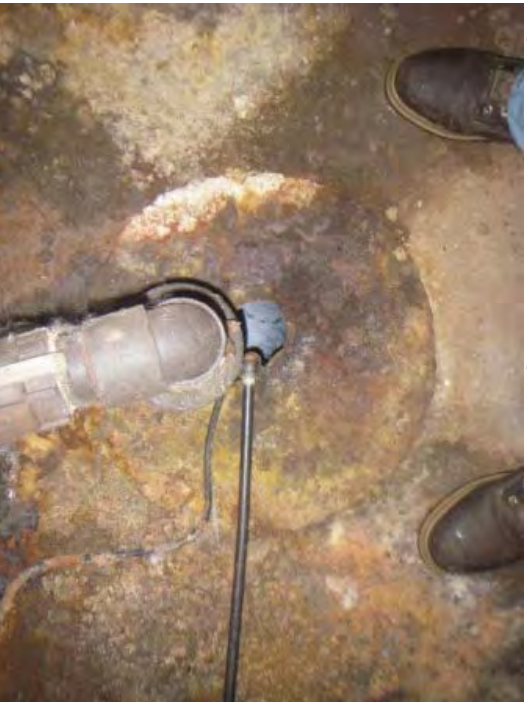
Photo 118. Building 1 : 007-003 floor drain topside. Note: 007-004 floor drain had a 8" x 14" grate with a 2" black PVC and a 1/4" diameter pipe

Note: Locations identified as 007-001 and 007-001A previously discharged through Outfall 007 and has been rerouted to Outfall 004 by the site.

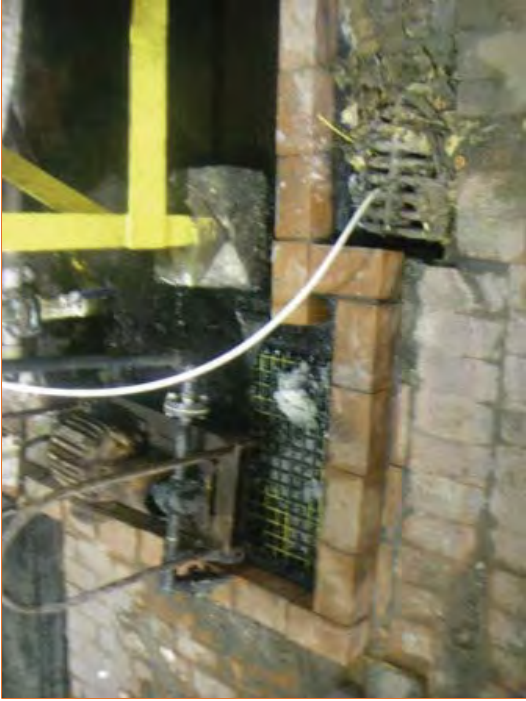
Photo 119. Outfall 004: 004-005 Floor drain in MPA Process Area
