## Outfall Evaluation Report, Former Hampshire Chemical Corp Facility, Waterloo, New York

PREPARED FOR: Jerome Cibrik/Dow Remediation Leader

PREPARED BY: CH2M HILL Project Team

DATE: February 22, 2011

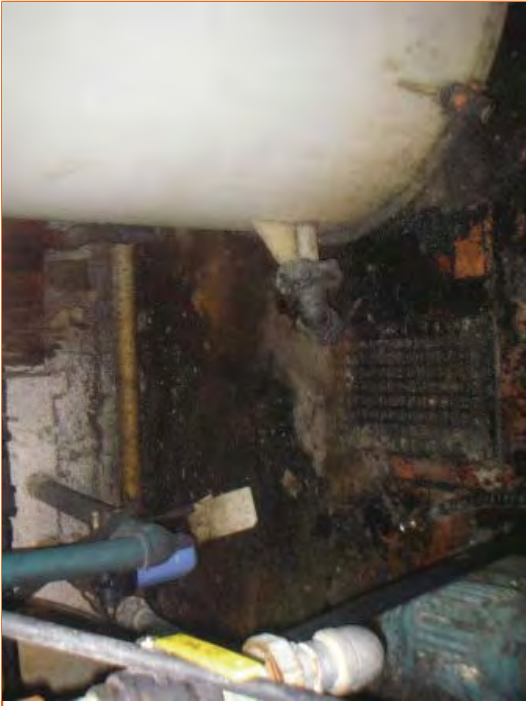
Photo 120. Building 2A : 007-008 Floor drain

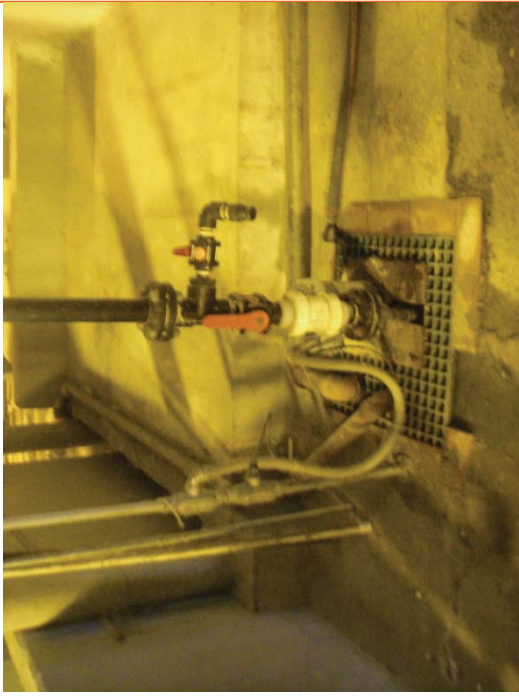
Photo 121. Building 2A: 007-008 floor drain

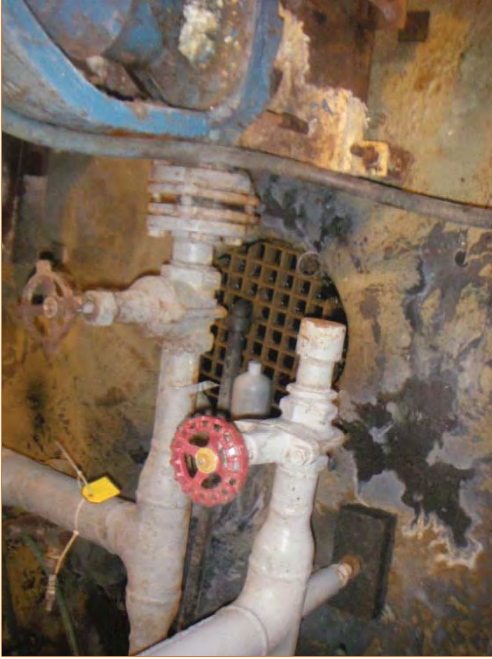
Photo 122. Building 3 floor drain near northwest wall

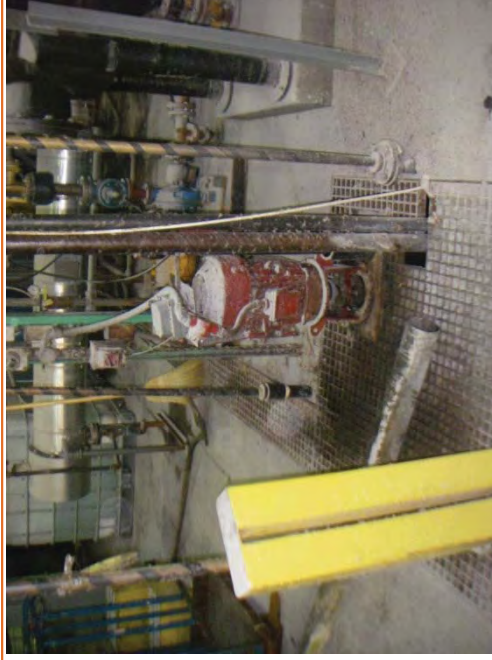
Photo 123. Building 3 floor drain near northeast wall

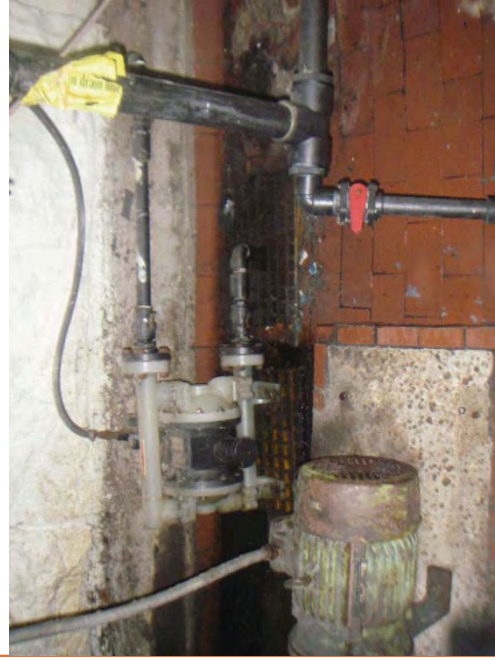
Photo 124. Building 4 floor drain near south wall

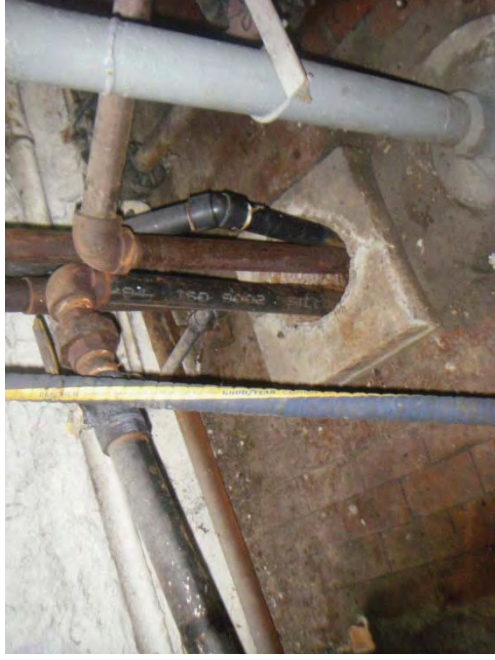
Photo 125. Building 4 floor drain near east wall

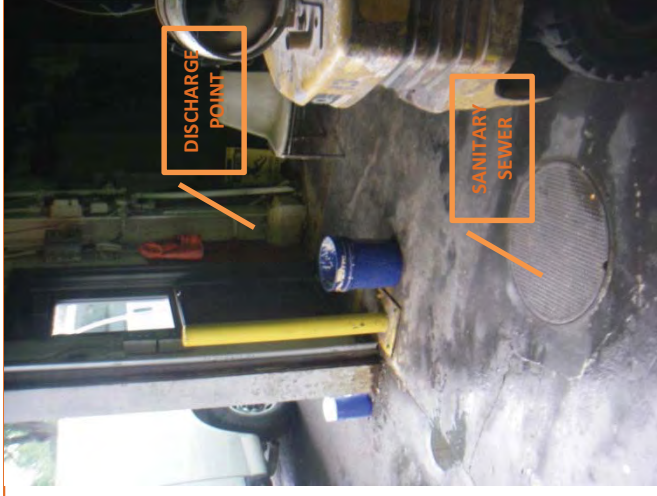
Photo 132. Building 2-A noncontact cooling water discharge point to Outfall 004 (south of Building 2 entrance)

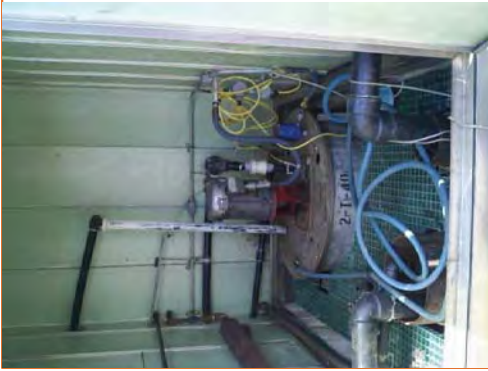
Photo 133. Building 2-A noncontact cooling water discharge point to Outfall 004 and sanitary sewer 004-008

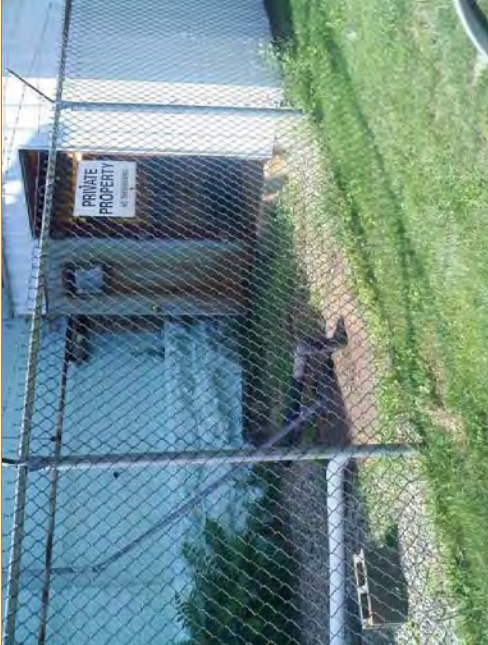
Photo 134. Former Hotwell 1A. Grate covered pit with AST and inlet piping

Note: All former hot wells have either been paved over or replaced by aboveground storage tanks, and are no longer operational. Noncontact cooling water may be discharged at these locations.

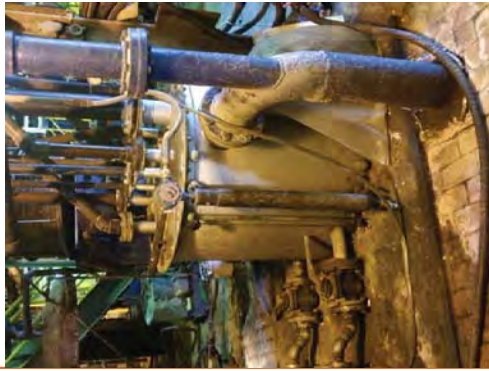
Photo 136. Former Hotwell 2; concrete paved with AST and inlet piping

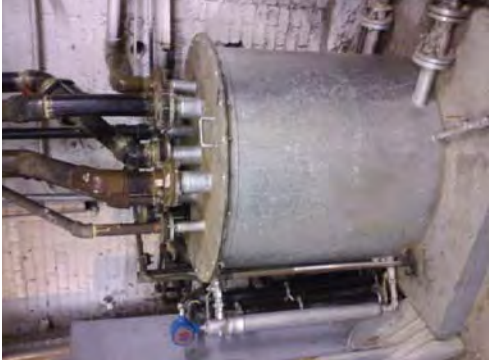
Photo 137. Former Hotwell 2A; concrete paved with AST and inlet piping

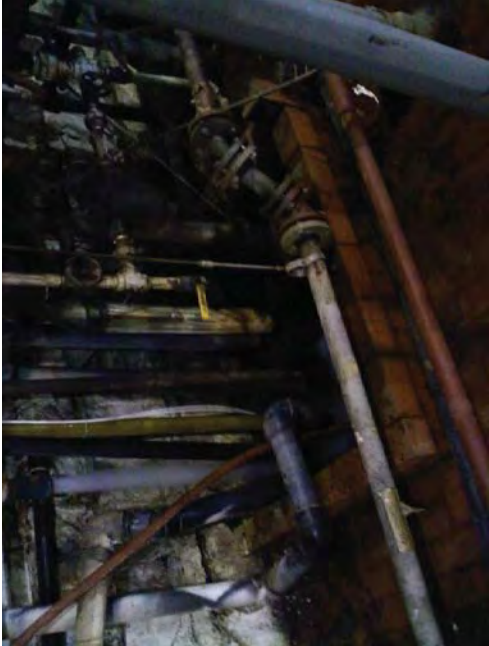
Photo 138. Former Hotwell 3; concrete paved with AST and inlet piping

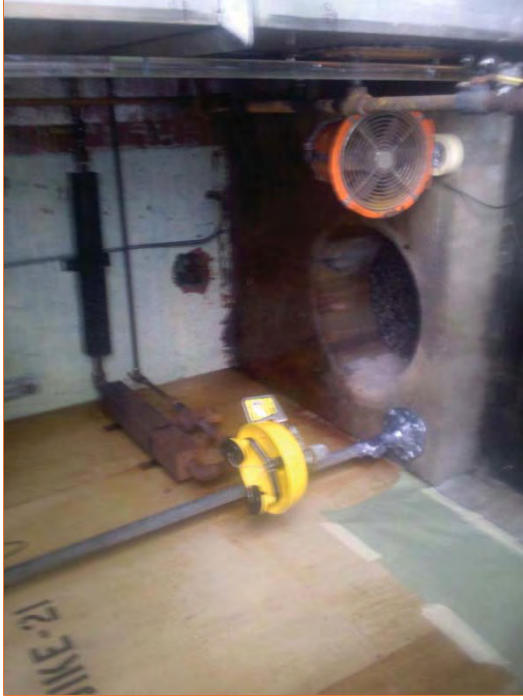
Photo 139. Former Hotwell 4; open pit with various inlet piping

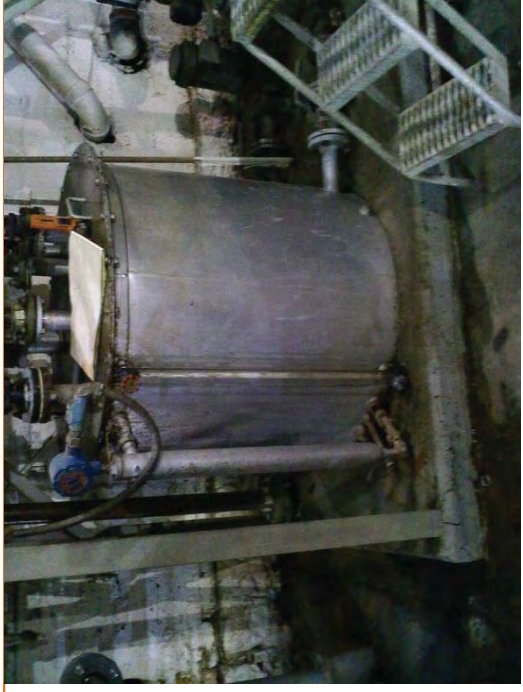
Photo 140. Former Hotwell 4A in S-6 shed outside south wall of Building 4; concrete paved with inlet piping

Note: All former hot wells have either been paved over or replaced by aboveground storage tanks, and are no longer operational. Noncontact cooling water may be discharged at these locations.
