Subject: Gorham Street/AOC C Interim Operations and Maintenance Plan/Periodic Review Report
2014; Former Hampshire Chemical Corp. Site, Waterloo, New York—Site No. 850001A

Interim Operations and Maintenance Plan/Periodic Review Report 2014, Gorham Street Area, Former Hampshire Chemical Corp. Facility, Waterloo, New York

PREPARED BY: CH2M HILL

DATE: January 2015

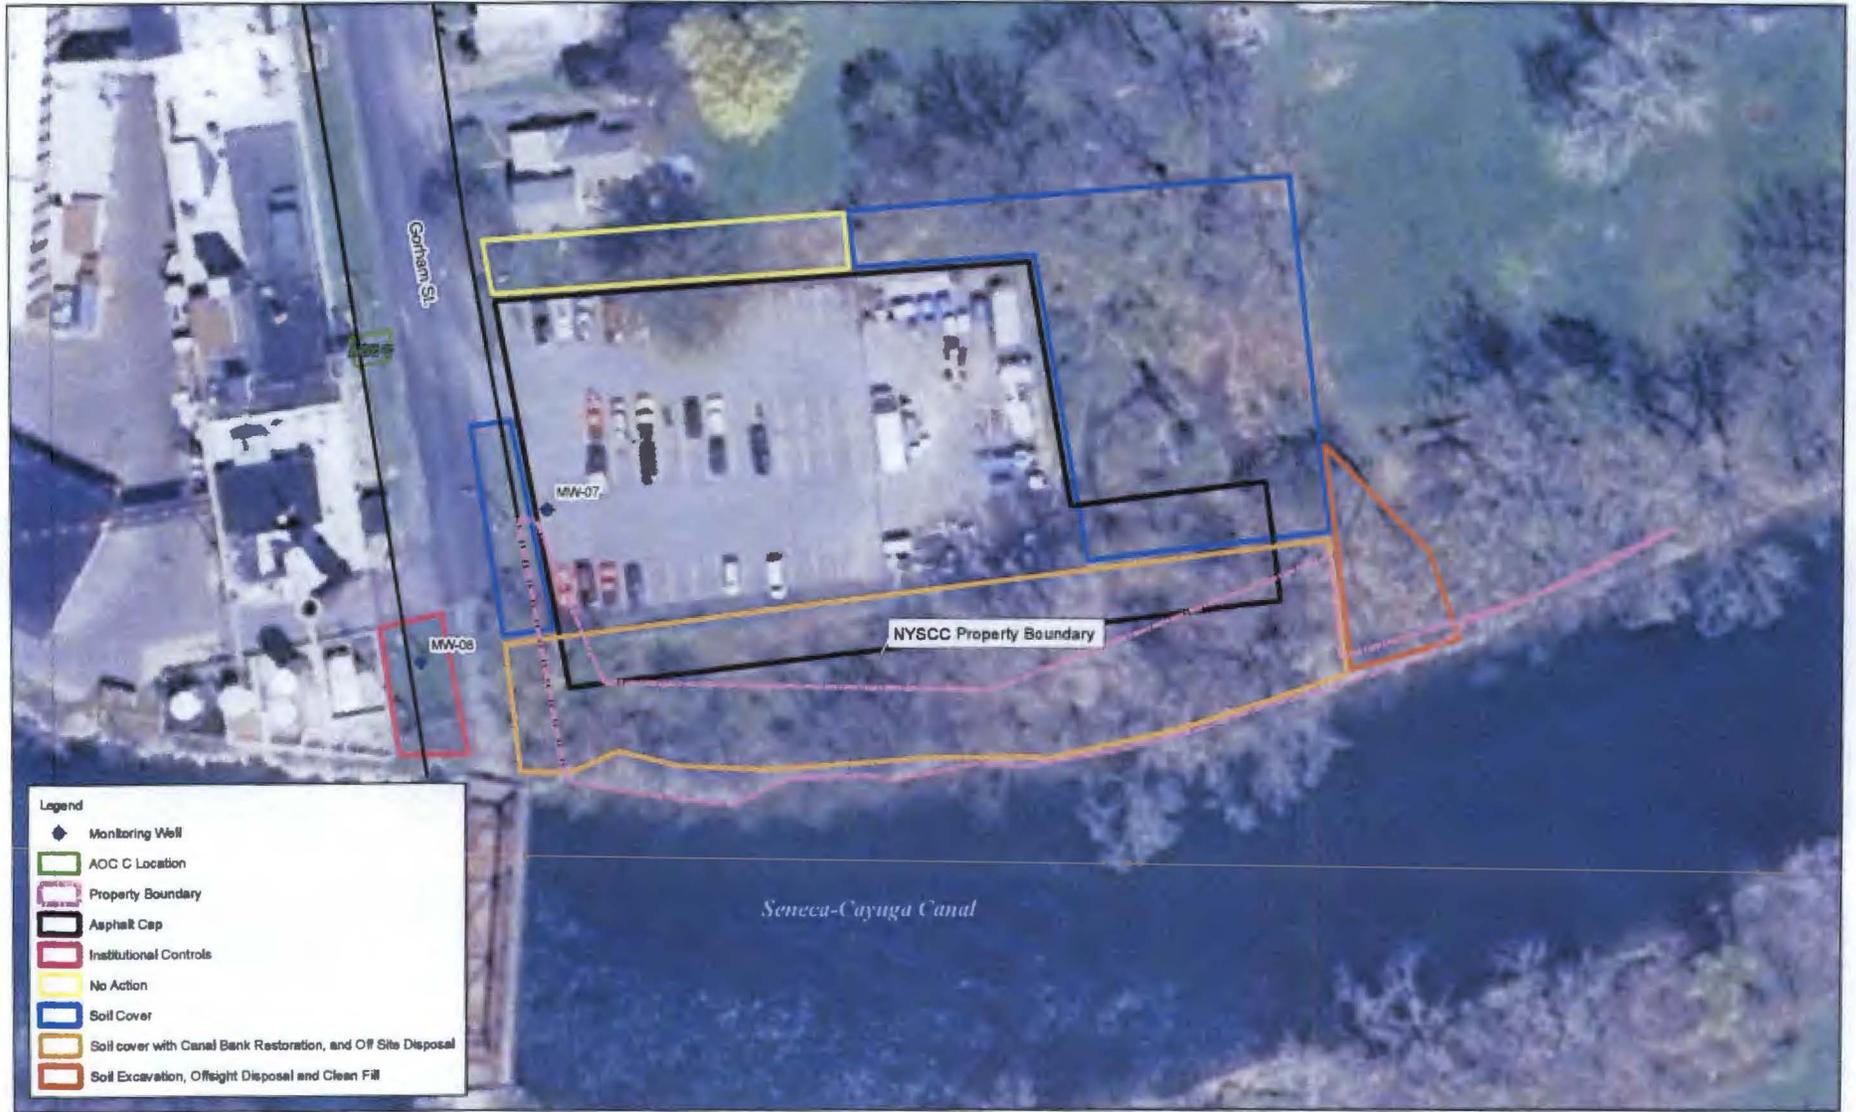
Figure 1
 Interim Operations and Maintenance Plan / Periodic Review Inspection Area
 2014 Periodic Review Report for Garham Street Area
 Former Hampshire Chemical Corp. Facility
 Waterloo, New York
