# 2022 Restoration Monitoring Report

**Penn Yan Former Manufactured Gas Plant Site**  
**NYSDEC Site Number: 862009**

May 2023

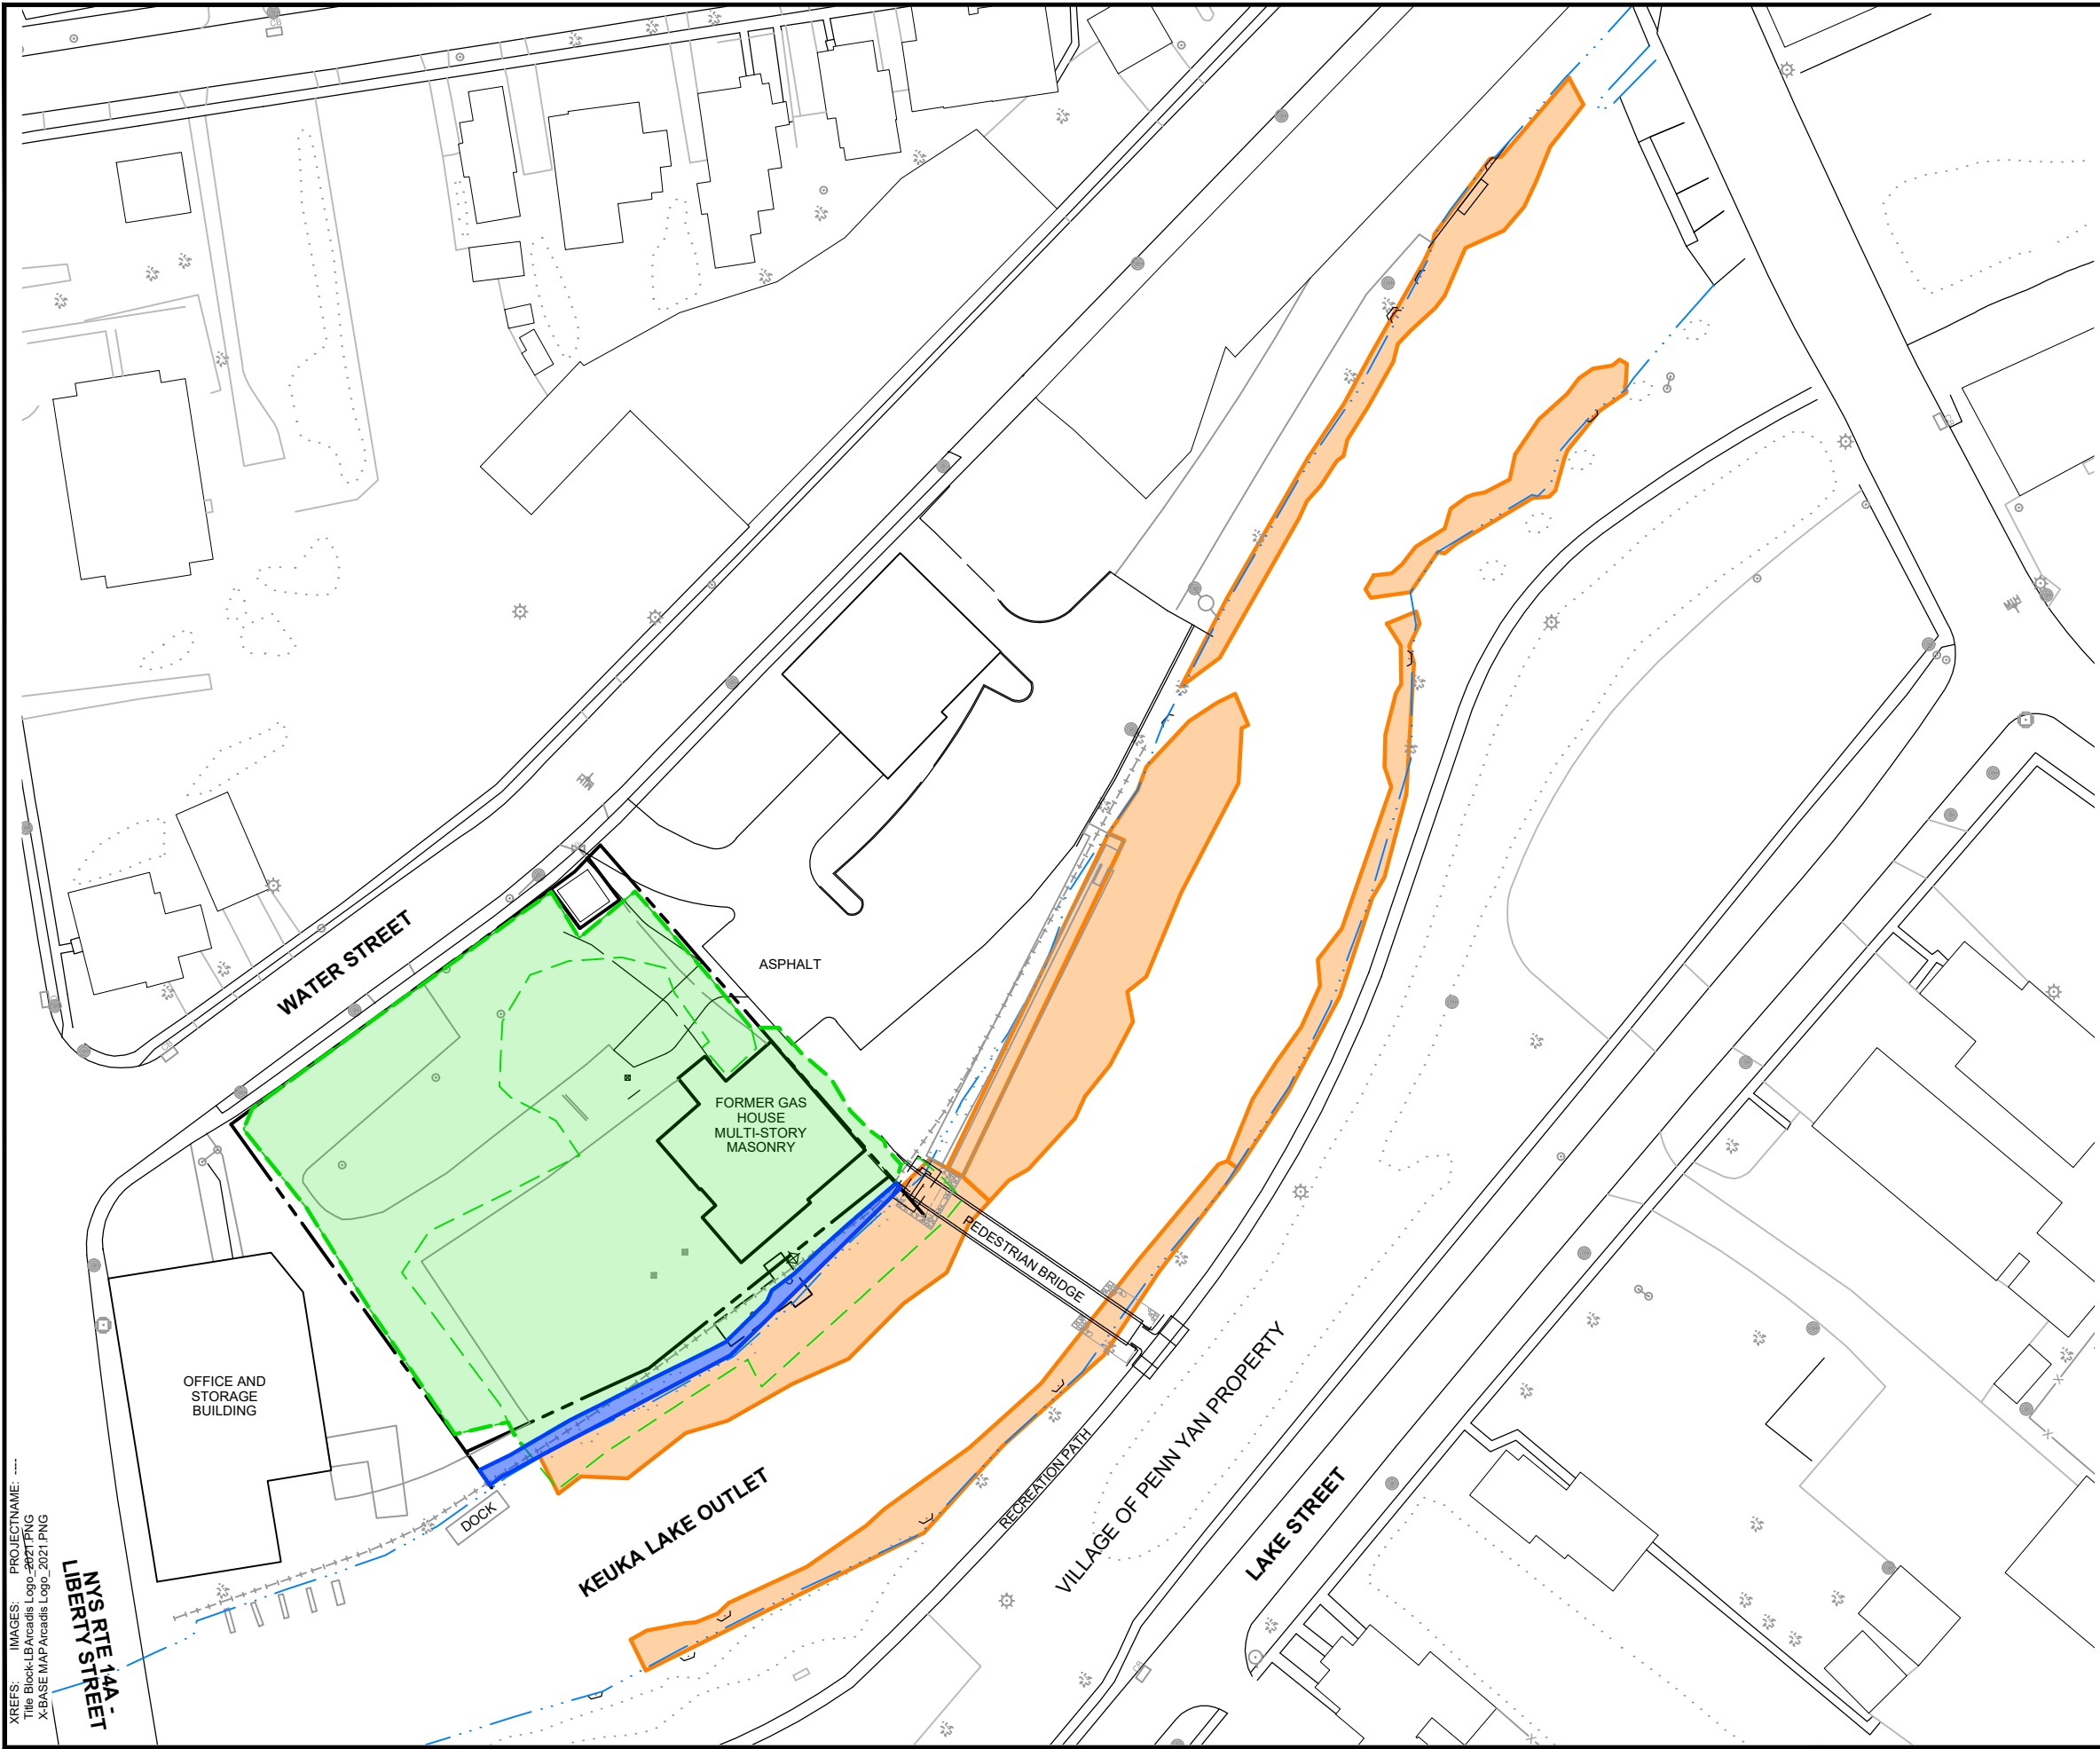
RESTORATION AREAS

In general, the RD (AECOM 2015) required post-remediation vegetative cover material installation to reestablish the upland, bank, and aquatic Site areas shown on Figure 2. The remediation contractor restored the upland on August 21, 2019 and bank September 19-20, 2019 by placing a clean soil layer and applying a riparian seed mix to establish a native vegetation cover. In addition to the riparian seed mix, the bank restoration included planting the following within the approximately 1,800-square-foot area:

The remediation contractor planted SAV and near-shore emergent vegetation beds from June 21 through July 12, 2017, and May 27 to 28, 2020, within six near-shore areas covering approximately 1.7 acres (AECOM 2023). More than 18,000 individual plant plugs comprising five aquatic plant species were installed between 2017 and 2020 and included white water lily (*Nymphaea odorata*), long-leaved pondweed (*Potamogeton nodosus*), common arrowhead (*Sagittaria latifolia*), soft-stem bulrush (*Schoenoplectus tabernaemontani*), and wild celery (*Valisneria americana*). SAV restoration area limits are shown on Figure 2.

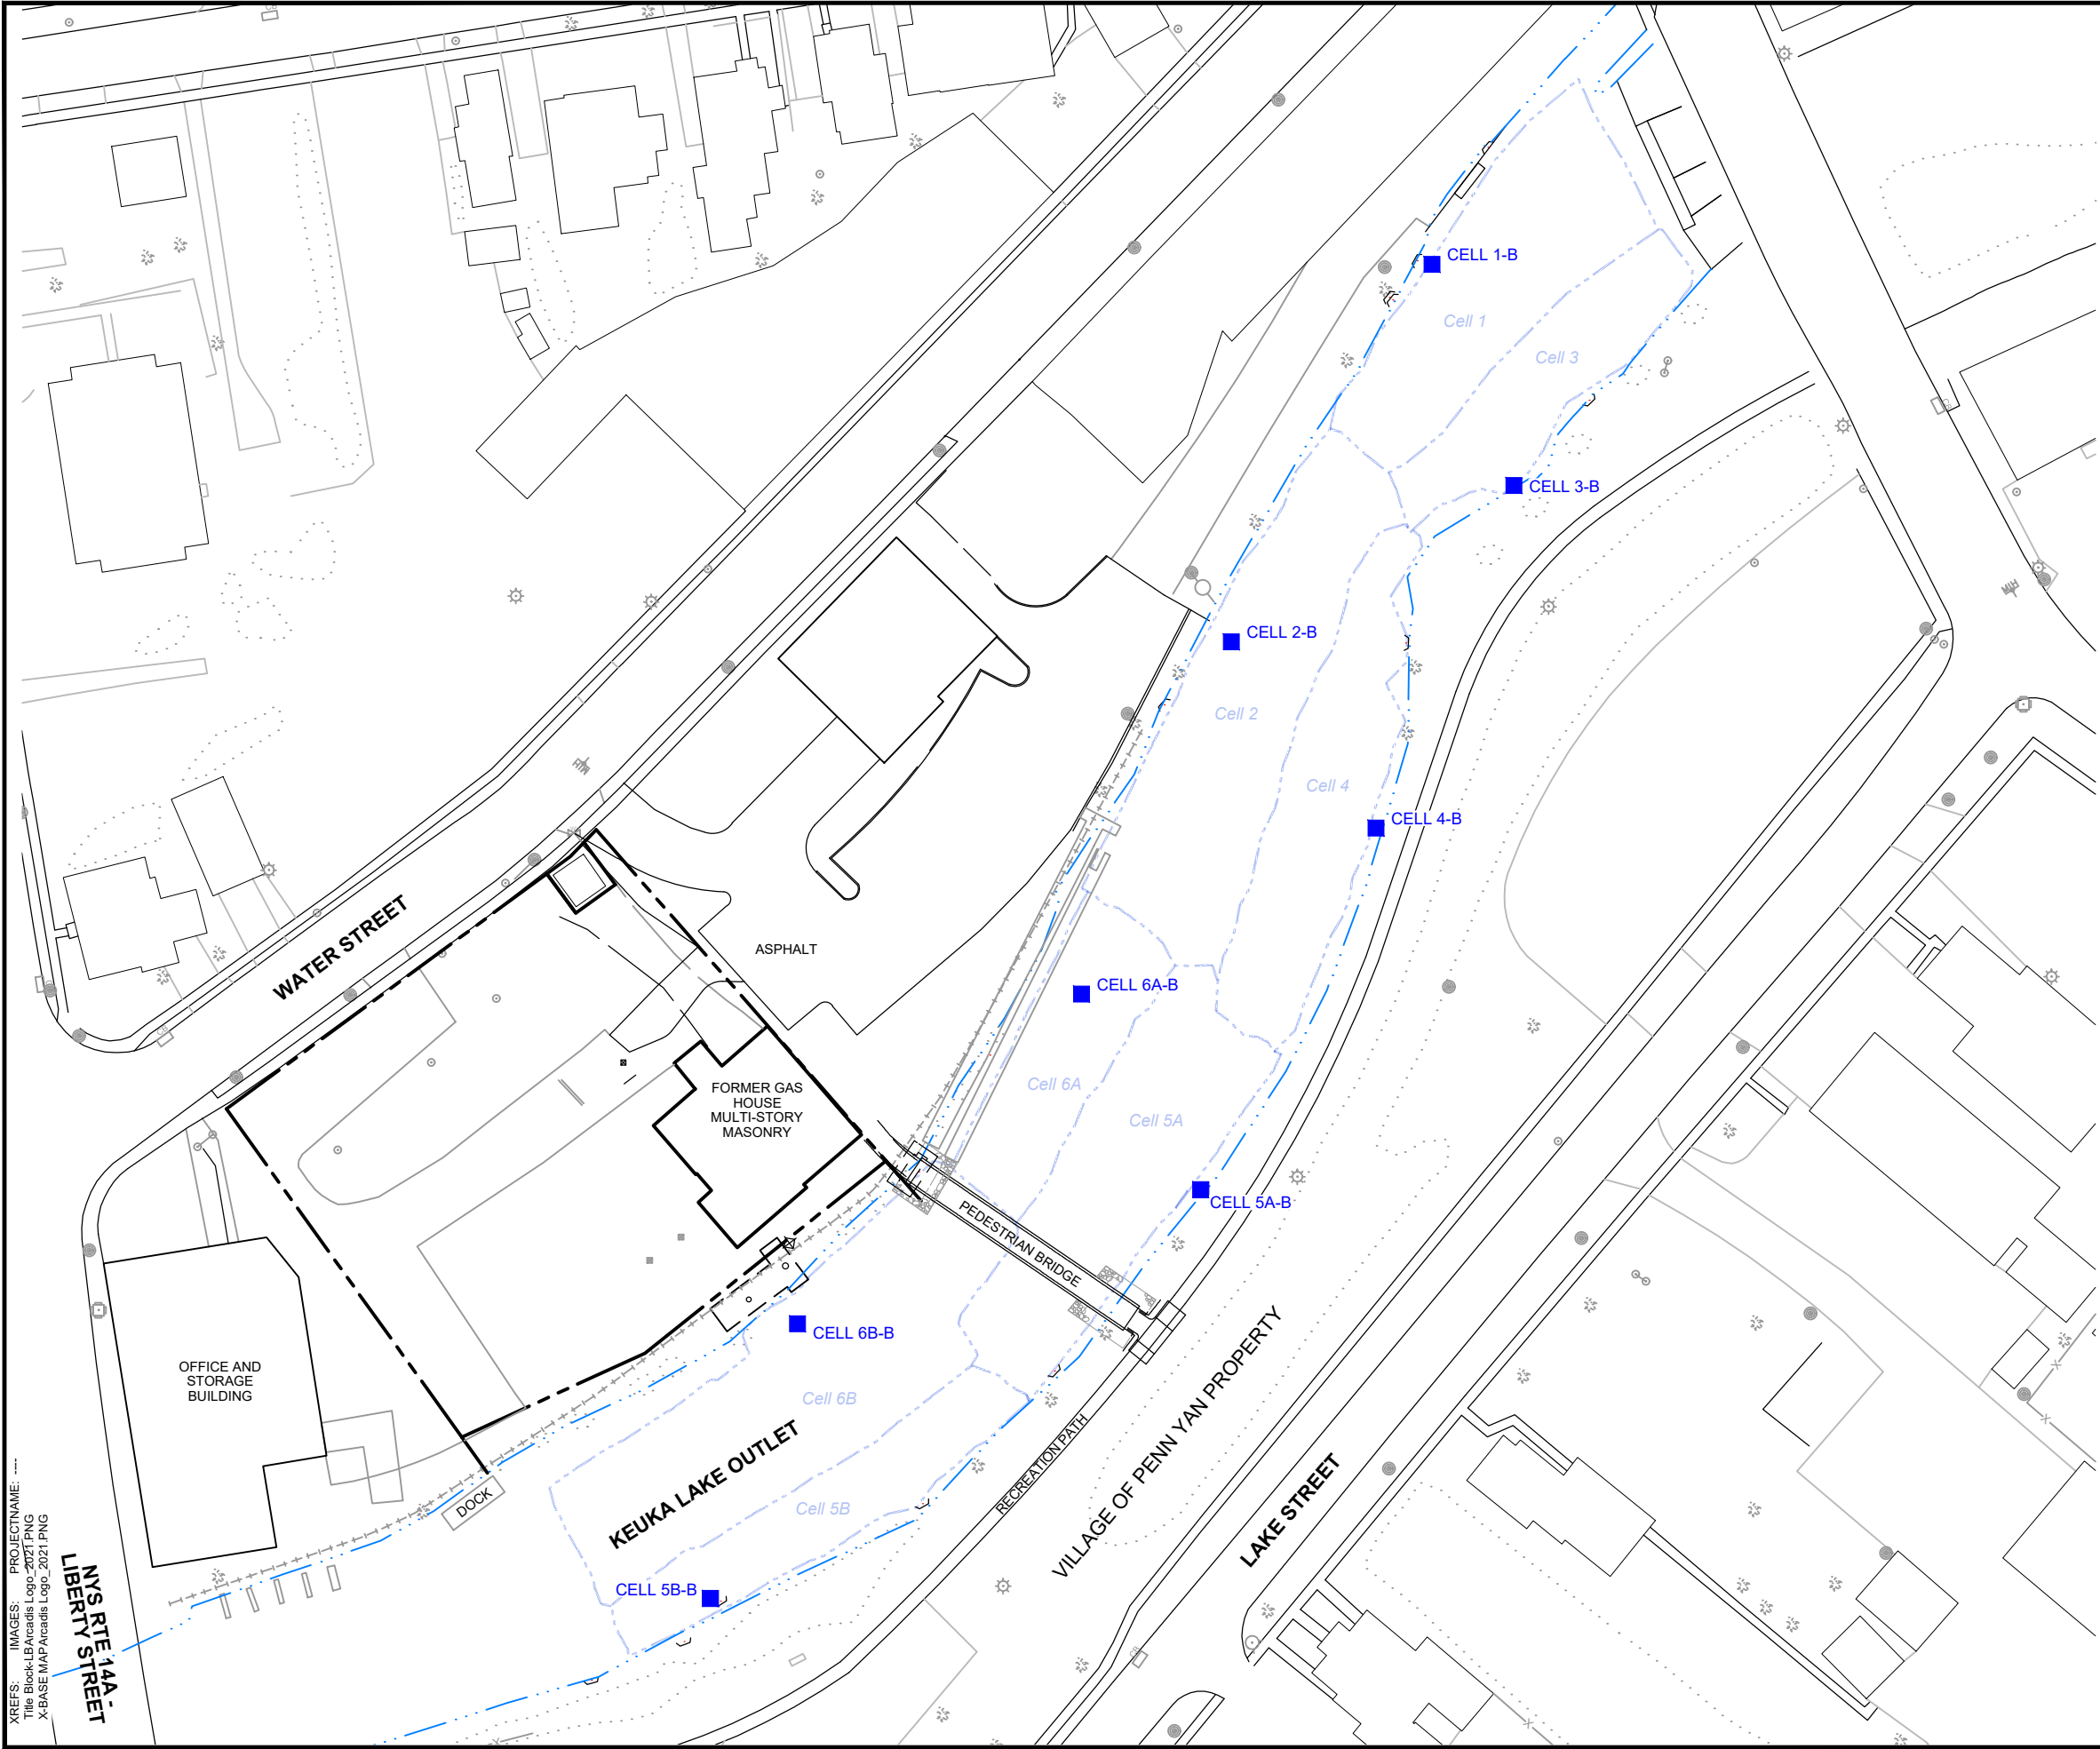
**Figure 4 – 2022 Benthic Monitoring Locations**

Arcadis conducted benthic invertebrate community assessment in each restored sediment cell to determine whether the benthic community had re-colonized after remediation and backfilling. Field personnel collected a representative petite ponar grab sample within each restored sediment cell. Samples were collected in substrates that allowed enough surface penetration to obtain a suitable sample for resident benthic organism taxonomic identification. Sample locations are shown on Figure 4. Samples were sieved and processed in the field, preserved with isopropanol, and sent to Normandeau Associates in Stowe, Pennsylvania, for identification and enumeration.

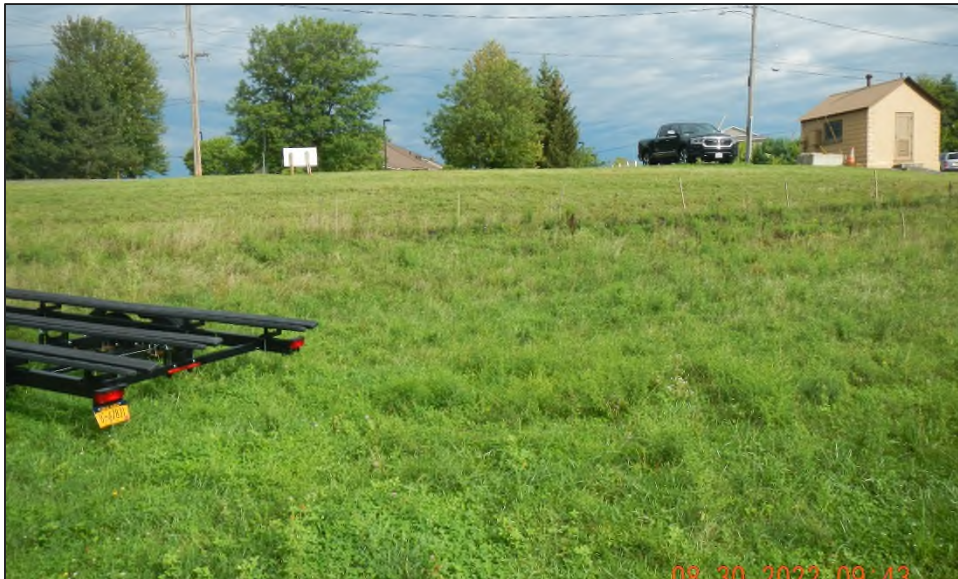
**Photo: 4**

The restored upland area was stable with no observed erosion and exhibited a high vegetative cover spatial distribution. The restored bank area was stable and had a diverse mix of seeded species, along with some remaining planted shrubs within the understory. Three trees planted along the bank were healthy and did not exhibit signs of stress. Similar to the baseline assessment, SAV beds within the Keuka Lake Outlet indicated a diverse native and non-native species community. Invasive Eurasian watermilfoil was observed at a lower frequency/coverage relative to the baseline assessment when it was observed to be a dominant species in most areas identified for remediation. Biological drift from upstream plants within the Keuka Lake Outlet would make it difficult to meet the desired performance standard for invasive aquatic species control. Aquatic life and potential wildlife use is supported by upland, bank, and aquatic restoration areas, which provide in-water shelter and food, along with near-shore vegetation for nesting and cover. Benthic community sampling results indicated that the restored sediment areas have been re-colonized, and the community is similar to what would be expected in lake outlet waters observed in New York State.

- Overseed the upland area. Vegetative cover in the upland area is relatively stable at 90% but is slightly less than the 95% performance standard for this restored area. Overseeding using an upland seed mix similar to the one used during restoration activities should be applied in the fall of 2023, at a rate of 30 pounds per acre, to fill in any thin patches observed. Additionally, spotted knapweed observed in the upland restoration area may require maintenance and control during future visits, as its presence is slightly greater than 5%. This will continue to be monitored and, if needed, manual plant removal during late spring of 2024 will be recommended to target this species.

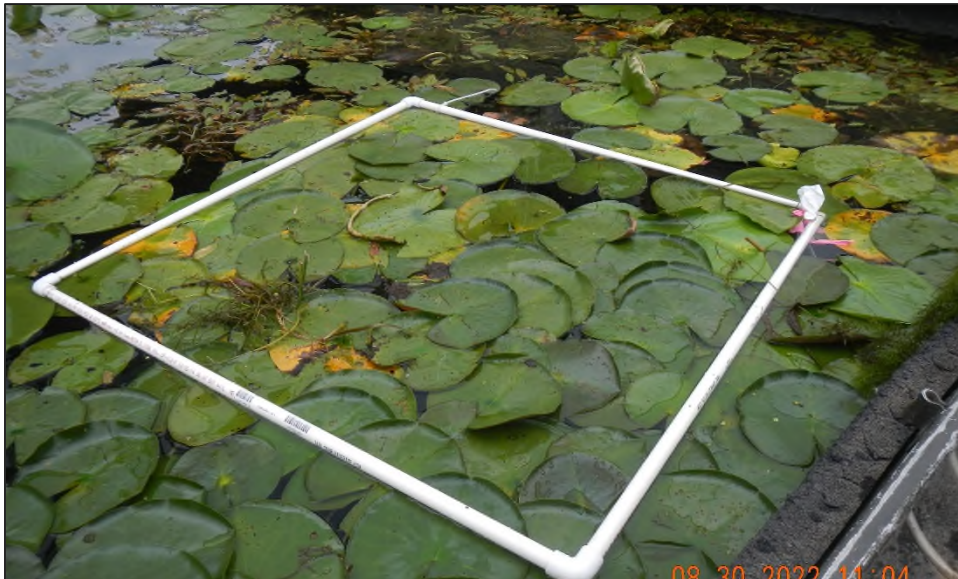
**Photo: 14**

Invasive Eurasian watermilfoil was observed in the restored SAVs. Additionally, invasive starry stonewort may also become established in the restored subaquatic areas as it has been observed in Keuka Lake. Manual pulling or chemical treatments could be used to reduce the invasive plant species' presence; however, this is not recommended at this time due to the risk of continued re-invasion from Keuka Lake and the fact that the invasive species' coverage is less than the coverages observed during the baseline assessment.
