New York State Electric & Gas

2023 Restoration Monitoring Report

Penn Yan Former Manufactured Gas Plant Site
Penn Yan, New York
NYSDEC Site Number: 862009

December 2023

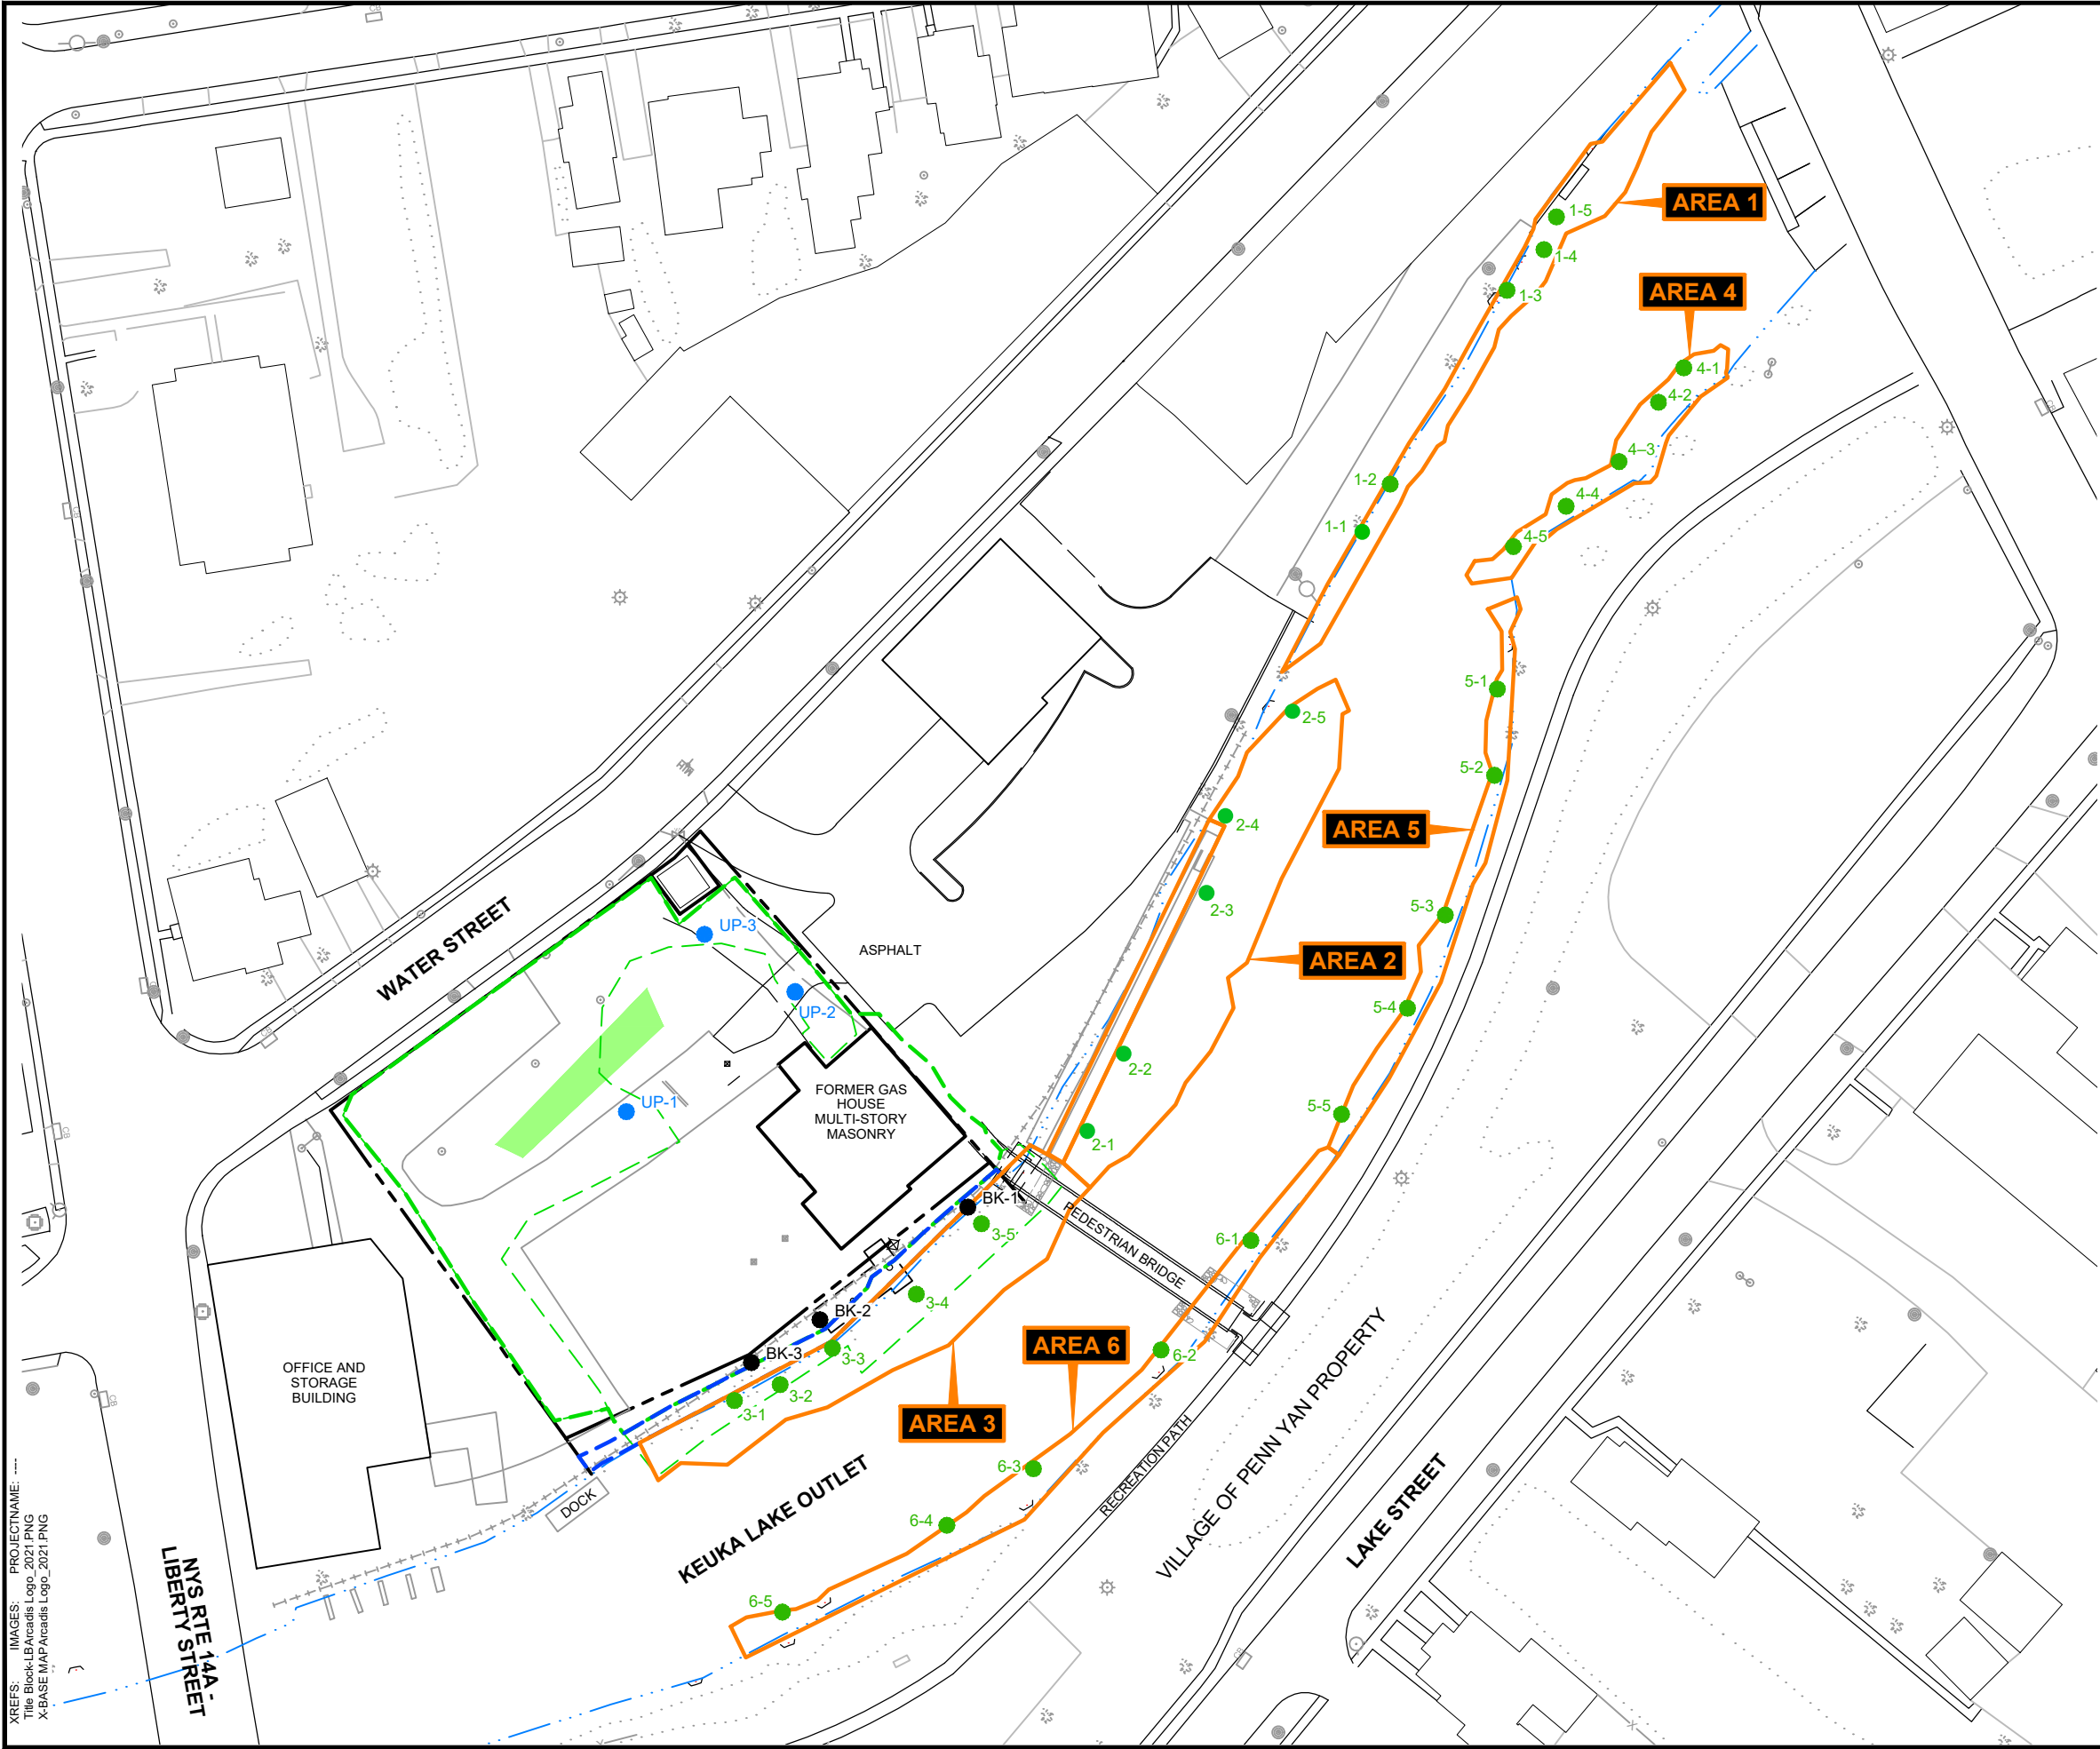
- Arcadis overseeded bare and/or sparsely vegetated portions of the upland area with a native grass seed mix and cover seed on September 6, 2023. Figure 3 shows where seed was dispersed, and Photograph 1 in Appendix A provides a representative view of the reseeded area. The seed mix specified for this upland area included a native mix of warm and cool season grasses suitable for this region. The mix was obtained from Ernst Conservation Seeds and contained 35% big bluestem (*Andropogon gerardii*), 30% Indiangrass (*Sorghastrum nutans*), 20% switchgrass (*Panicum virgatum*), and 15% Virginia wildrye (*Elymus virginicus*). This native grass mix was applied at approximately 28 pounds per acre to overseed, and a cover seed of grain rye (*Secale cereale*) was applied at approximately 60 pounds per acre. The seeded area was approximately 1,160 square feet, and natural straw was applied for protection.
