NEW YORK STATE DEPARTMENT OF
ENVIRONMENTAL CONSERVATION

REMEDIATION SUMMARY REPORT

SOIL EXCAVATION AND SITE RESTORATION PROJECT
VAN DER HORST PLANT NO. 1 SITE
CITY OF OLEAN, CATTARAUGUS COUNTY
CONTRACT NO. D003494
SITE NO. 9-05-008

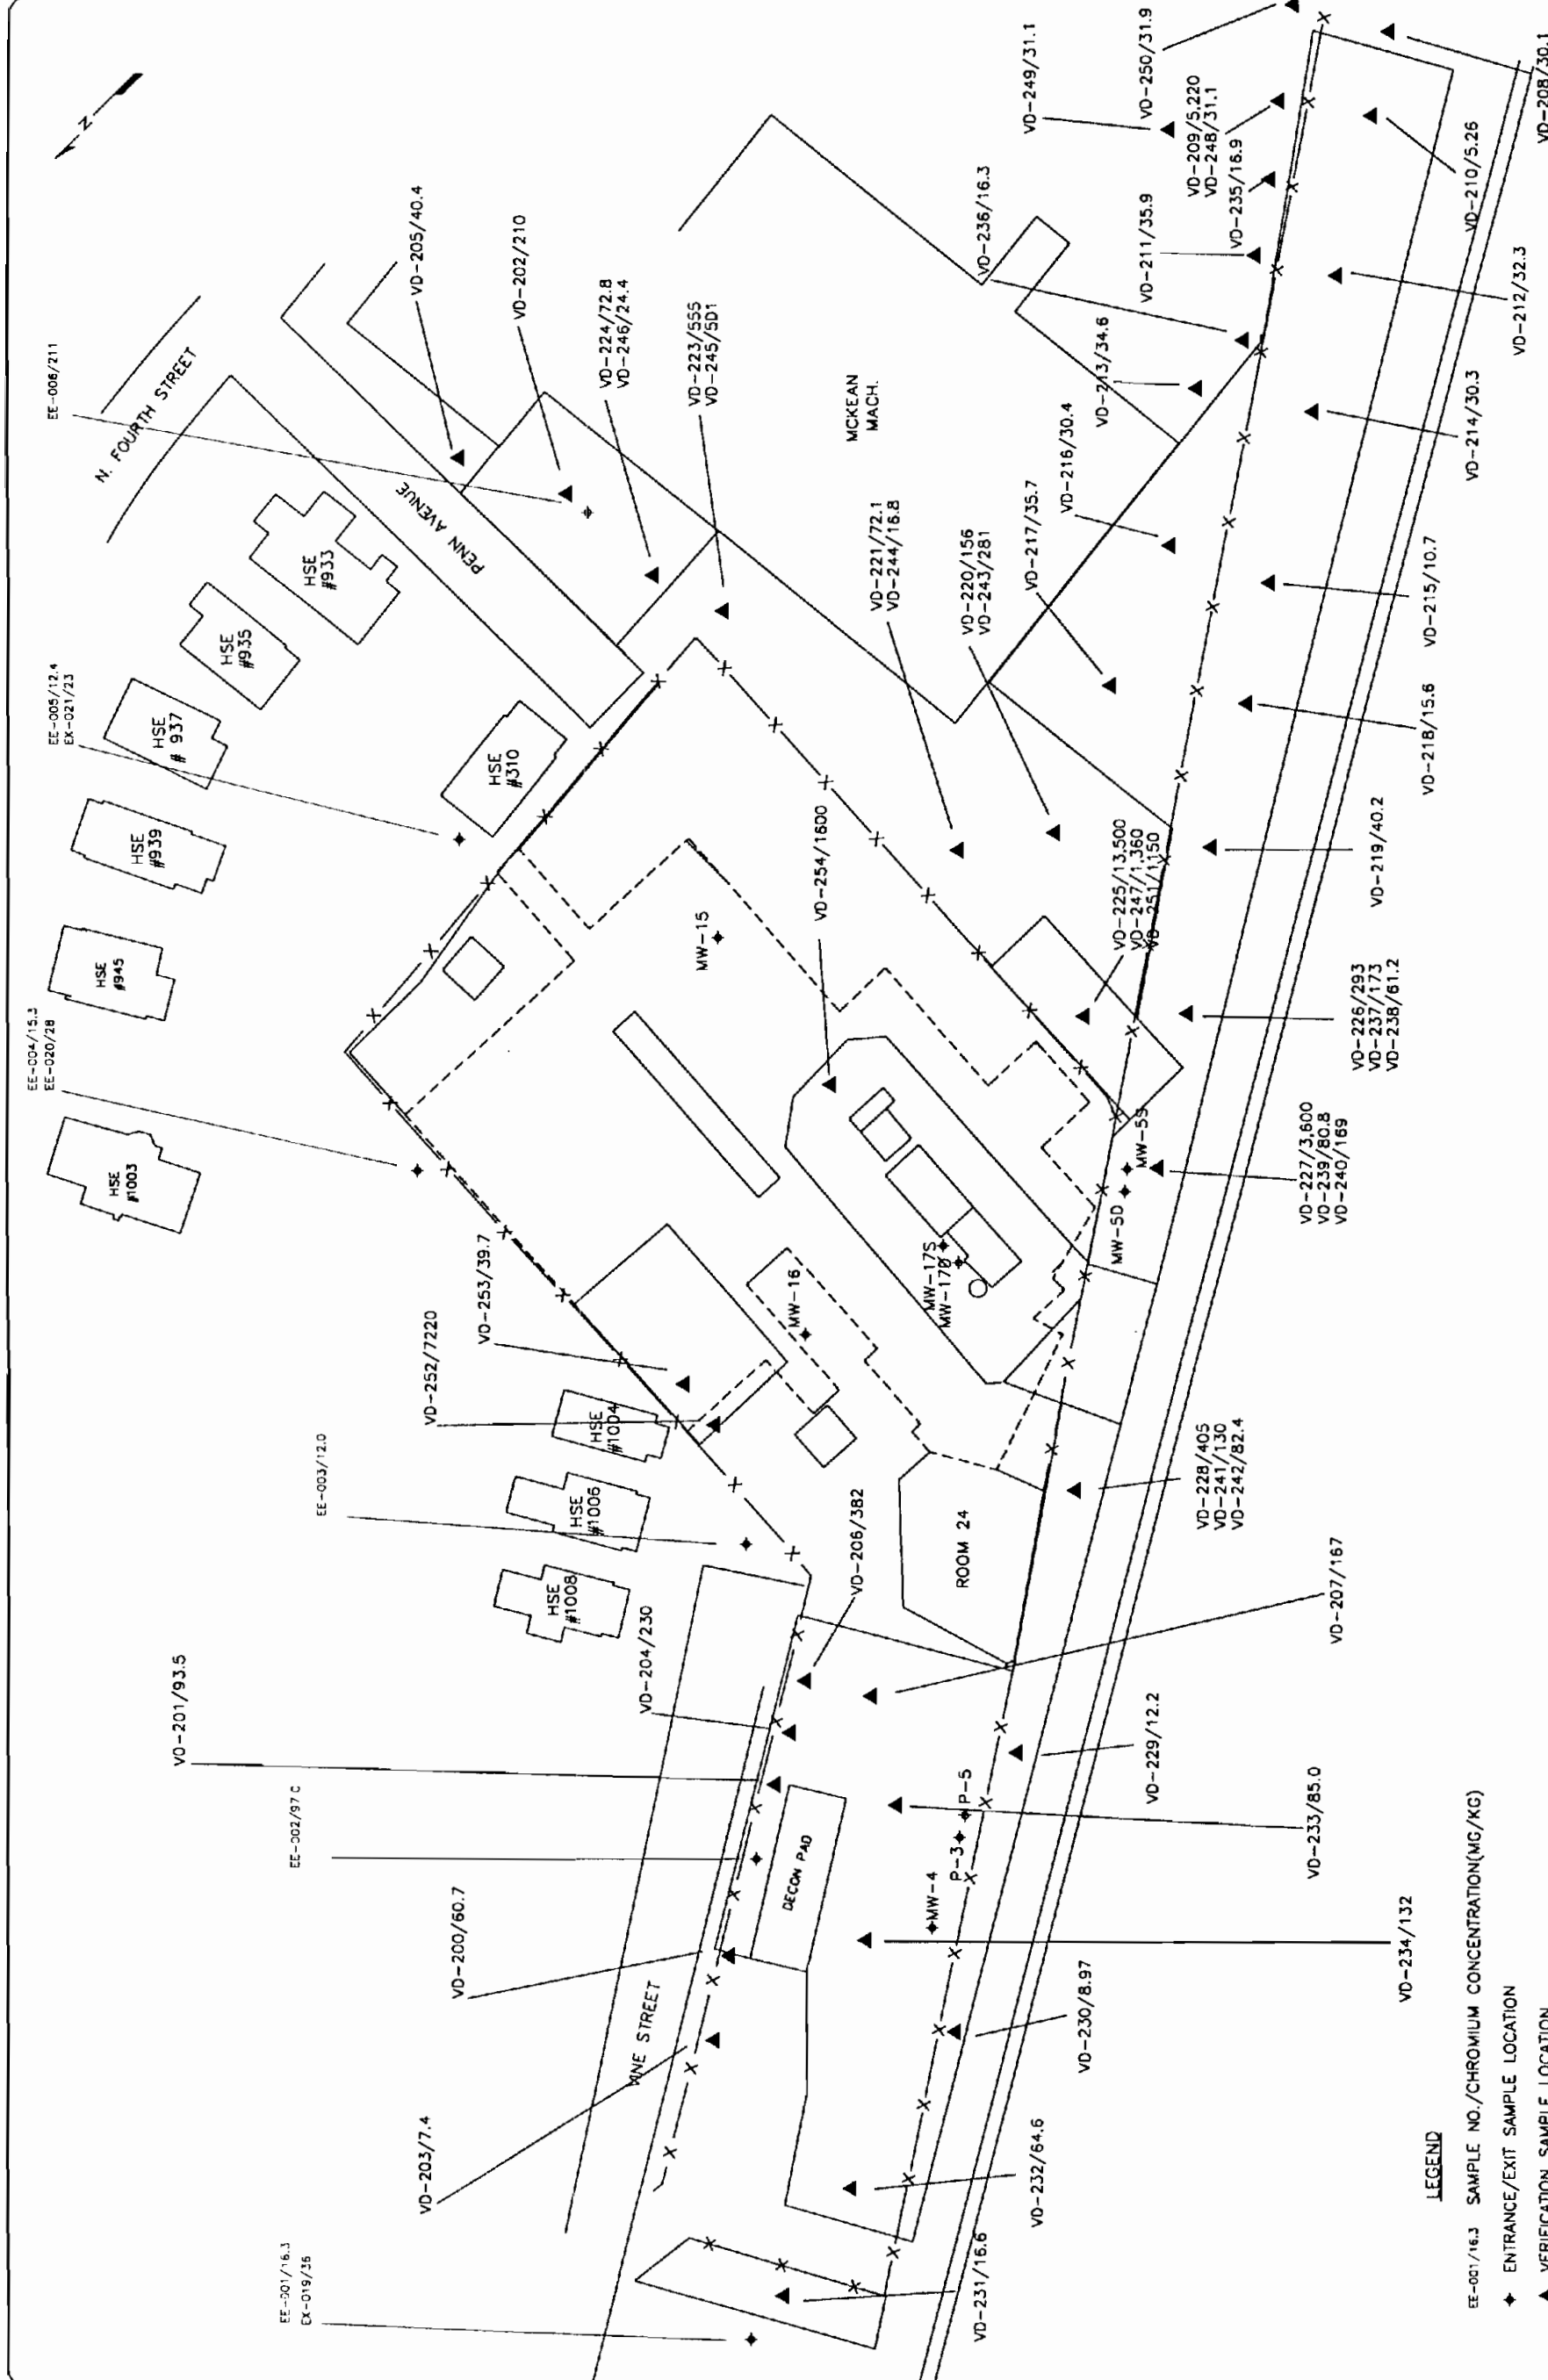
Figure 3

The contractor began the excavations of the dip tank area on December 19, 1996. During this excavation an unidentified concrete vault and a seventh 20" diameter, 35' deep dip tank were encountered (Figure 3).

visually stained, yellow and green, soils in this area. The results found the soils to be hazardous only for lead. Based on this sampling it was visually determined that the surface soils (1 foot deep) within approximately 10 feet of this area were also hazardous and were placed in the hazardous stockpile. Additionally, the remaining portion of a two and four foot excavation between the Monitoring Well 5 area and the Vat area was also visually contaminated (yellow and green staining) and were excavated to four feet and placed in the hazardous waste staging area for disposal. The design cut of seven foot was then completed in this area and the excavation backfilled with common fill (Figure 3).

The excavation of the additional hazardous materials began in the north east corner of the excavation and proceeded to the south and around the original excavation. This additional excavation averaged approximately 15 feet horizontally beyond the original excavation and to a depth of 18 feet below original ground surface (Figure 3).

The soil and concrete removed from area "M" increased from 156 cubic yards with approximately 45 cubic yards hazardous to 260 cubic yards with approximately 120 cubic yards hazardous (Figure 3).
