SITE RECON REPORT

Site Name:	Ischua Landfill (City	Inspector(s)	R. Piurek	Well(s)	Yes	ACCESS ID/	9073/
	of Olean)		(Parsons),			SWID#	05S20
			Steven				
			McDonnell				
			(NYSDEC)				
Address	5420 Airport Road,	NYSDEC DMM	Steven	Seeps	Yes, see	Inactive	N/A
	Olean, NY	Manager	McDonnell		fig.	Register #	
					below		
County	Cattaraugus	Site Contact	Robert Ring	Exposed	No	DER Class	N/A
		Name		Waste			
Decimal (Lat)	42.248377,	Site Contact	716-376-5650	Waste	Industrial	Approximate	8 acres
Degrees (Long)	-78.365391	Number		Type	Waste,	Fill Area	
					Ash,		
					Unknown

Title: Ischua Landfill (City of Olean)

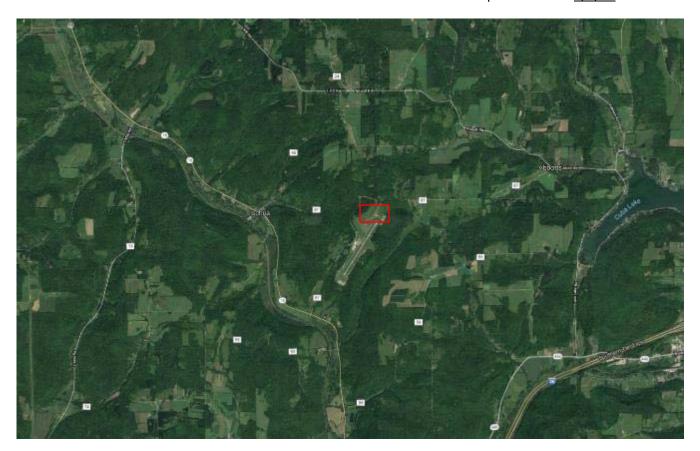
Ischua Landfill Site Plan

Possible leachate seeps (noted by heavy iron floc staining and a visible sheen) were observed at various locations around the perimeter of the landfills. The approximate locations of these leachate seeps are noted on the Site Plan below.
