Re: Consent Order No. 90-105,
Final Report, Wastewater Pond Cleaning

DUNLOP TIRE CORPORATION
BUFFALO PLANT

FINAL REPORT
WASTEWATER POND CLEANING

AS REQUIRED UNDER CONSENT ORDER NO. 90-105 OF THE
NEW YORK STATE DEPARTMENT OF ENVIRONMENTAL CONSERVATION

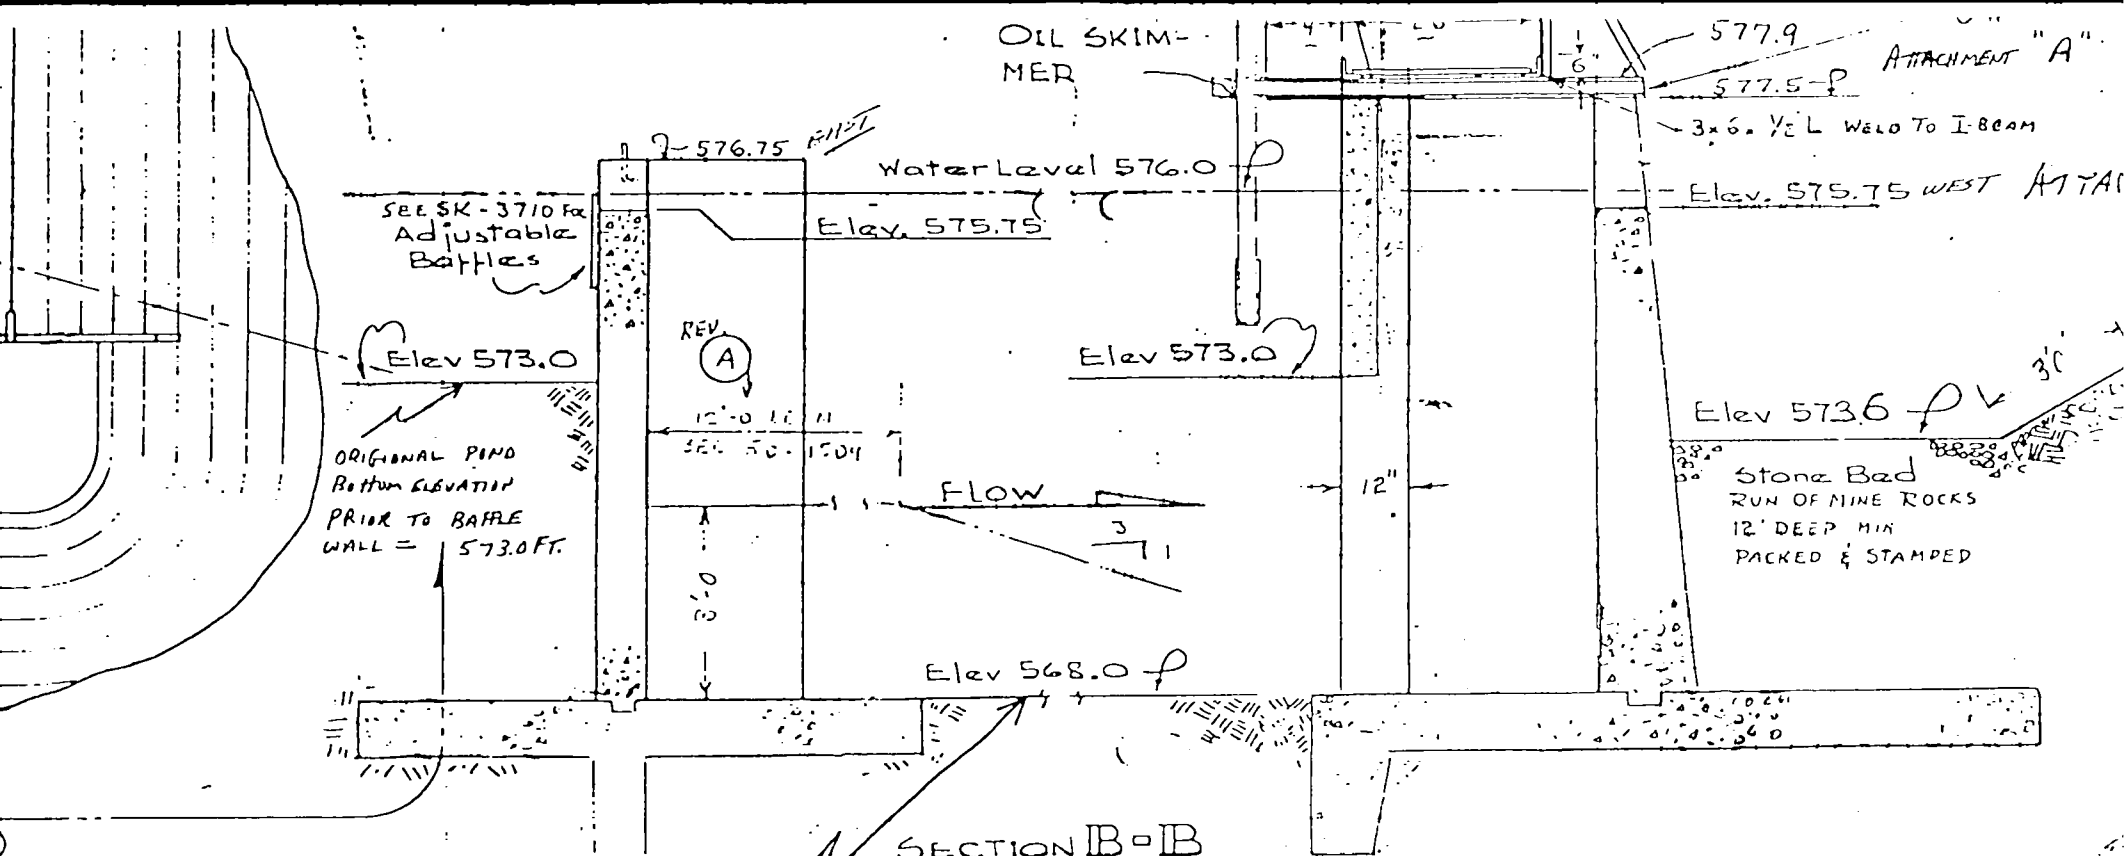
ORIGINAL POND BOTTOM ELEVATION = 568.0 FT.

POND WATER DEPTH IN FEET TO TOP OF SLUDGE BLANKET

Re-establishment of the weir flow baffles was required due to damage to four of the baffles during the remediation process. Dames & Moore were given the report as compiled by Environmental Products and Services and verify that the baffles are reset to original elevations.

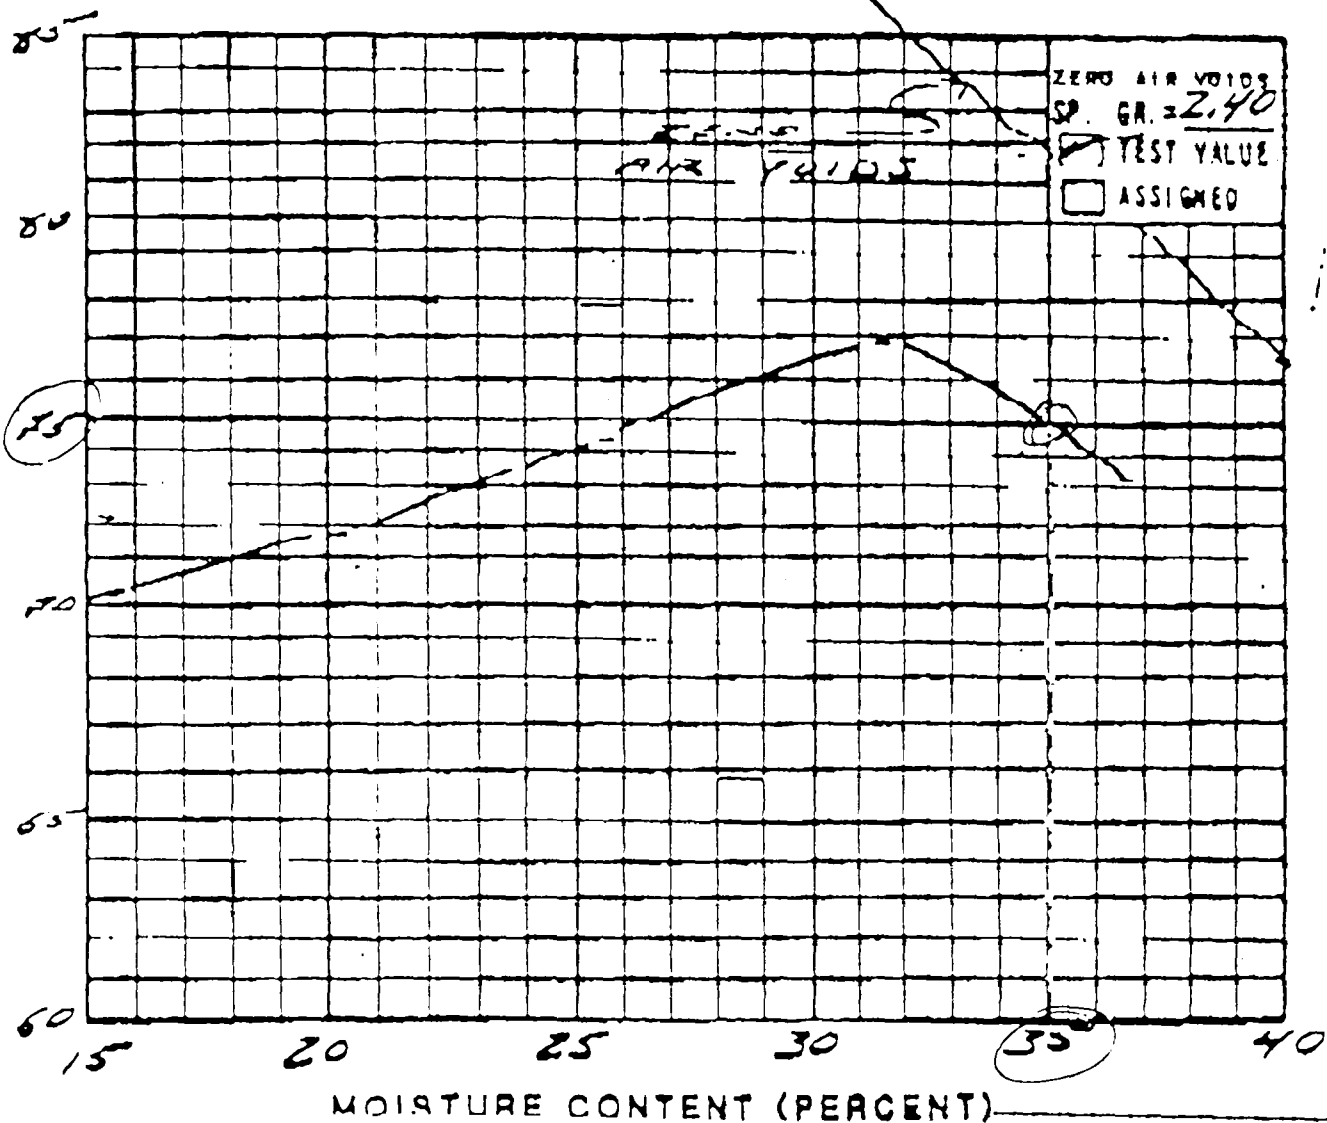
FROM MOISTURE - DENSITY CURVE (ATTACHED) @ 35%
MOISTURE, DENSITY IS APPROXIMATELY 75 LBS/FT³

OPTIMUM MOISTURE CONTENT 34.5

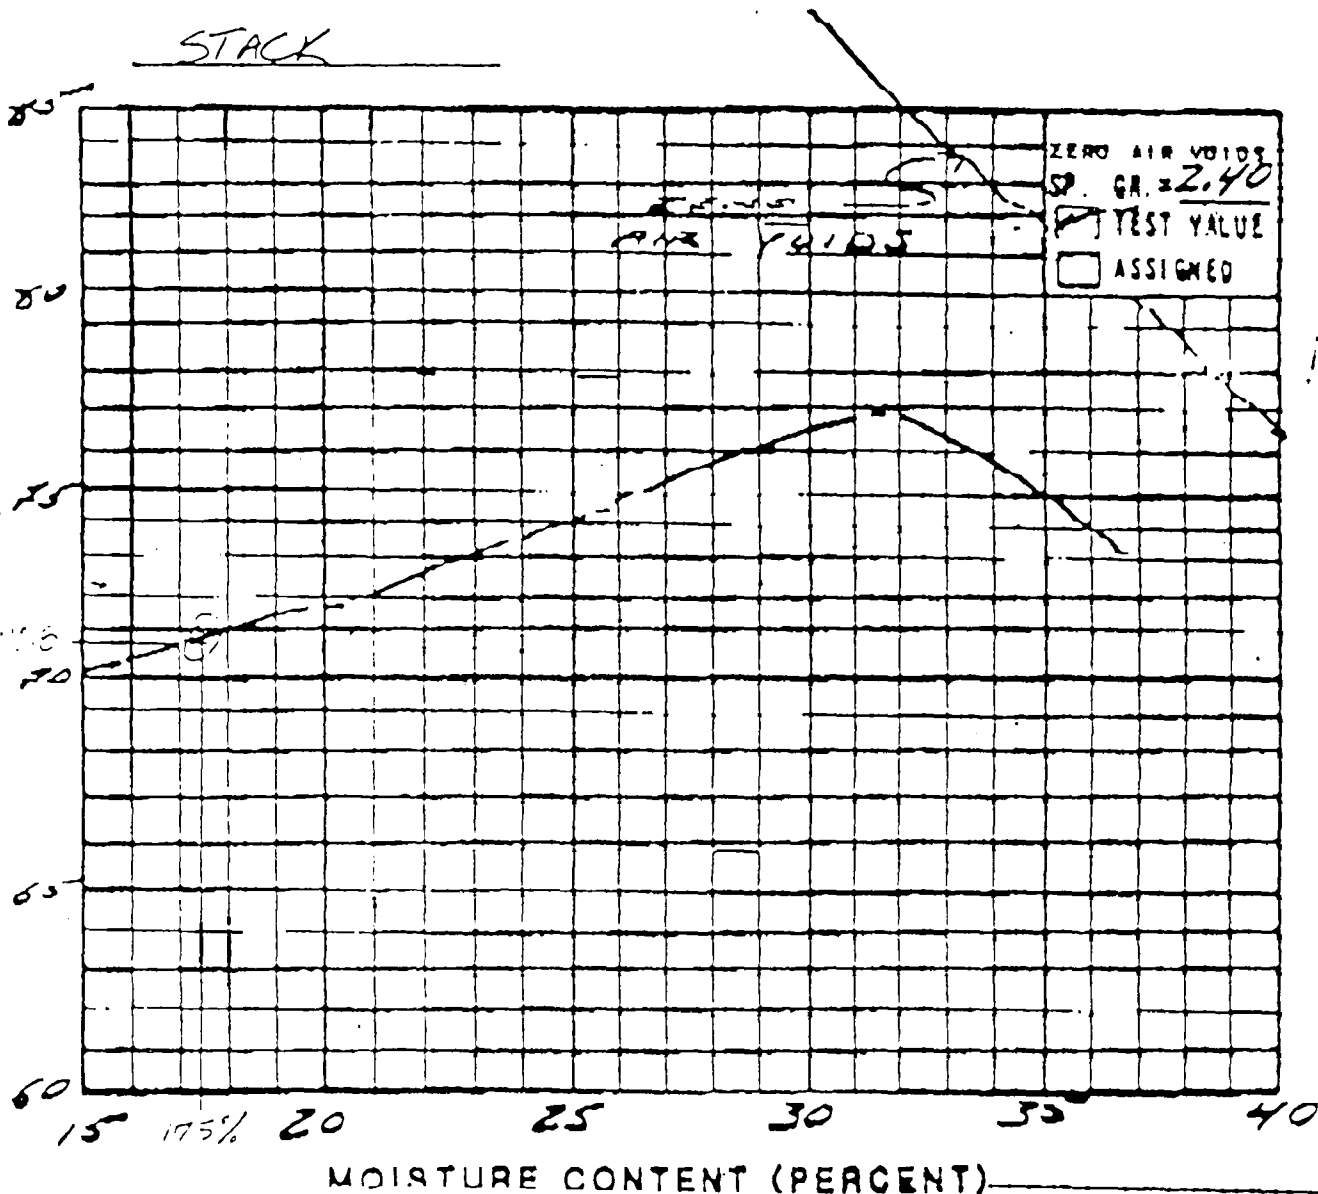
Figure 9

OPTIMUM MOISTURE CONTENT 34.5
