ENGINEERING INVESTIGATIONS AT INACTIVE HAZARDOUS WASTE SITES

PHASE II INVESTIGATION

Ferro Corporation - Electro Division Site No. 915020
City of Lackawanna Erie County

DATE: February 1990

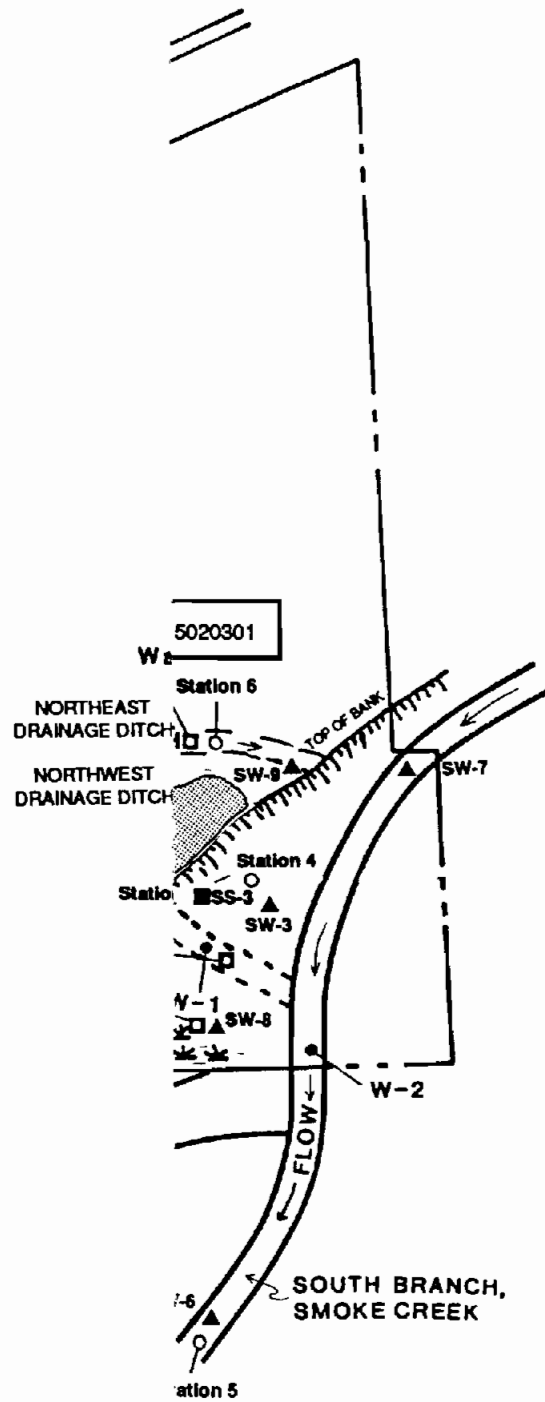
Figure 3-1

**SITE MAP AND PHASE II
SAMPLING LOCATIONS**

Surface water and sediment were sampled at four locations (SW-1, SW-2, SW-4, and SW-5). The samples were collected from each of the four drainage ditches located on or adjacent to the Ferro property (Figure 3-1). SW-1 is located in the northern part of the large ditch on the western perimeter of the property, which is fed by underground drainage pipes from the plant. The SW-1 samples were collected beneath one of the pipes that drain into the ditch. SW-2 is located in a smaller ditch that runs southward across the land-filled area. This ditch was sampled near its beginning, adjacent to the fence on the southwest side of the plant. There are two drainage ditches on the north side of Willet Road: across from the plant and adjacent to the railroad tracks. SW-4 was collected from a lagoon area in the ditch on the west side of the tracks. This ditch was the site of a tar spill observed by NYSDEC in 1981. During a NYSDEC site visit in 1985 oil was observed in the discharge into the ditch. The water in the ditch had a slight sheen on the surface and a strong petroleum odor. SW-5 is located in the ditch on the east side of the tracks. A tan-yellow substance that appeared to be settling out of the water covered the bottom of this ditch. NYSDEC observed this substance during 1985 and 1986 investigations. The SW-5 sediment sample was taken from this material.

SS-4 is sited near several old tanks between the fence and the large drainage ditch on the western perimeter of the property (Figure 3-1). Some of the soil appeared to be oil-stained. A composite sample of the surface soil around the tanks was collected with a stainless steel spoon. The soil was composed of clay and silt with some sand and fragments of woody material and fill.

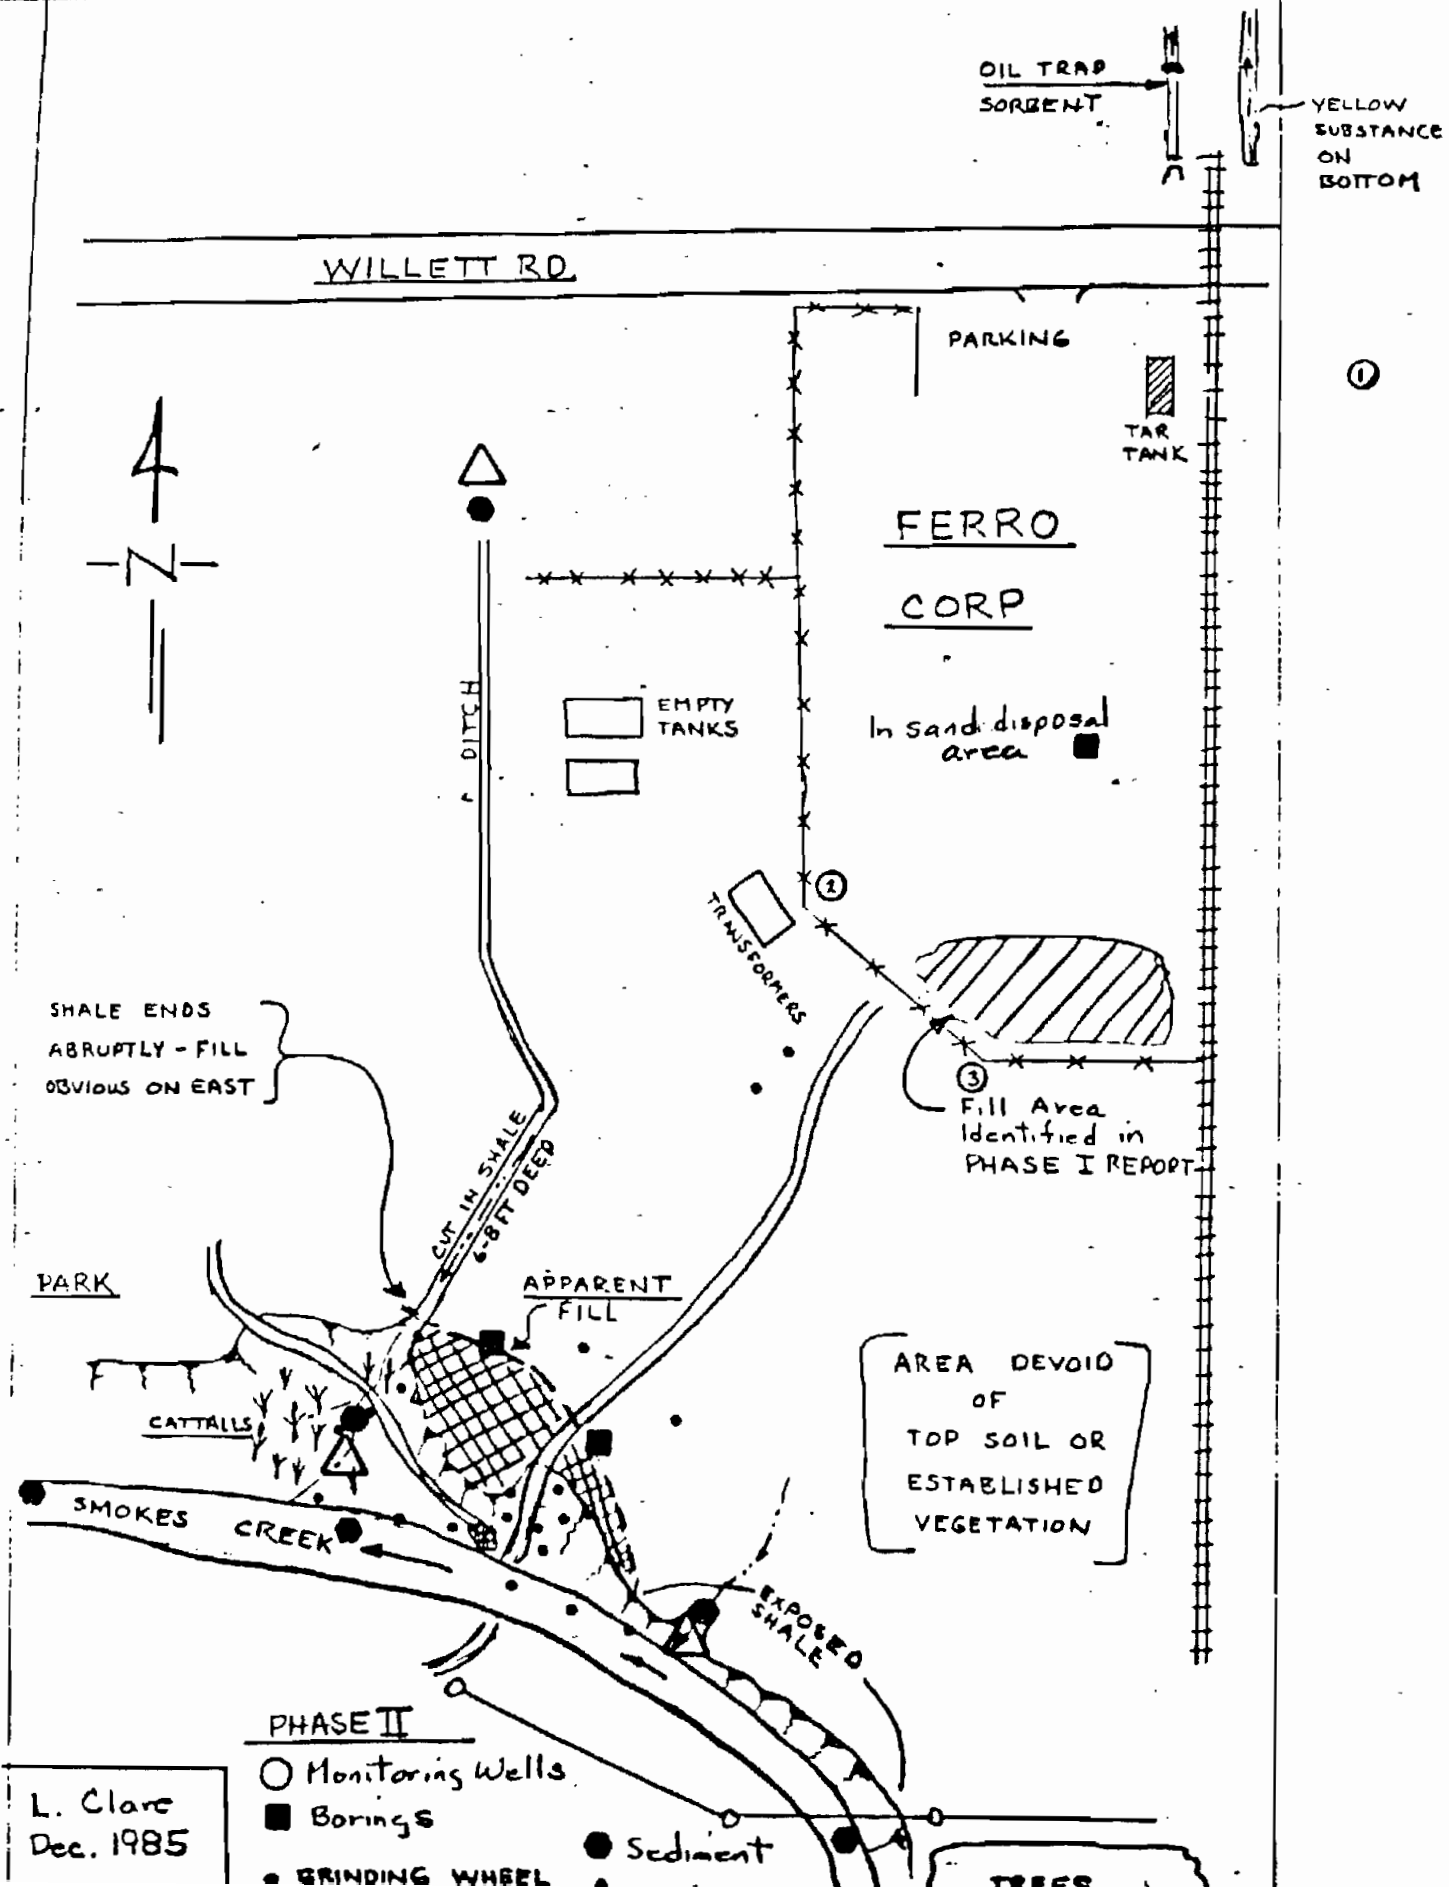
SKETCH NO 2

X SAMPLING SITES
