PERIODIC REVIEW REPORT
REPORTING PERIOD: JANUARY 31, 2022 THROUGH JANUARY 31, 2025

12975 CLARENCE CENTER ROAD
AKRON, NEW YORK
NYSDEC SITE NO. 915053

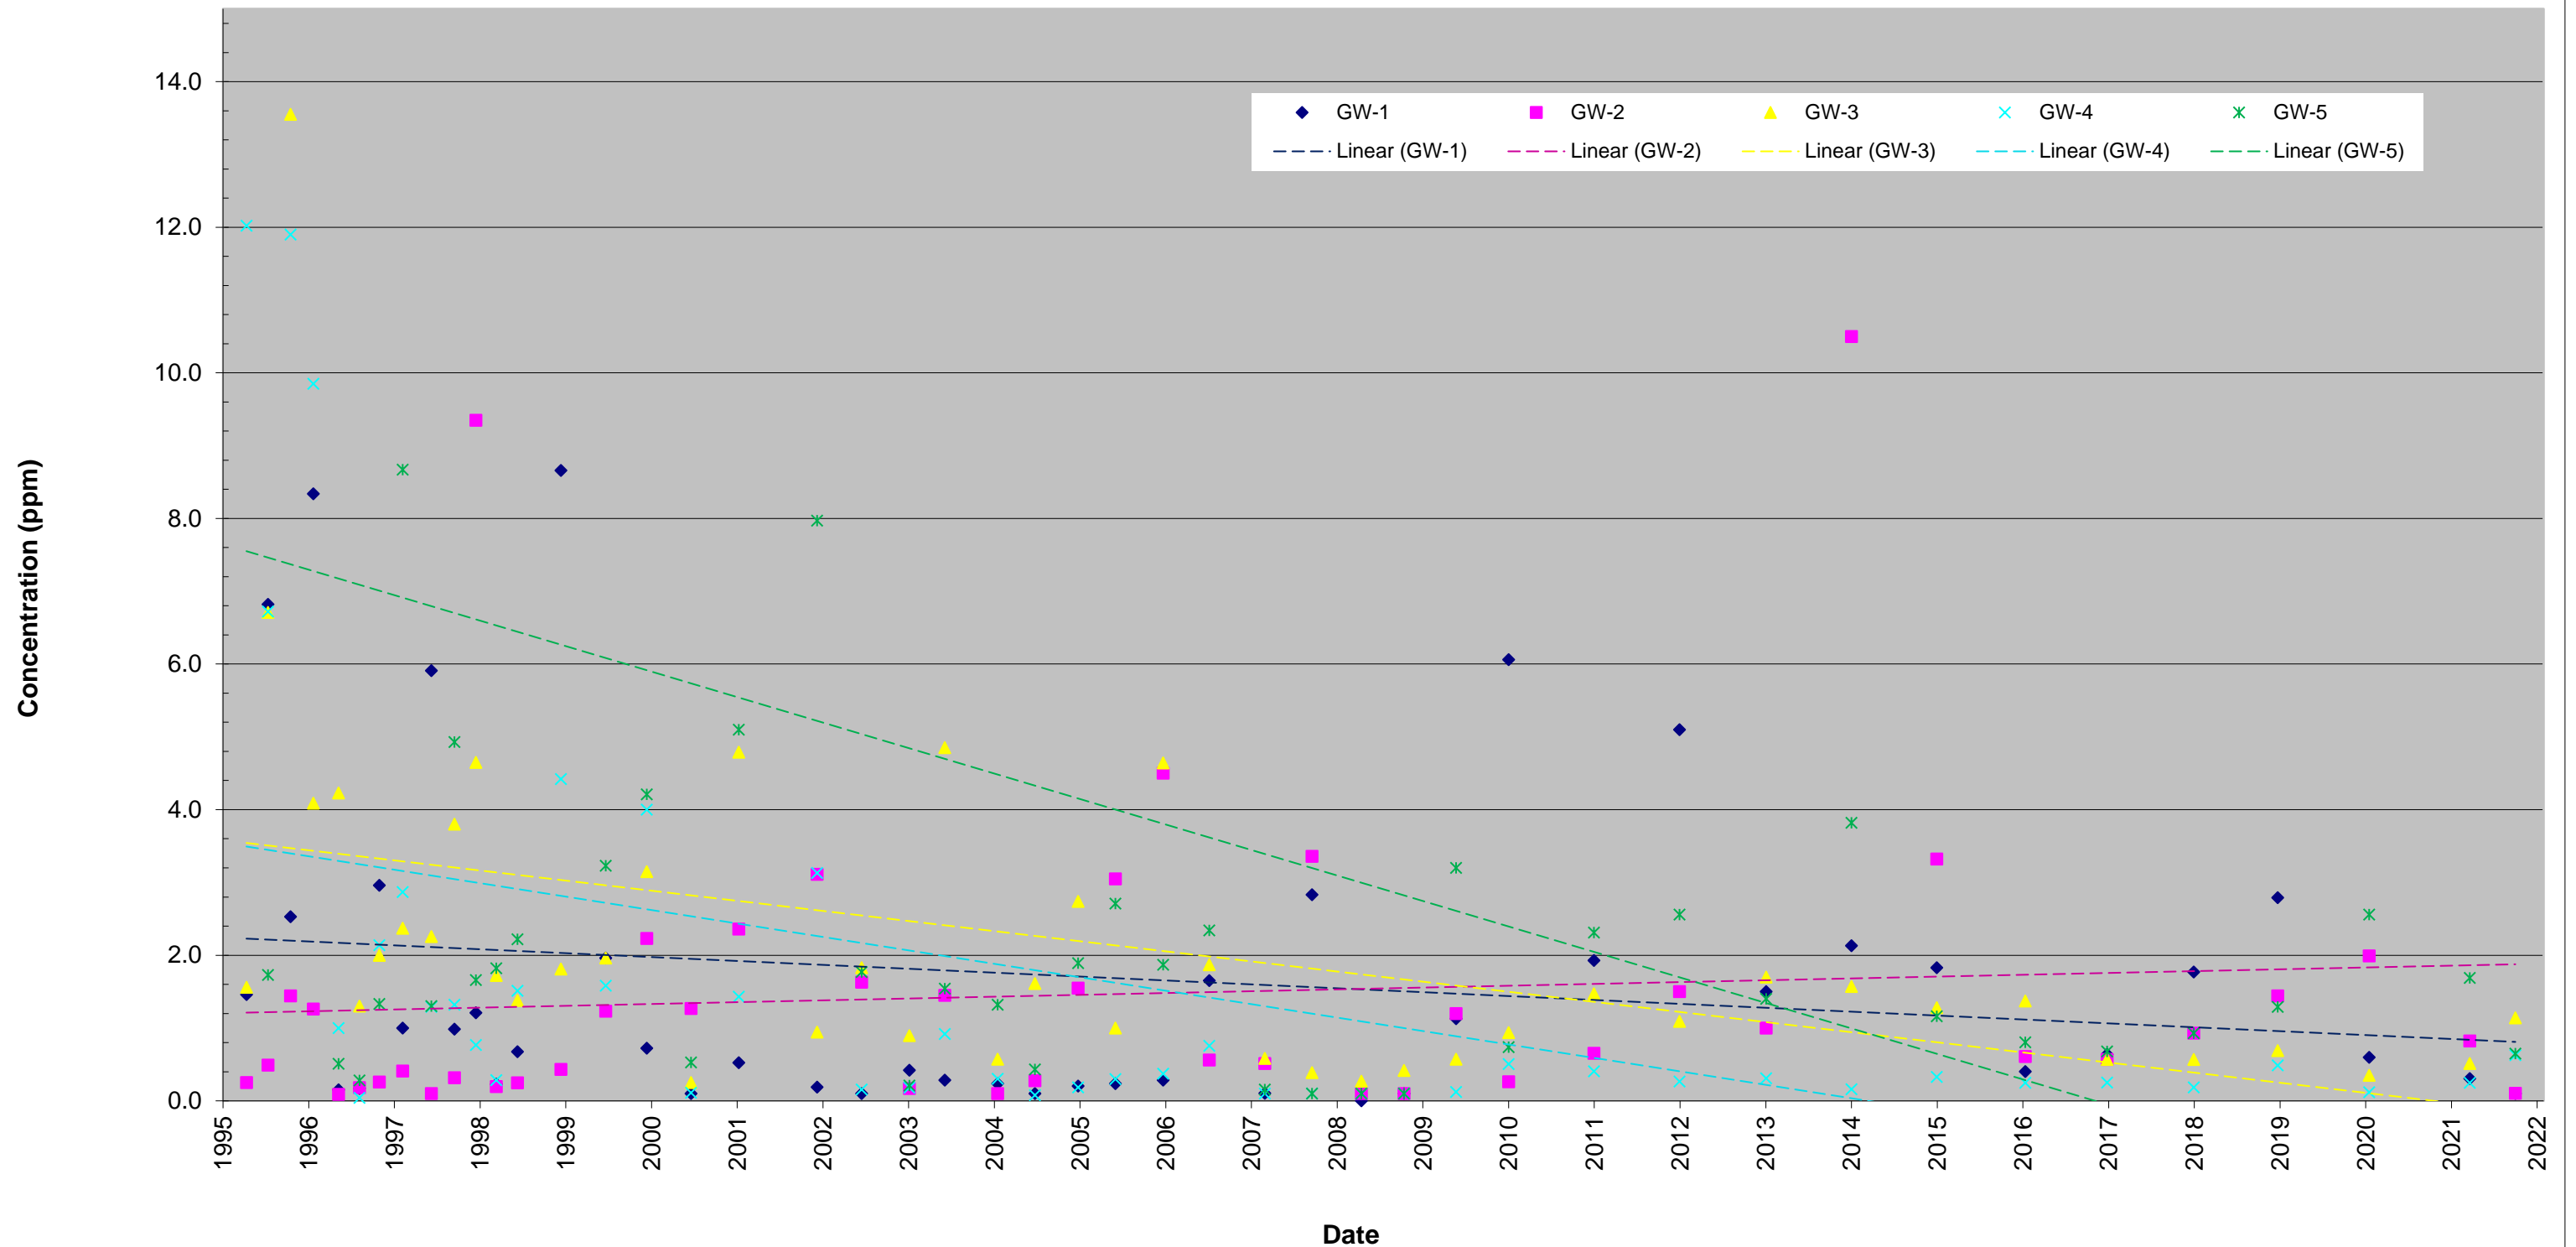
Figure 4

As indicated by Figure 4, a decreasing trend is apparent in the concentrations of total iron measured in downgradient monitoring wells between April 1995 and October 2021.

Summary of Detected Iron (total) - Groundwater Samples - April 1995 through October 2021 - and Linear Interpolation of Long-Term Trends

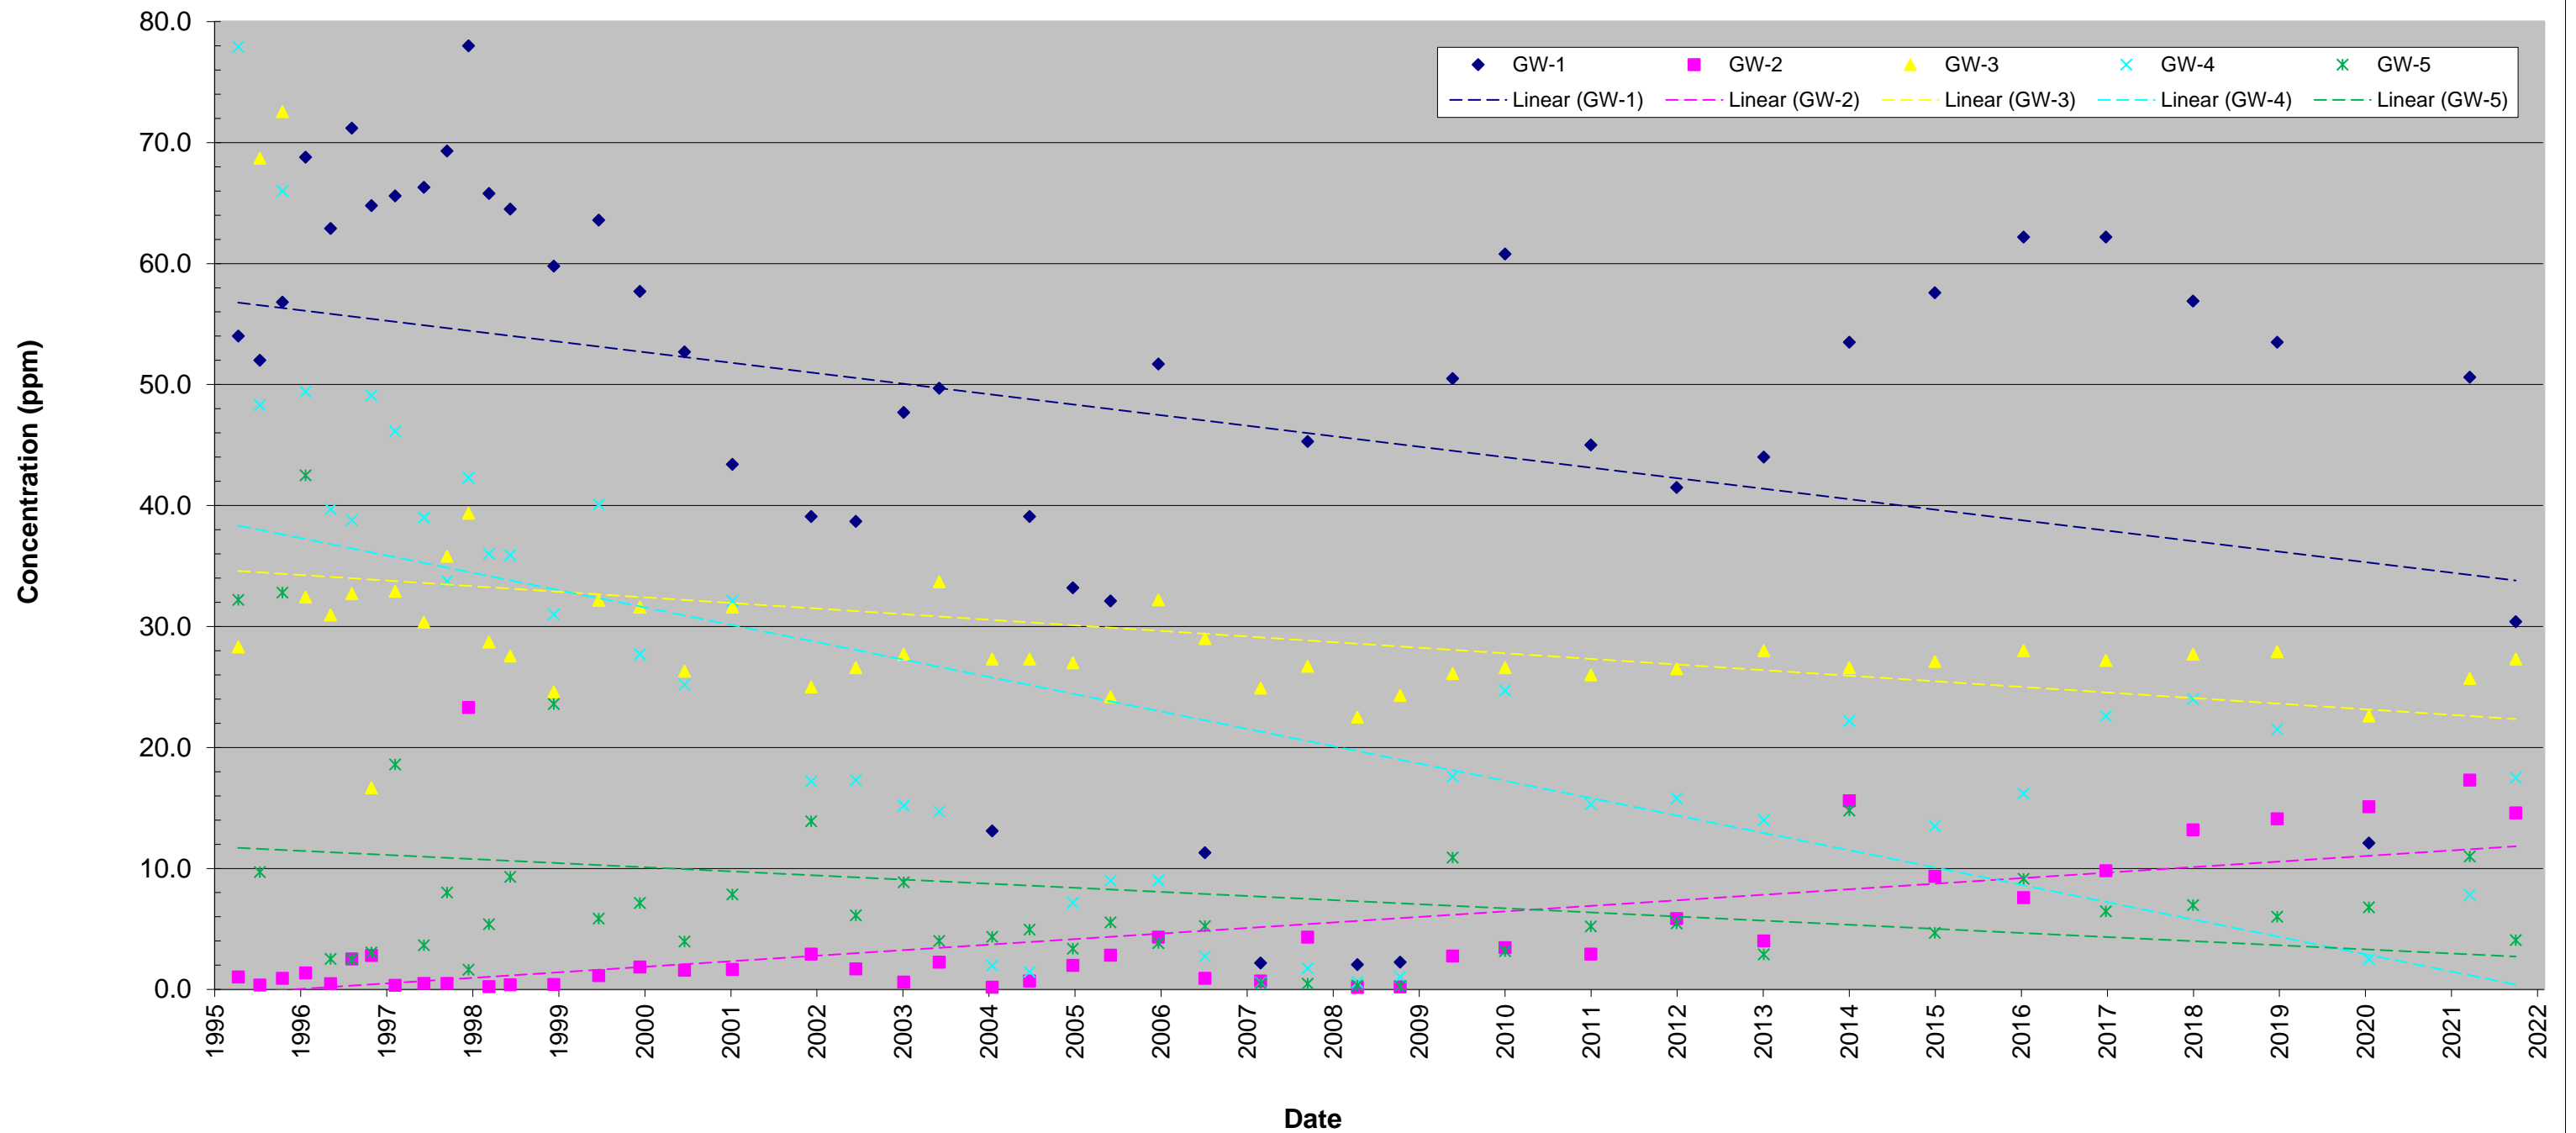
Figure 5

As indicated by Figure 5, a decreasing trend is apparent in the concentrations of total magnesium measured in downgradient monitoring wells between April 1995 and October 2021.

Summary of Detected Magnesium (total) - Groundwater Samples - April 1995 through October 2021 - and Liner Interpolation of Long-Term Trends

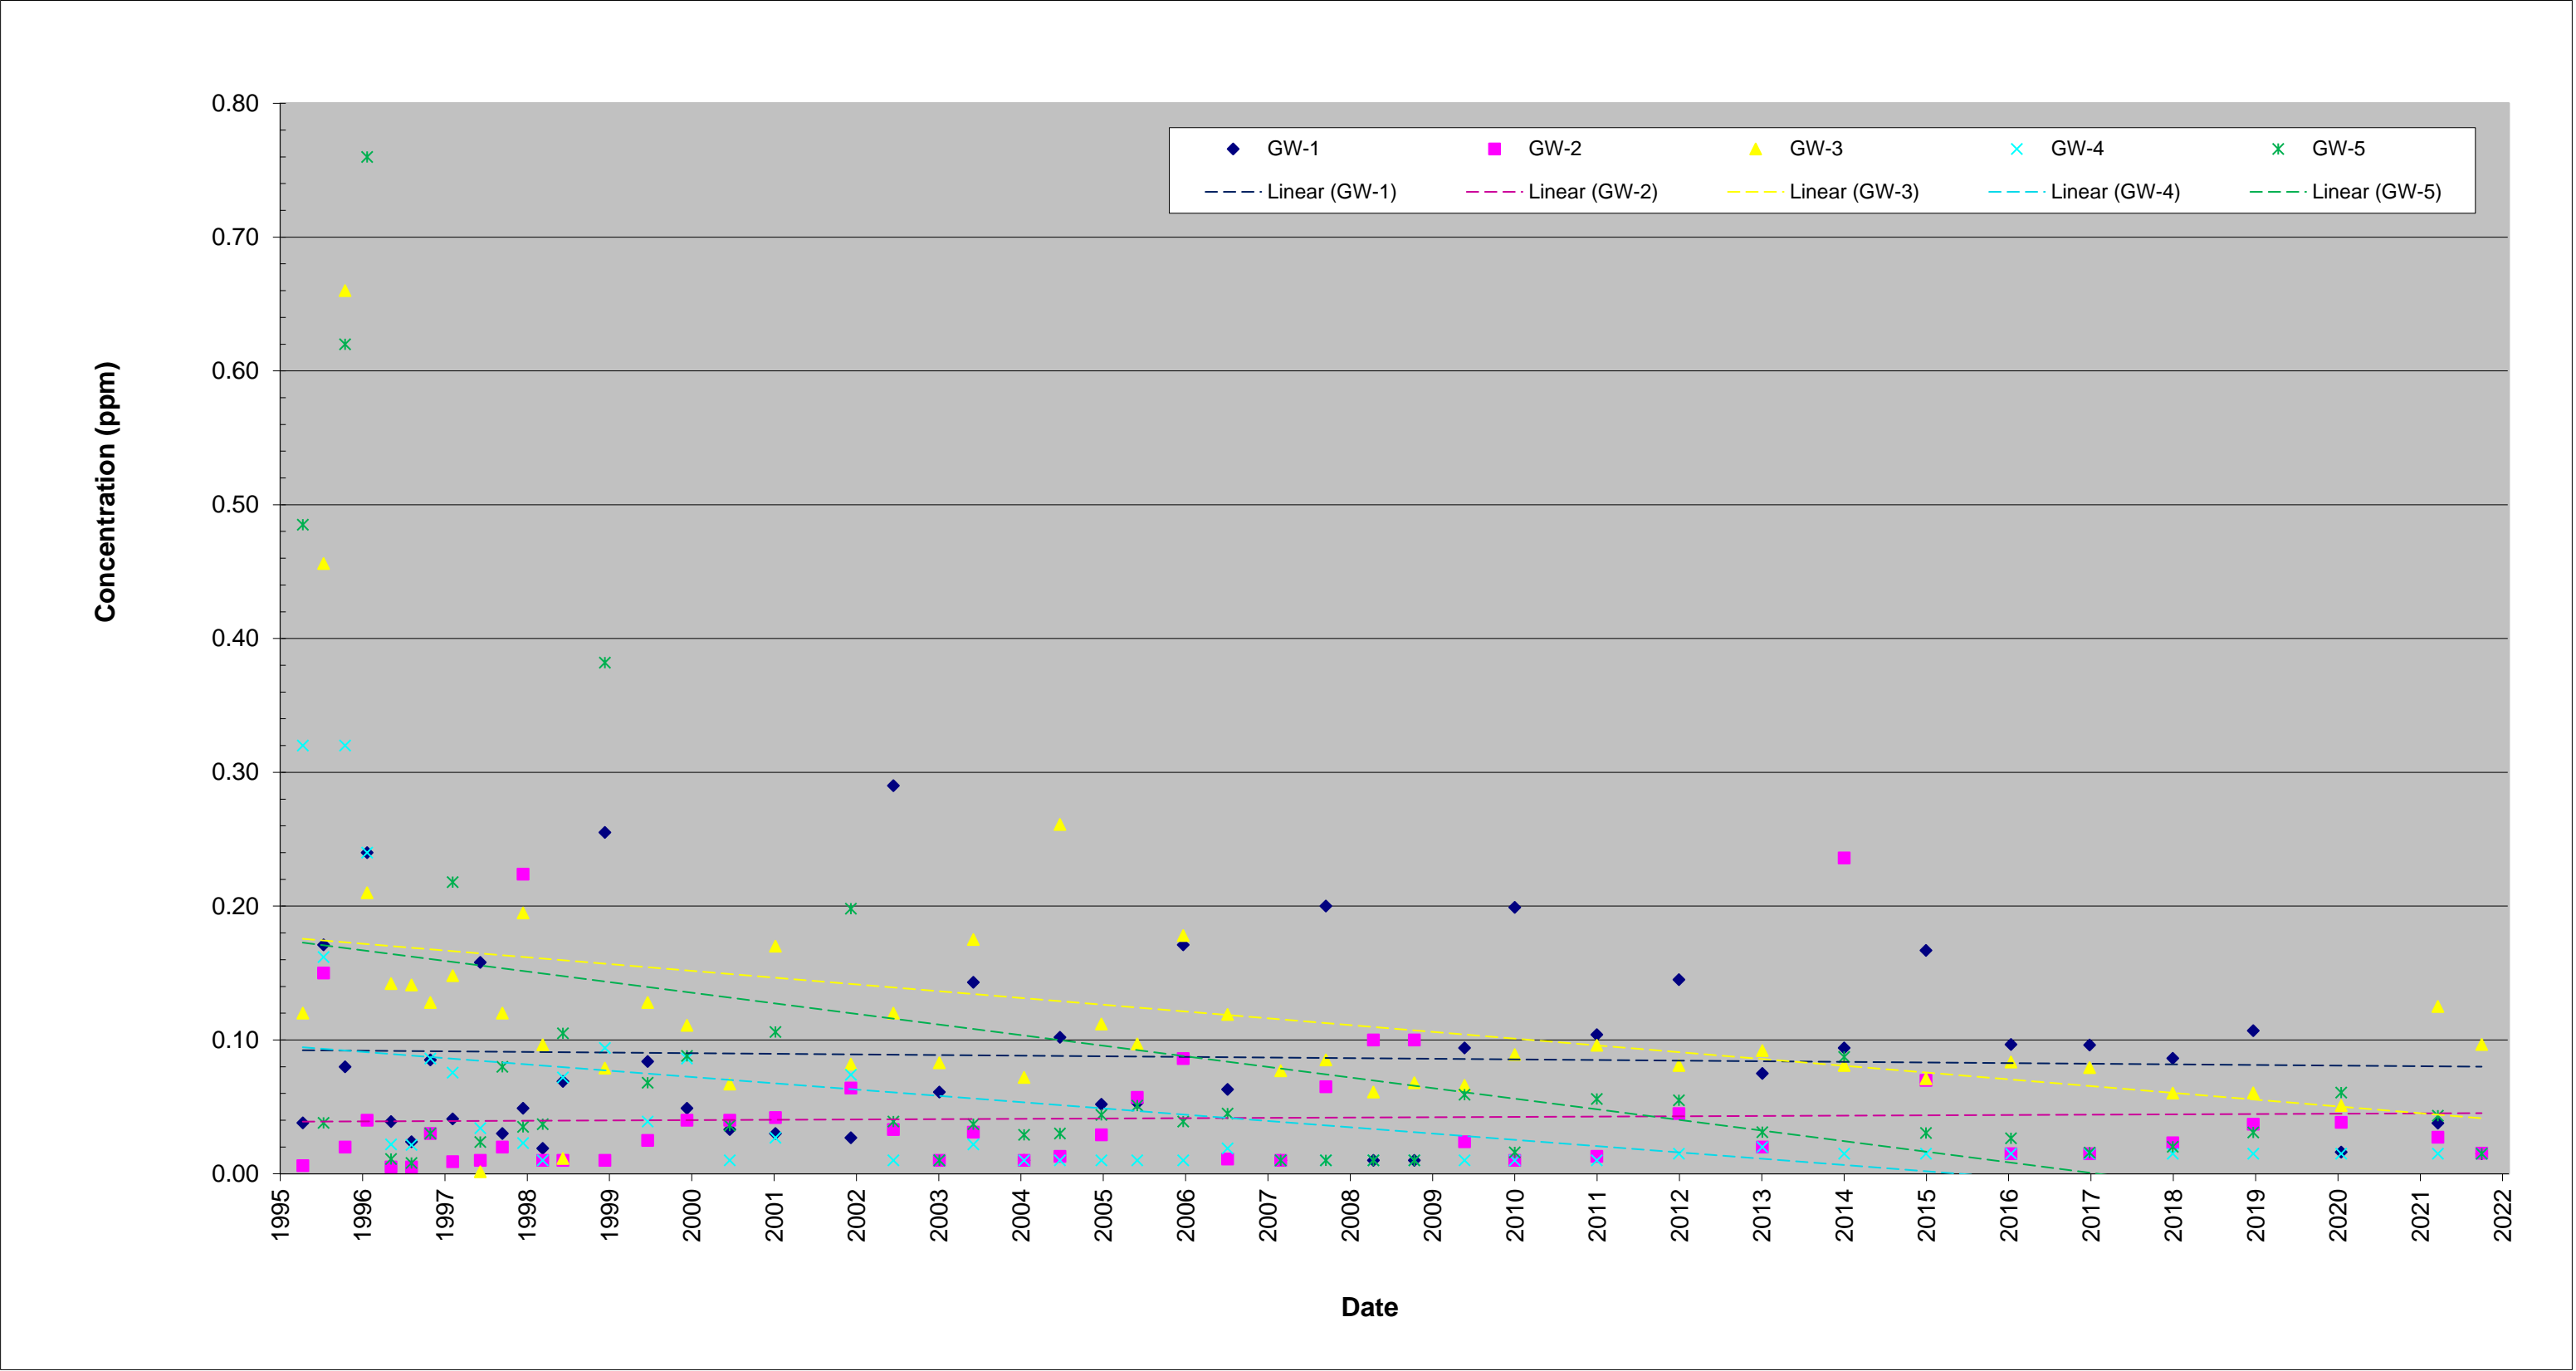
Figure 6

As indicated by Figure 6, a decreasing trend is apparent in the concentrations of total manganese measured in downgradient monitoring wells between April 1995 and October 2021.

Summary of Detected Manganese (total) - Groundwater Samples - April 1995 through October 2021 - and Liner Interpolation of Long-Term Trends

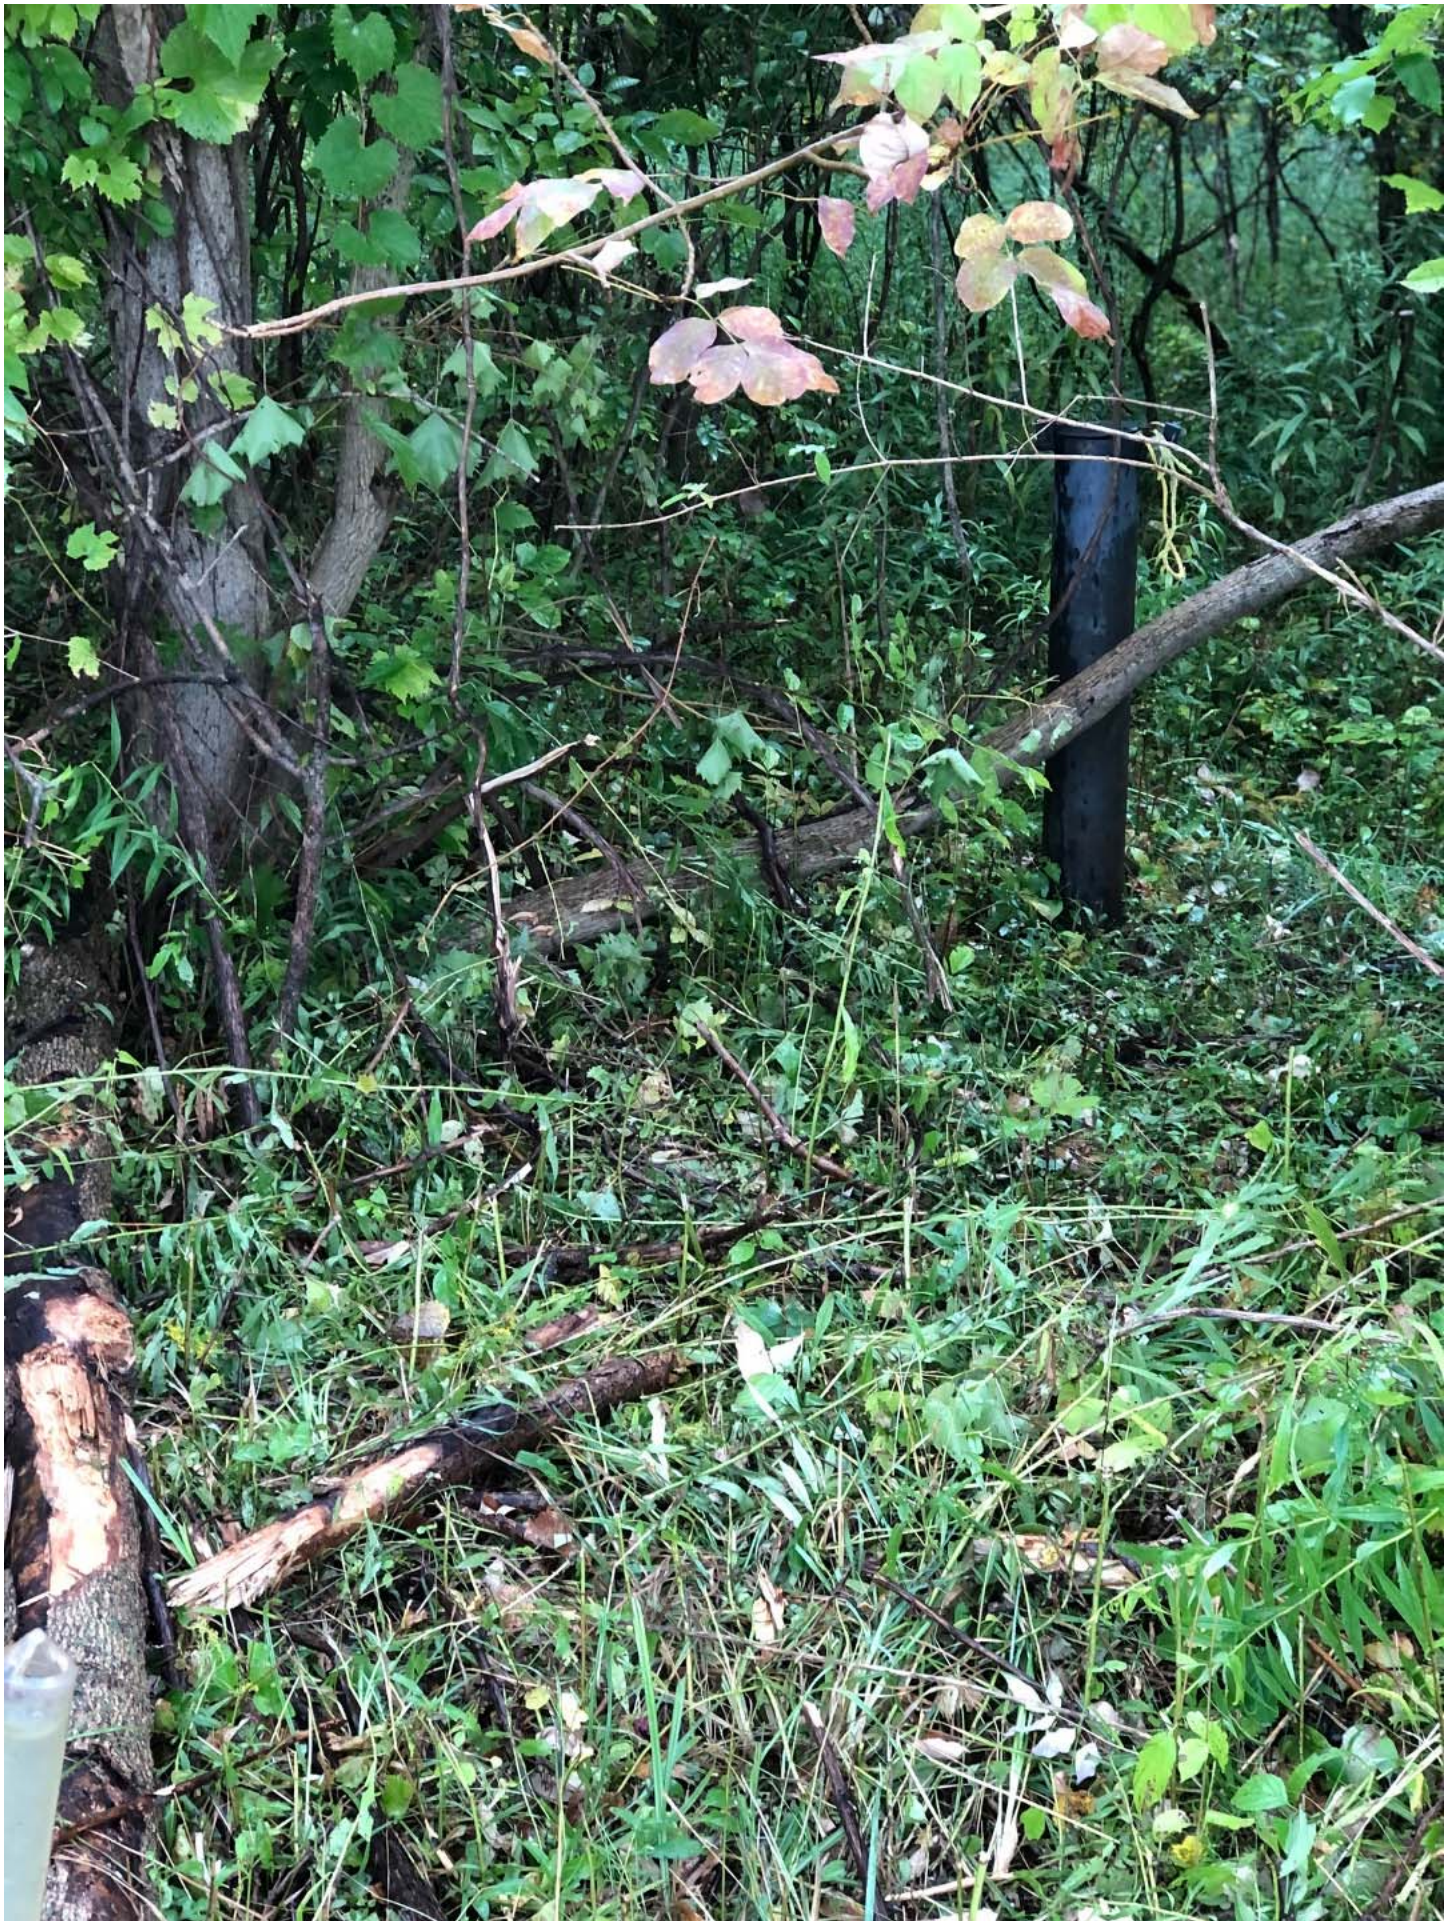
View of the monitoring well GW-1 protective steel casing prior to decommissioning, facing west.

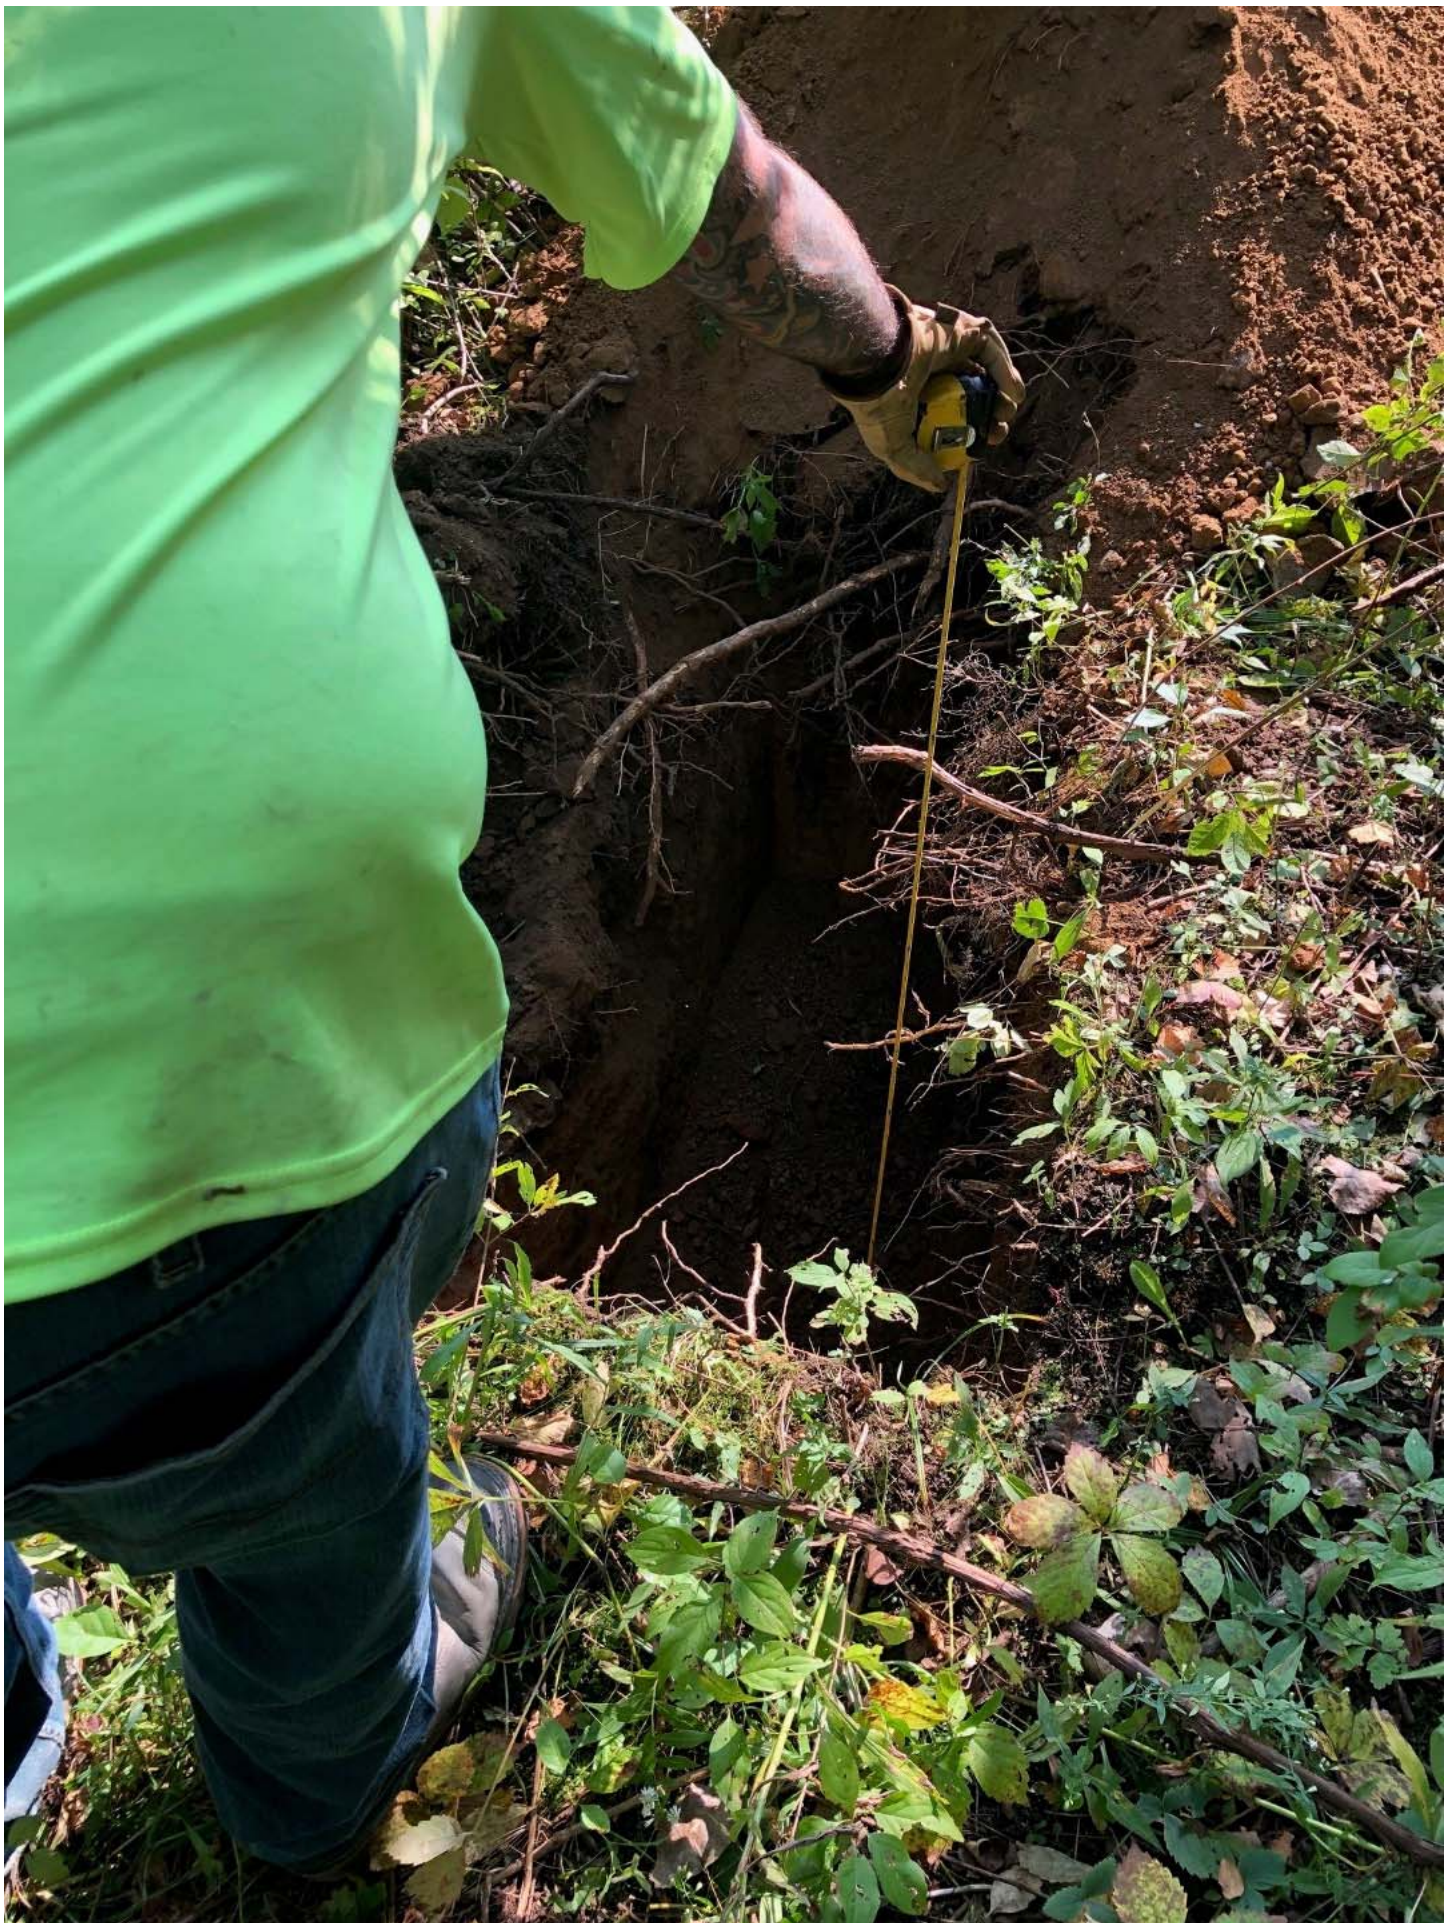
View of the excavation made to remove the monitoring well GW-1 protective steel casing and associated well materials from the ground.

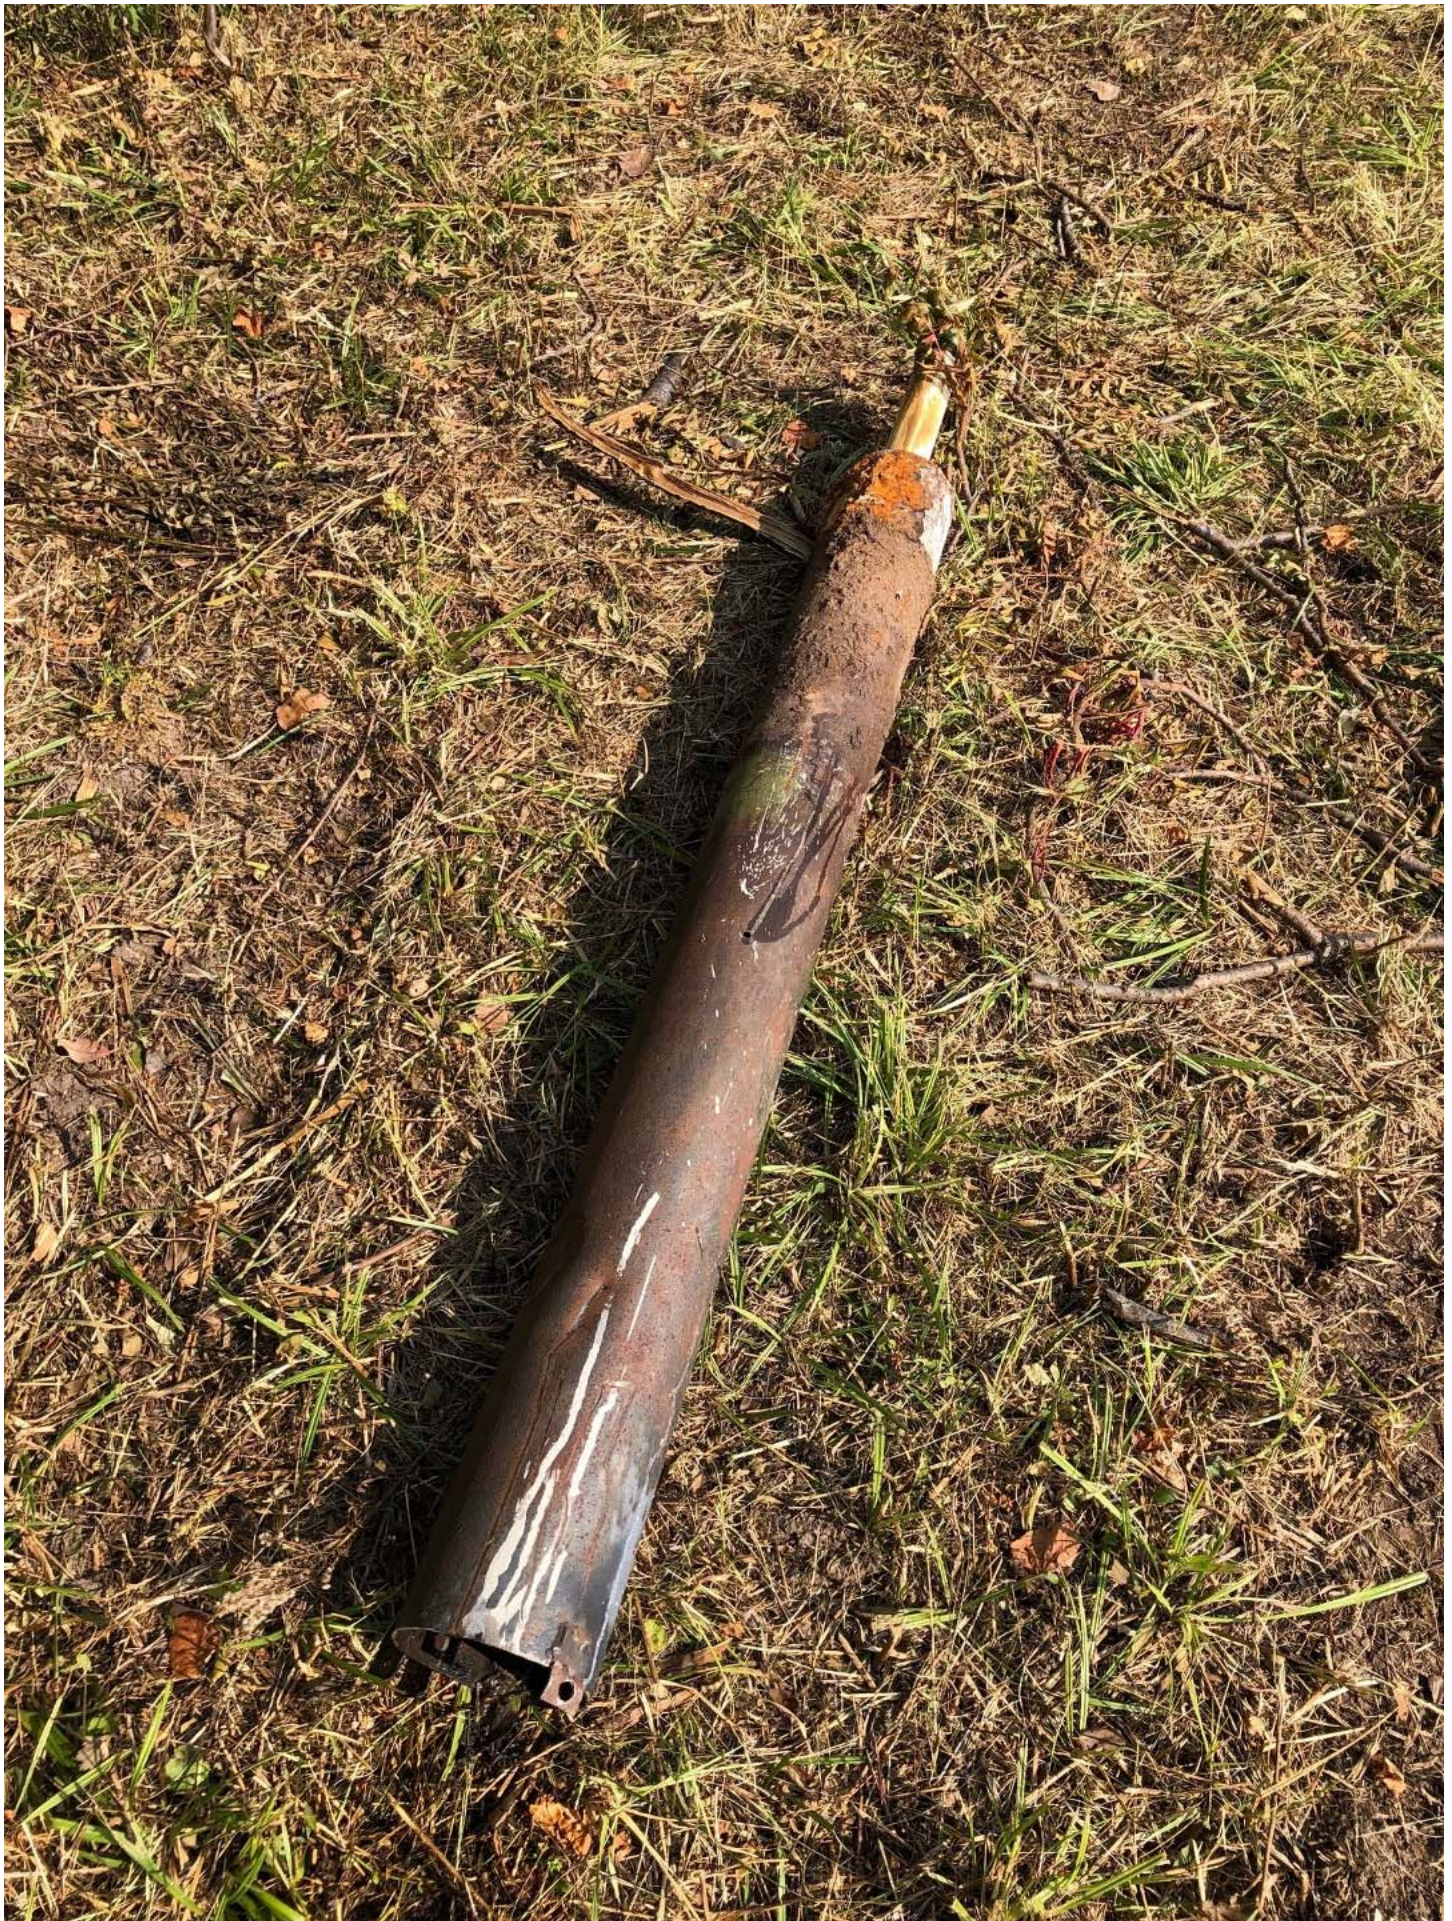
View of the monitoring well GW-1 protective steel casing and associated well materials that were removed from the ground following monitoring well decommissioning.

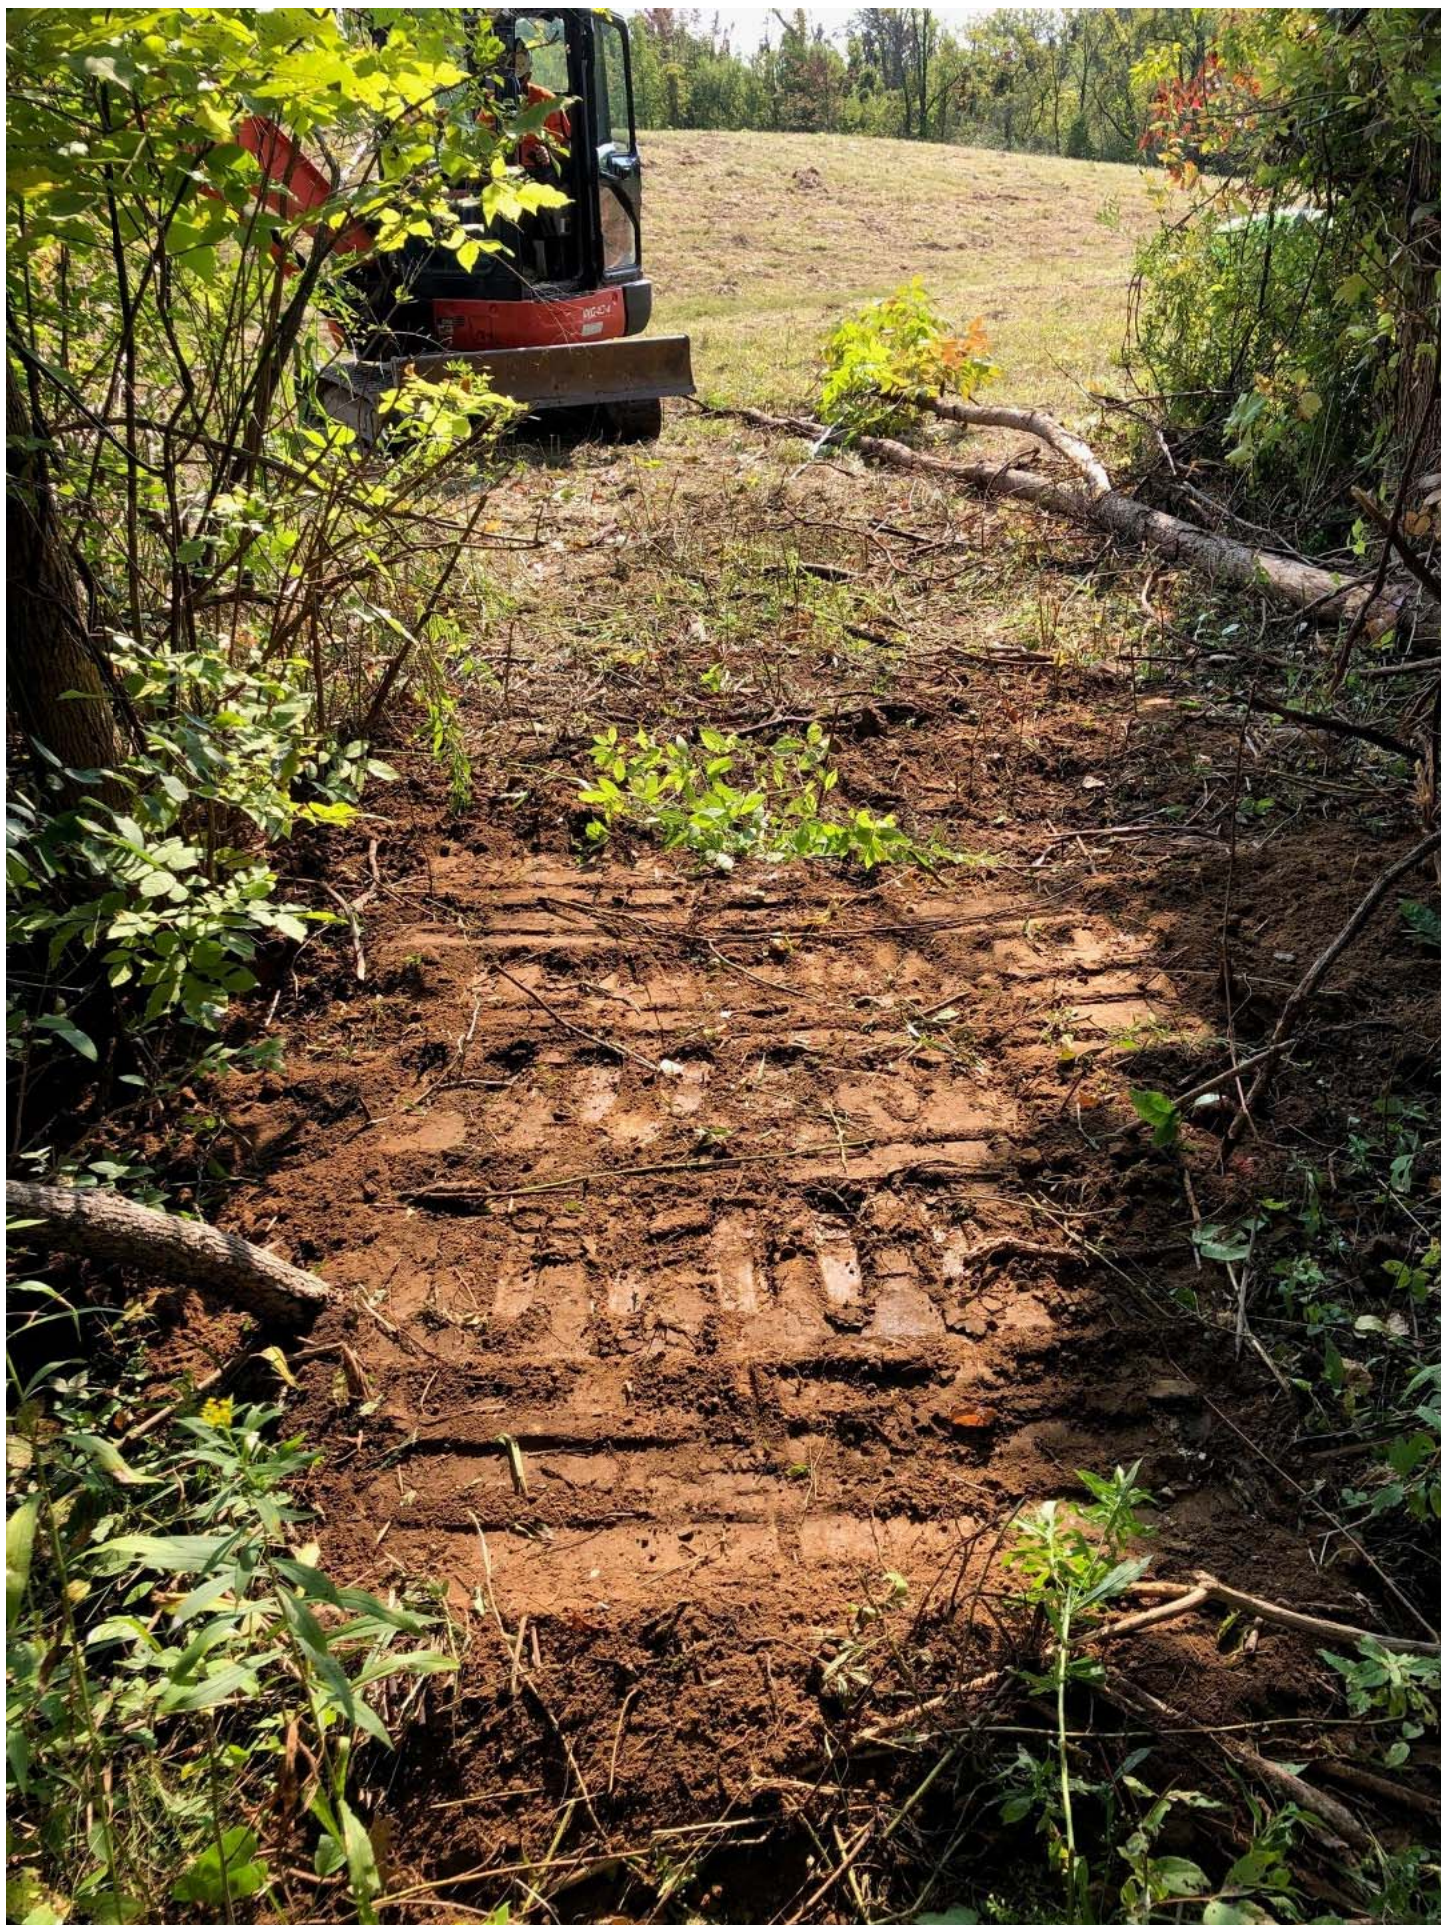
View of the restored ground surface following the removal of monitoring well GW-1 protective steel casing and associated well materials, facing east.
