PERIODIC REVIEW REPORT
REPORTING PERIOD: JANUARY 31, 2022 THROUGH JANUARY 31, 2025

12975 CLARENCE CENTER ROAD
AKRON, NEW YORK
NYSDEC SITE NO. 915053

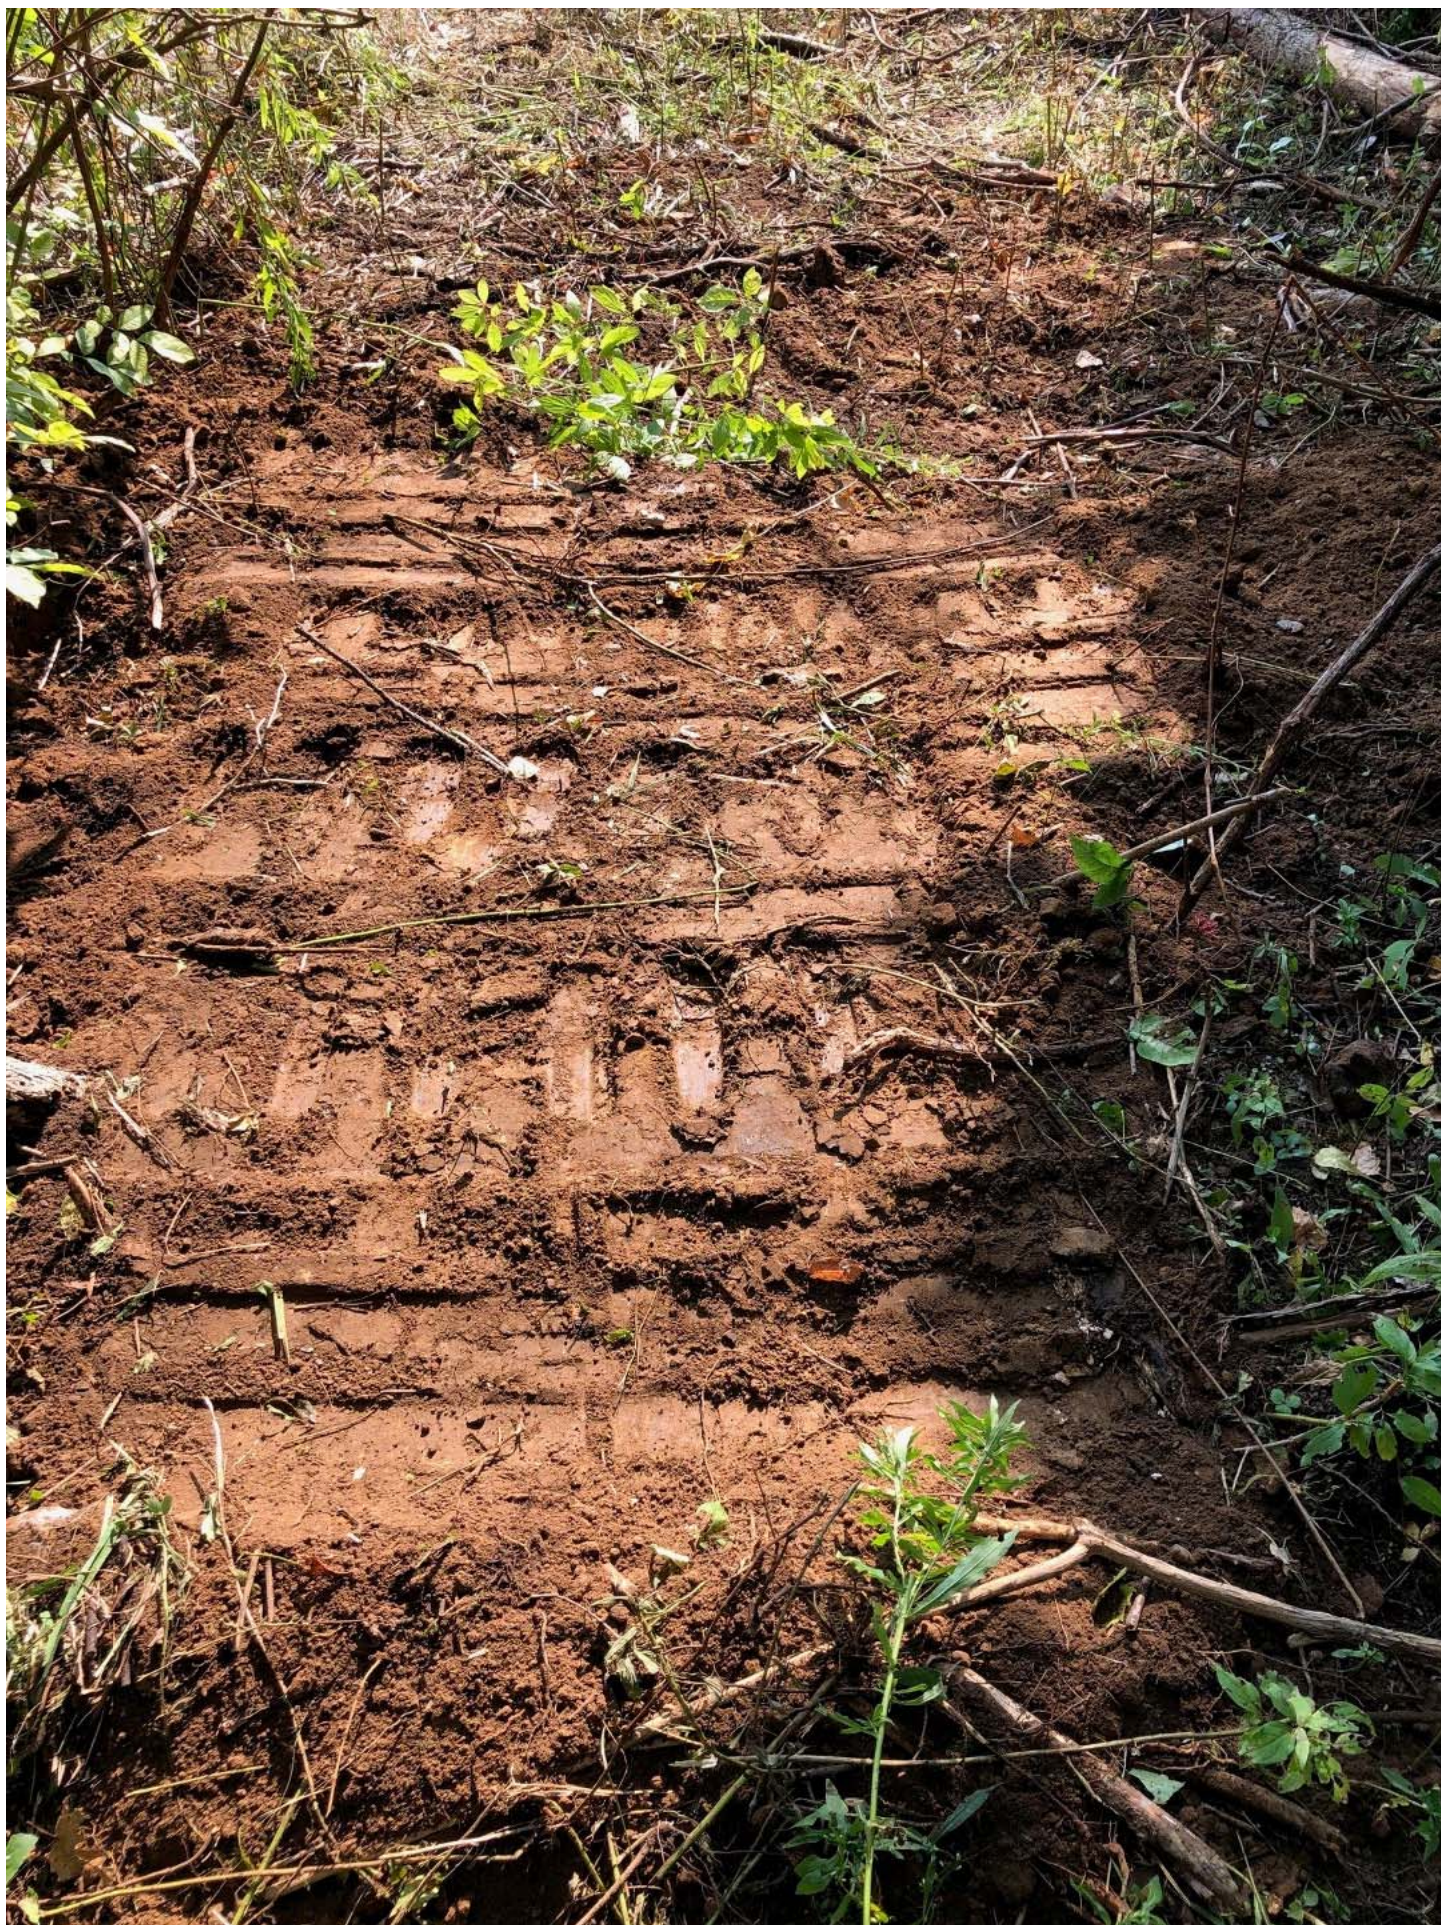
Close-up view of the restored ground surface following the removal of monitoring well GW-1 protective steel casing and associated well materials, facing east.

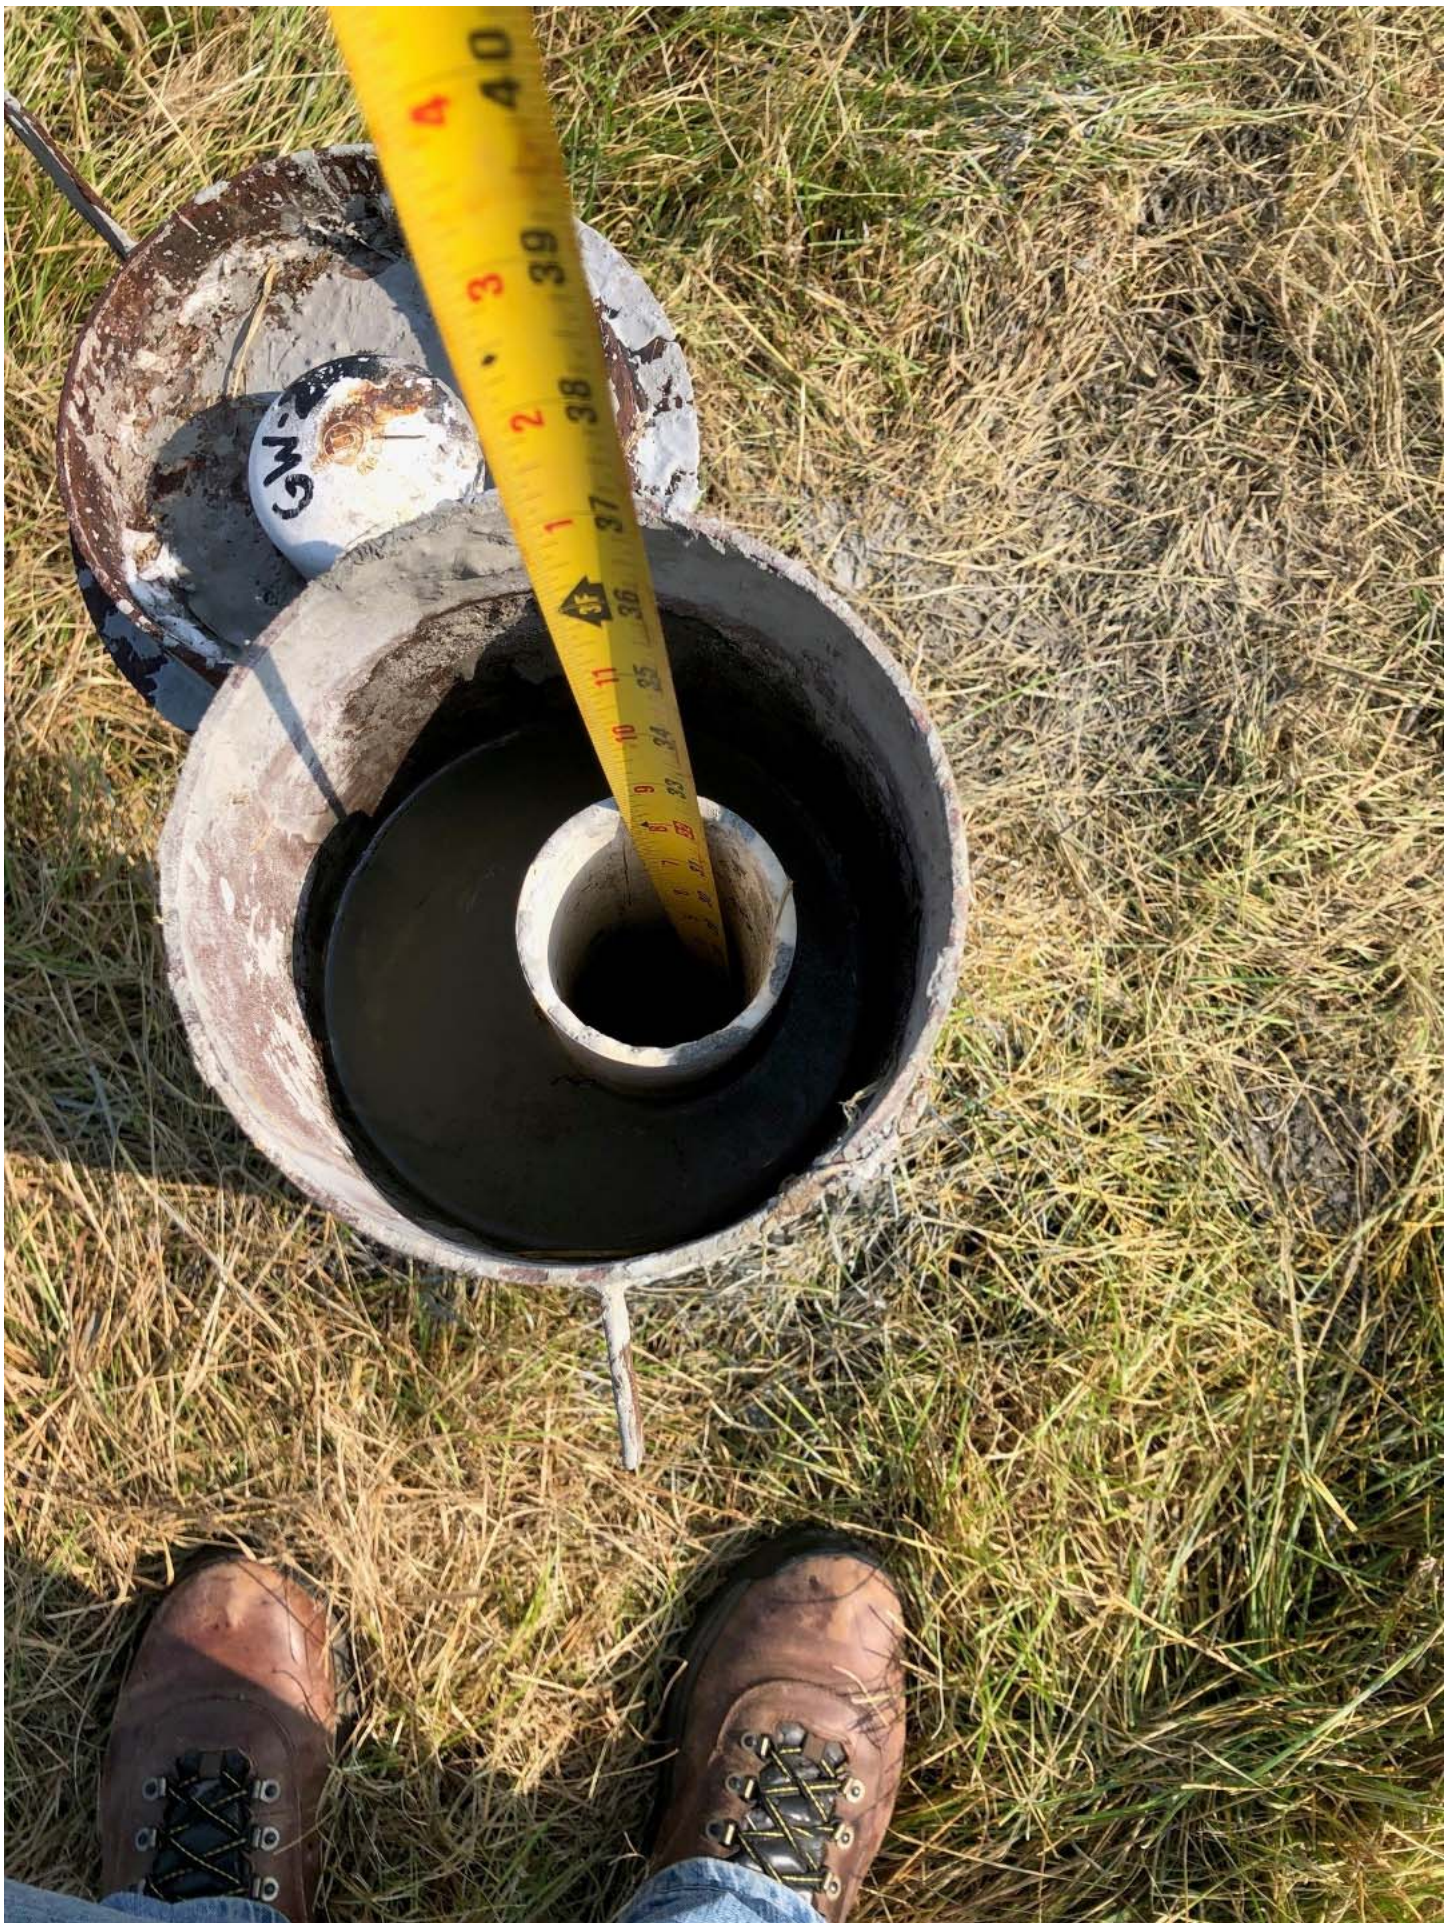
View showing the depth (below the top of PVC casing) to the top of the grout, tremmied into monitoring well GW-2, following monitoring well decommissioning activities.

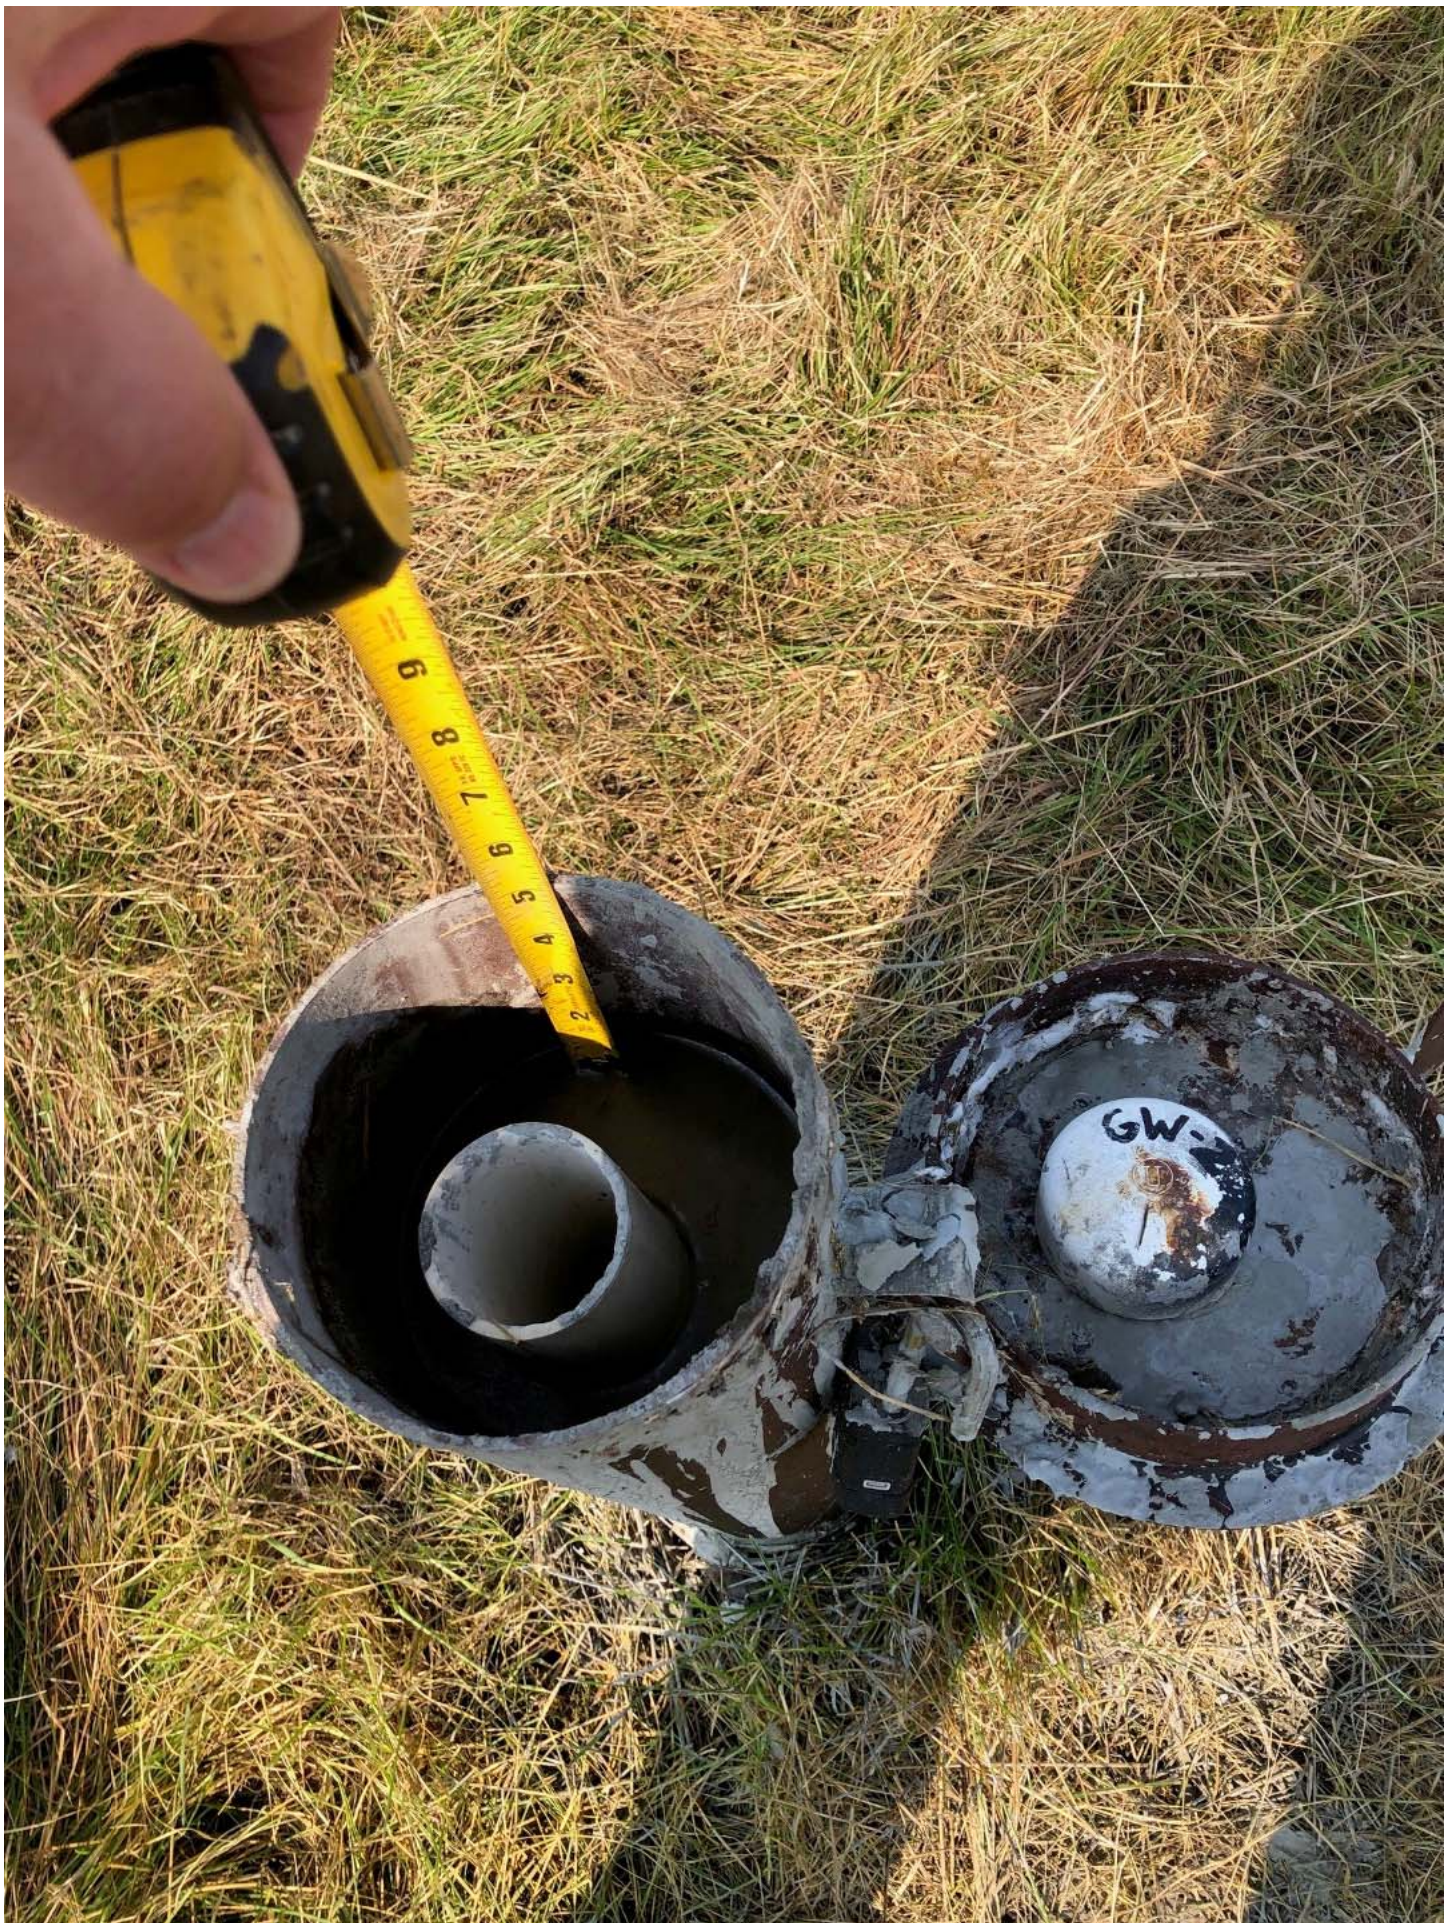
View showing the depth (below top of steel casing) of the grout placed between the monitoring well casing and protective steel casing for monitoring well GW-2, following decommissioning activities.

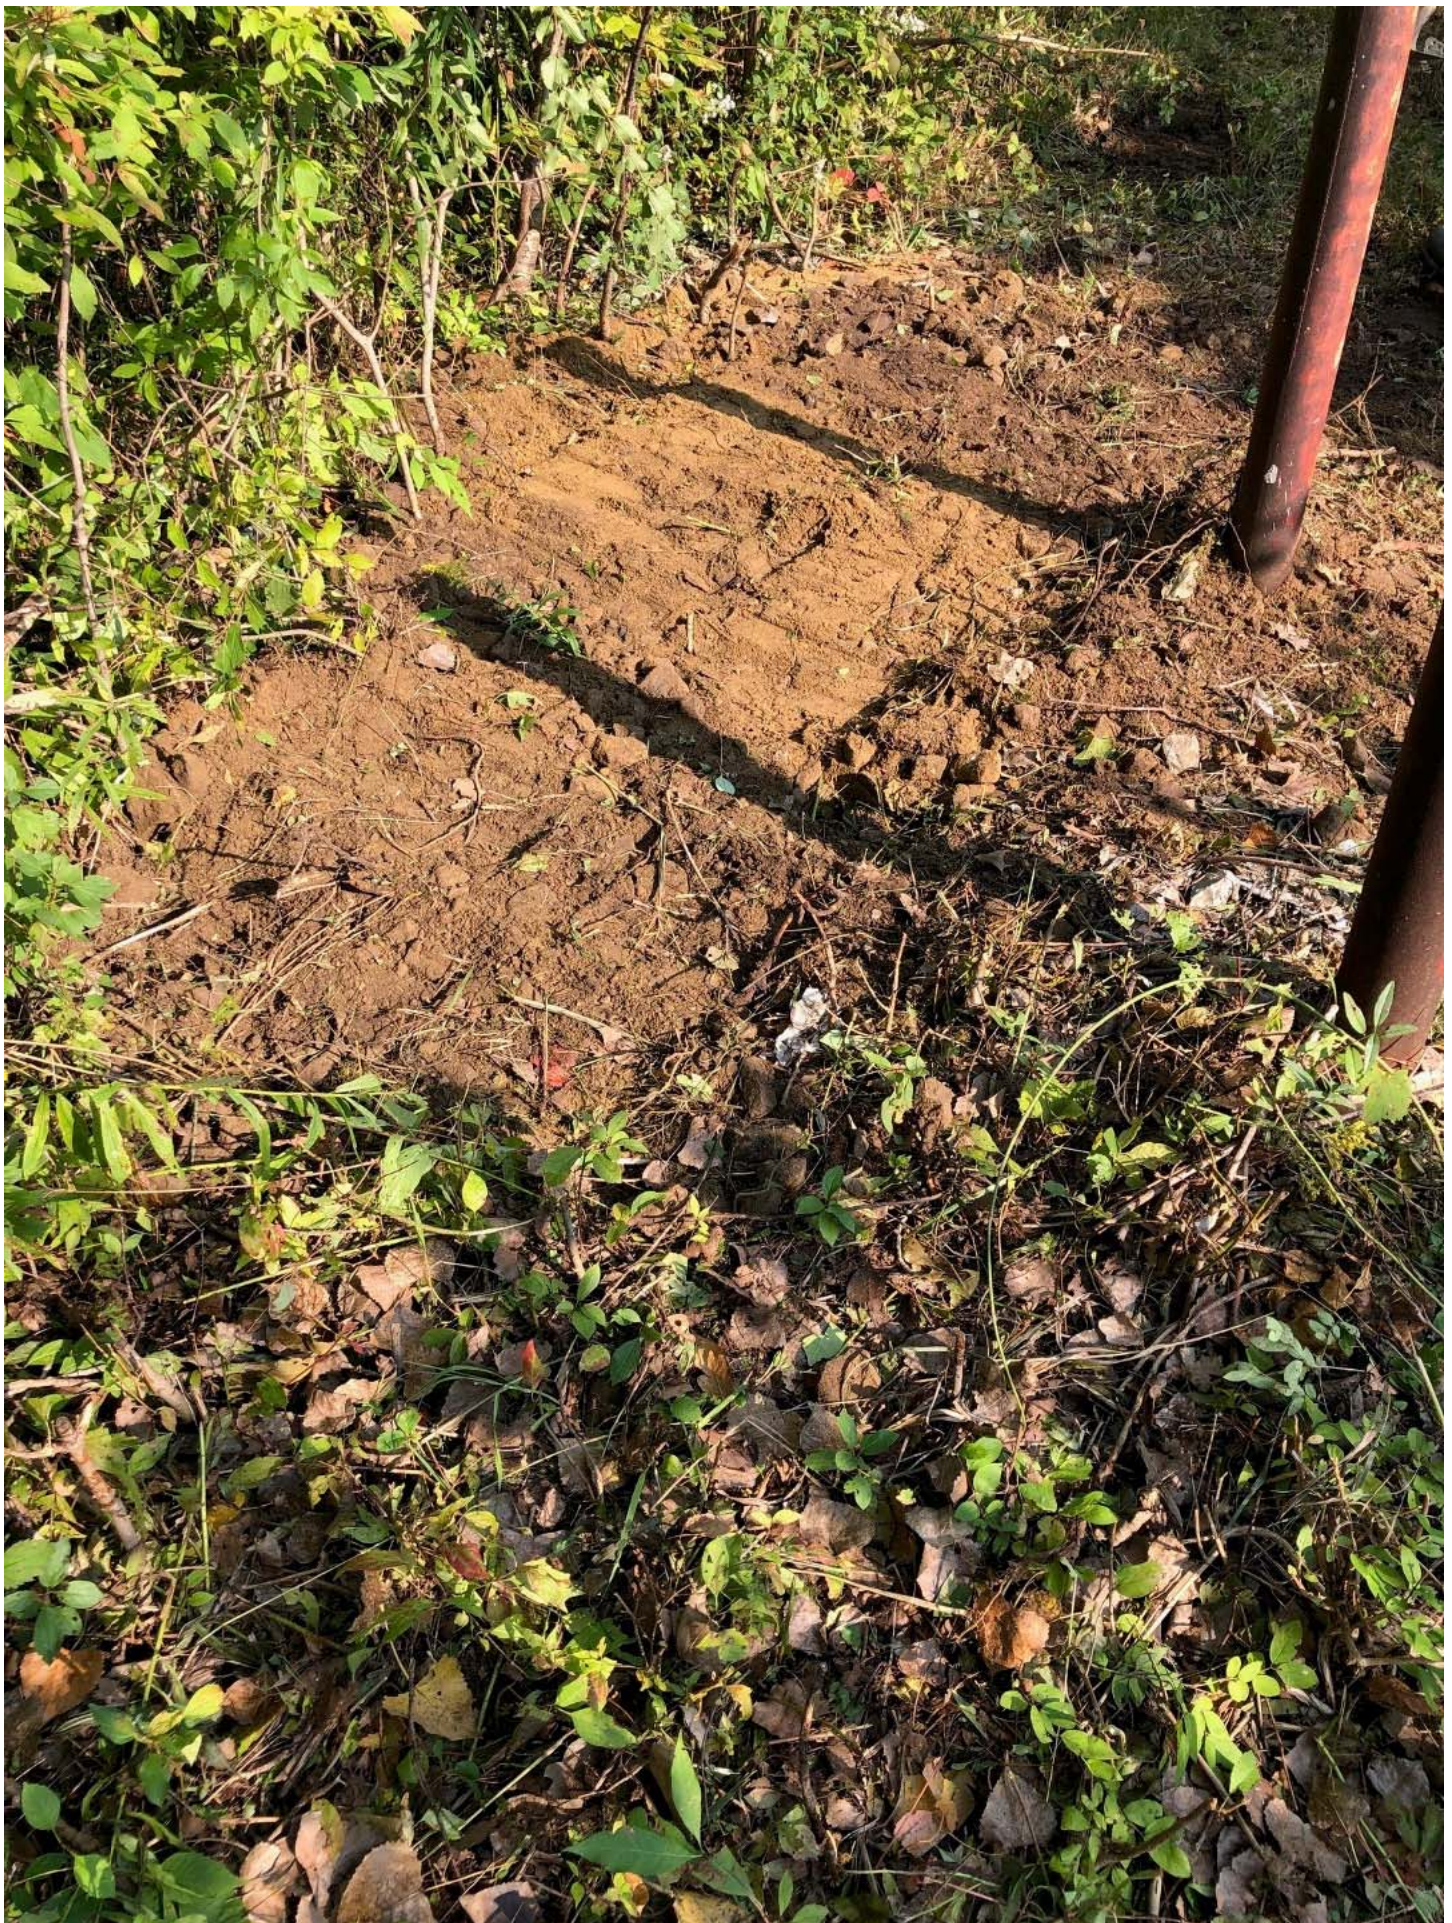
View of the restored ground surface following the removal of monitoring well GW-3 protective steel casing and associated well materials, facing northwest. (Note: the protective bollards were left in place.)

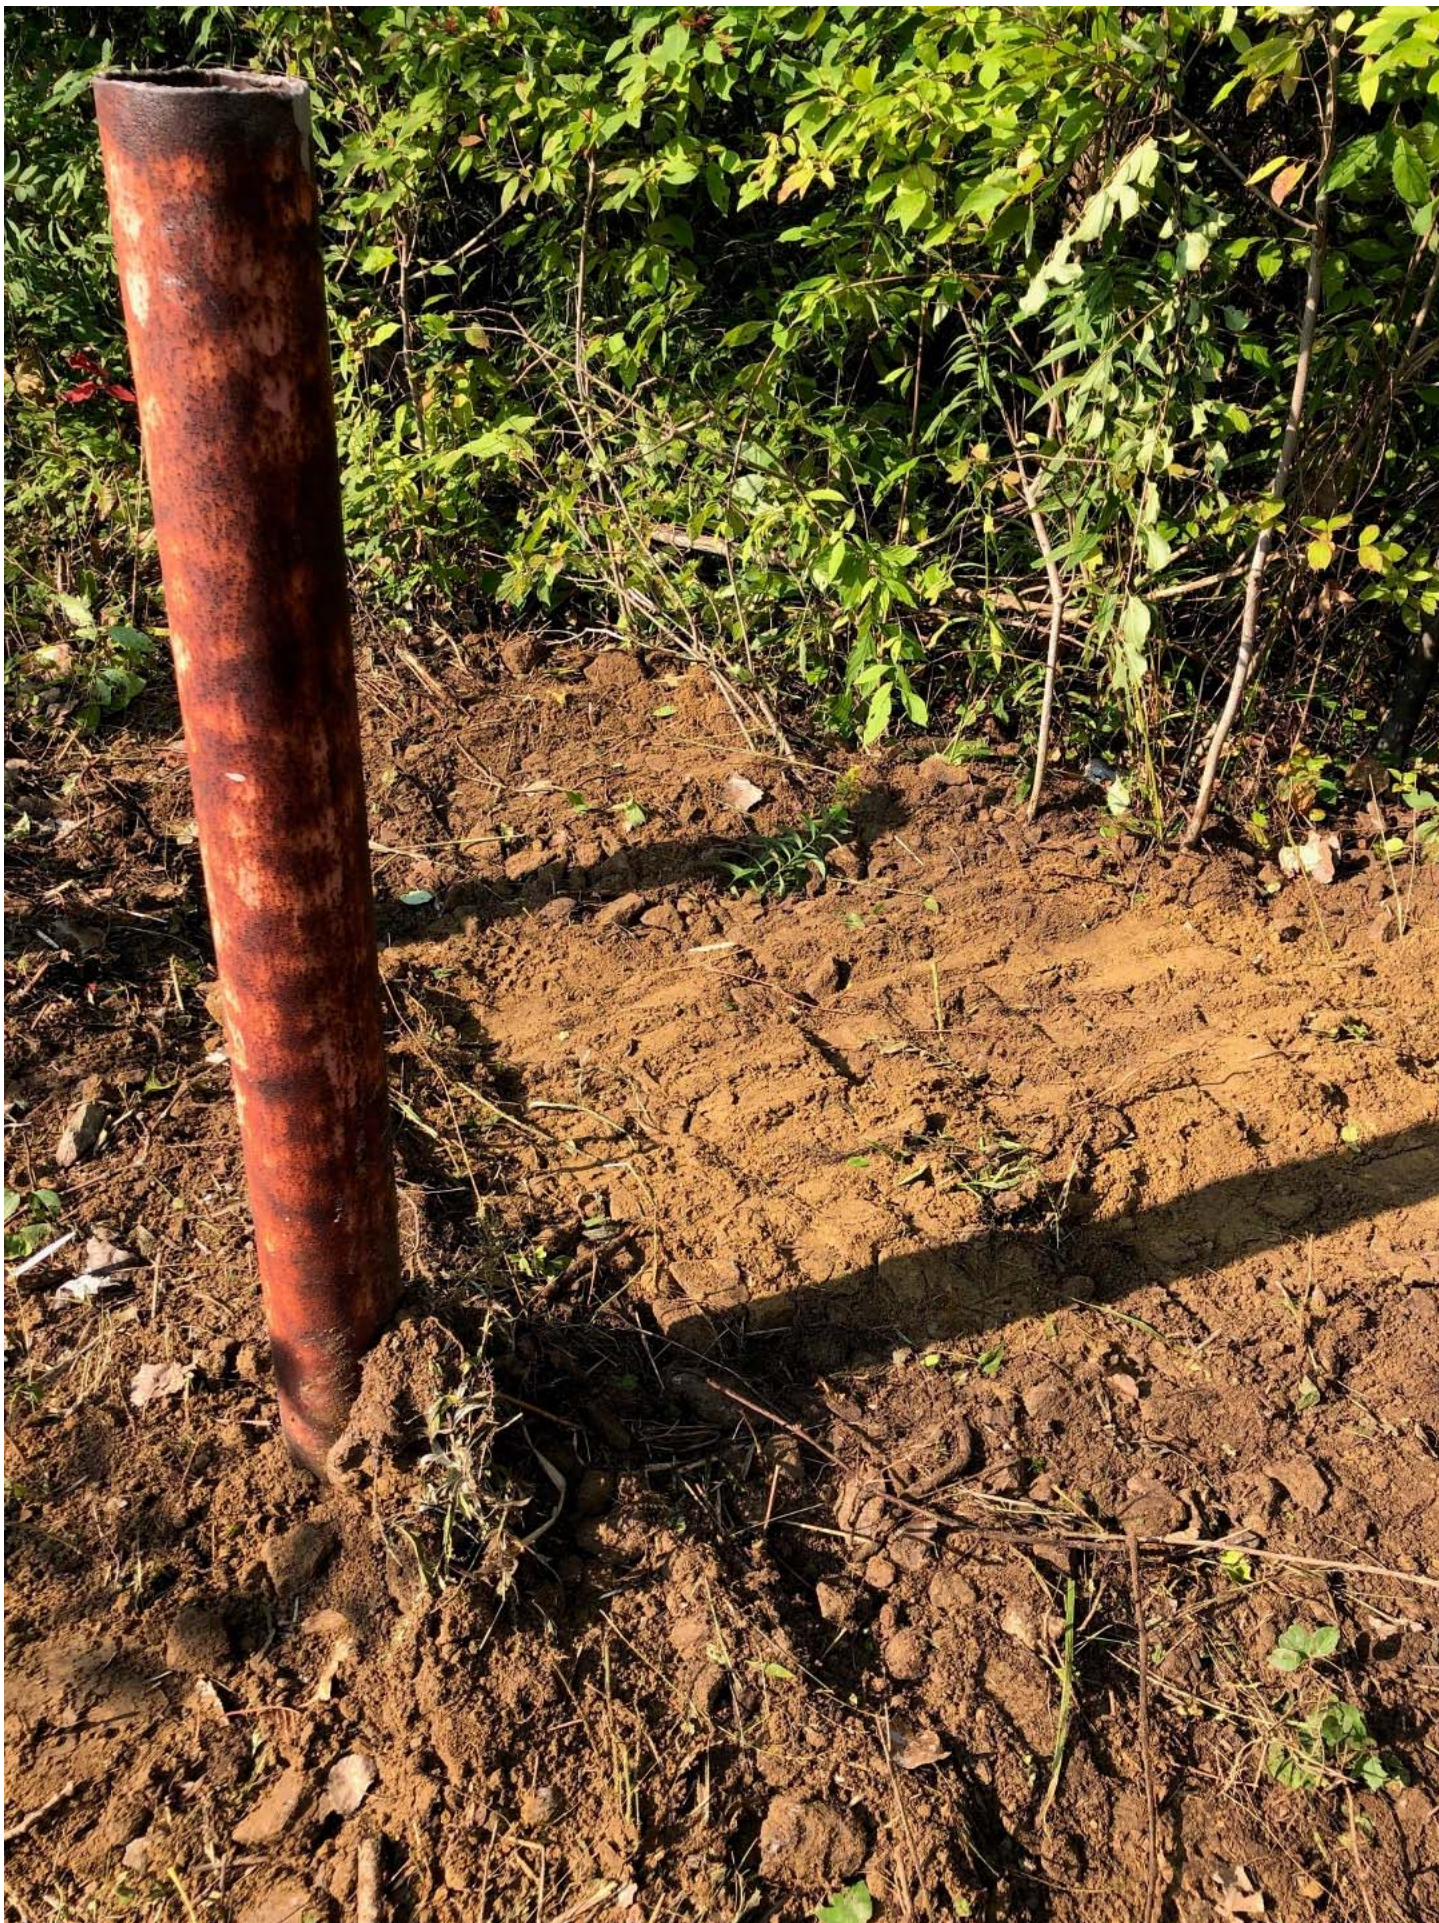
View of the restored ground surface following the removal of monitoring well GW-3 protective steel casing and associated well materials, facing southwest. (Note: the protective bollards were left in place.)

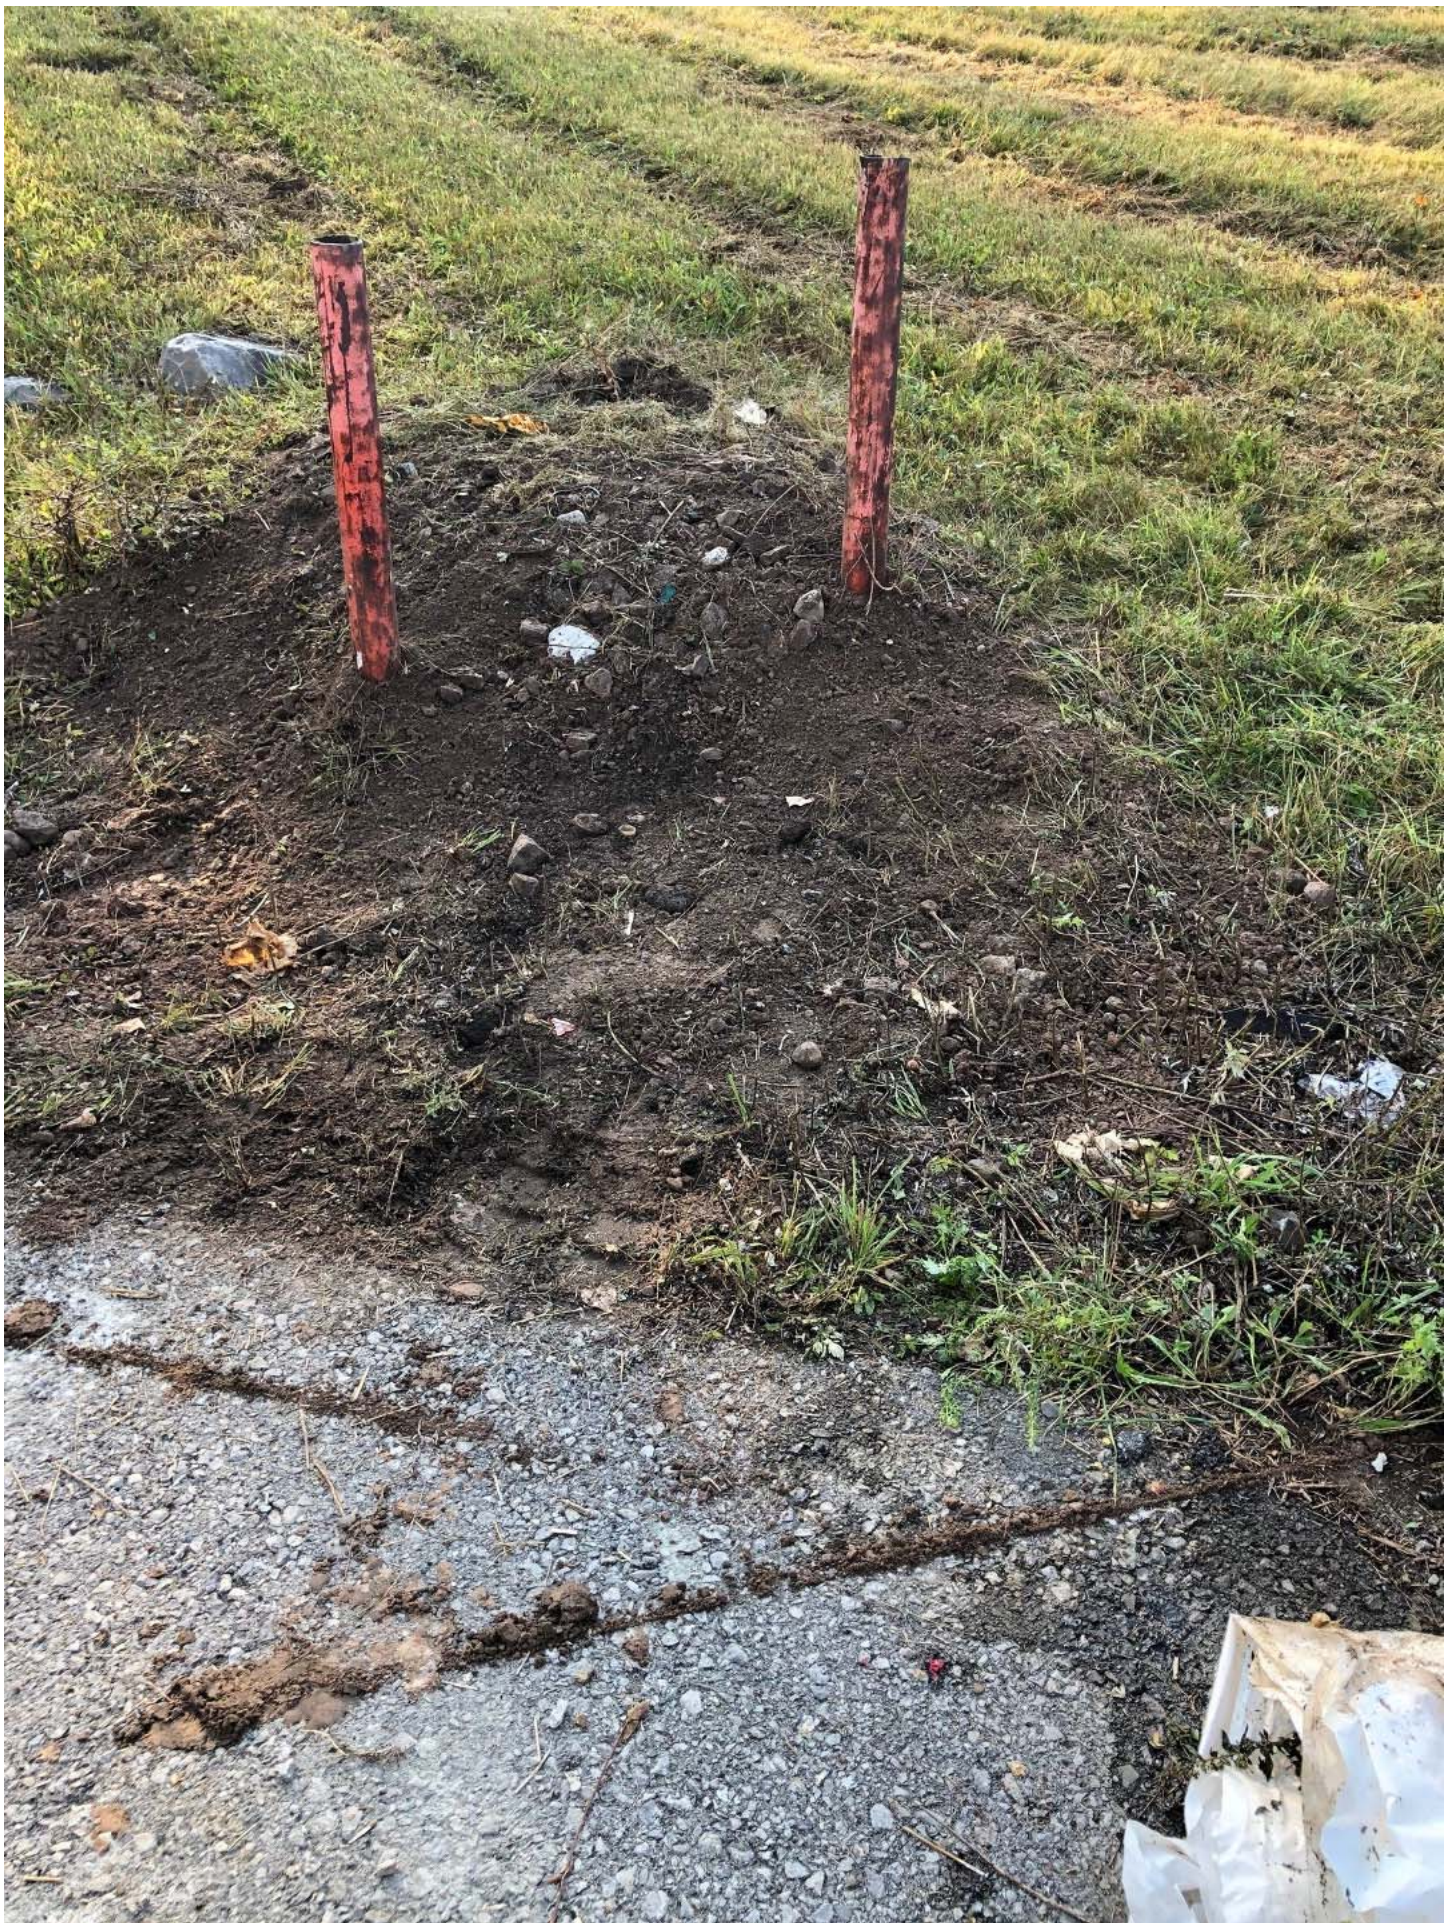
View of the restored ground surface following the removal of monitoring well GW-4 protective steel casing and associated well materials, facing south. (Note: the protective bollards were left in place.)

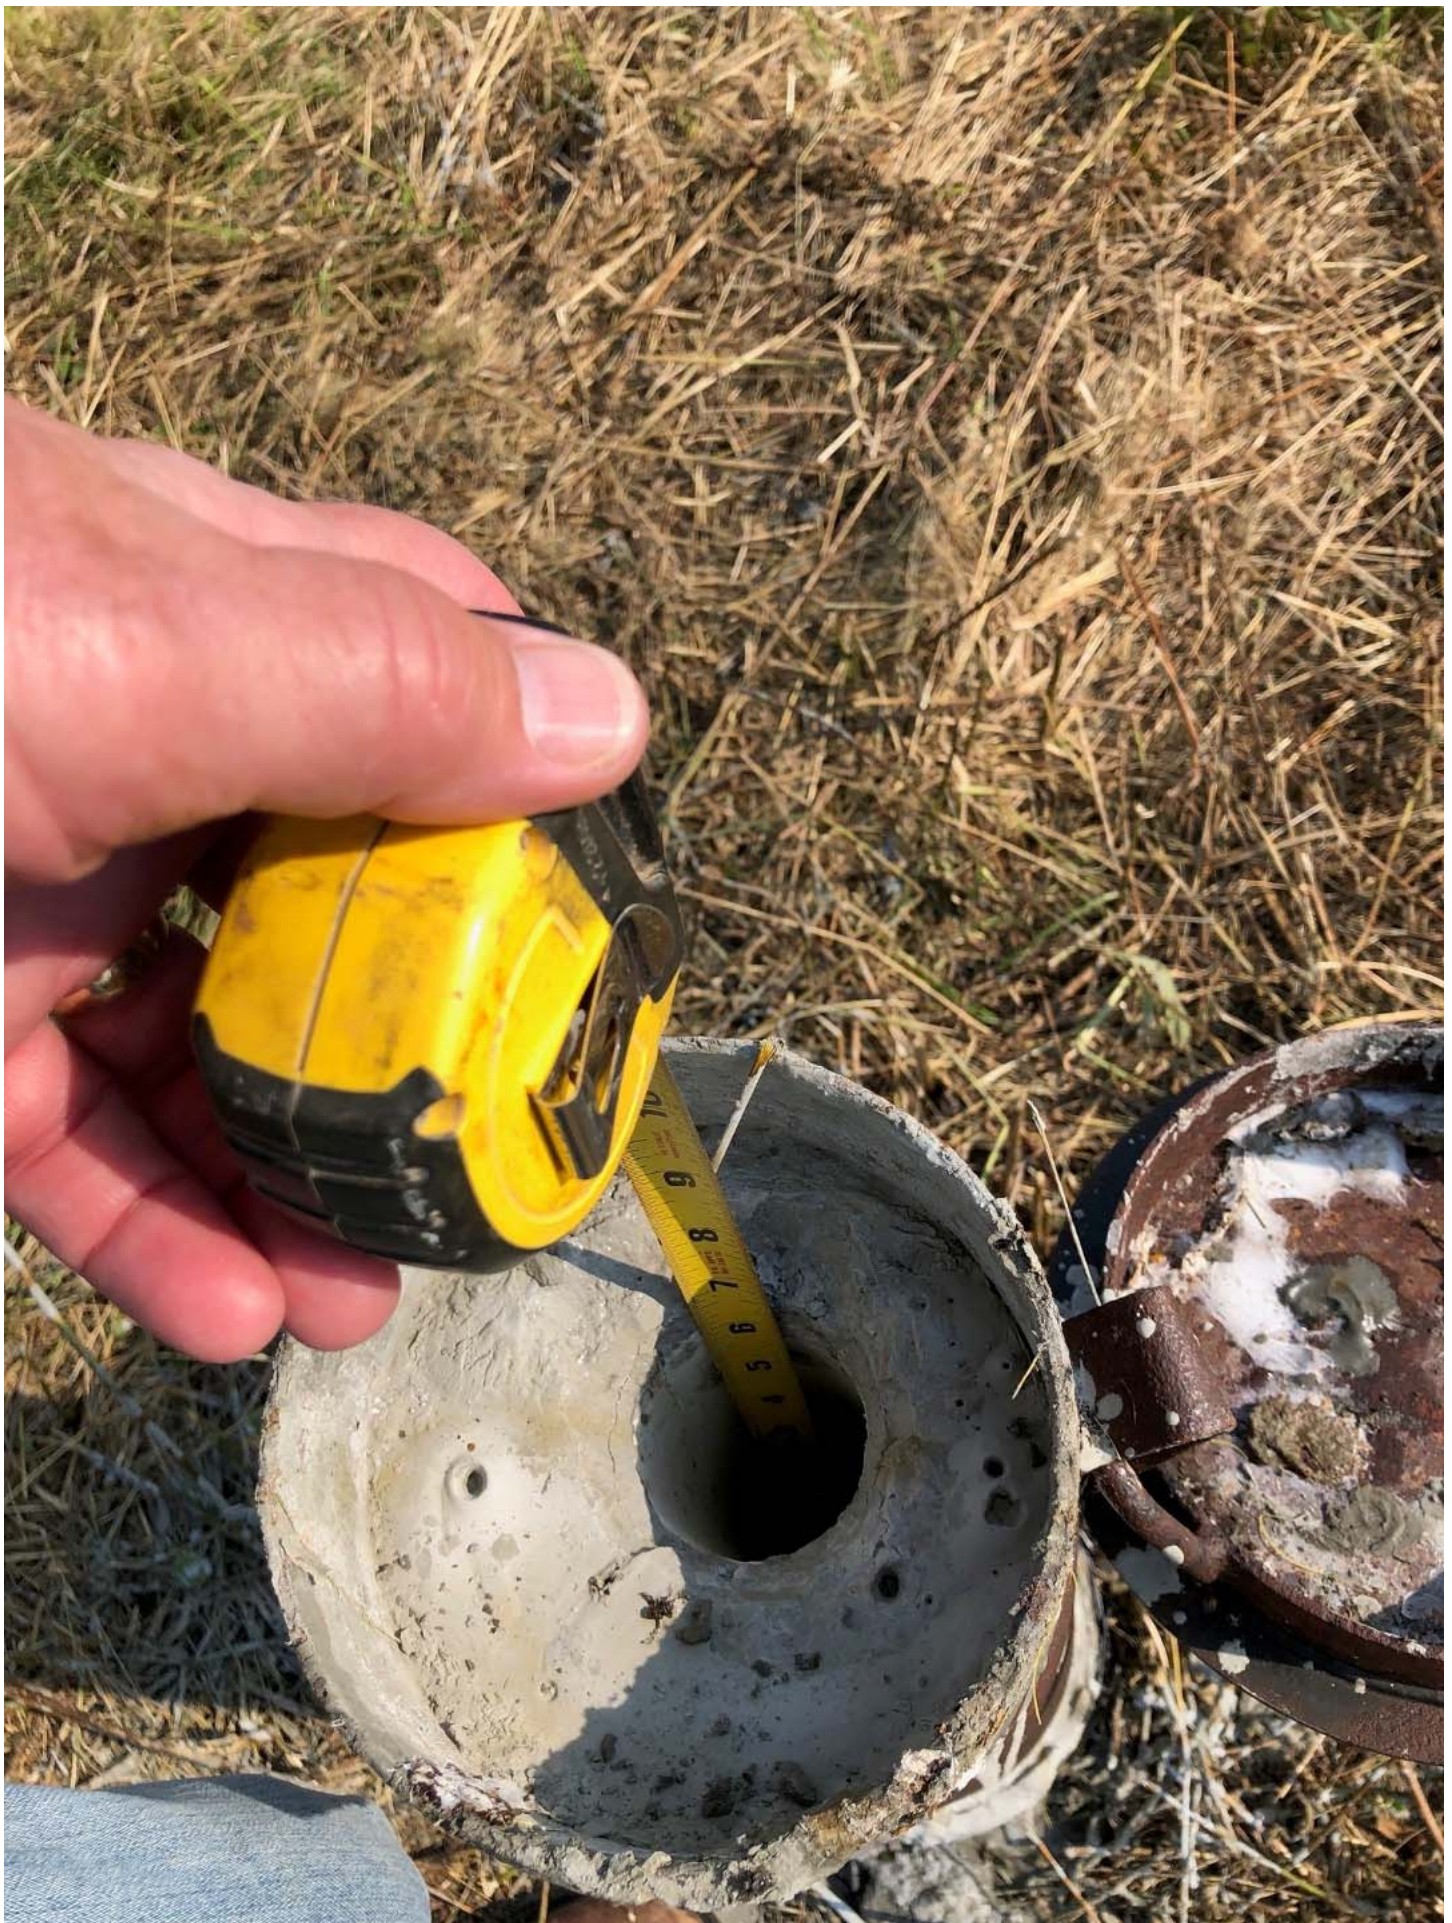
View showing the depth (below the top of PVC casing) to the top of the grout, tremmied into monitoring well GW-5, following monitoring well decommissioning activities.

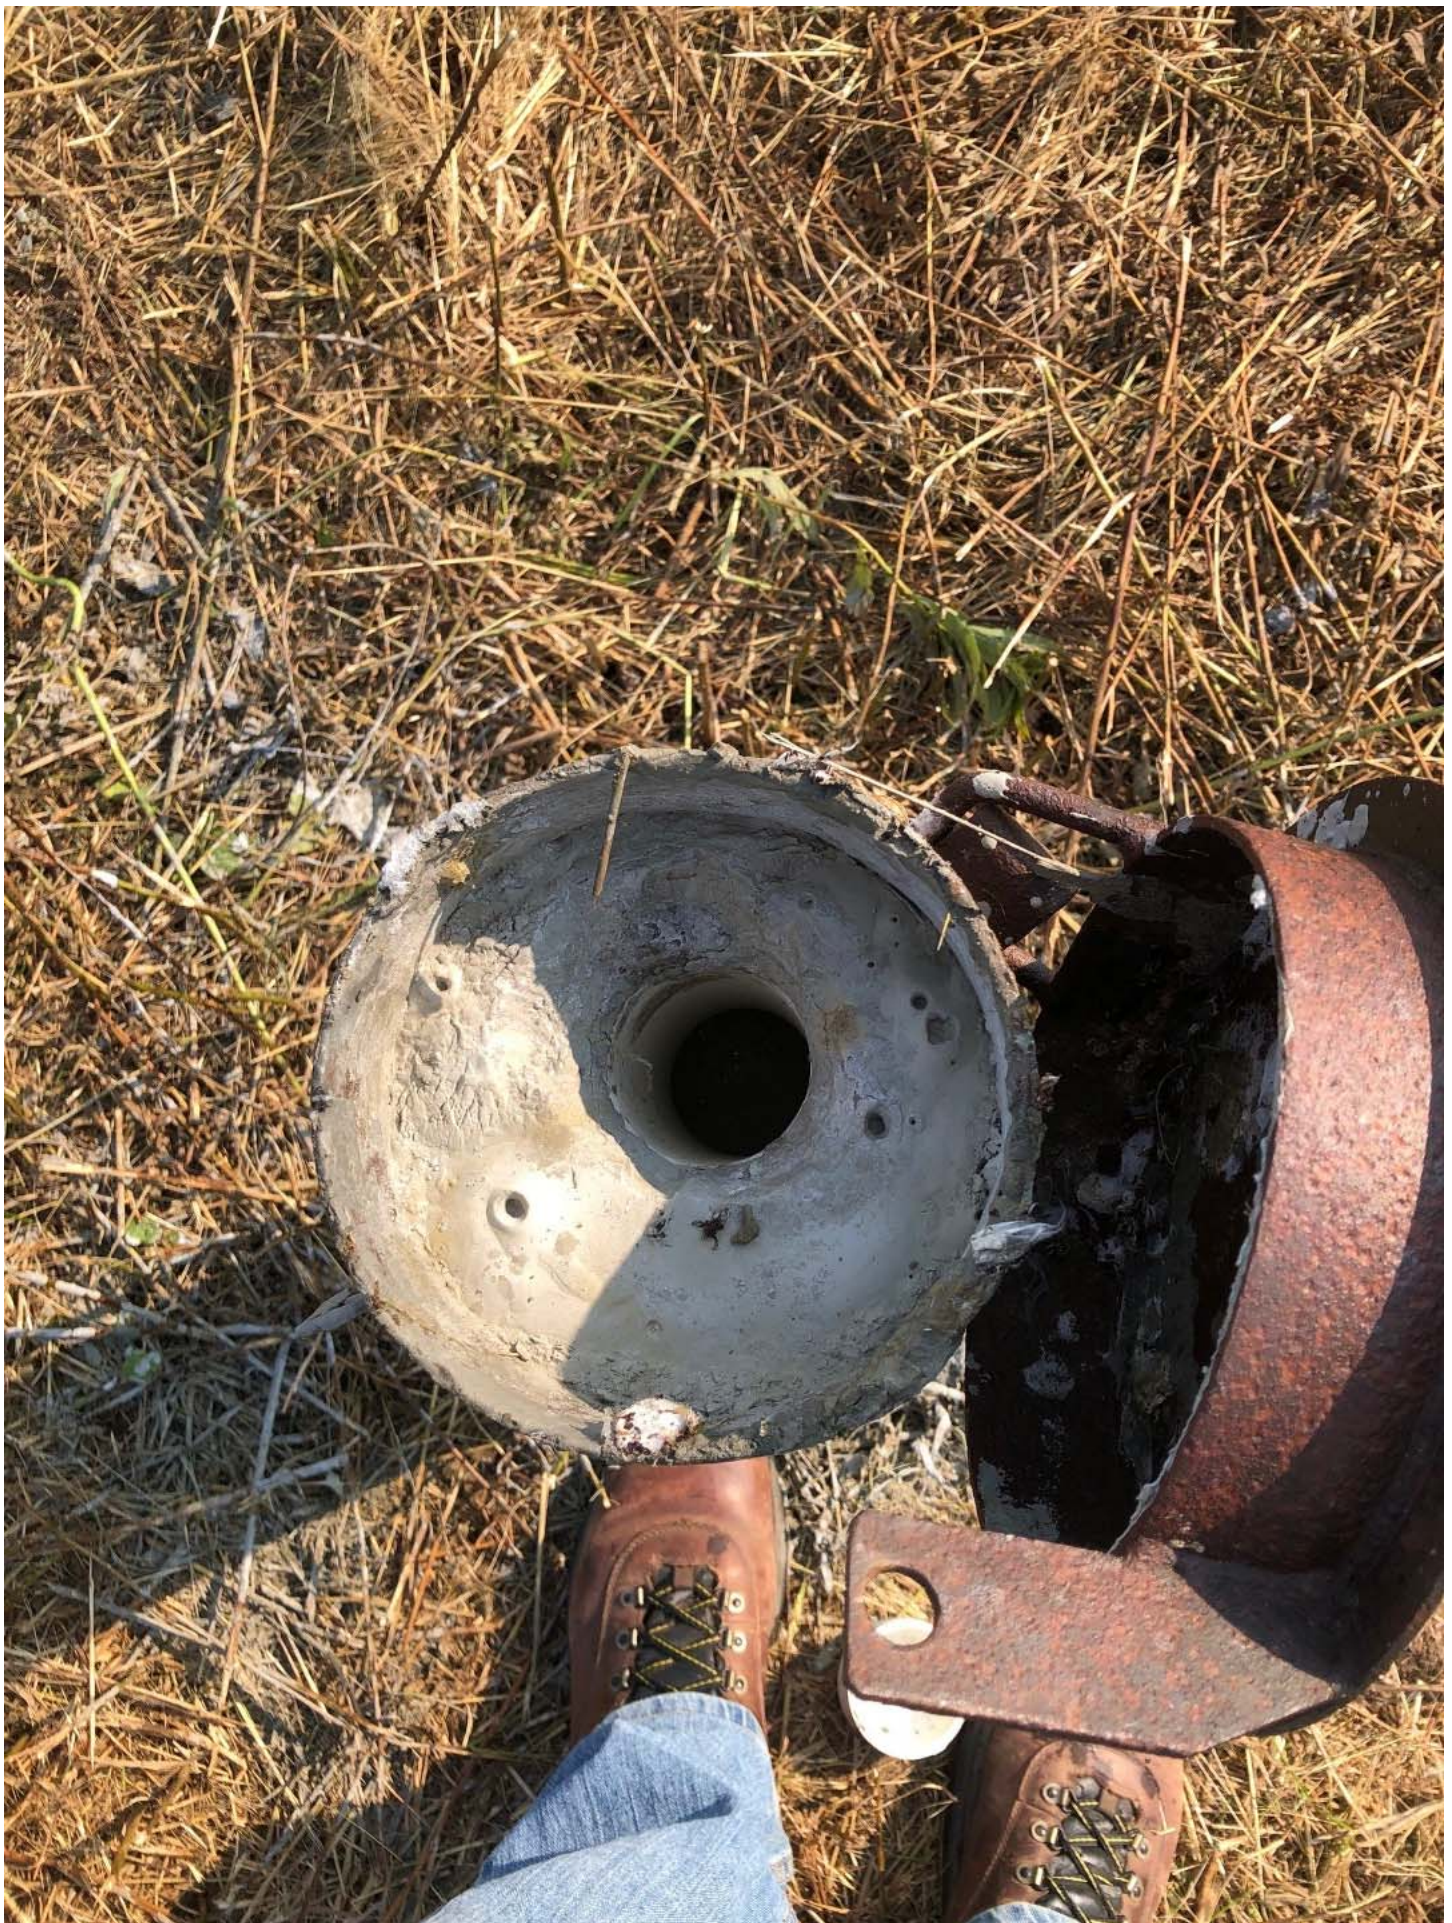
View showing the top of the grout, tremmied into monitoring well GW-5, and between the well casing and protective steel casing, following monitoring well decommissioning activities.
