PERIODIC REVIEW REPORT
REPORTING PERIOD: JANUARY 31, 2022 THROUGH JANUARY 31, 2025

12975 CLARENCE CENTER ROAD
AKRON, NEW YORK
NYSDEC SITE NO. 915053

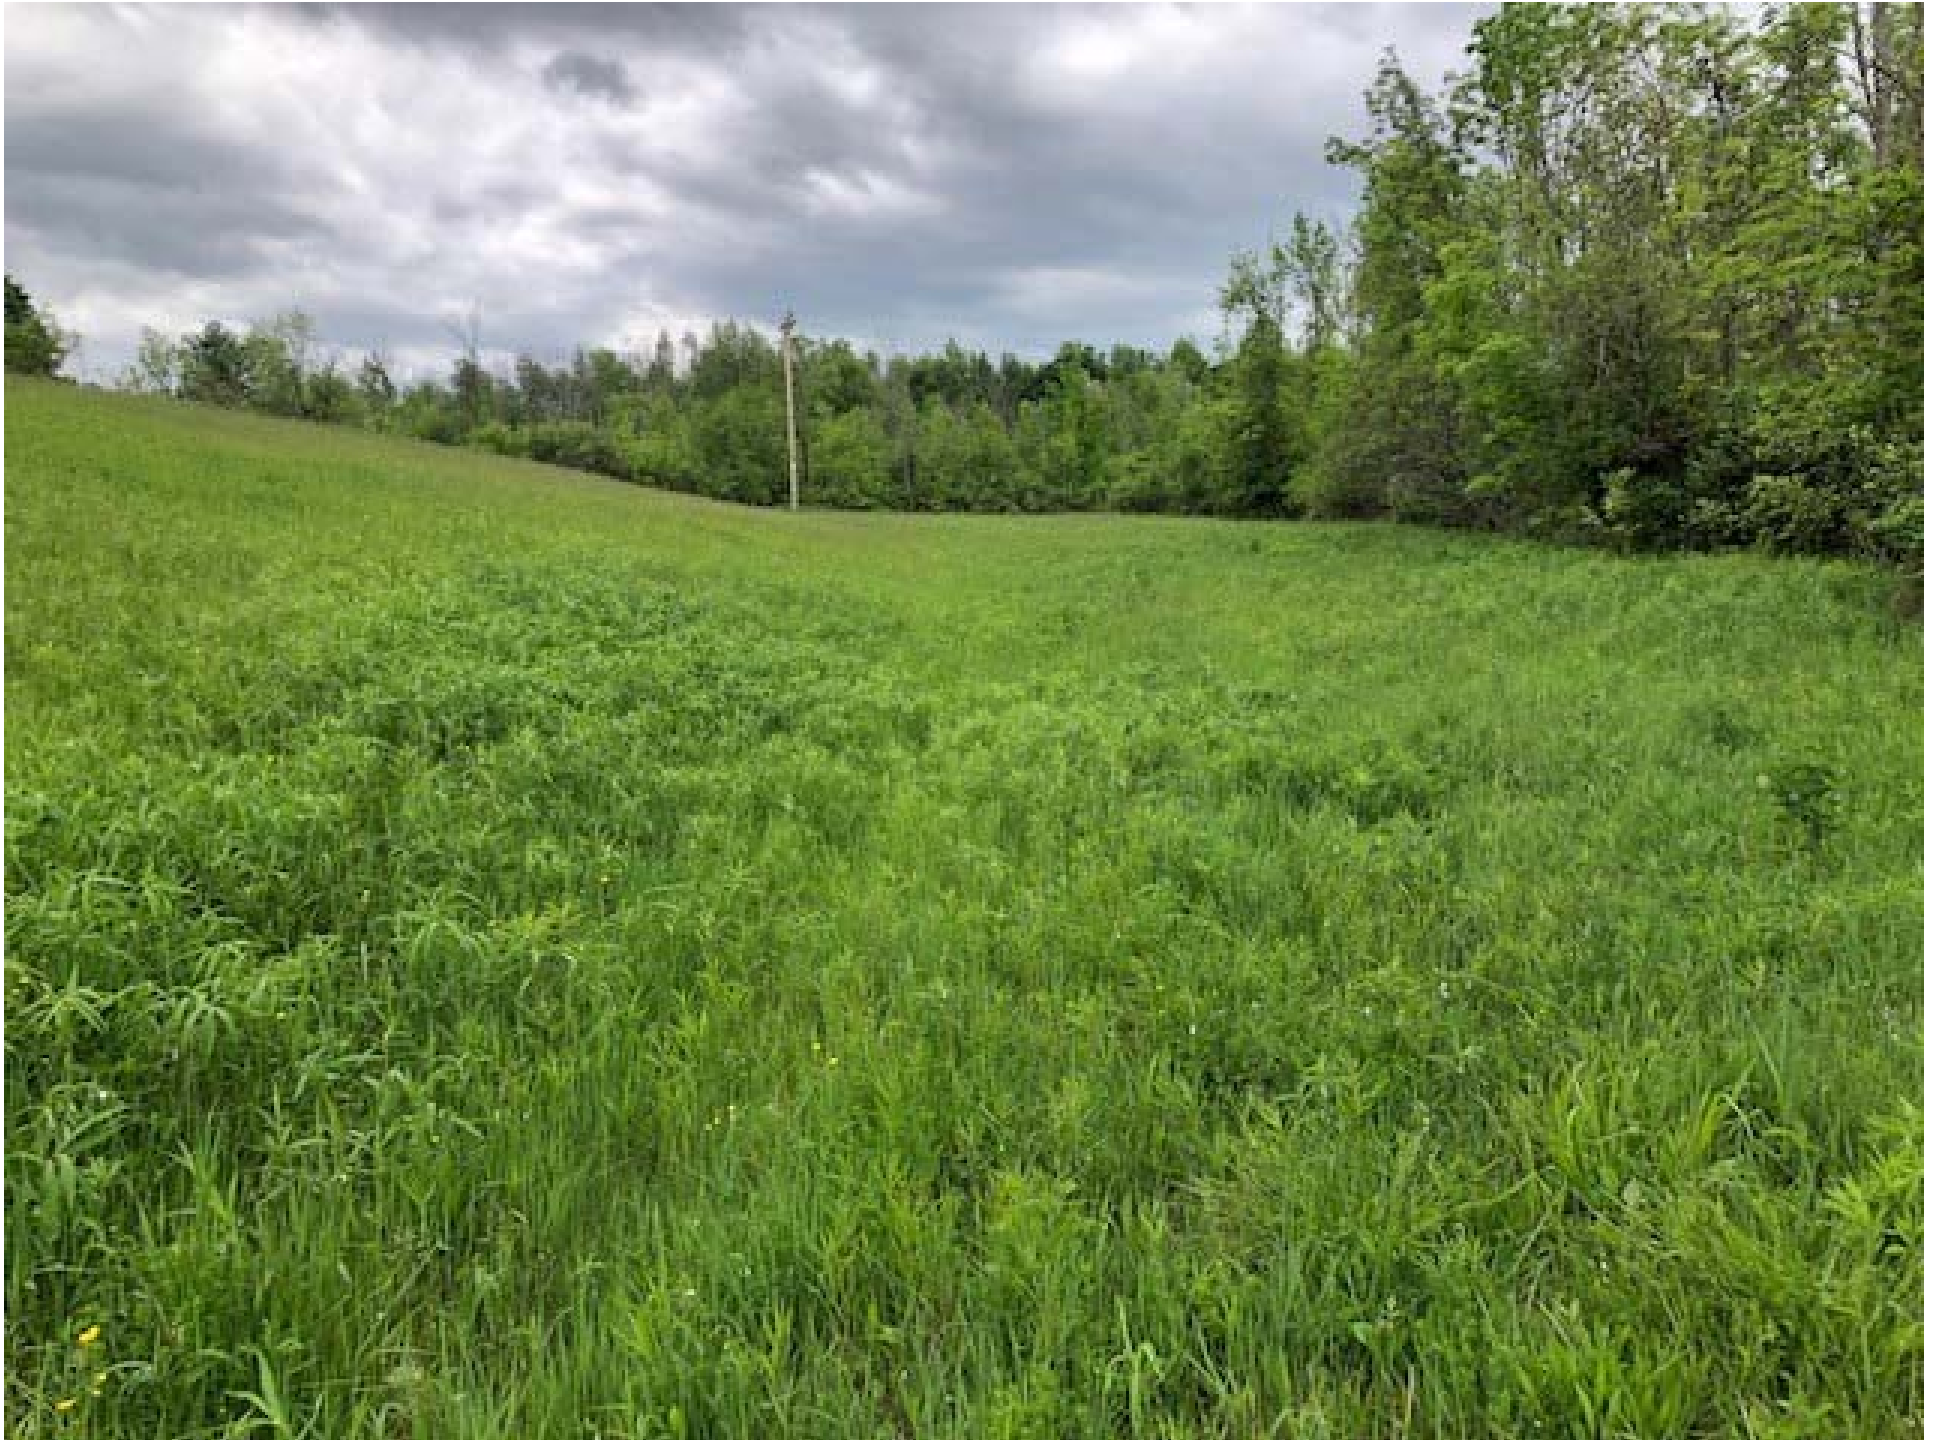
View of the vegetative cover on the west slope of the landfill, facing south.

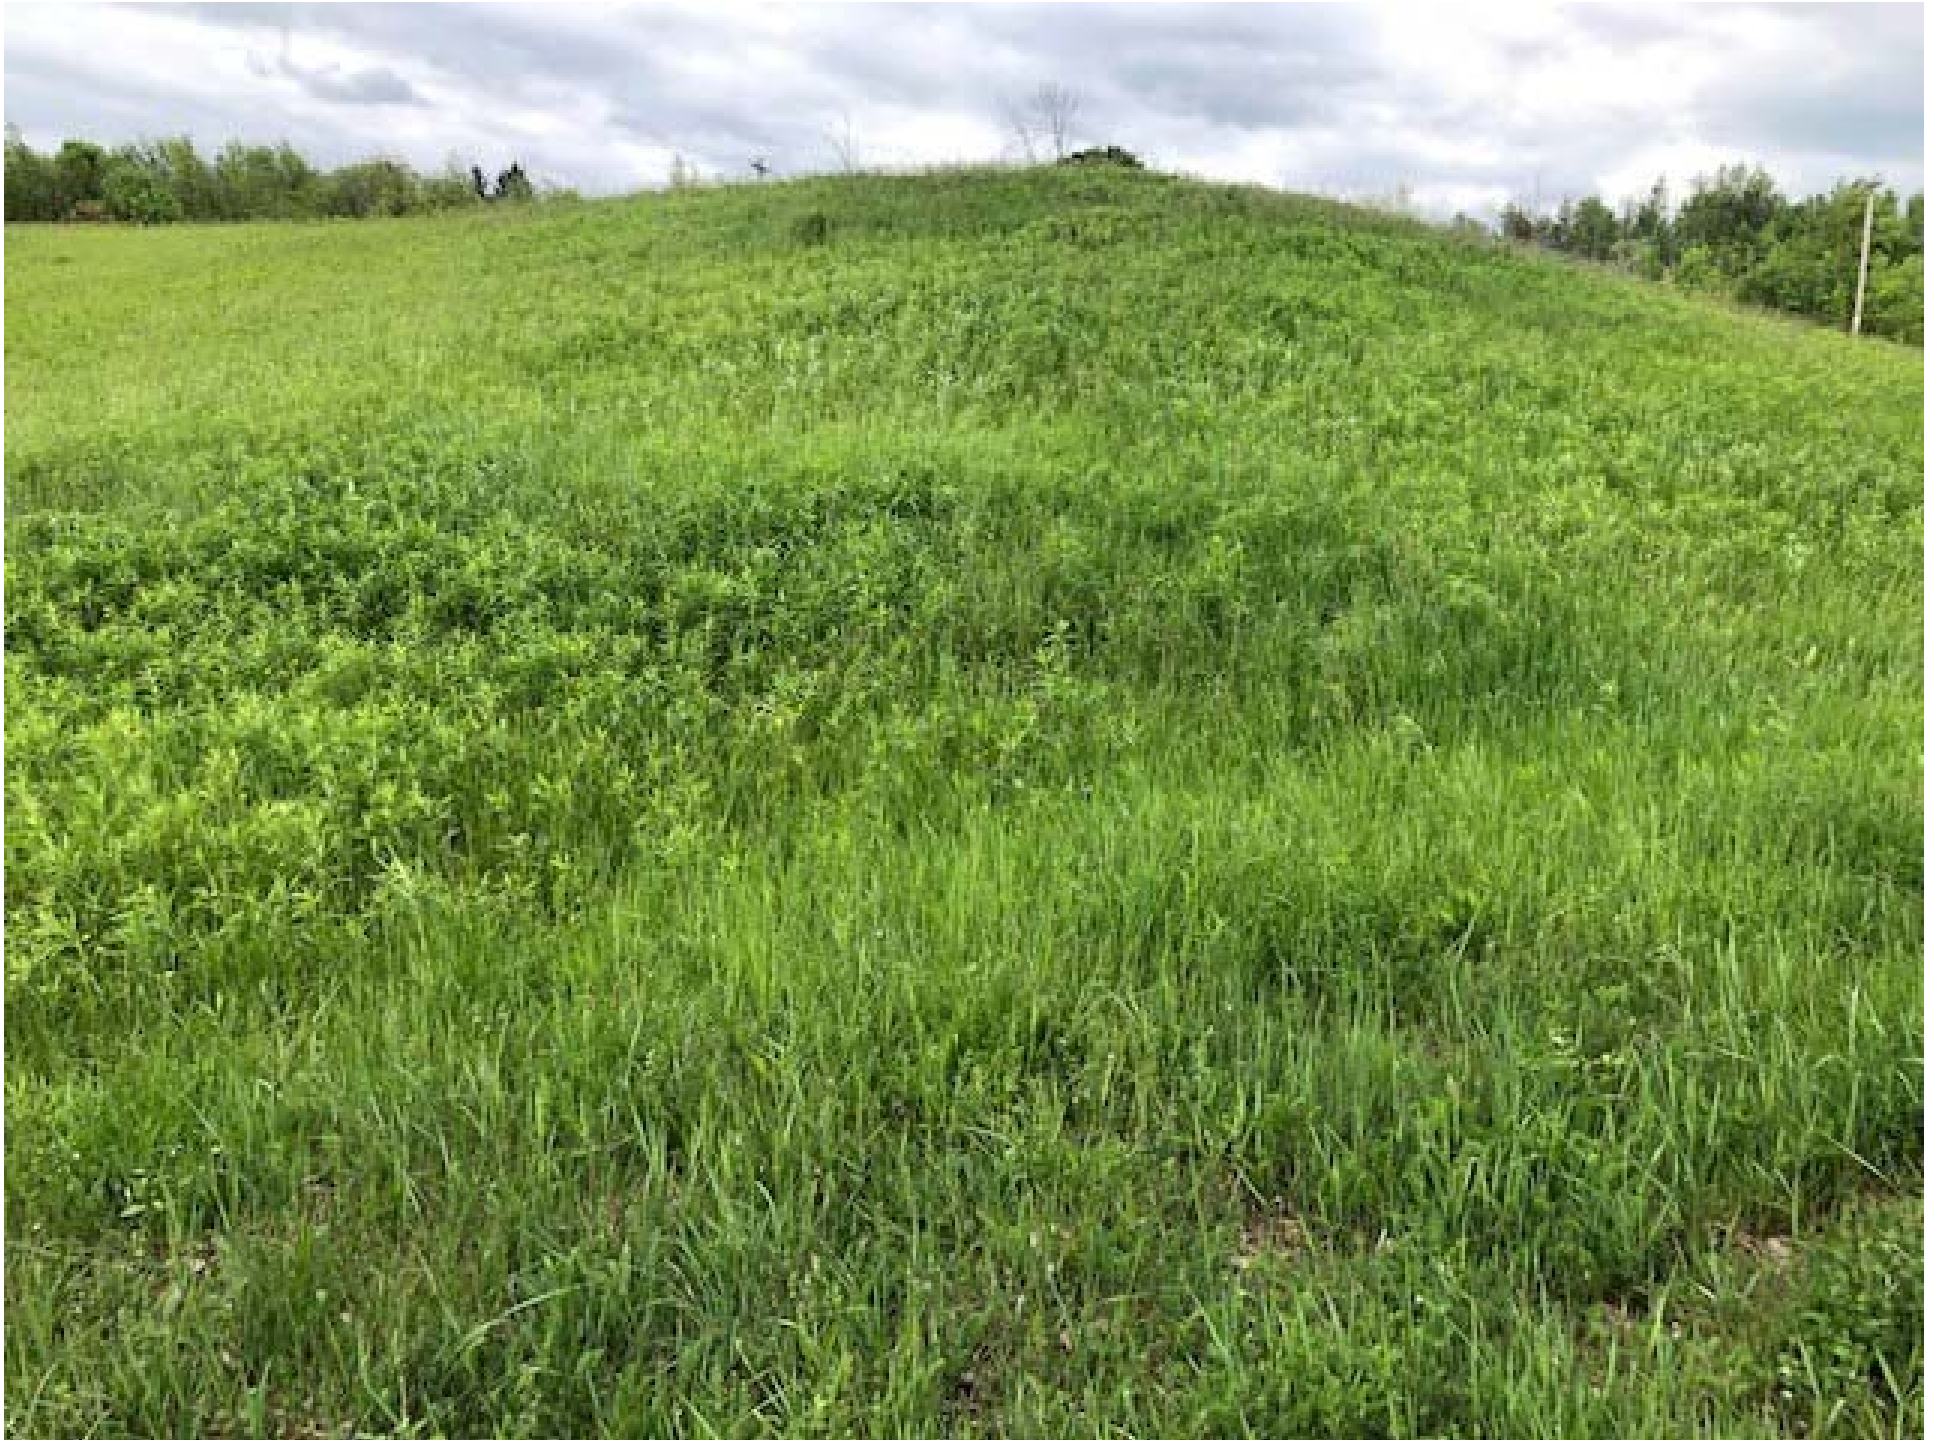
View of the vegetative cover on the northwest slope of the landfill, facing south.

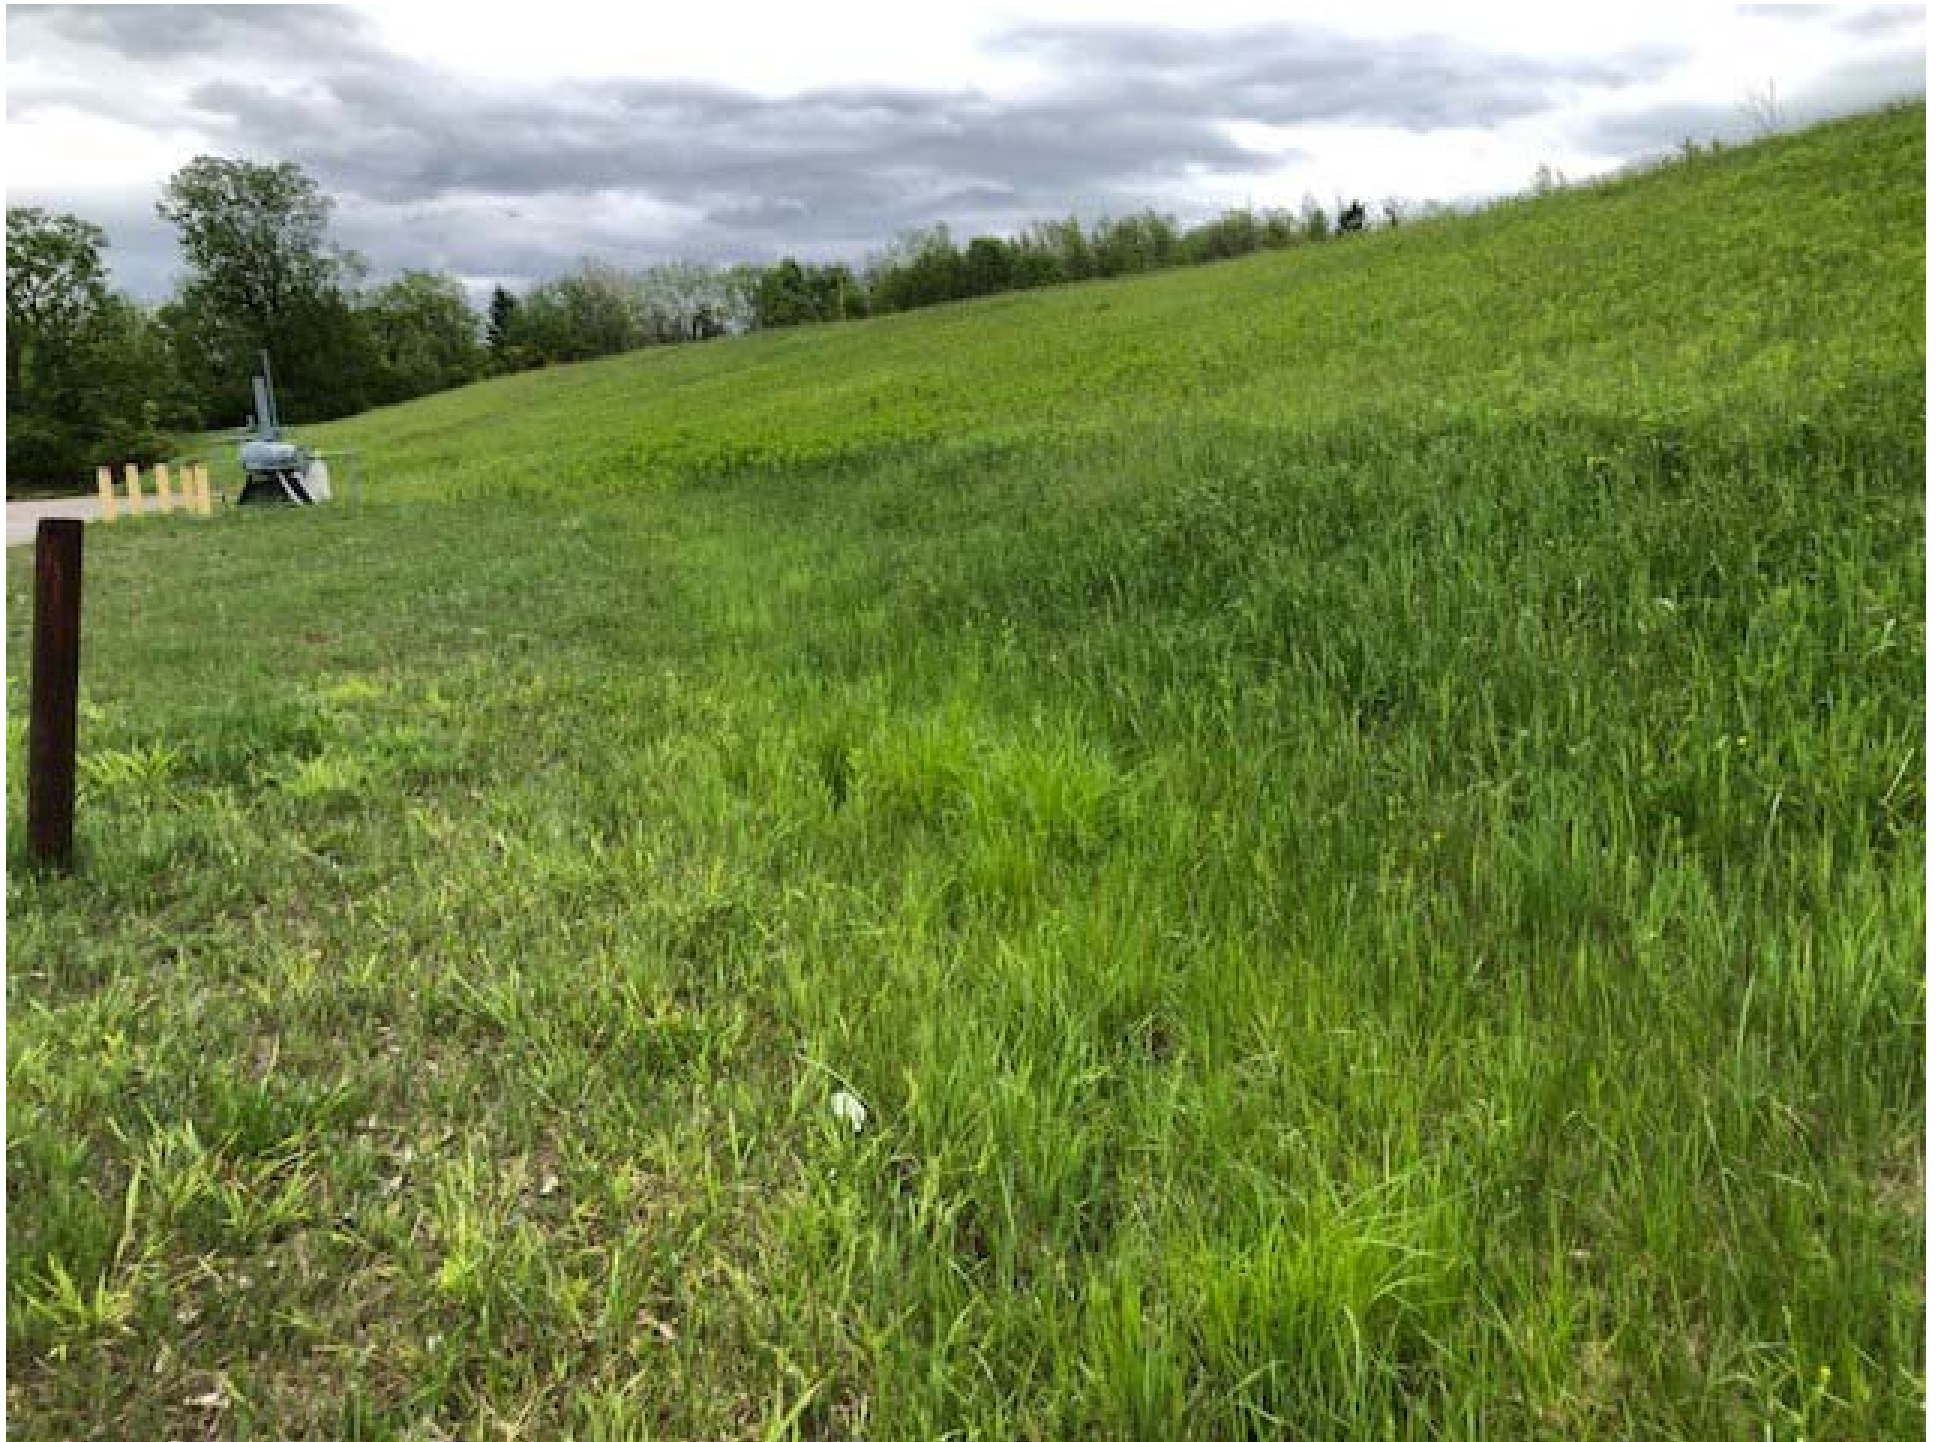
View of the vegetative cover on the north slope of the landfill, decanting tank associated with the gas well (left), facing east.

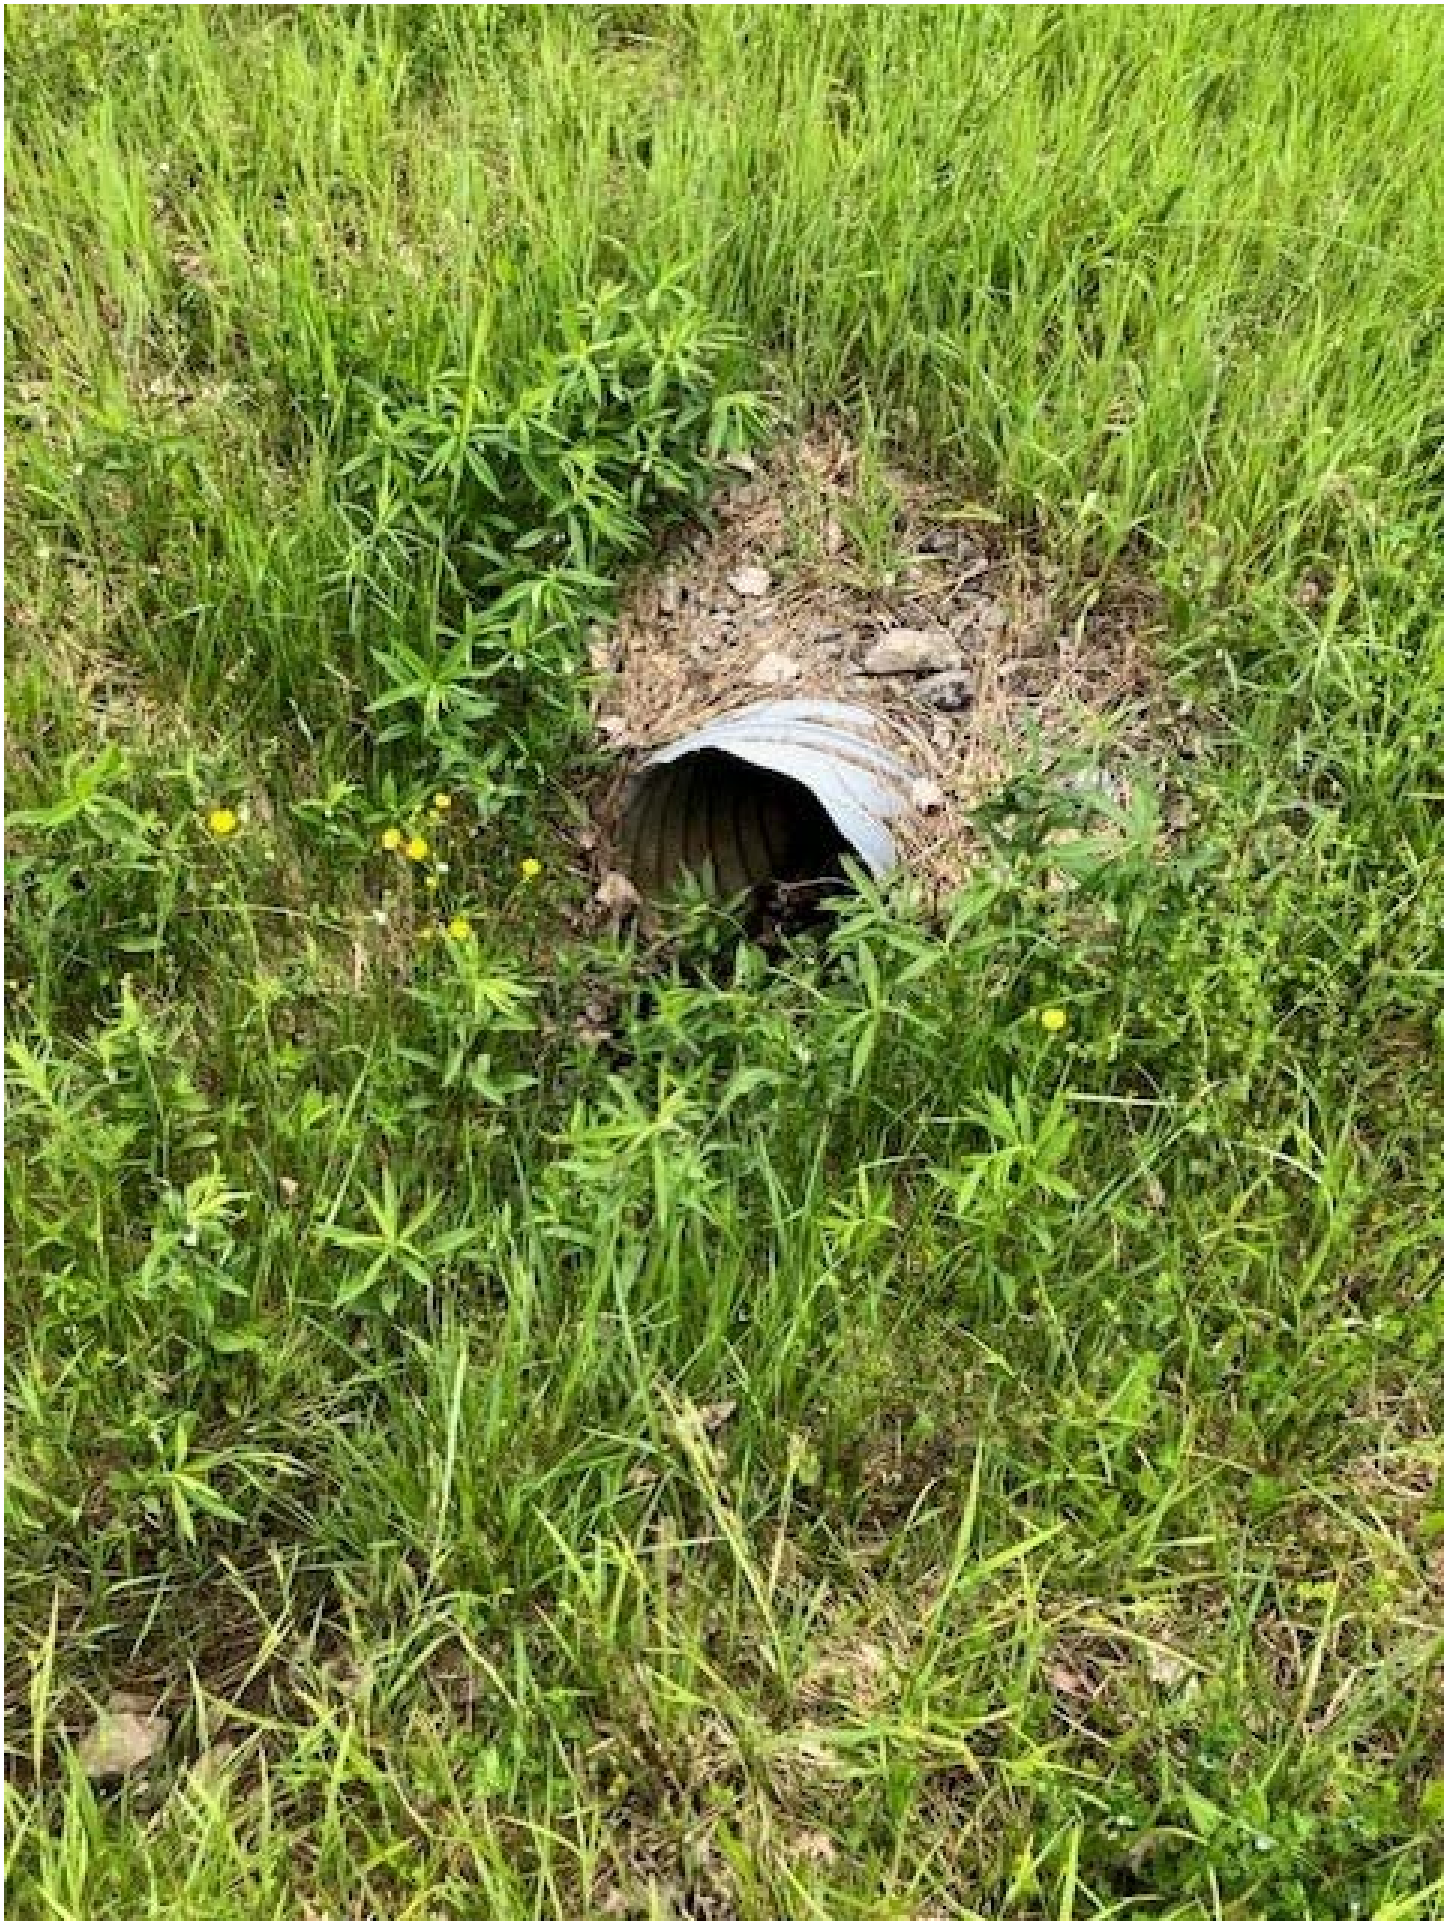
View of the beginning of the drainage way located to the northwest of the landfill area, facing southwest.

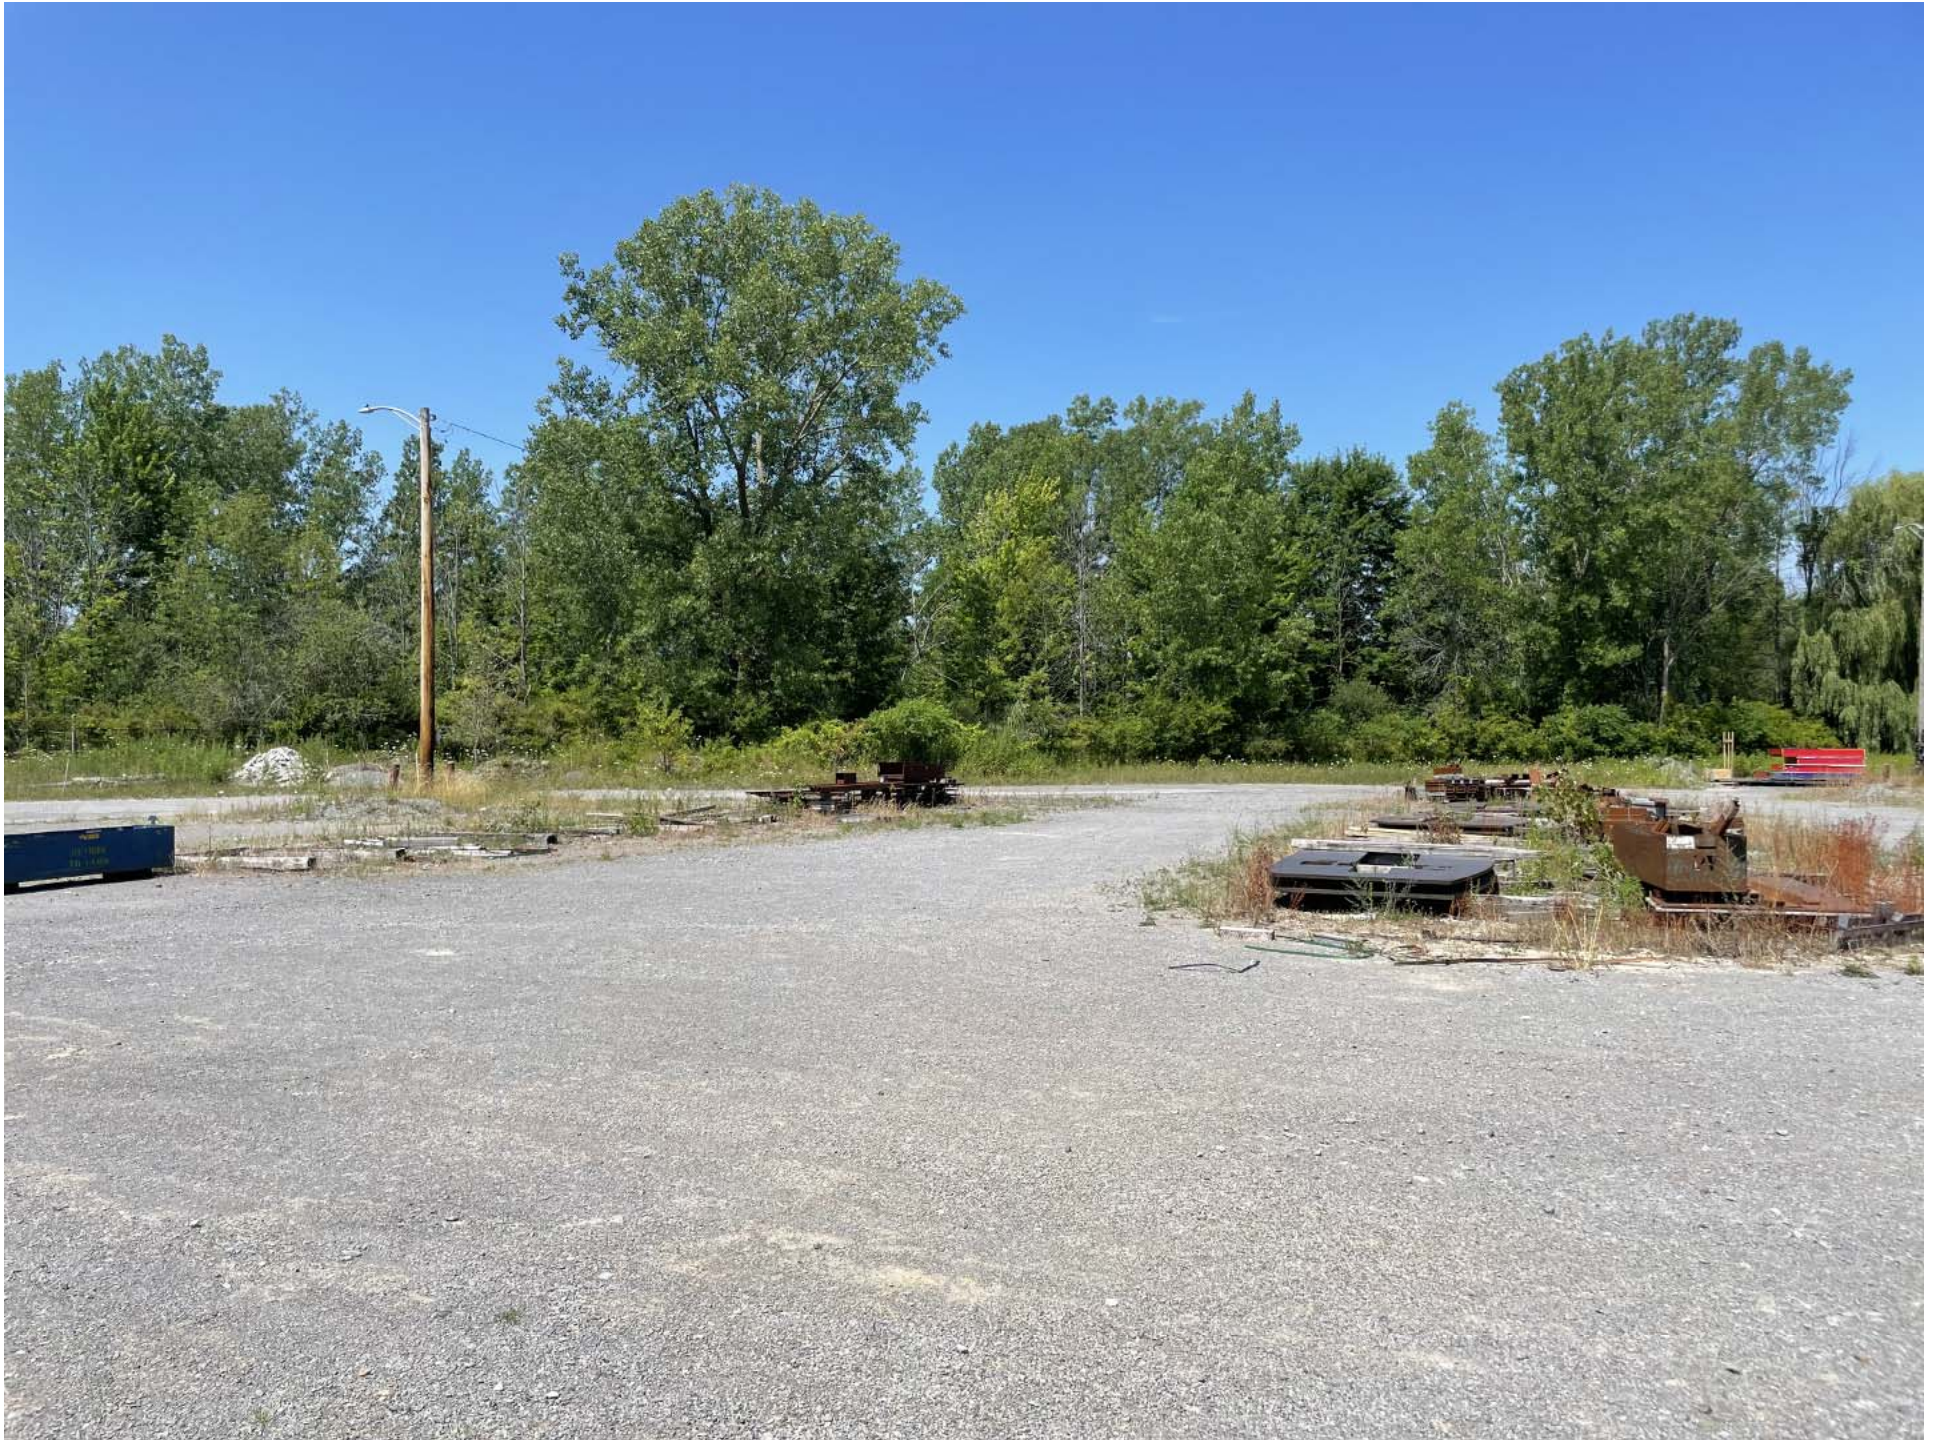
View of the drainage ways (background) located to the northwest of the landfill (not visible in photo), facing west.

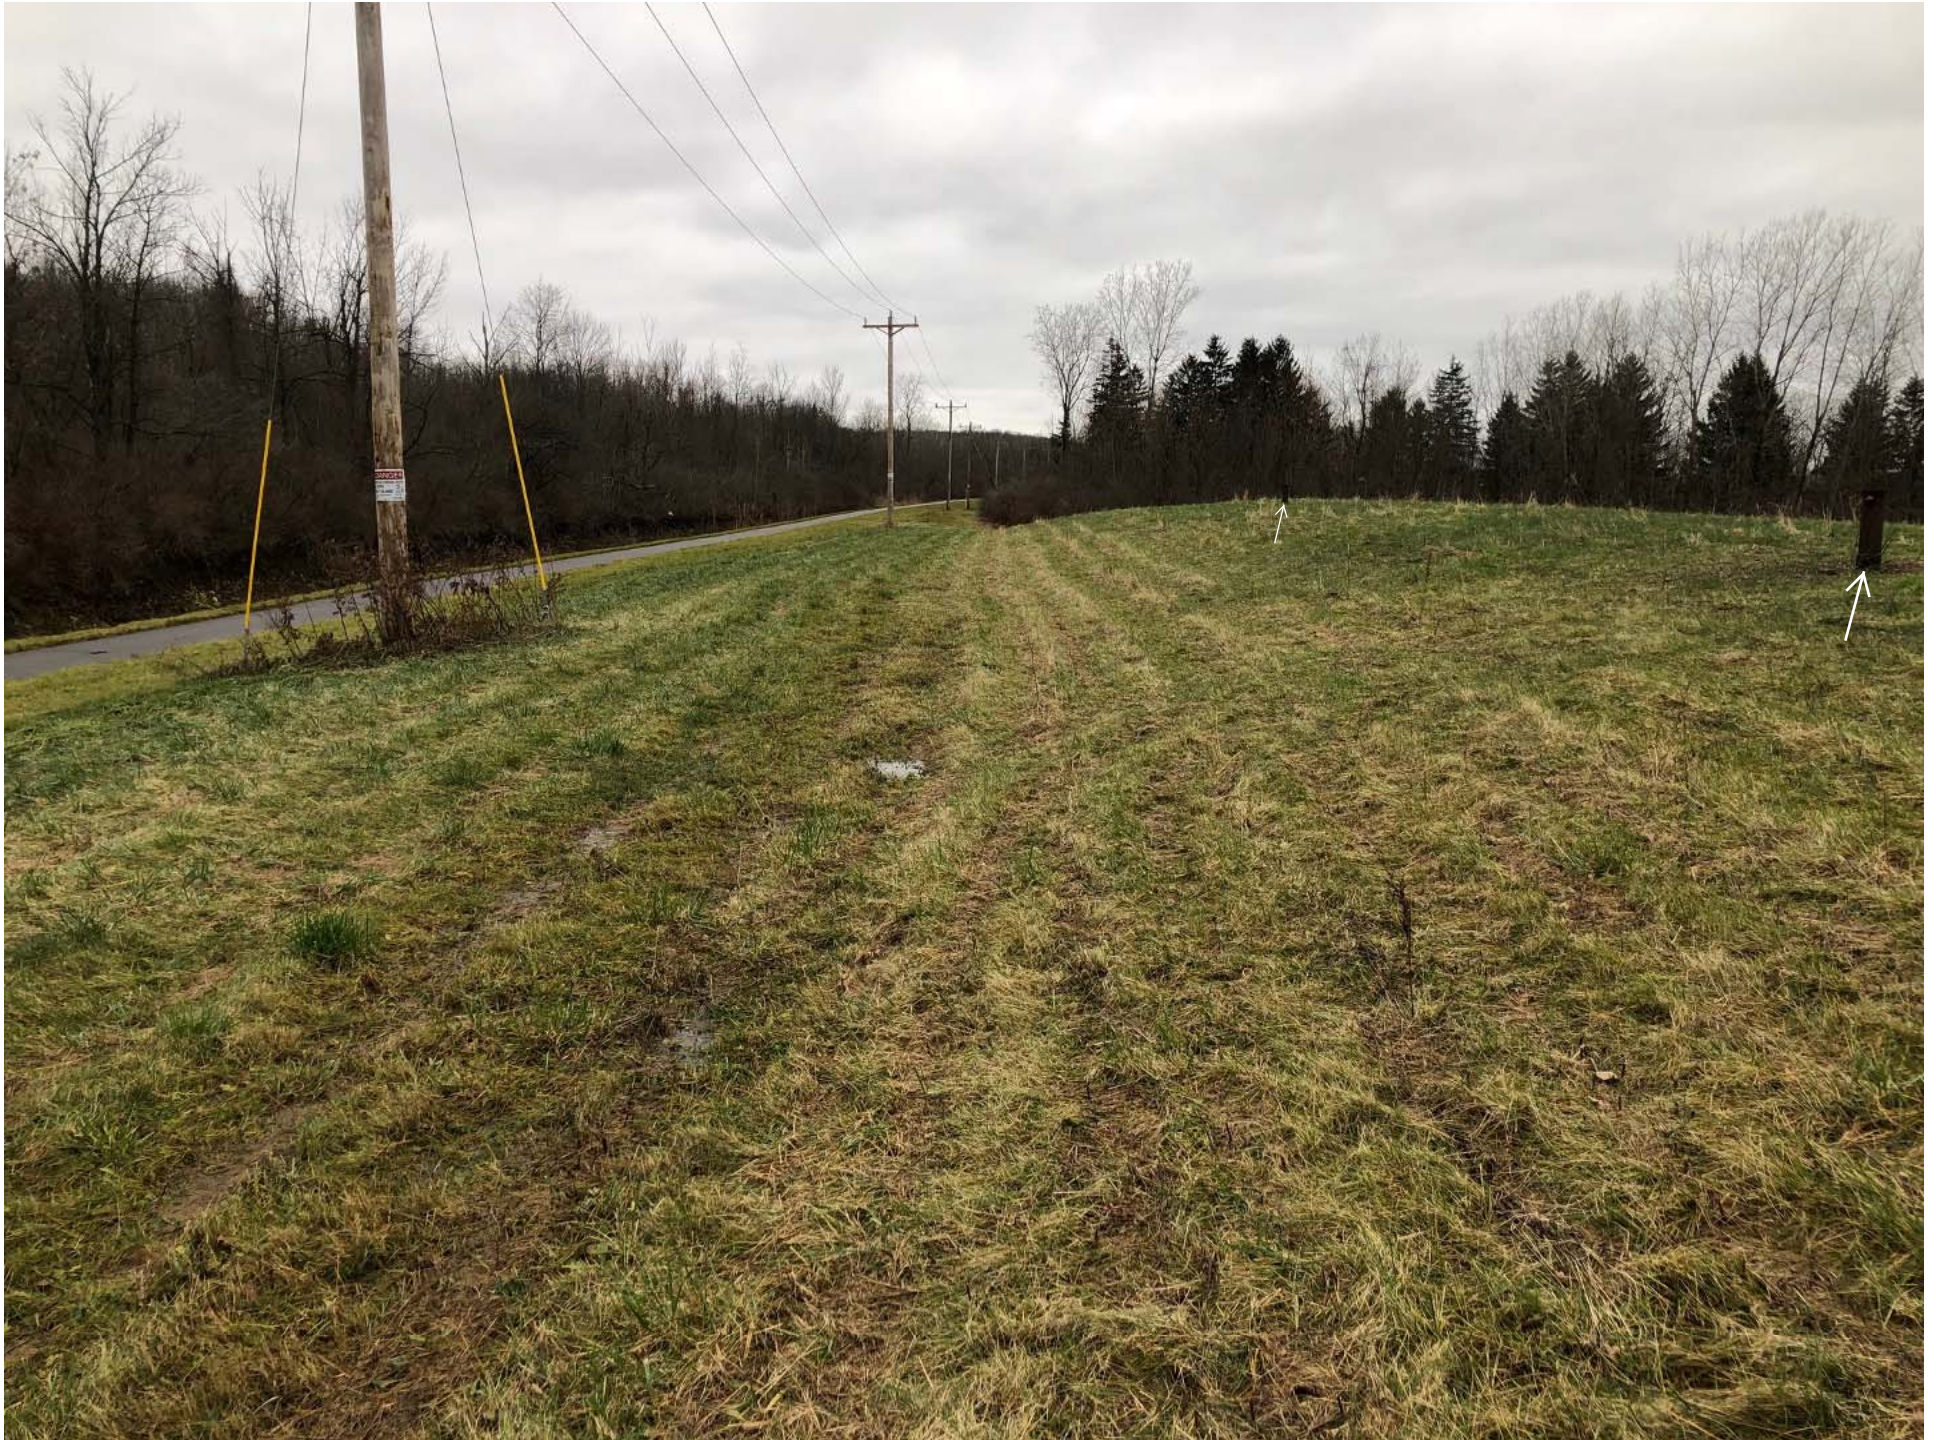
View of the vegetative cover on the top/southern edge of the landfill area, adjacent pedestrian path (left), and monitoring well casings (right, arrows) facing west.

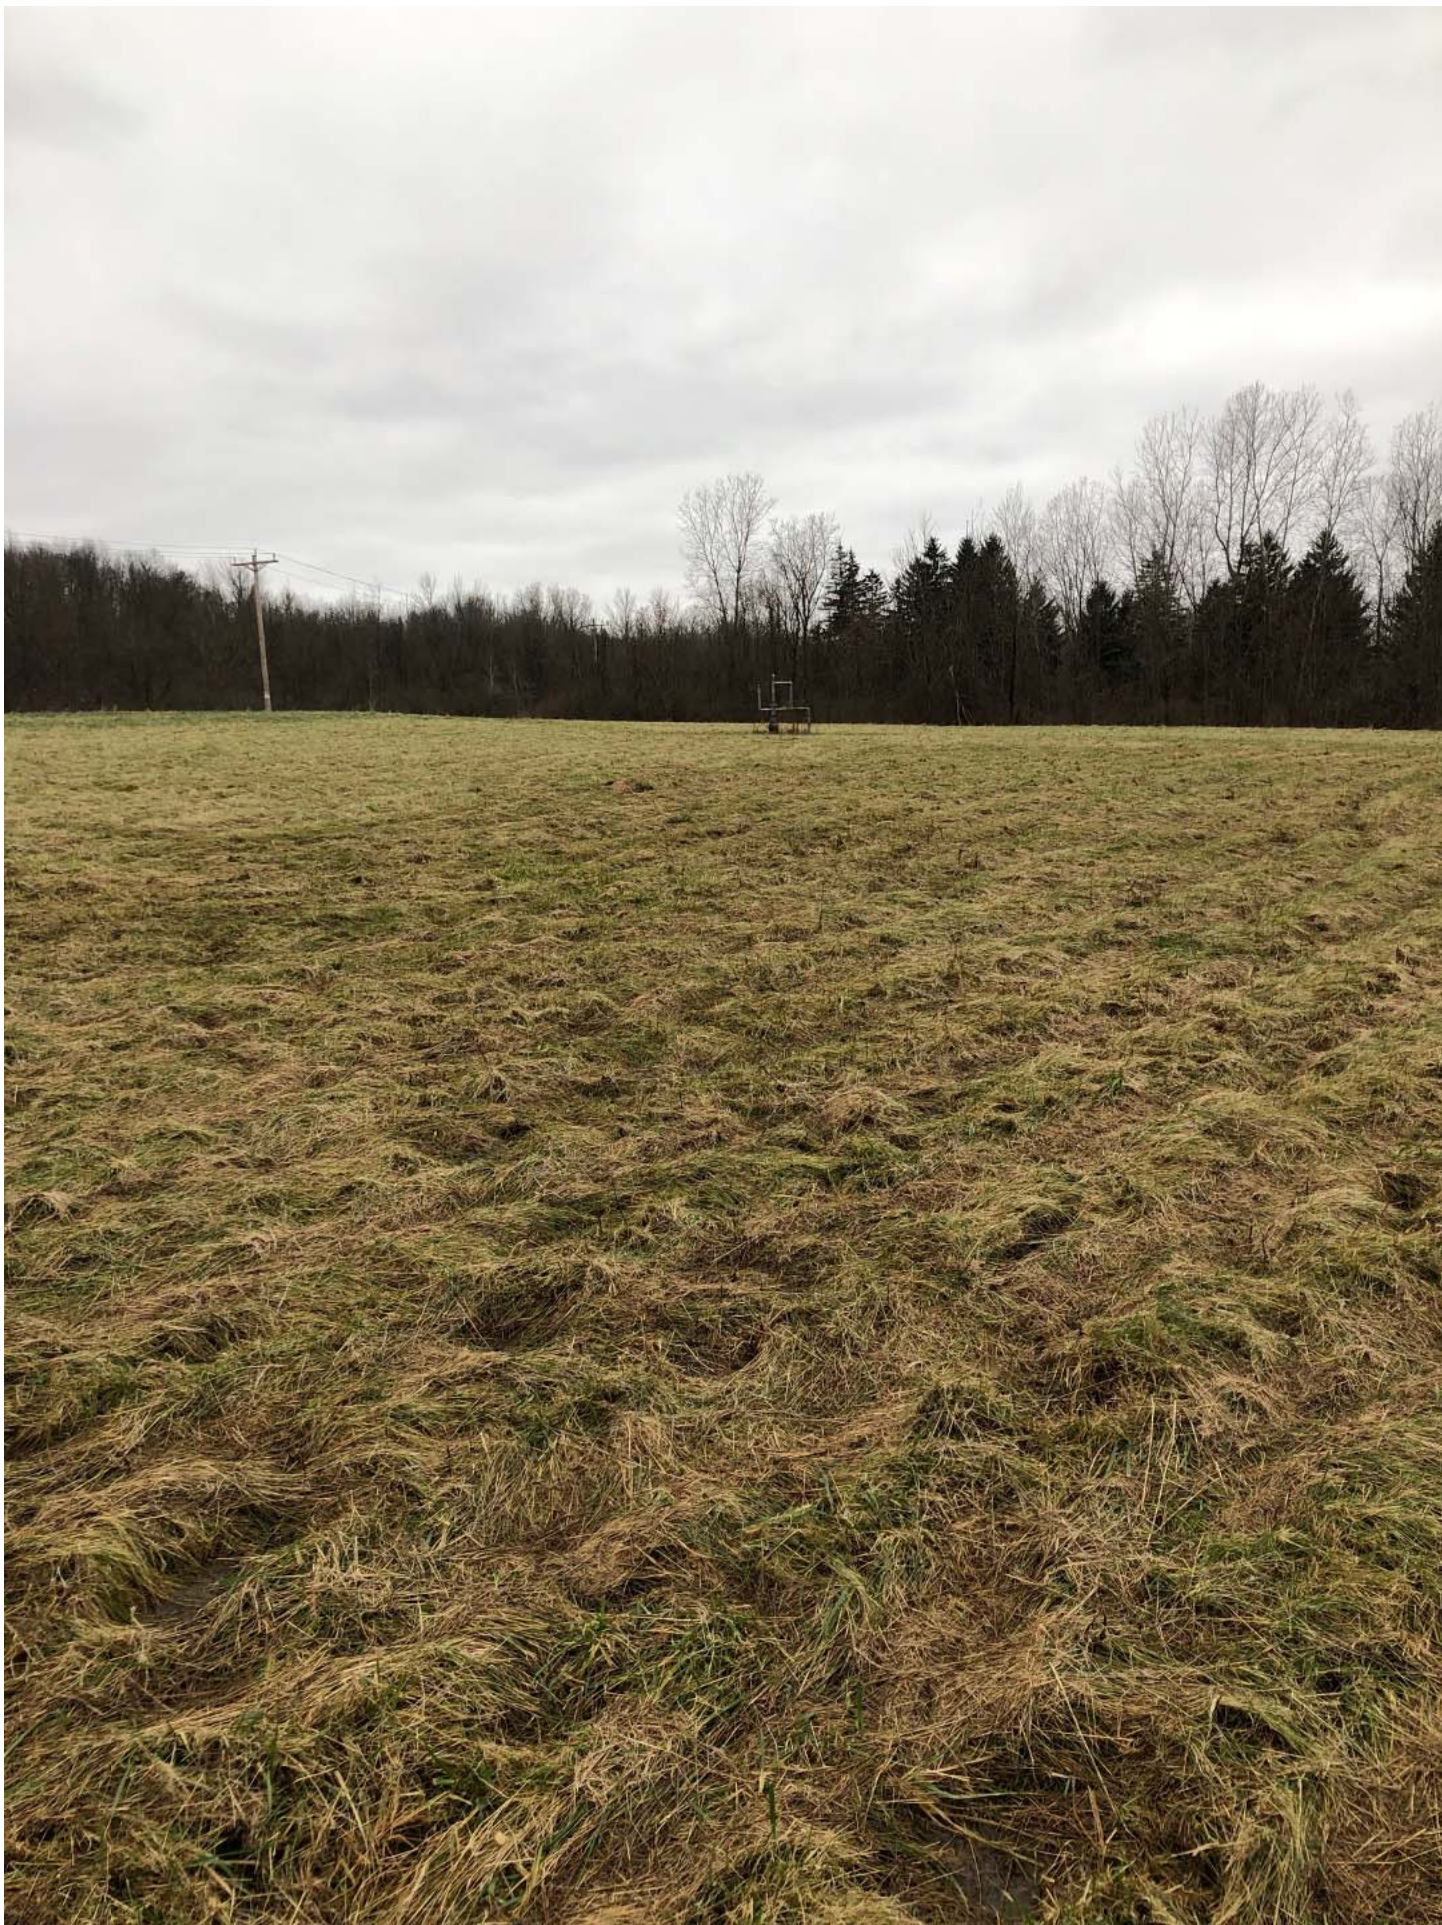
View of the vegetative cover on the top of the landfill area with the gas well visible in the background, facing southwest.

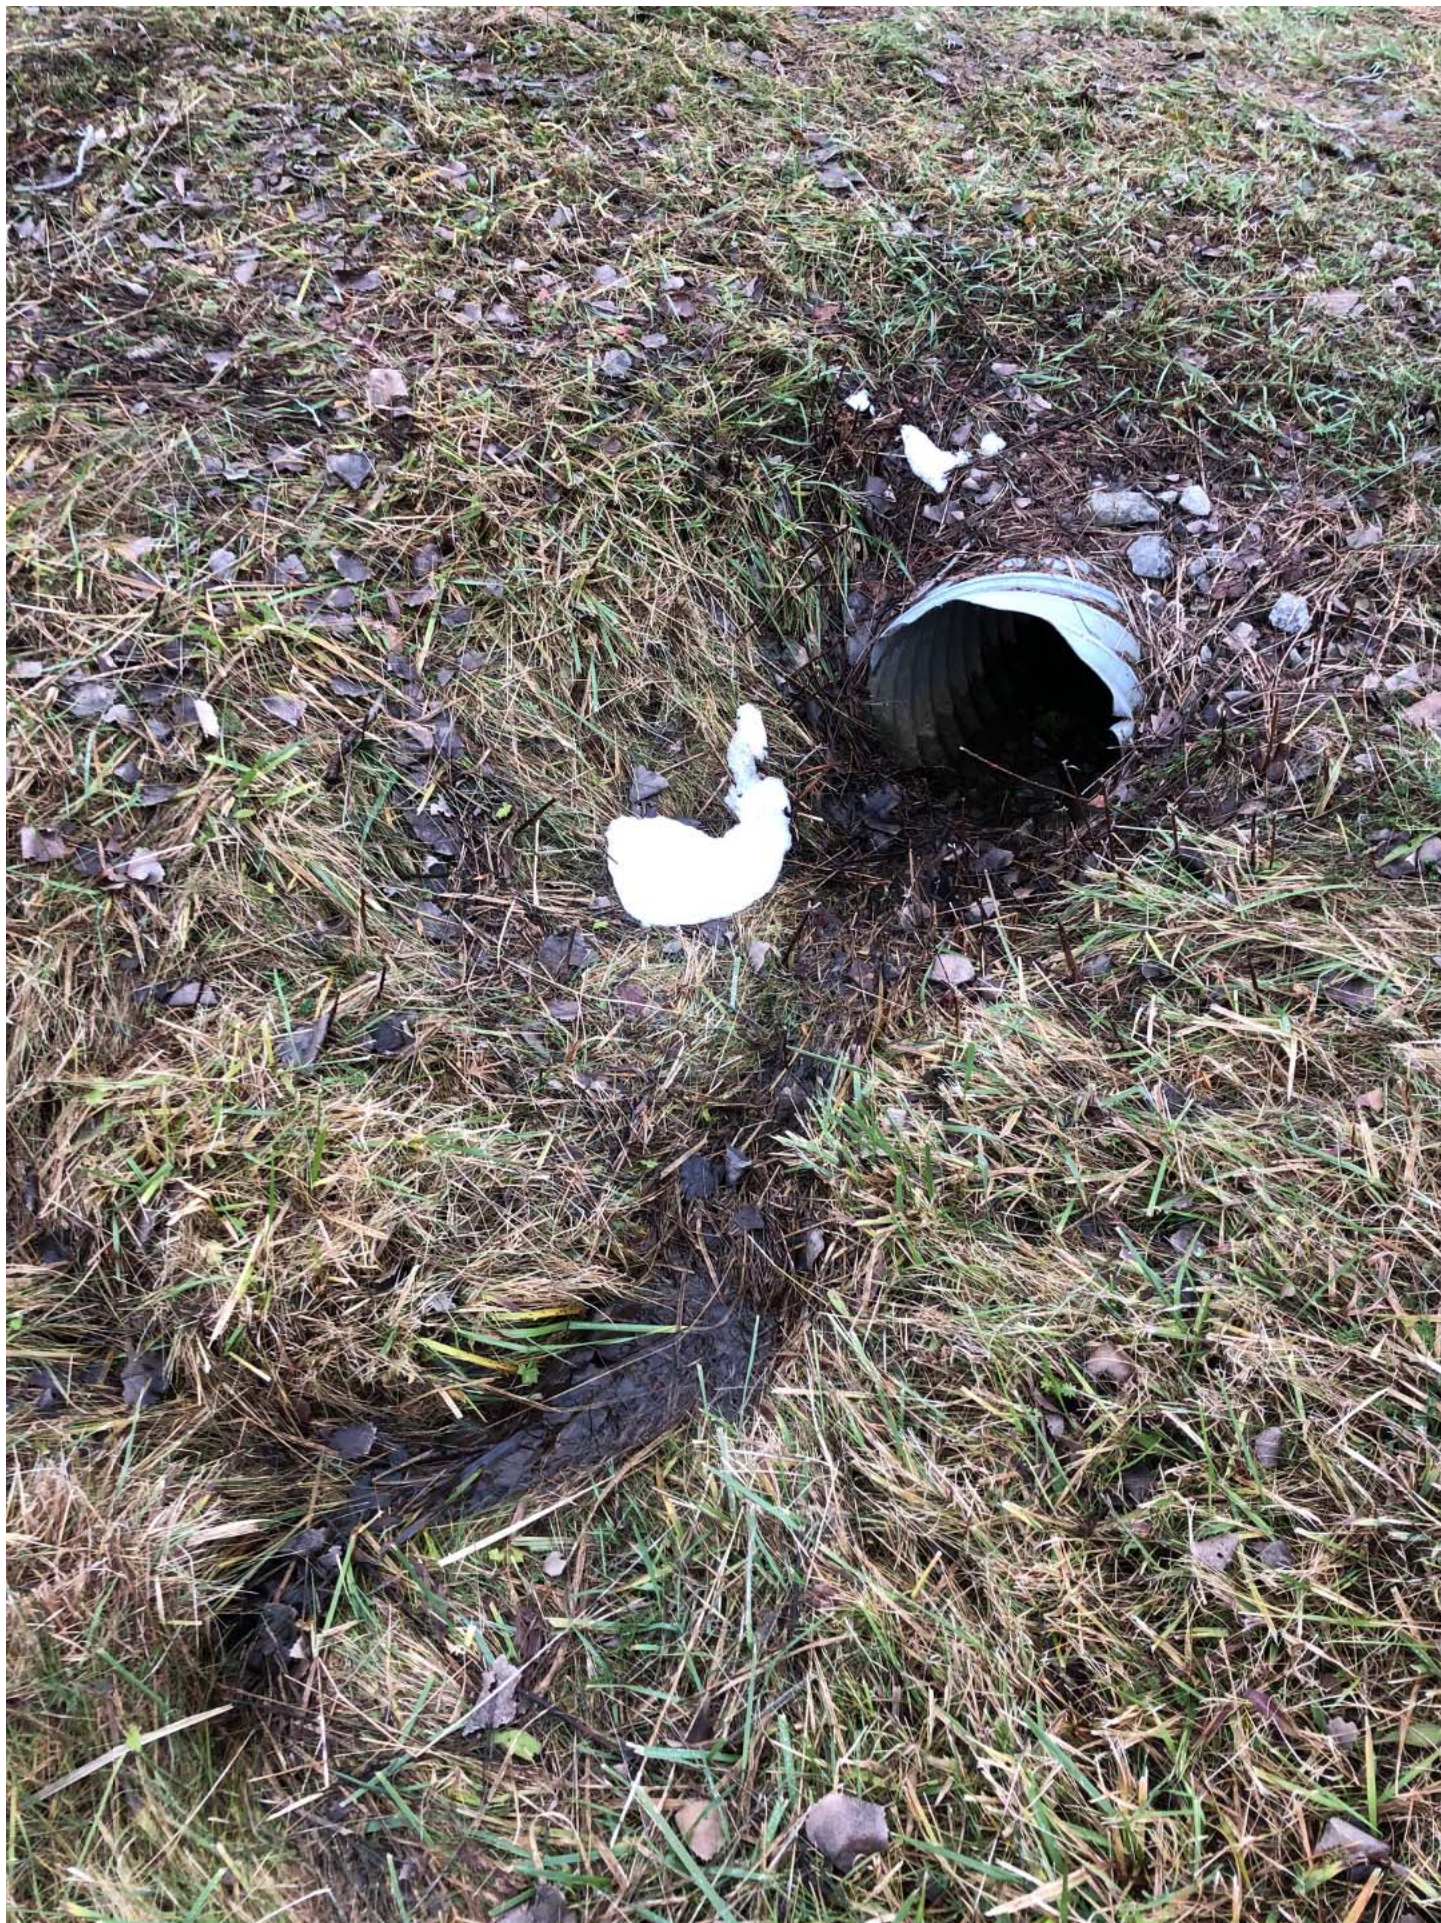
View of the beginning of the drainage way located to the northwest of the landfill area, facing southwest.
