PERIODIC REVIEW REPORT
REPORTING PERIOD: JANUARY 31, 2022 THROUGH JANUARY 31, 2025

12975 CLARENCE CENTER ROAD
AKRON, NEW YORK
NYSDEC SITE NO. 915053

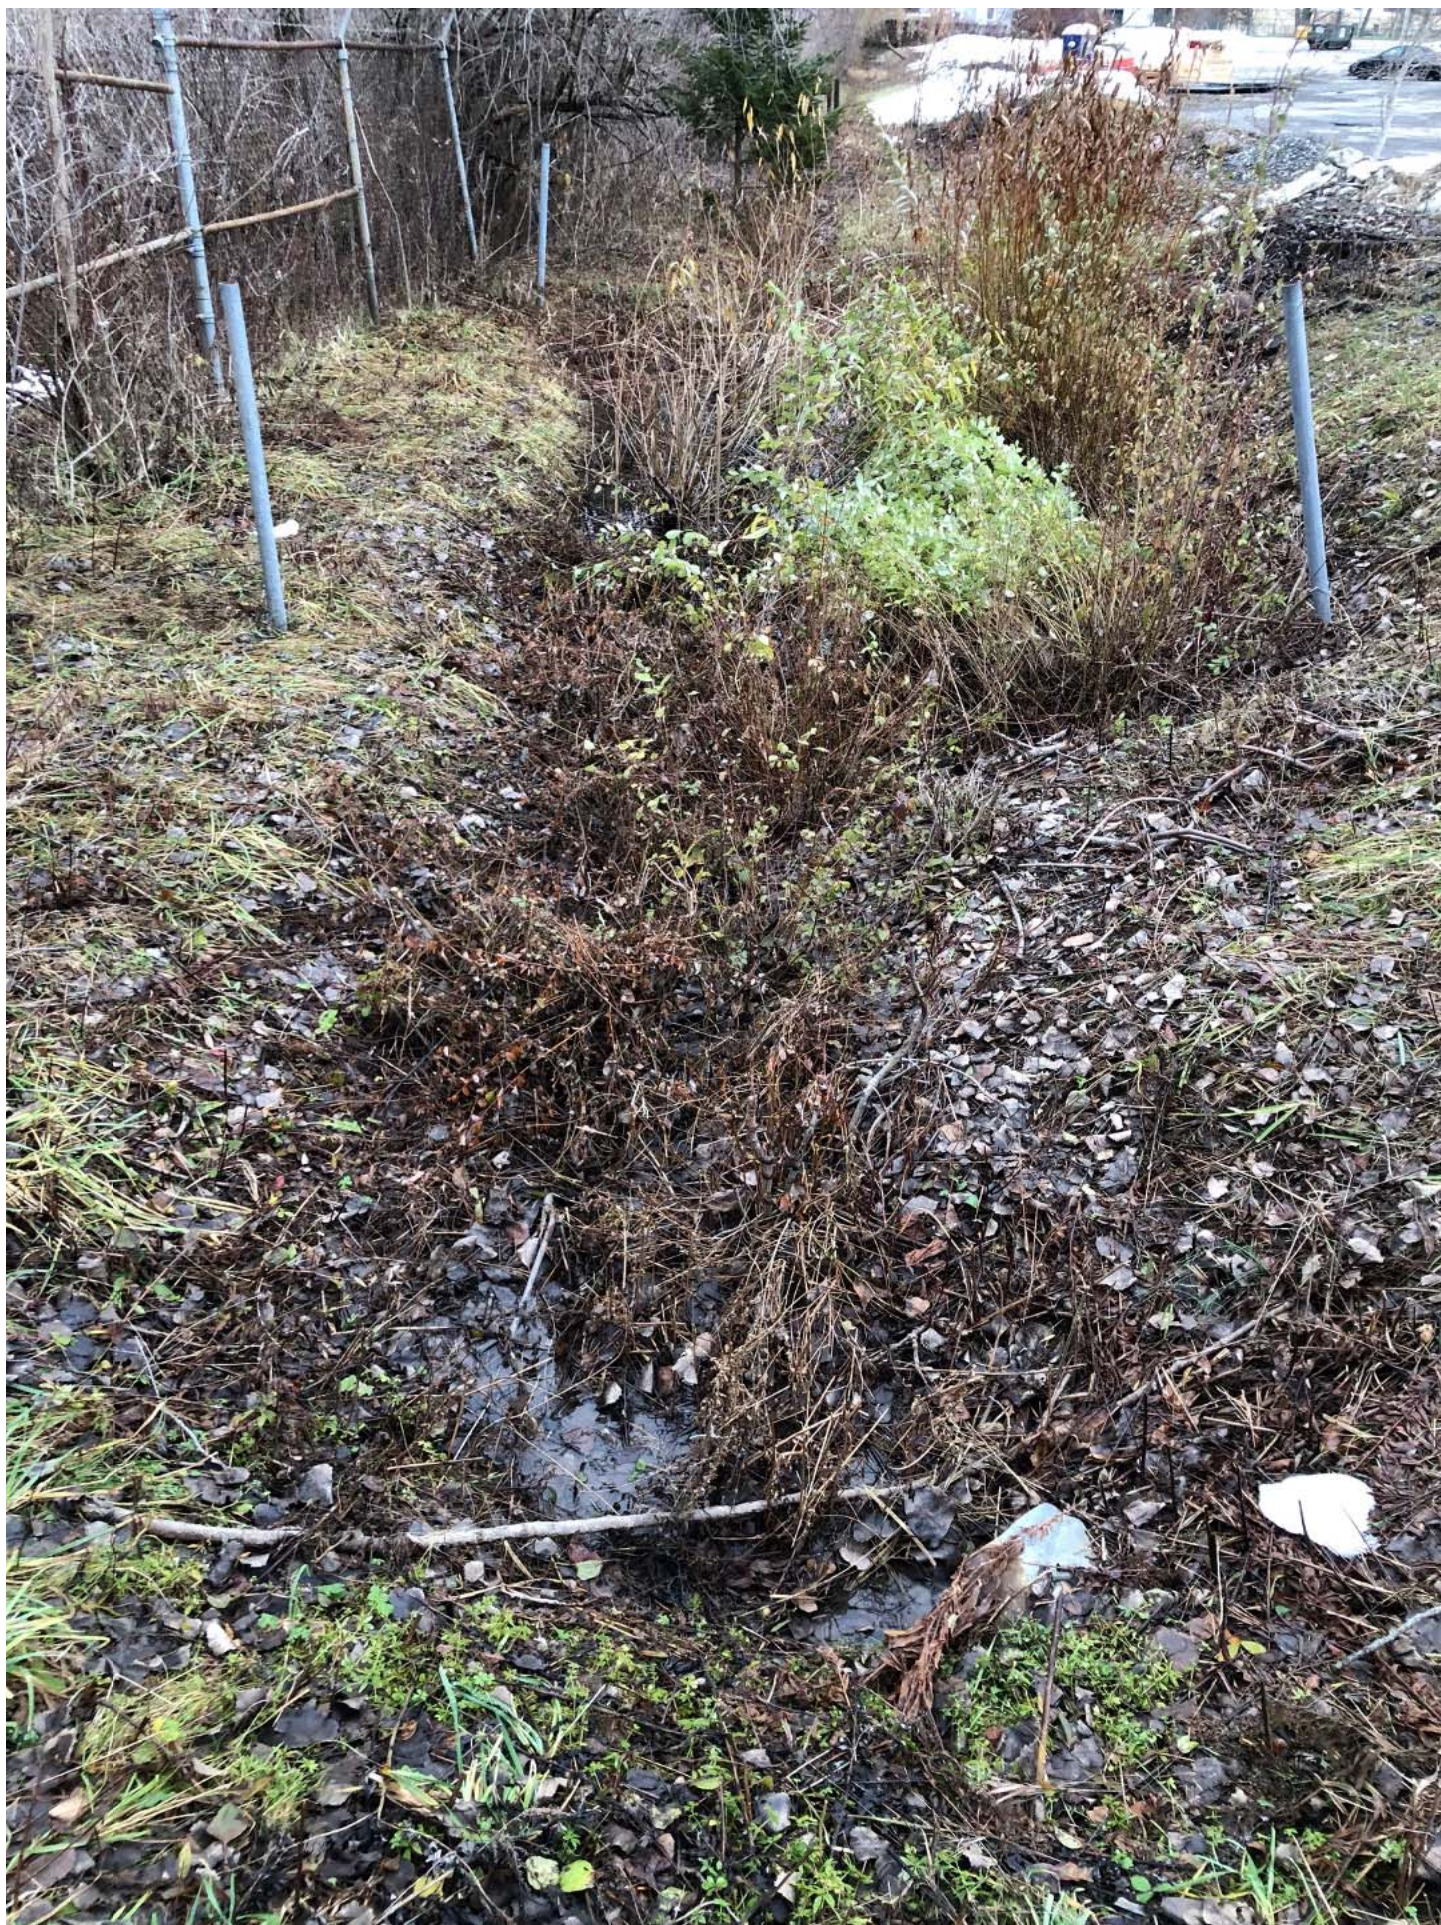
Condition of drainage ways (discuss amount of water/sediments present, vegetative growth unusual staining, blockage, etc.): Drainage ways are generally free of sediment and debris. Some vegetation in detention pond, but flow does not appear to restricted.

View of the drainage way (partially blocked by vegetation) located to the northwest of the landfill area facing northwest.

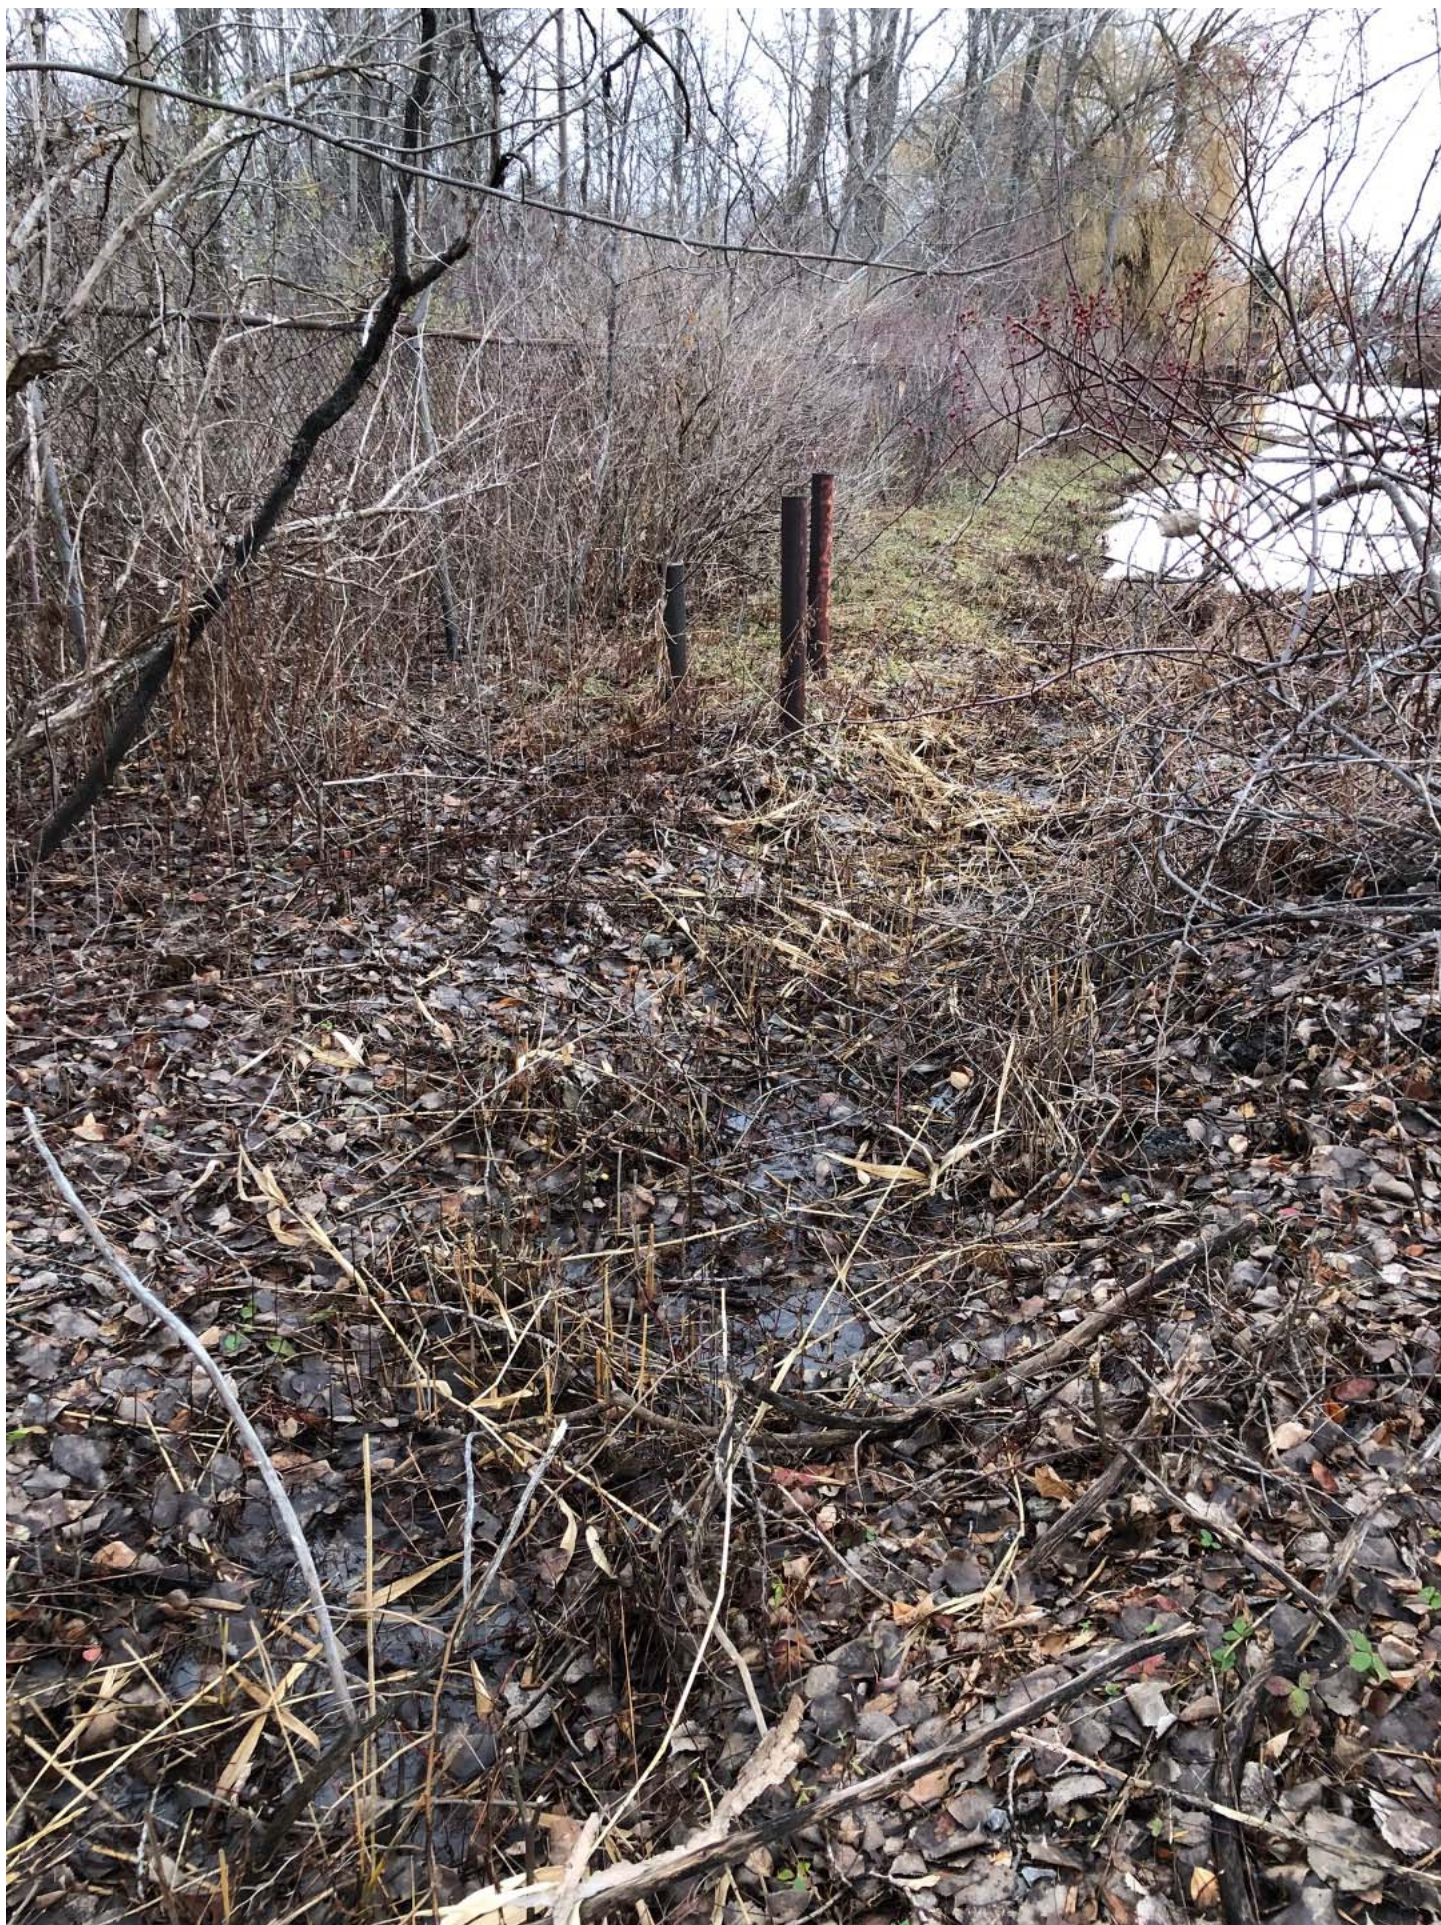
View of the drainage way (partially blocked by vegetation) located to the northwest of the landfill area, with monitoring well GW-2 and protective bollards visible in the middleground, facing northwest.

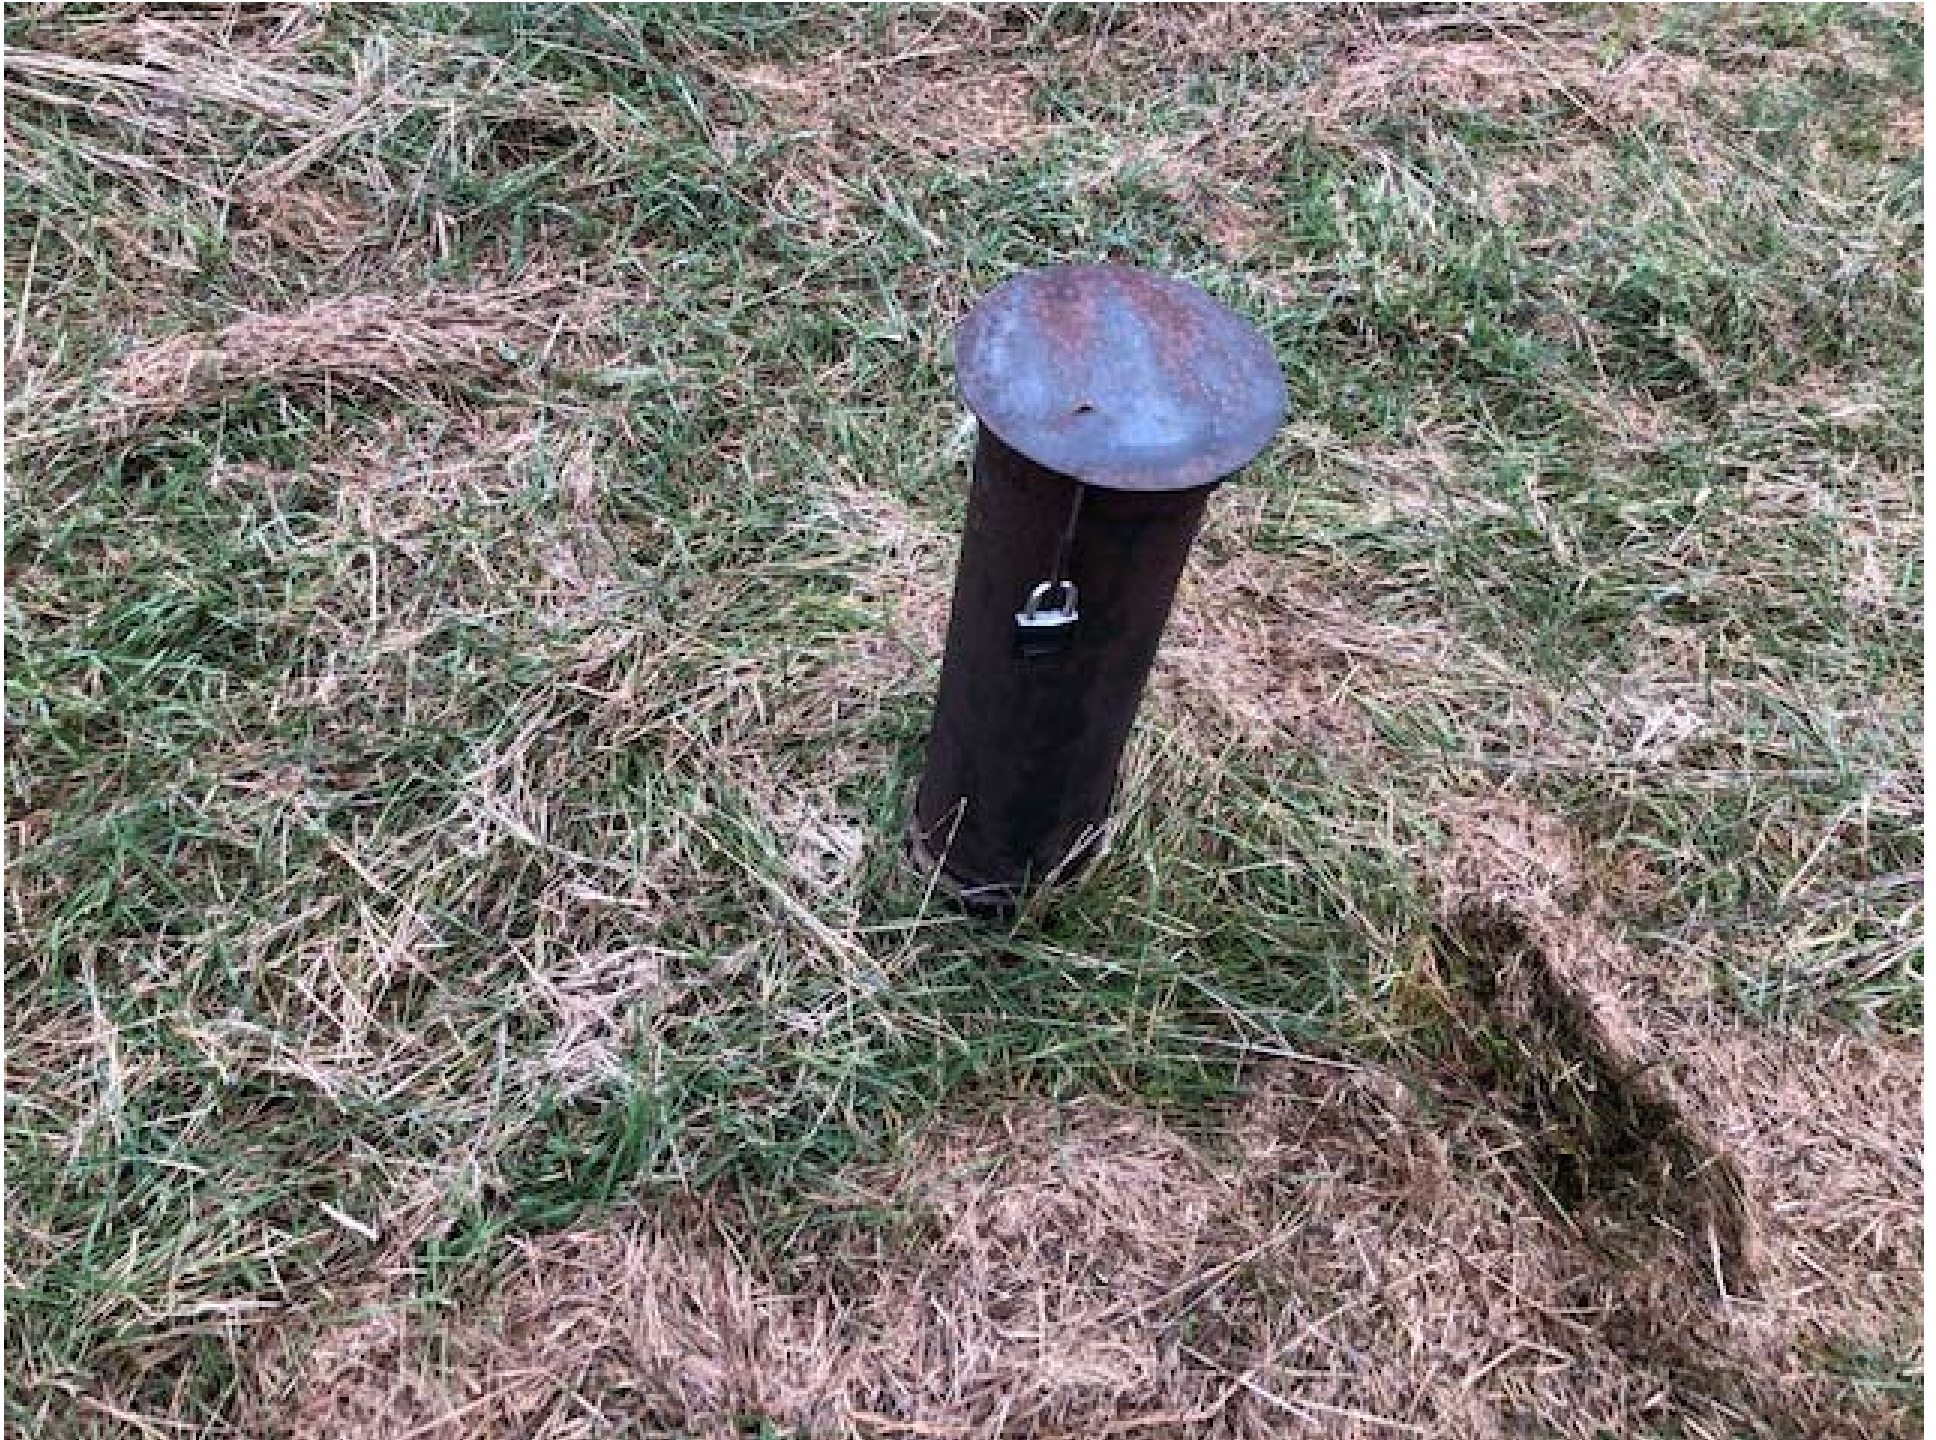
View of the stick-up, steel, protective casing and cover for groundwater monitoring well GW-2.

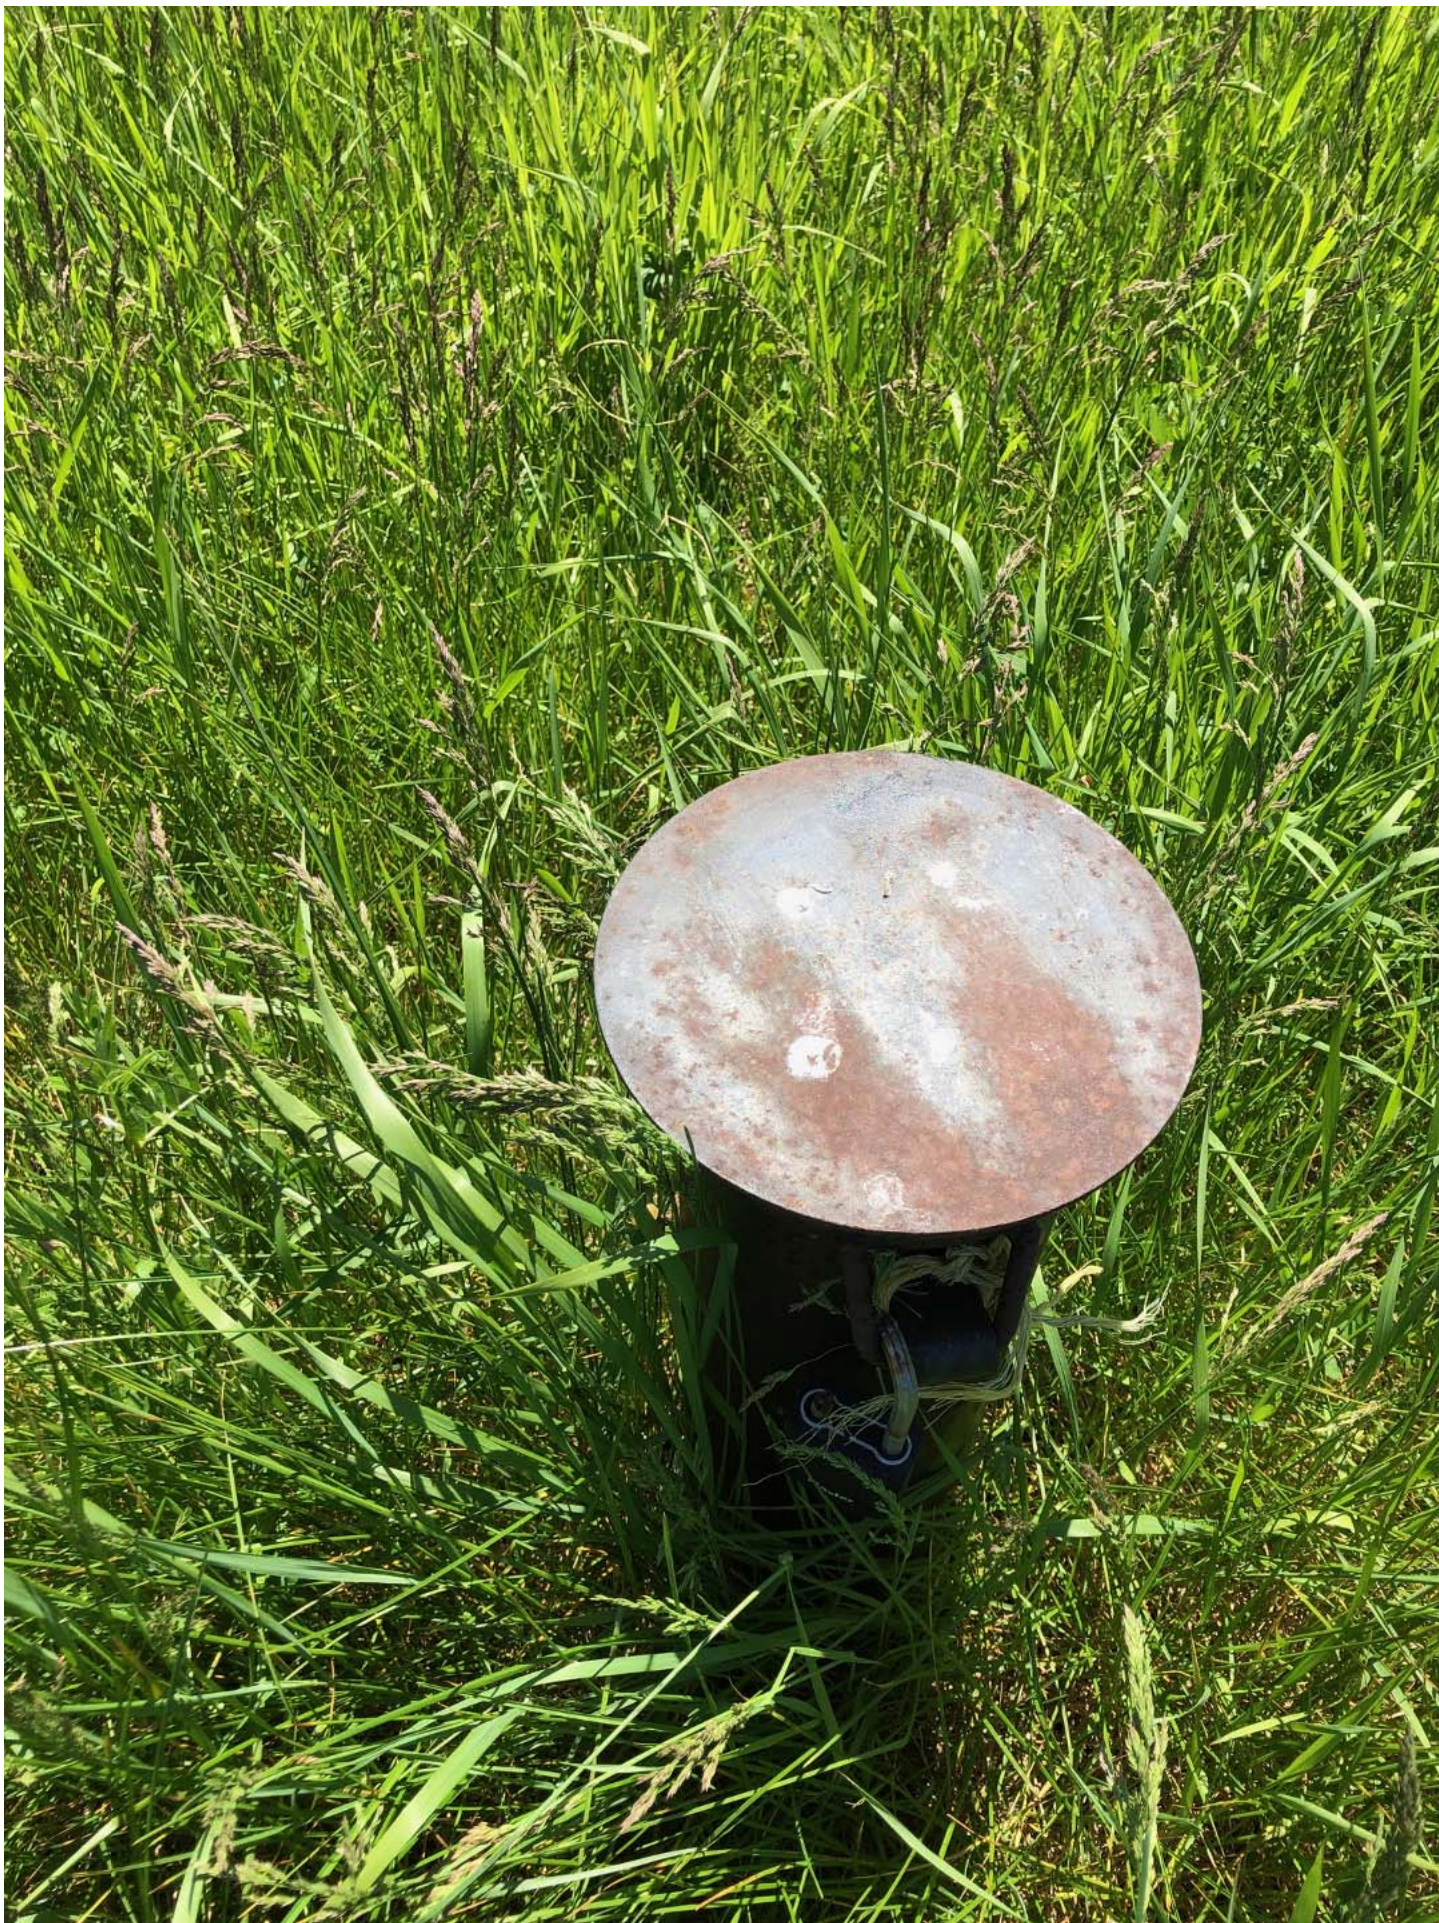
Condition of monitoring wells and gas wells: Monitoring wells are in good condition and locked (i.e., except GW-2, where the lock is present, but has been cut). Gas well and decanting tank are in good condition.

View of the stick-up, steel, protective casing and cover for groundwater monitoring well GW-2, facing northwest.

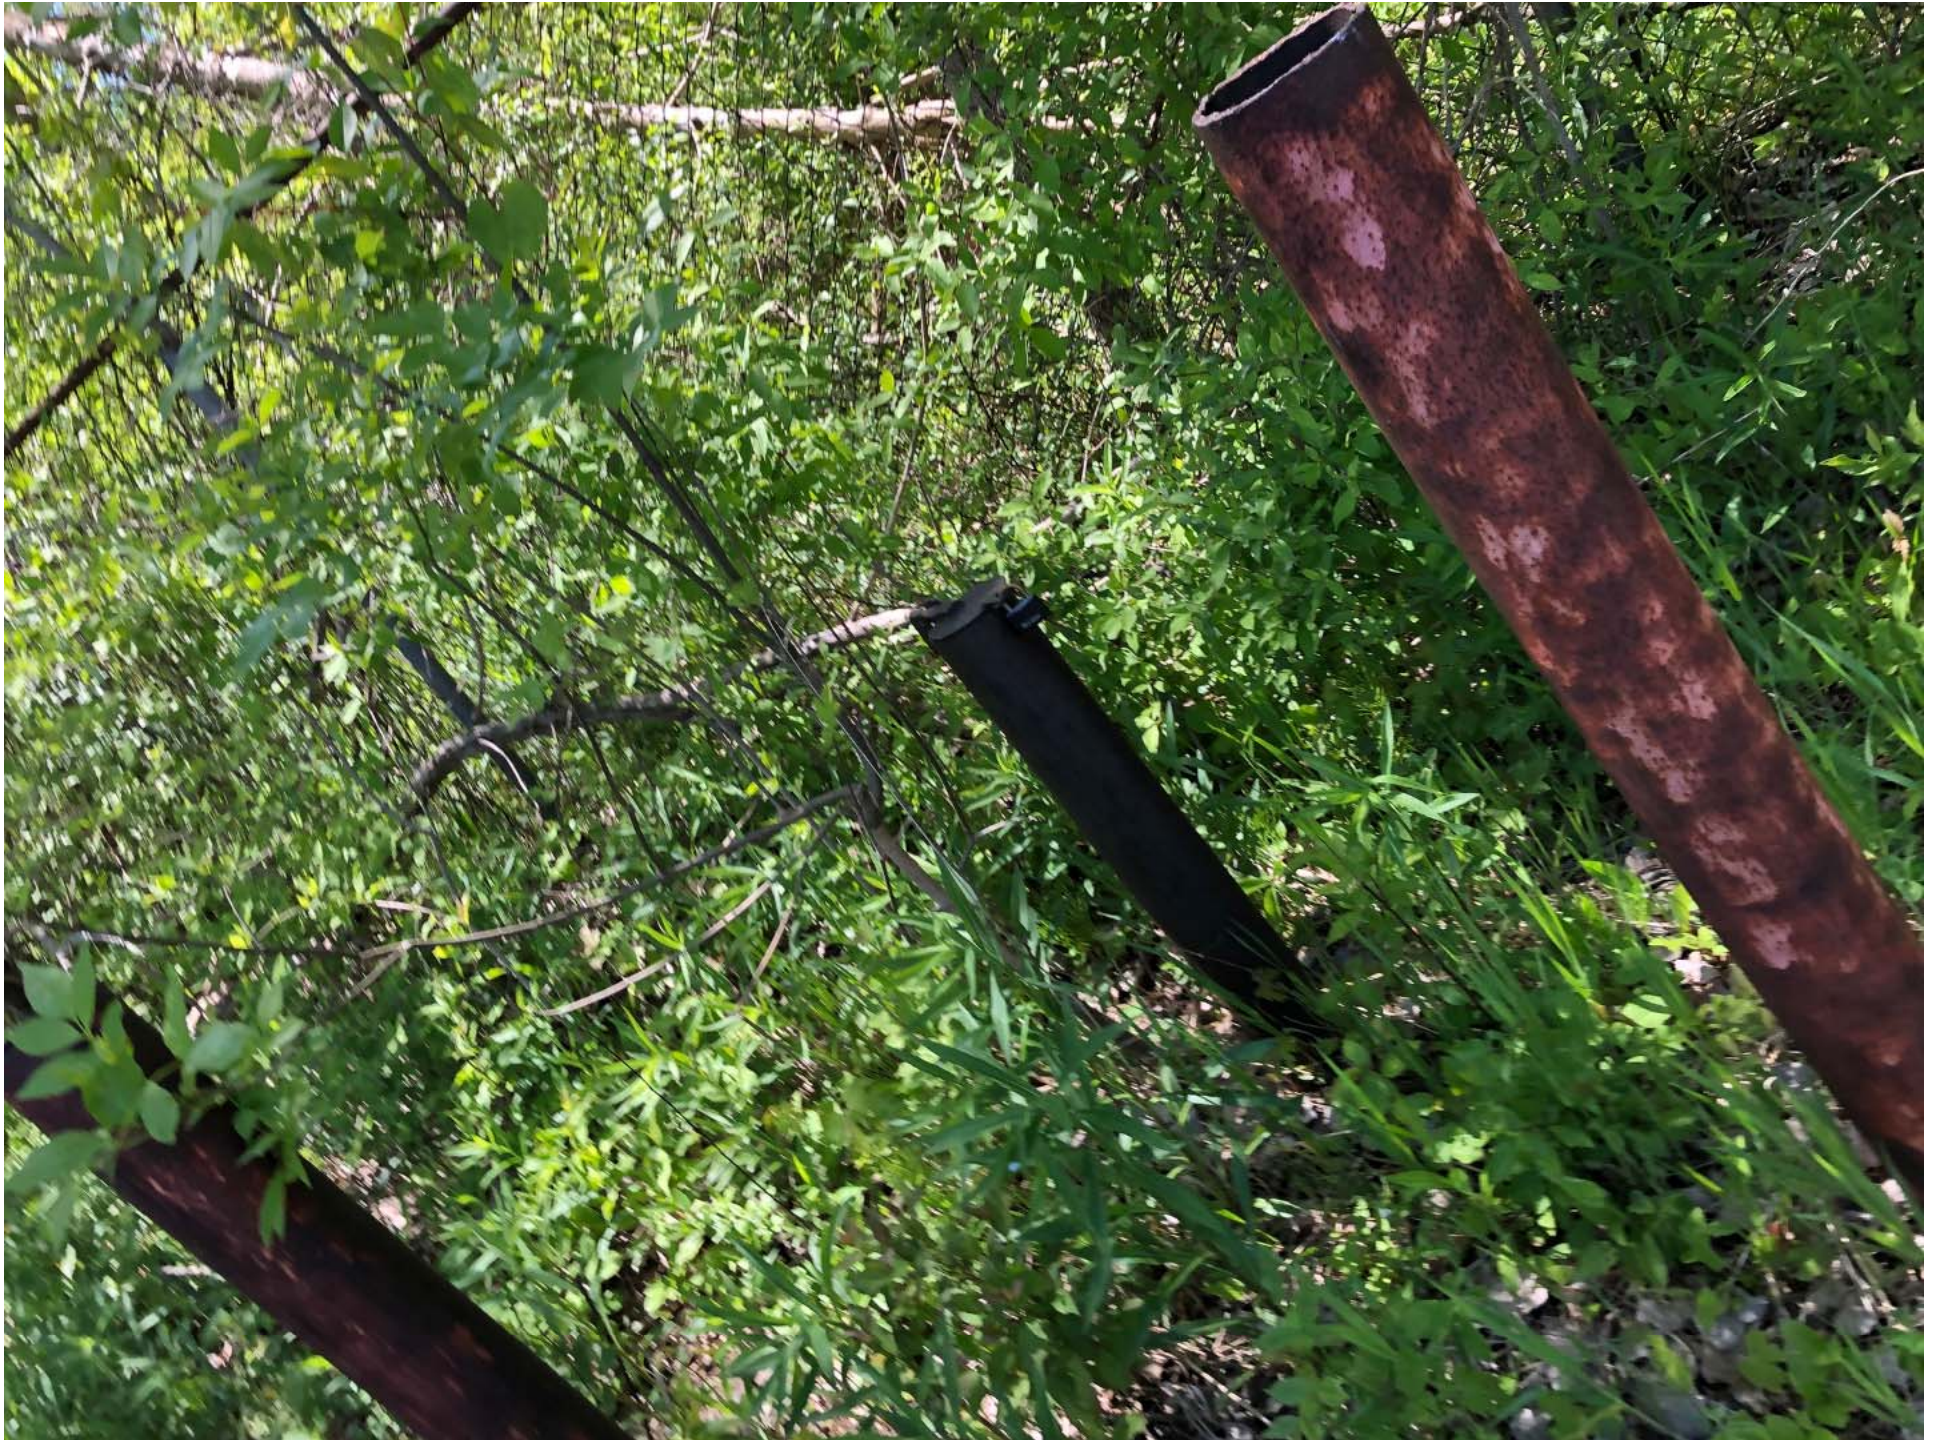
View of the stick-up, steel, protective casing and cover for groundwater monitoring well GW-3, and protective bollards, facing west.

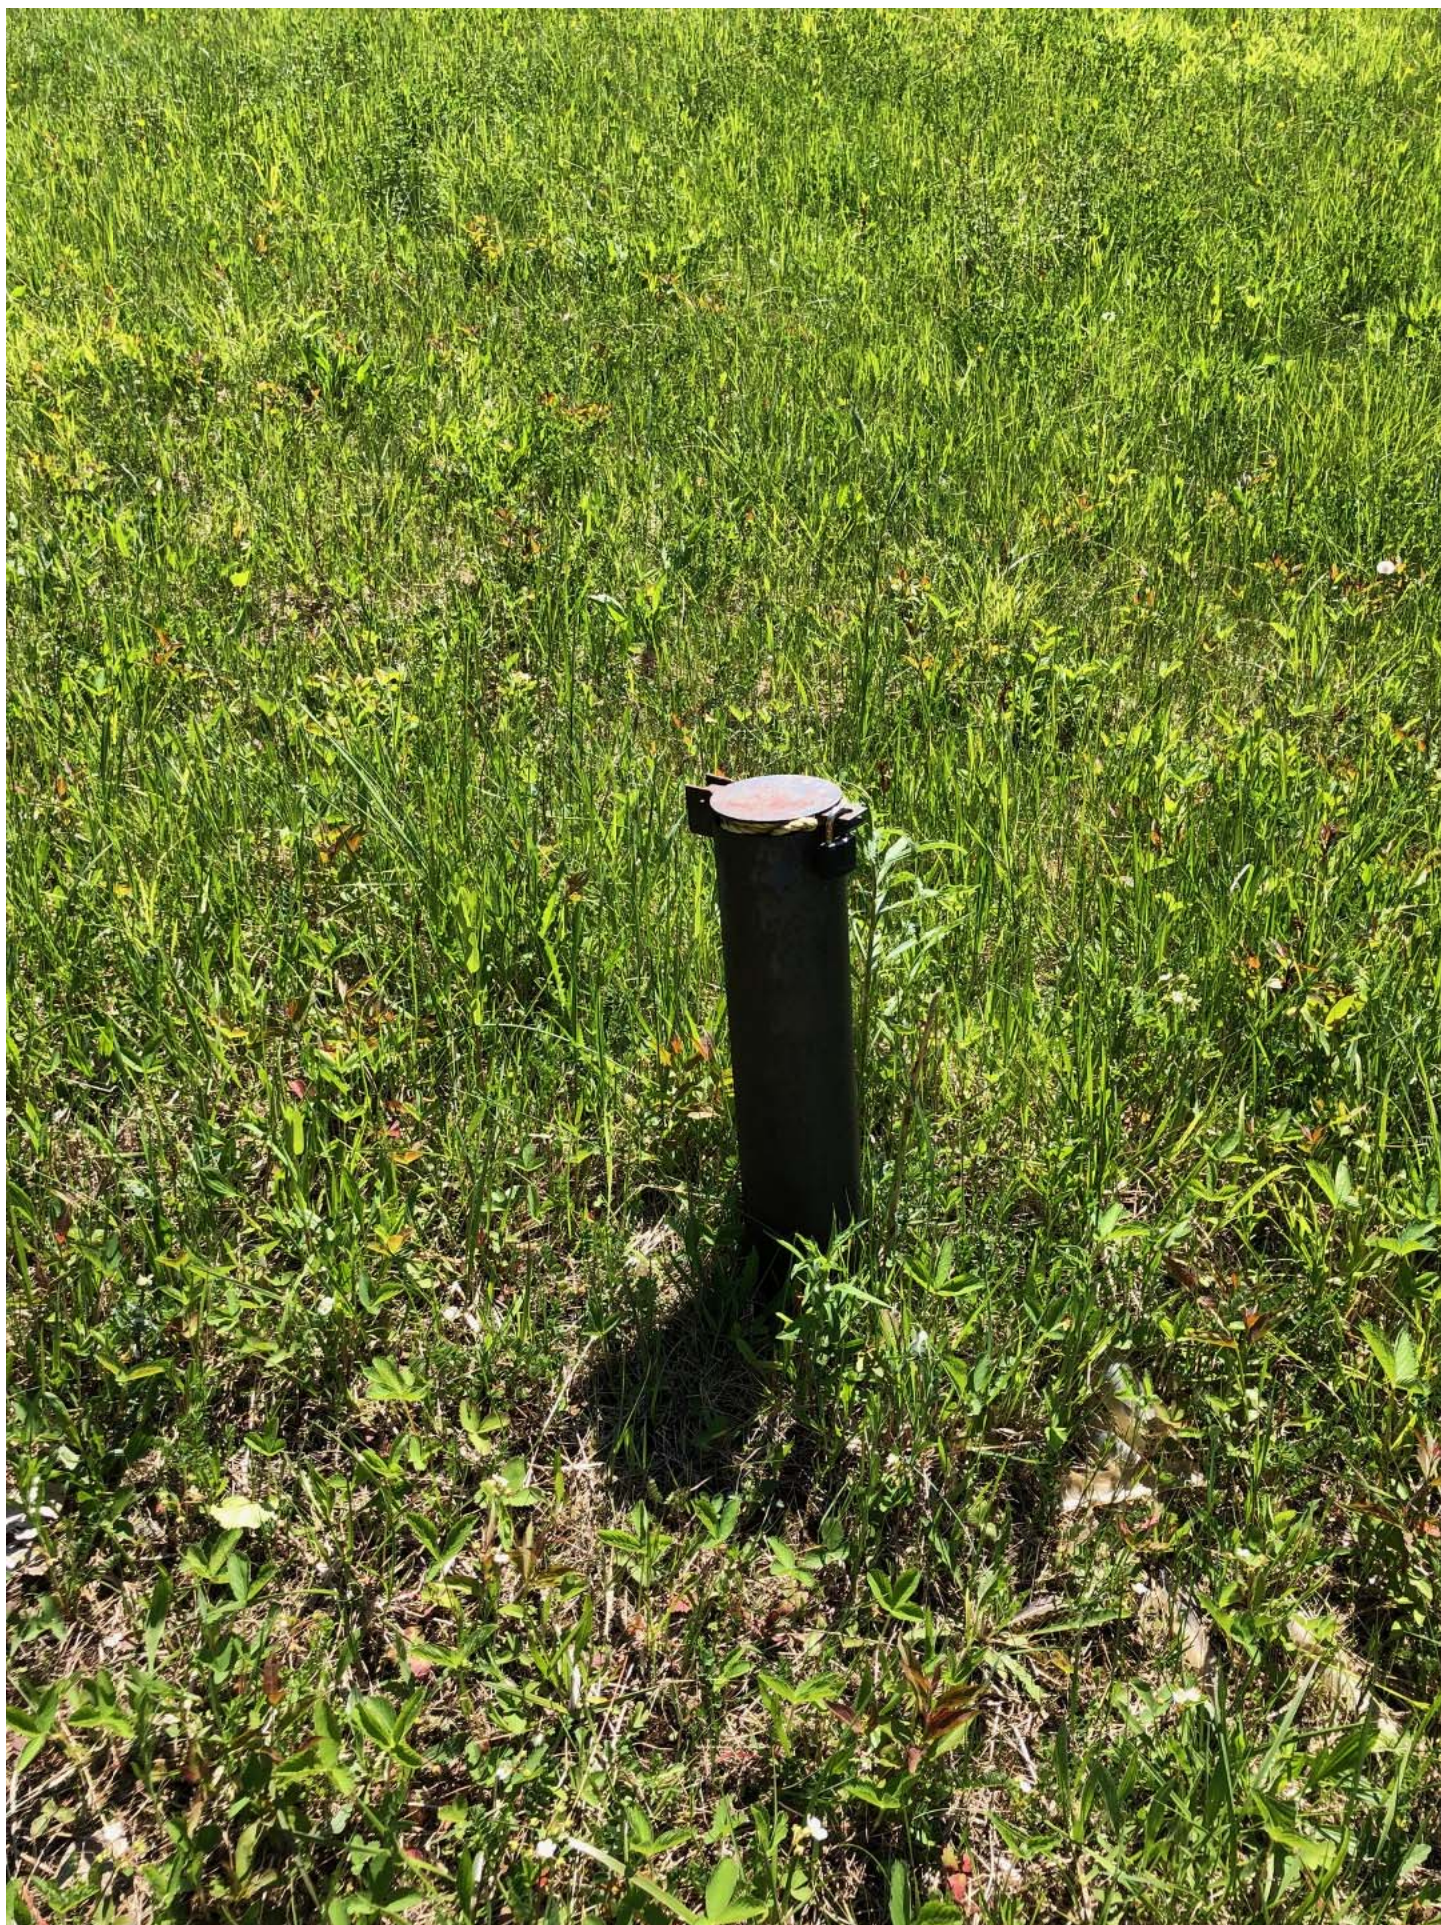
View of the stick-up, steel, protective casing and cover for groundwater monitoring well GW-4, facing southwest.

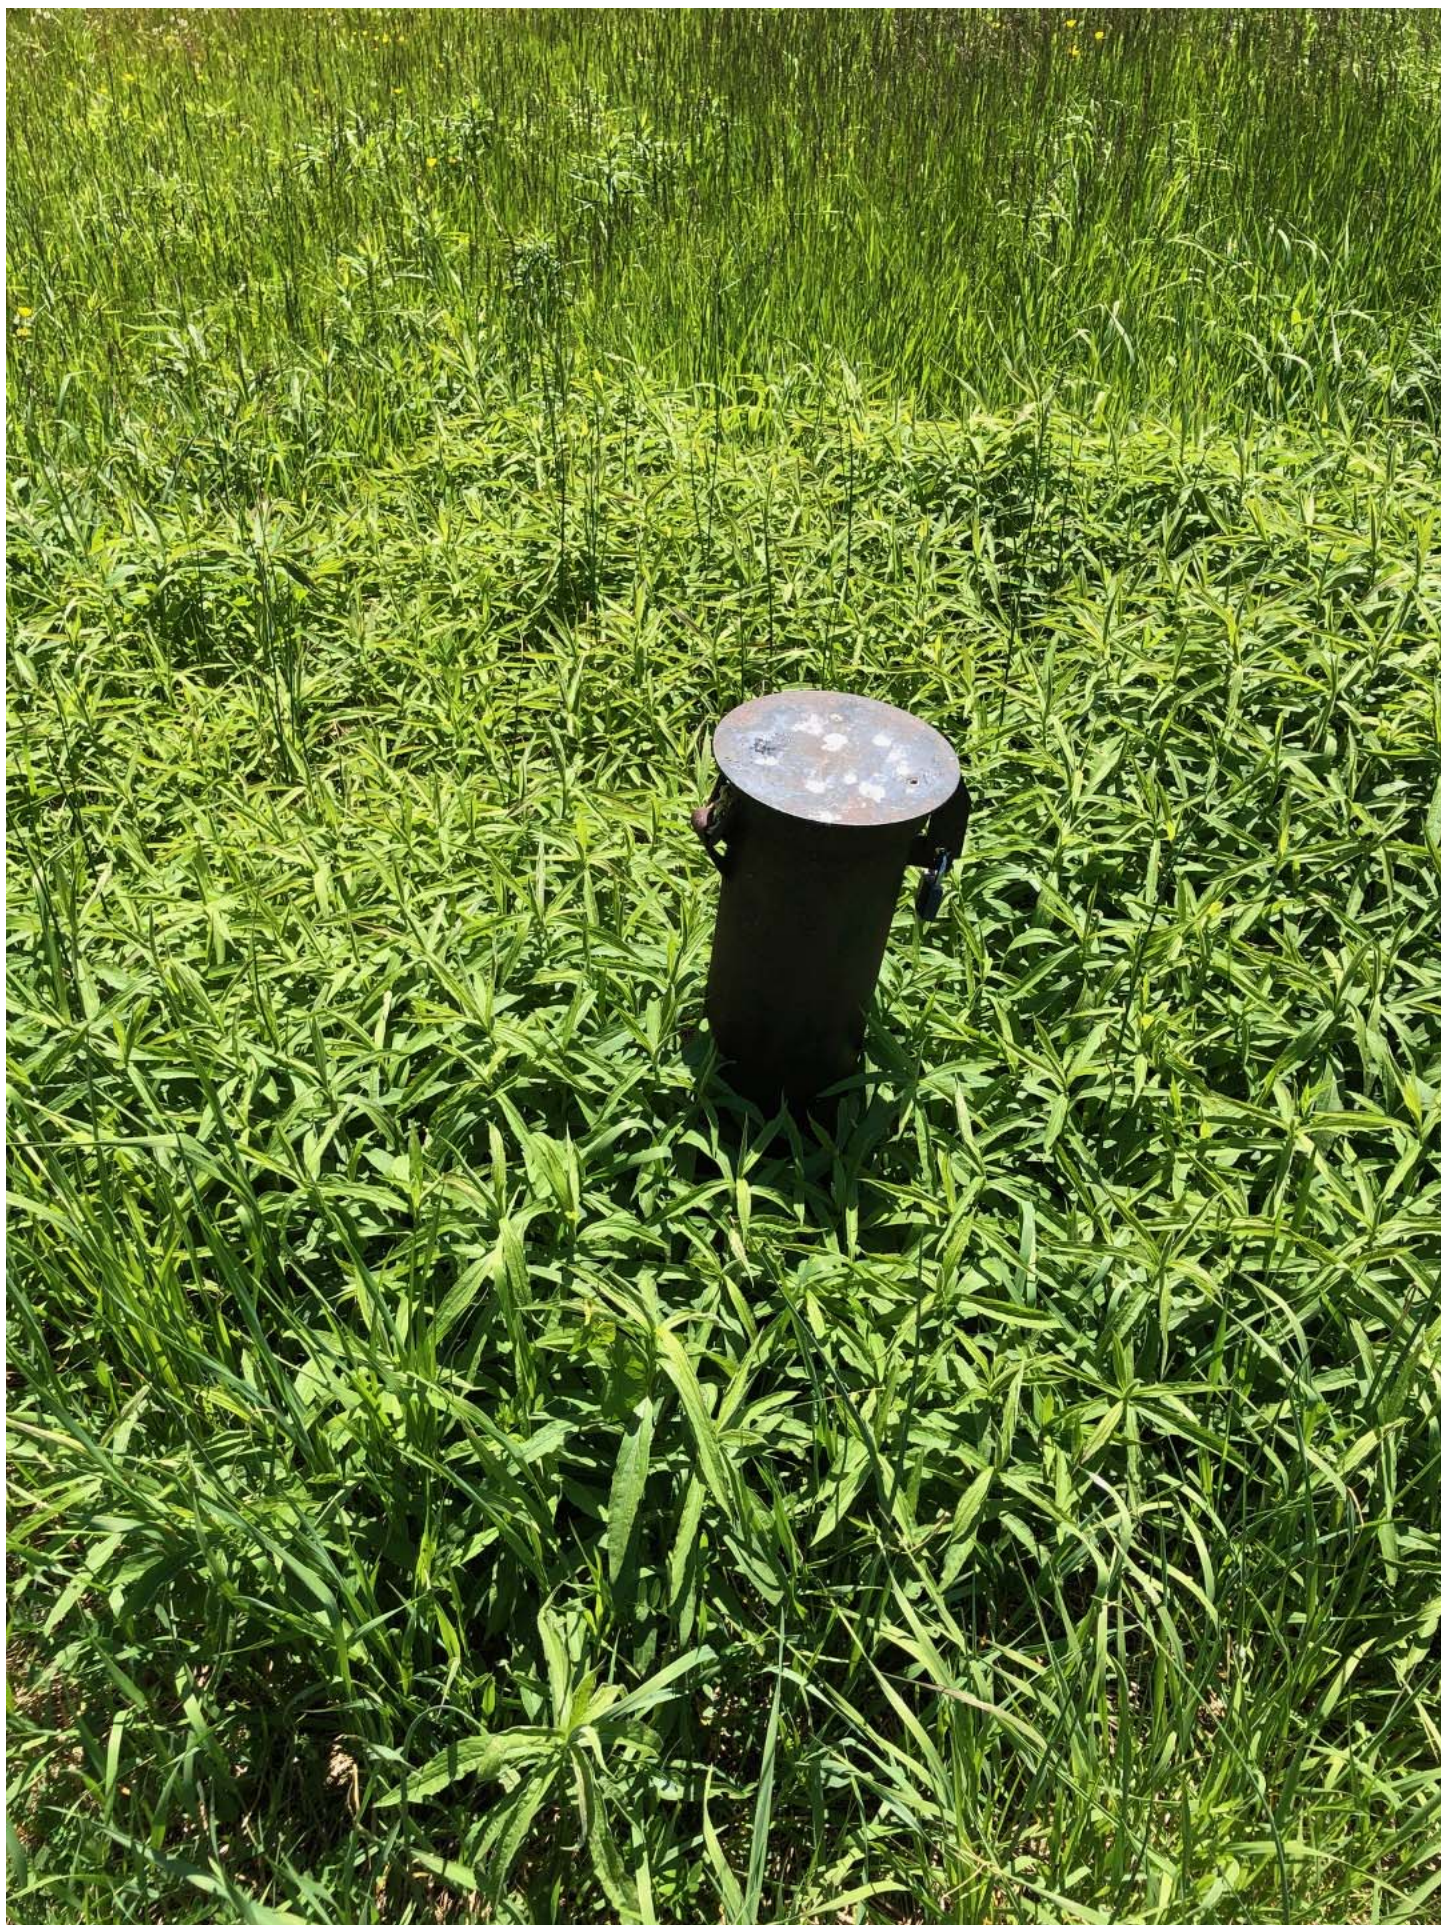
View of the stick-up, steel, protective casing and cover for groundwater monitoring well GW-5, facing north.

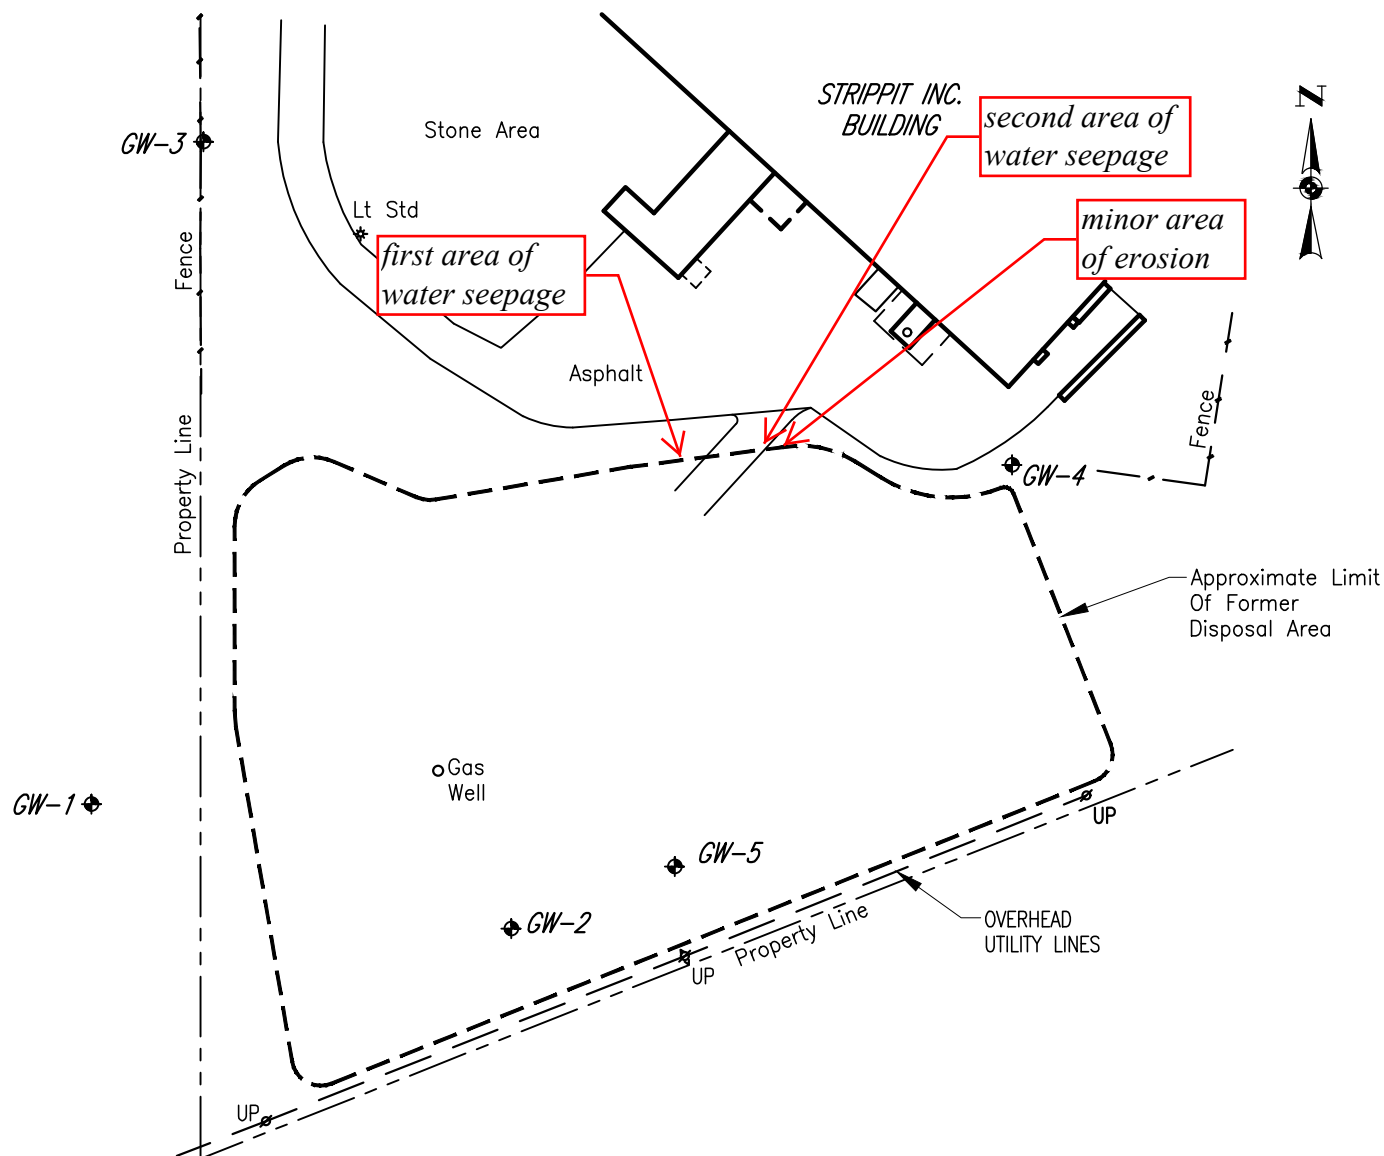
SITE SKETCH

Explain: Two areas of water seepage observed exiting the northeastern slope of the landfill (refer to Site Sketch in Attachment B) with slight discharge onto the paved access road (i.e., rust-colored precipitate evident in the standing water). Refer to photographs in Attachment A.
