PERIODIC REVIEW REPORT
REPORTING PERIOD: JANUARY 31, 2022 THROUGH JANUARY 31, 2025

12975 CLARENCE CENTER ROAD
AKRON, NEW YORK
NYSDEC SITE NO. 915053

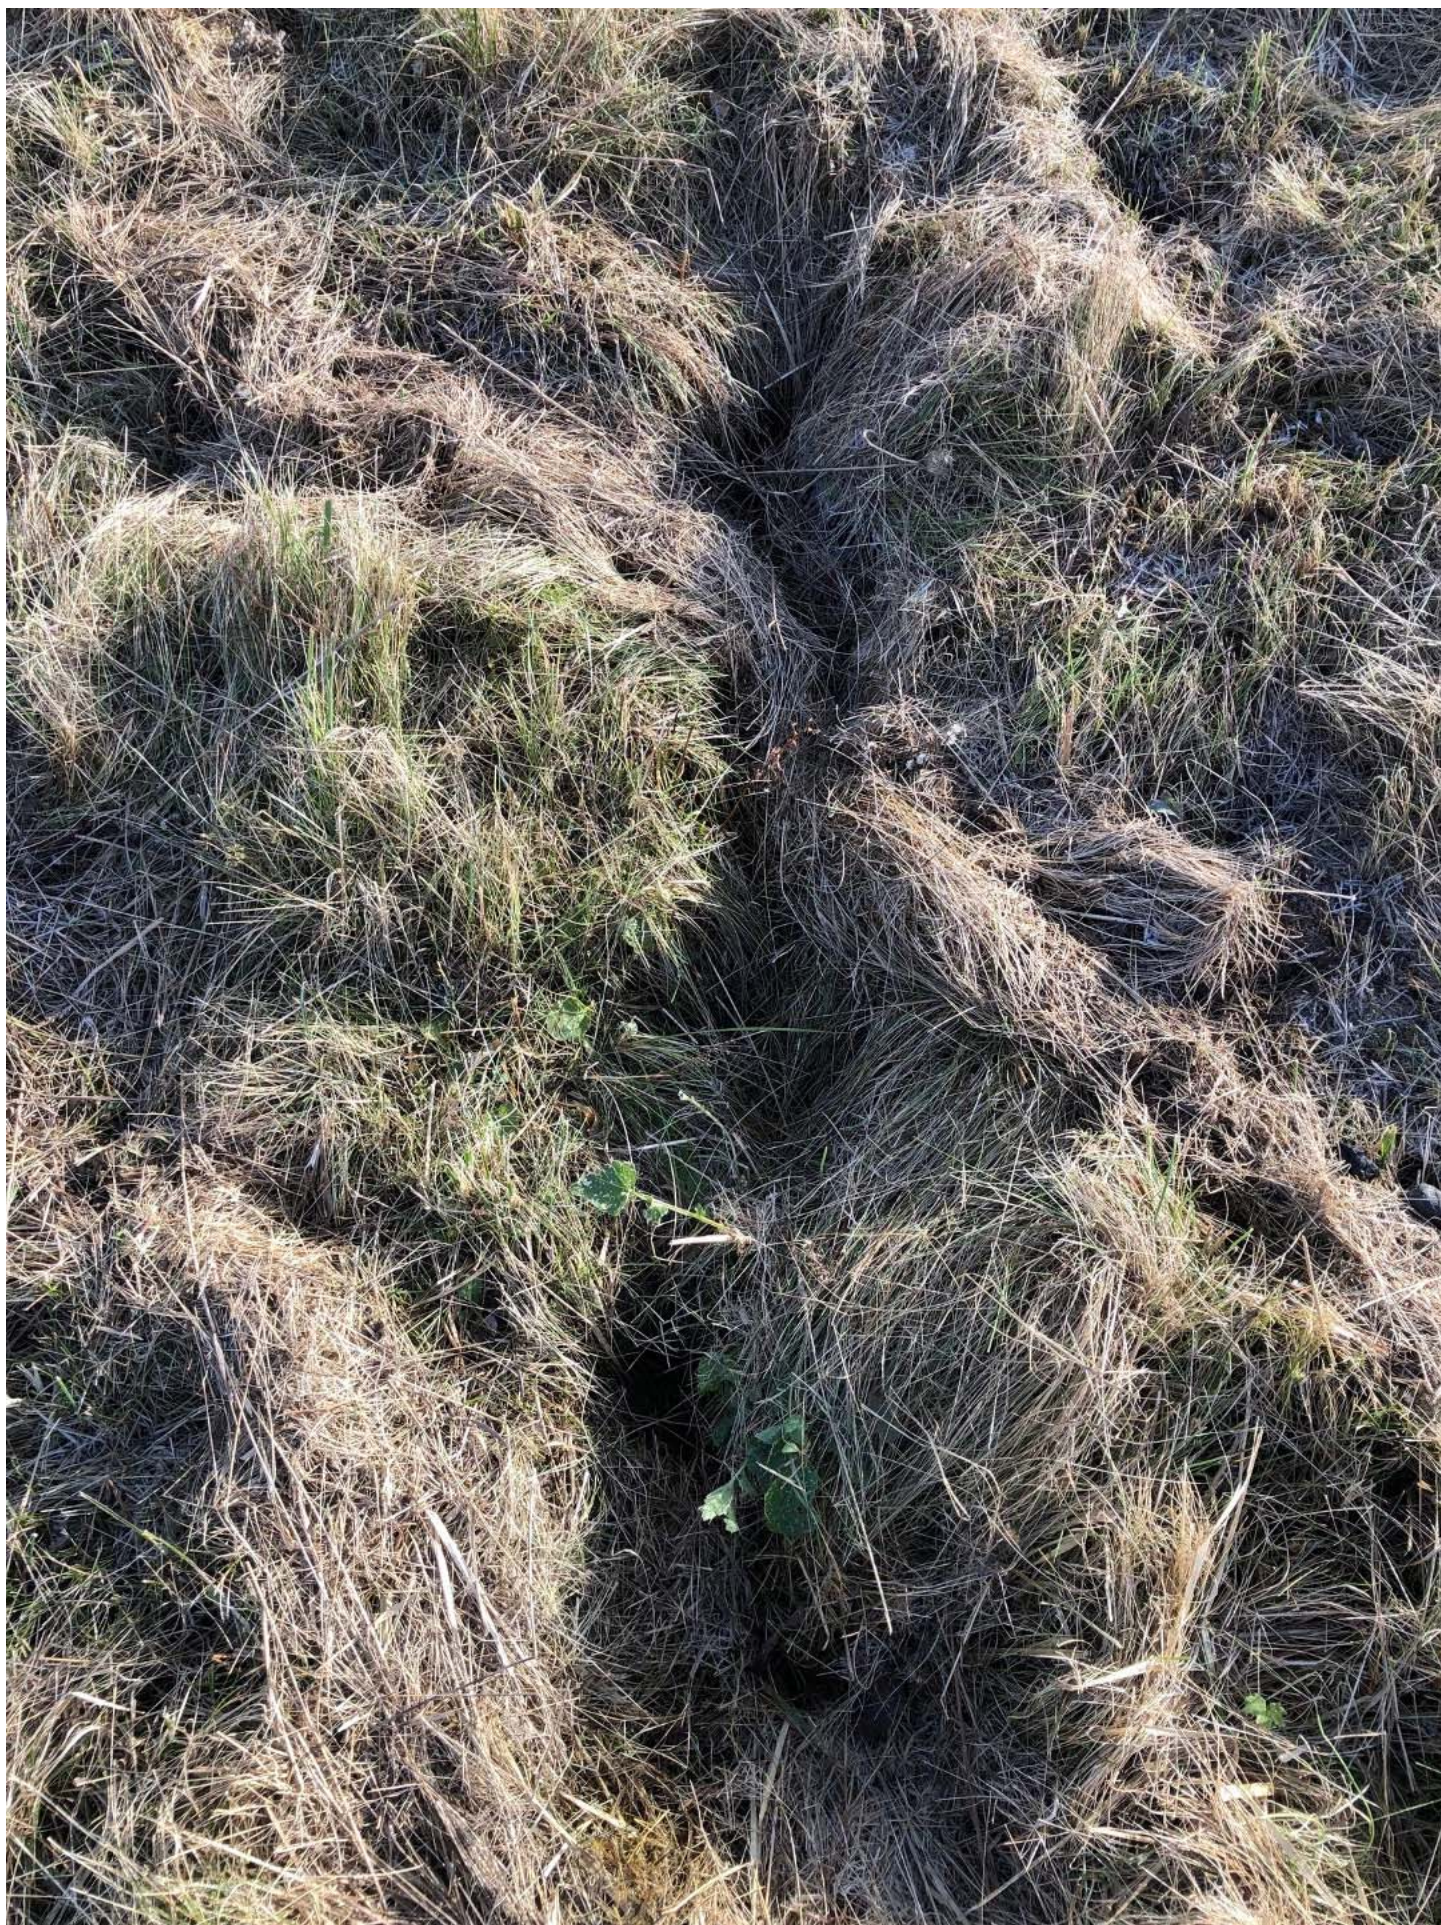
General Condition of Cover: The cover was cut at the end of the growing season. Approximately 3 inches of cut vegetation remain on the surface of the landfill. Overall, the cover is in good condition, with only minor rutting observed on the northeastern slope of the landfill. Refer to photographs in Attachment A.

Close-up view of the area or minor rutting located on the northern slope of the landfill area.

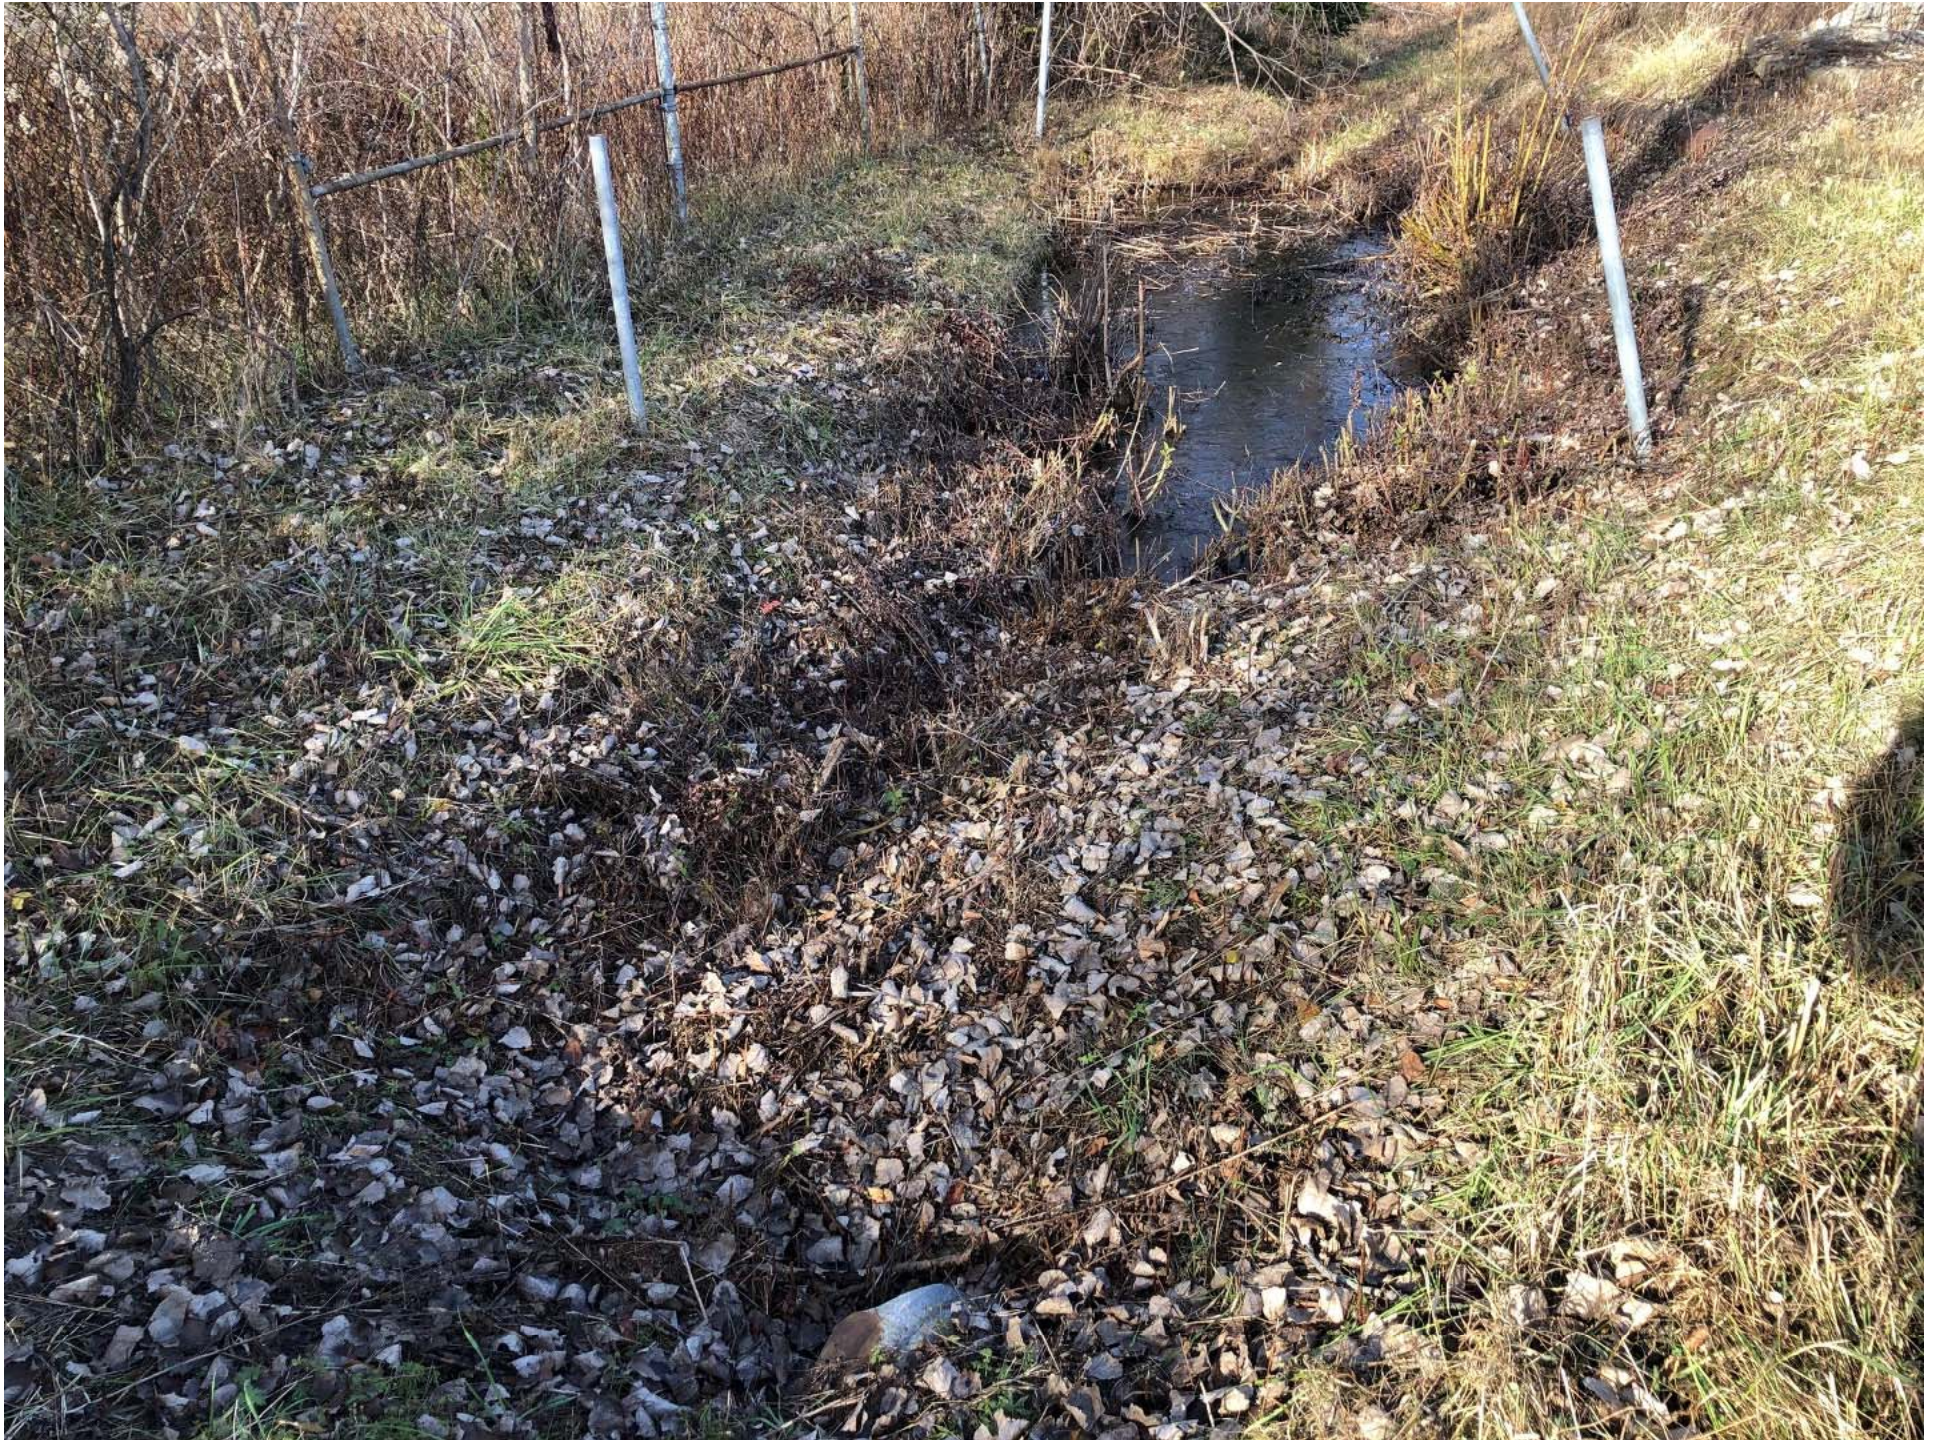
Condition of drainage ways (discuss amount of water/sediments present, vegetative growth unusual staining, blockage, etc.): Drainage ways are free of sediment and debris. However, saplings observed in the retention basin during the May 26, 2023 site visit have been cut.

View of the drainage way (recently cleared of vegetation) located to the northwest of the landfill area facing northwest.

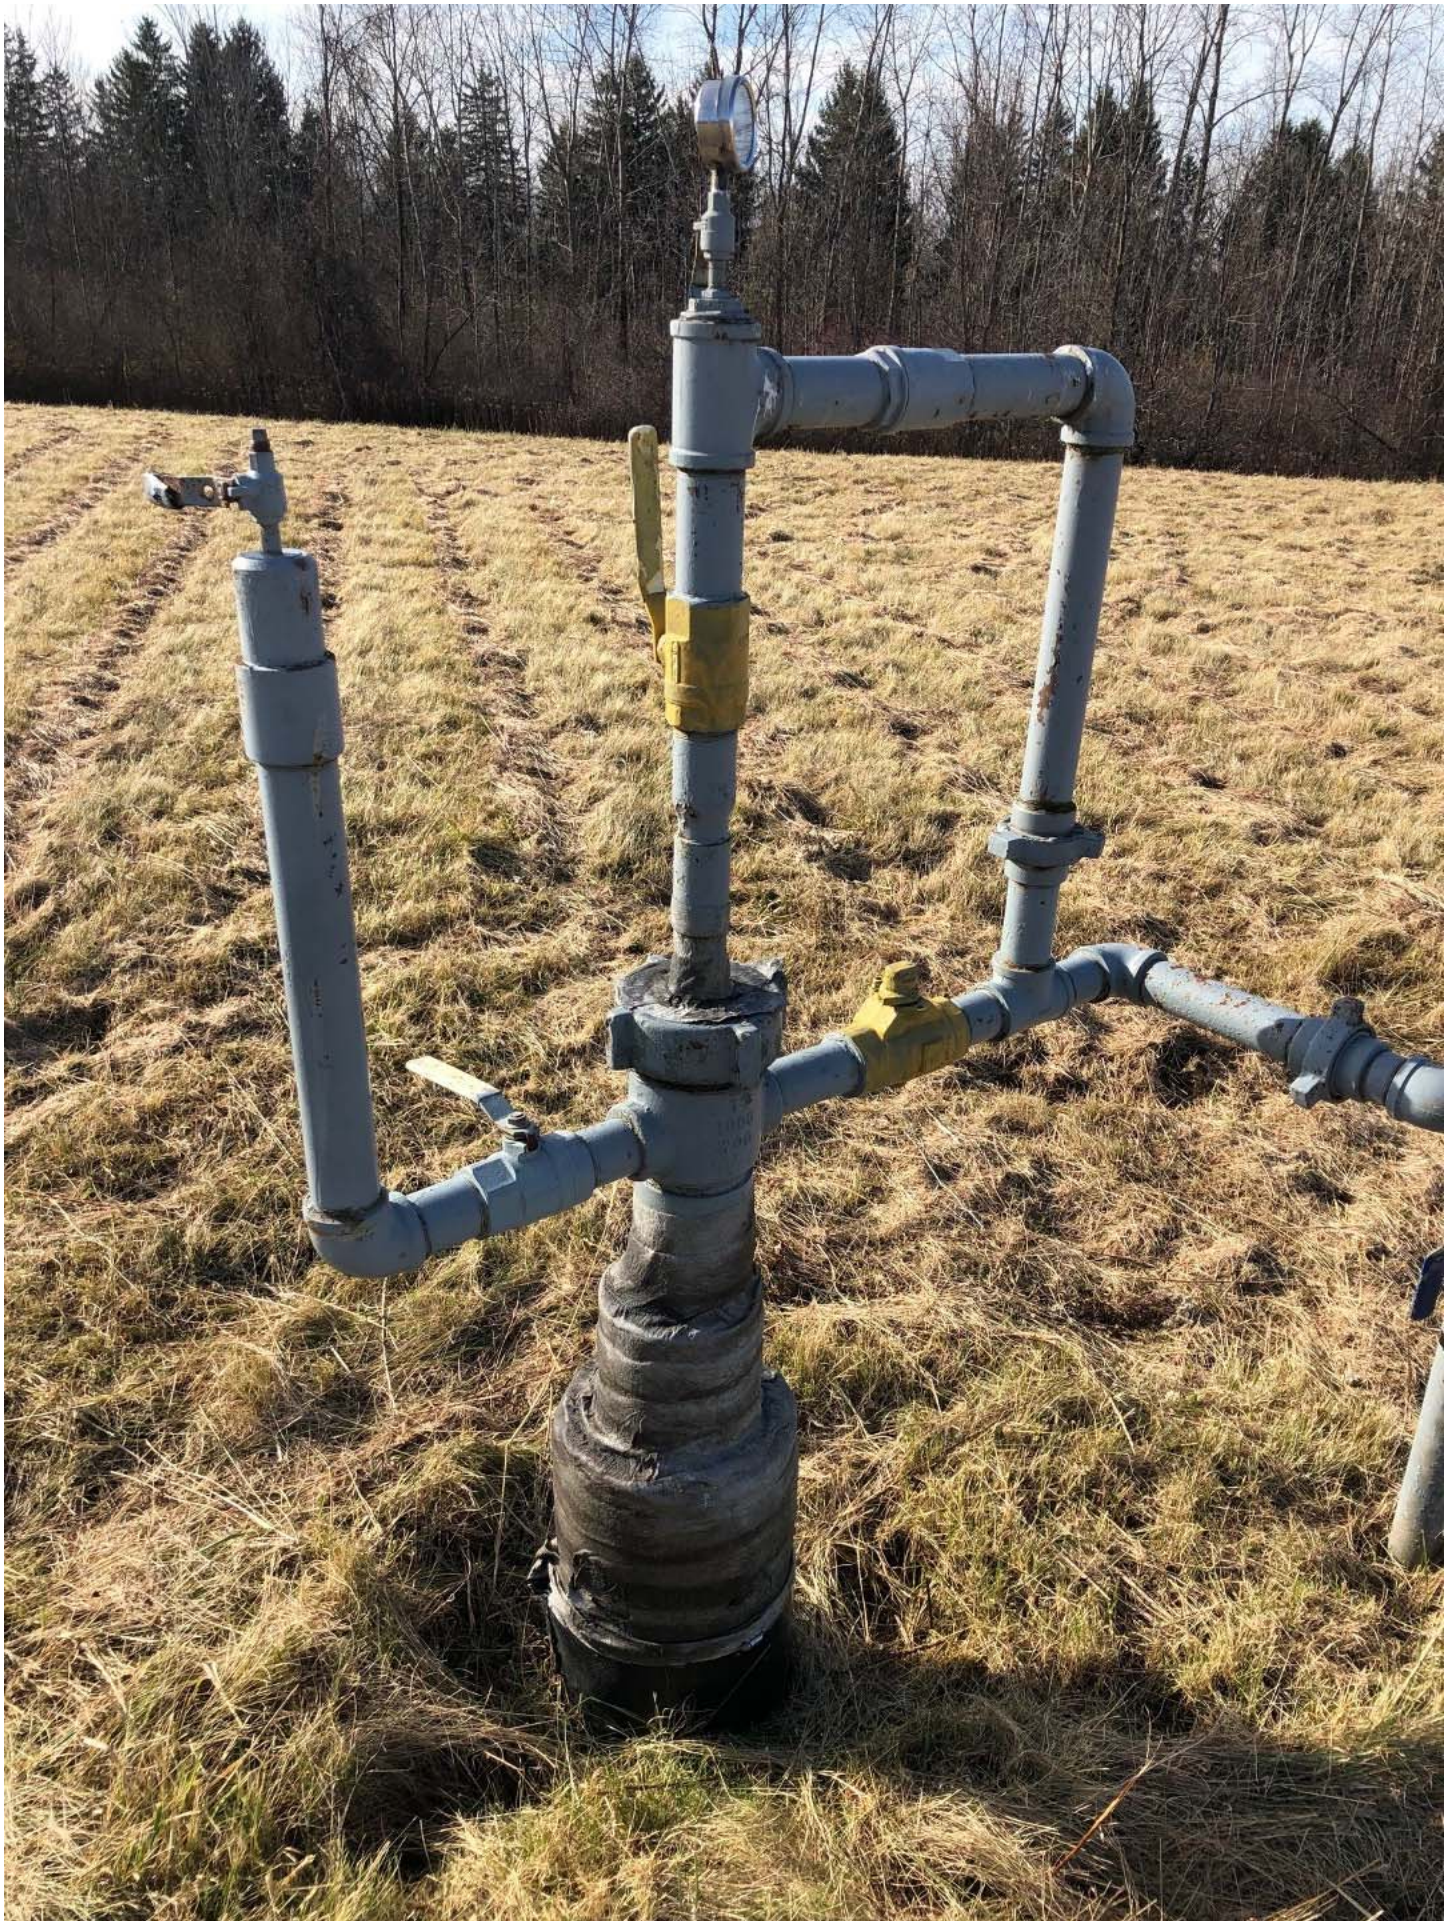
View of the gas well, facing west.

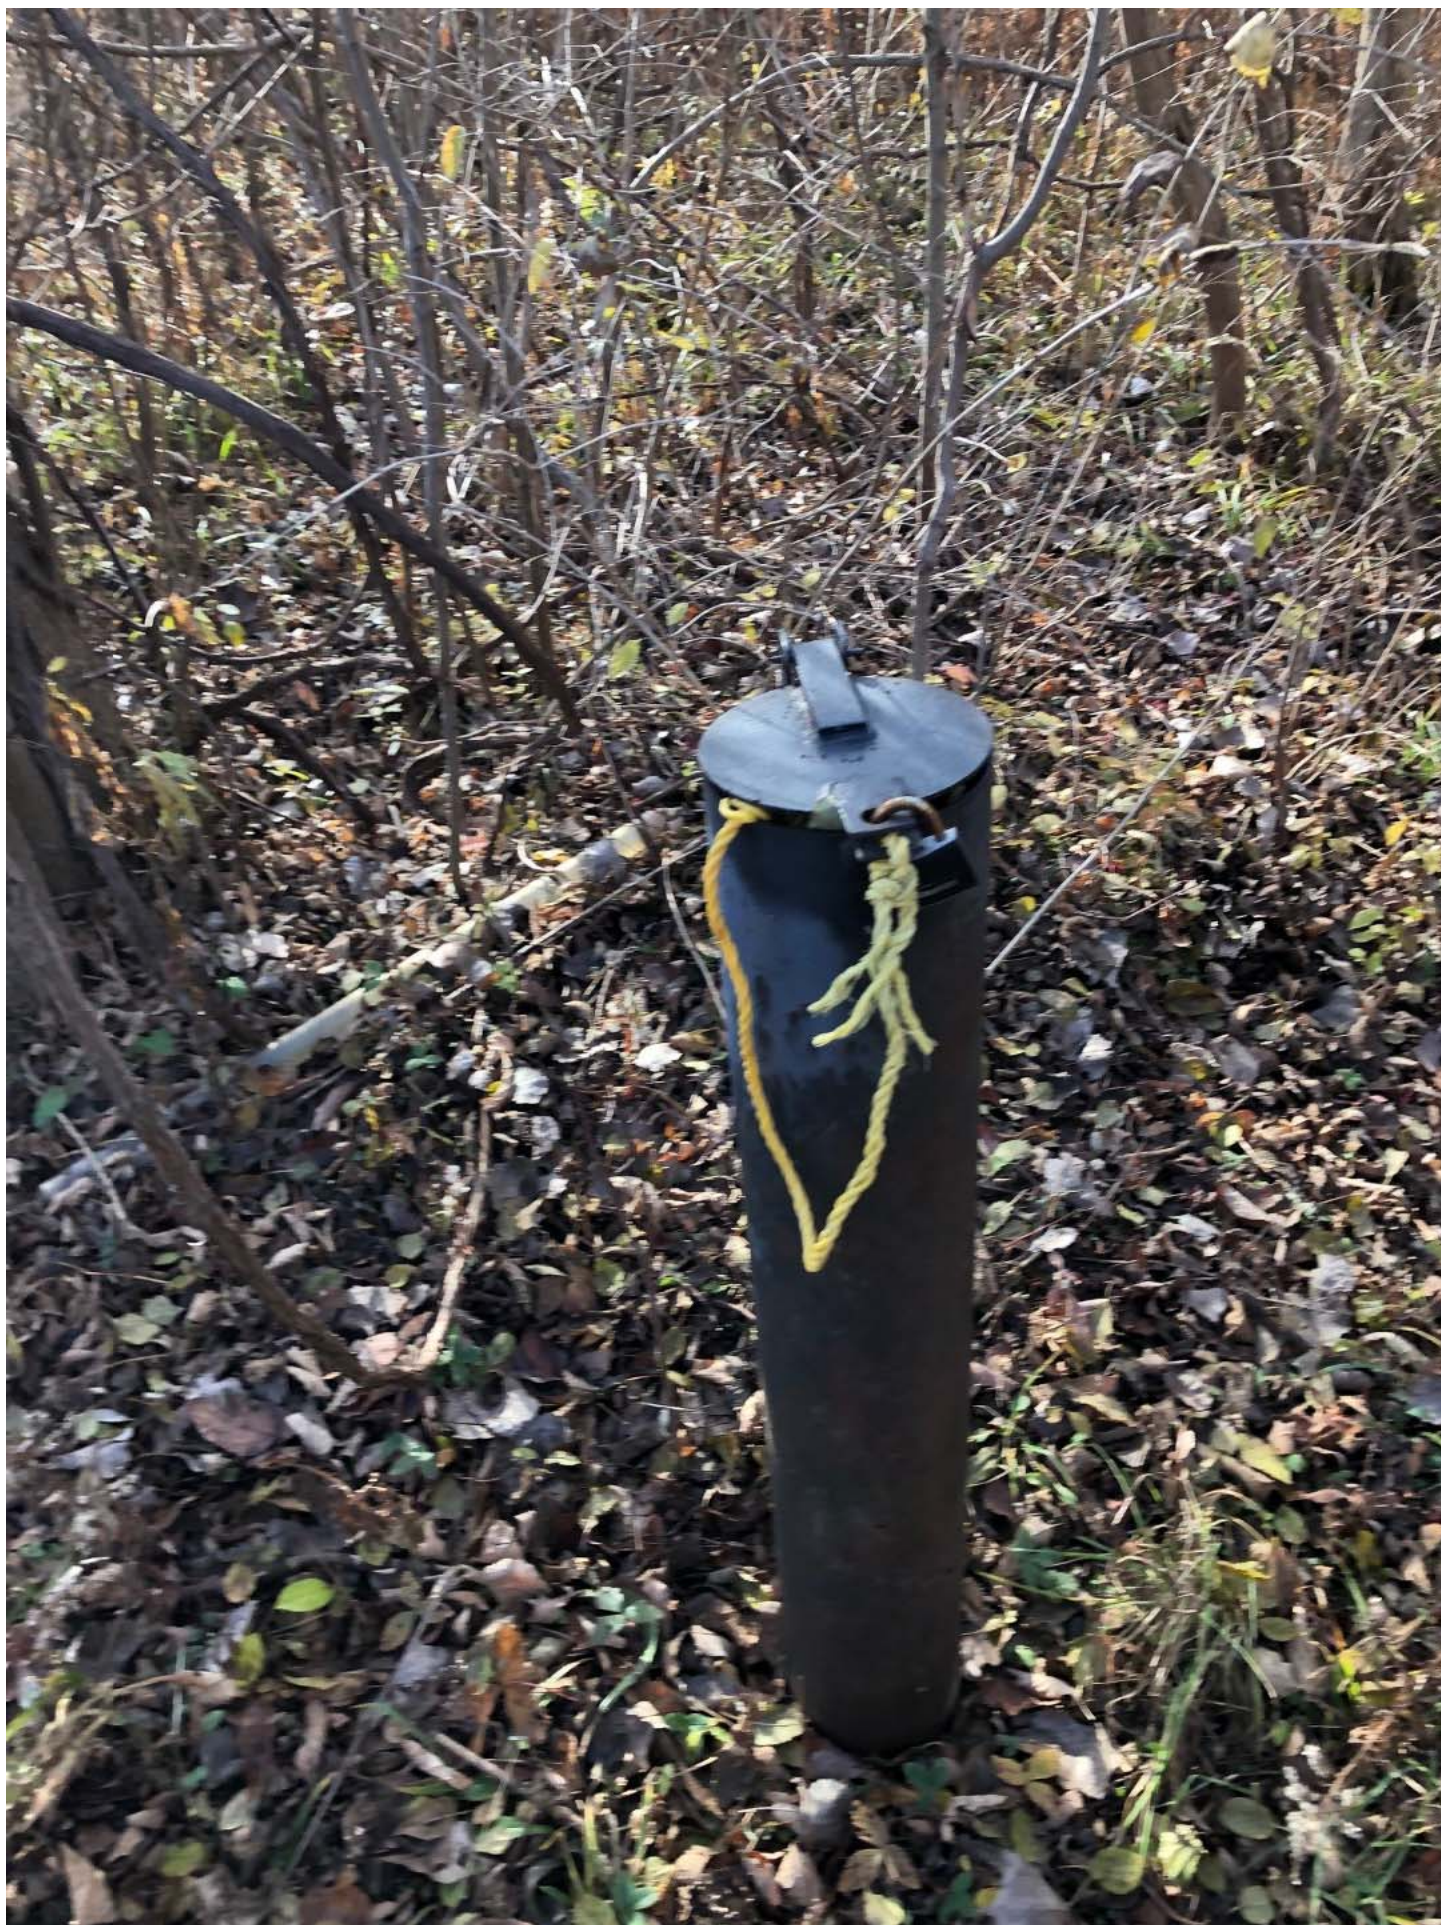
View of the stick-up, steel, protective casing and cover for groundwater monitoring well GW-1, facing southwest.

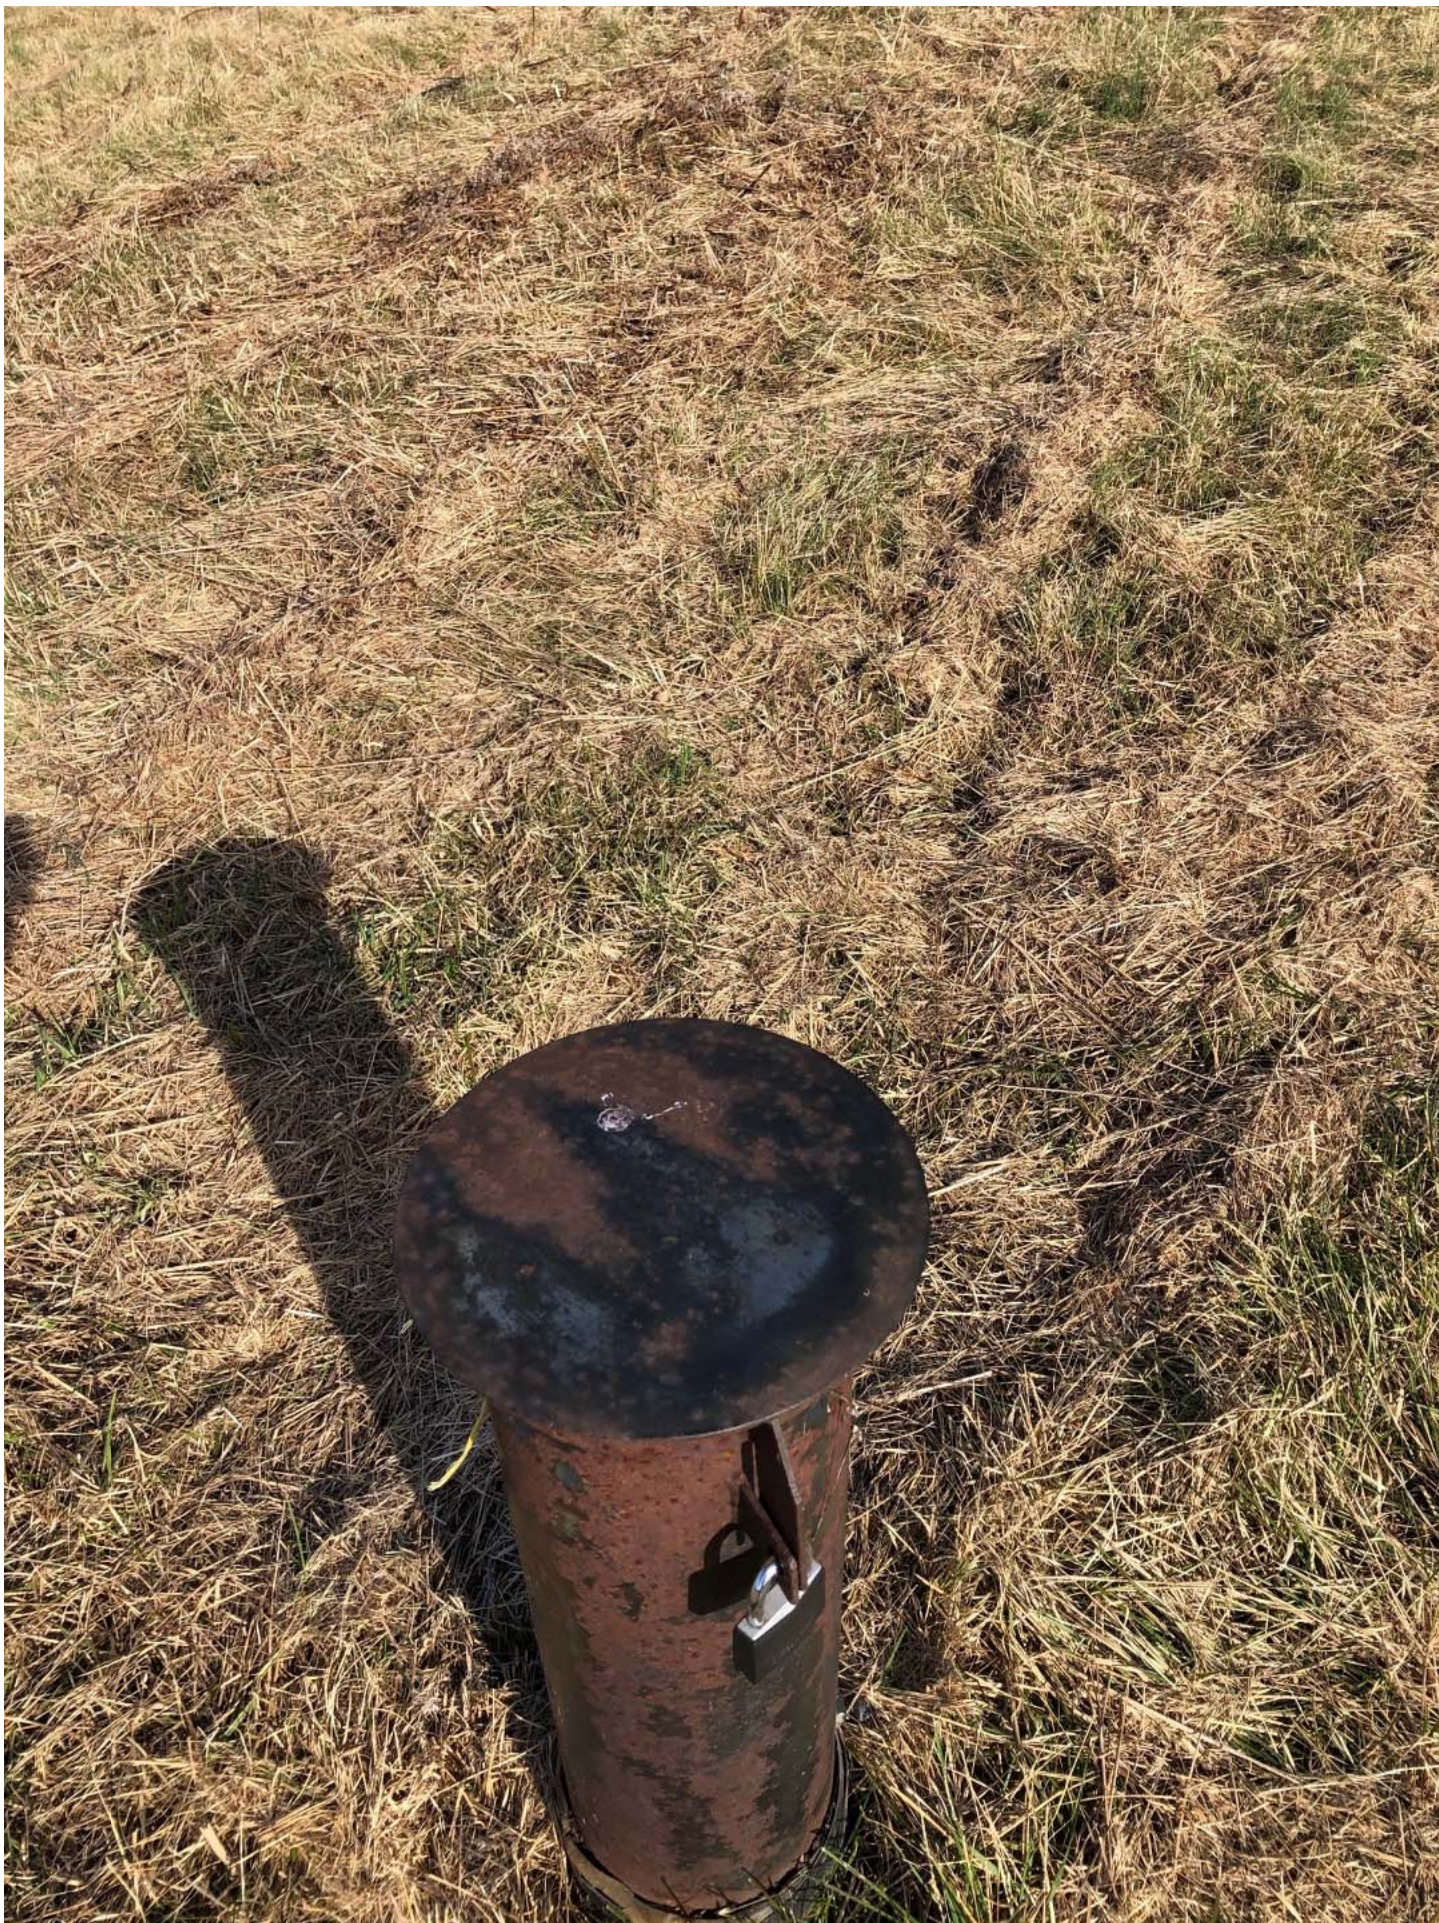
Condition of monitoring wells and gas wells: Monitoring wells are in good condition and locked (i.e., except GW-2, where the lock is present, but has been cut). Gas well and decanting tank are in good condition.

View of the stick-up, steel, protective casing and cover for groundwater monitoring well GW-2, facing southeast.

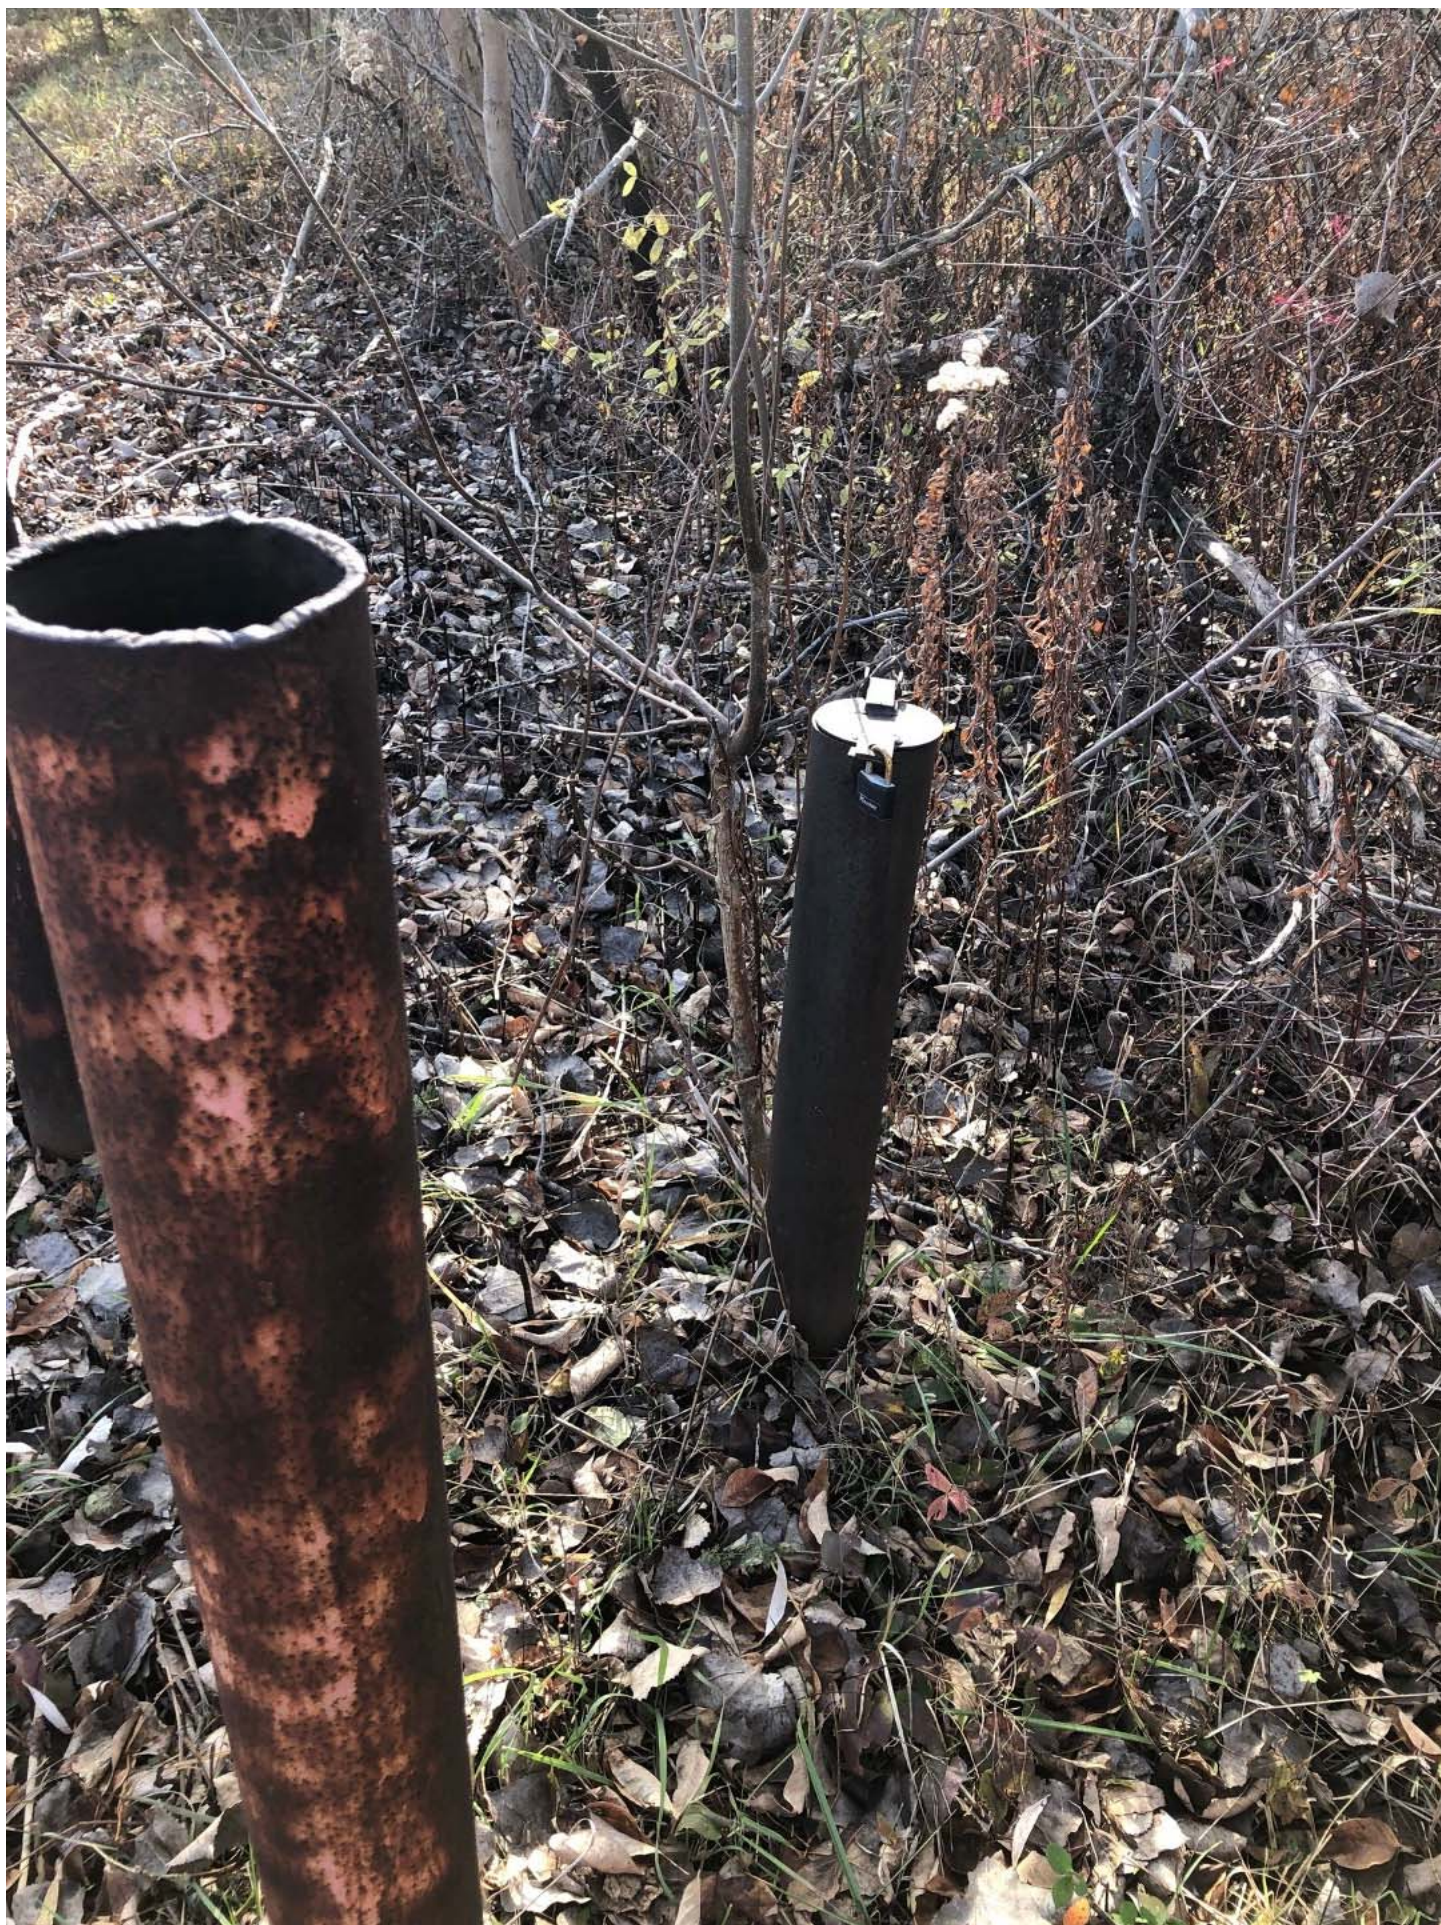
View of the stick-up, steel, protective casing and cover for groundwater monitoring well GW-3, and protective bollards, facing southwest.

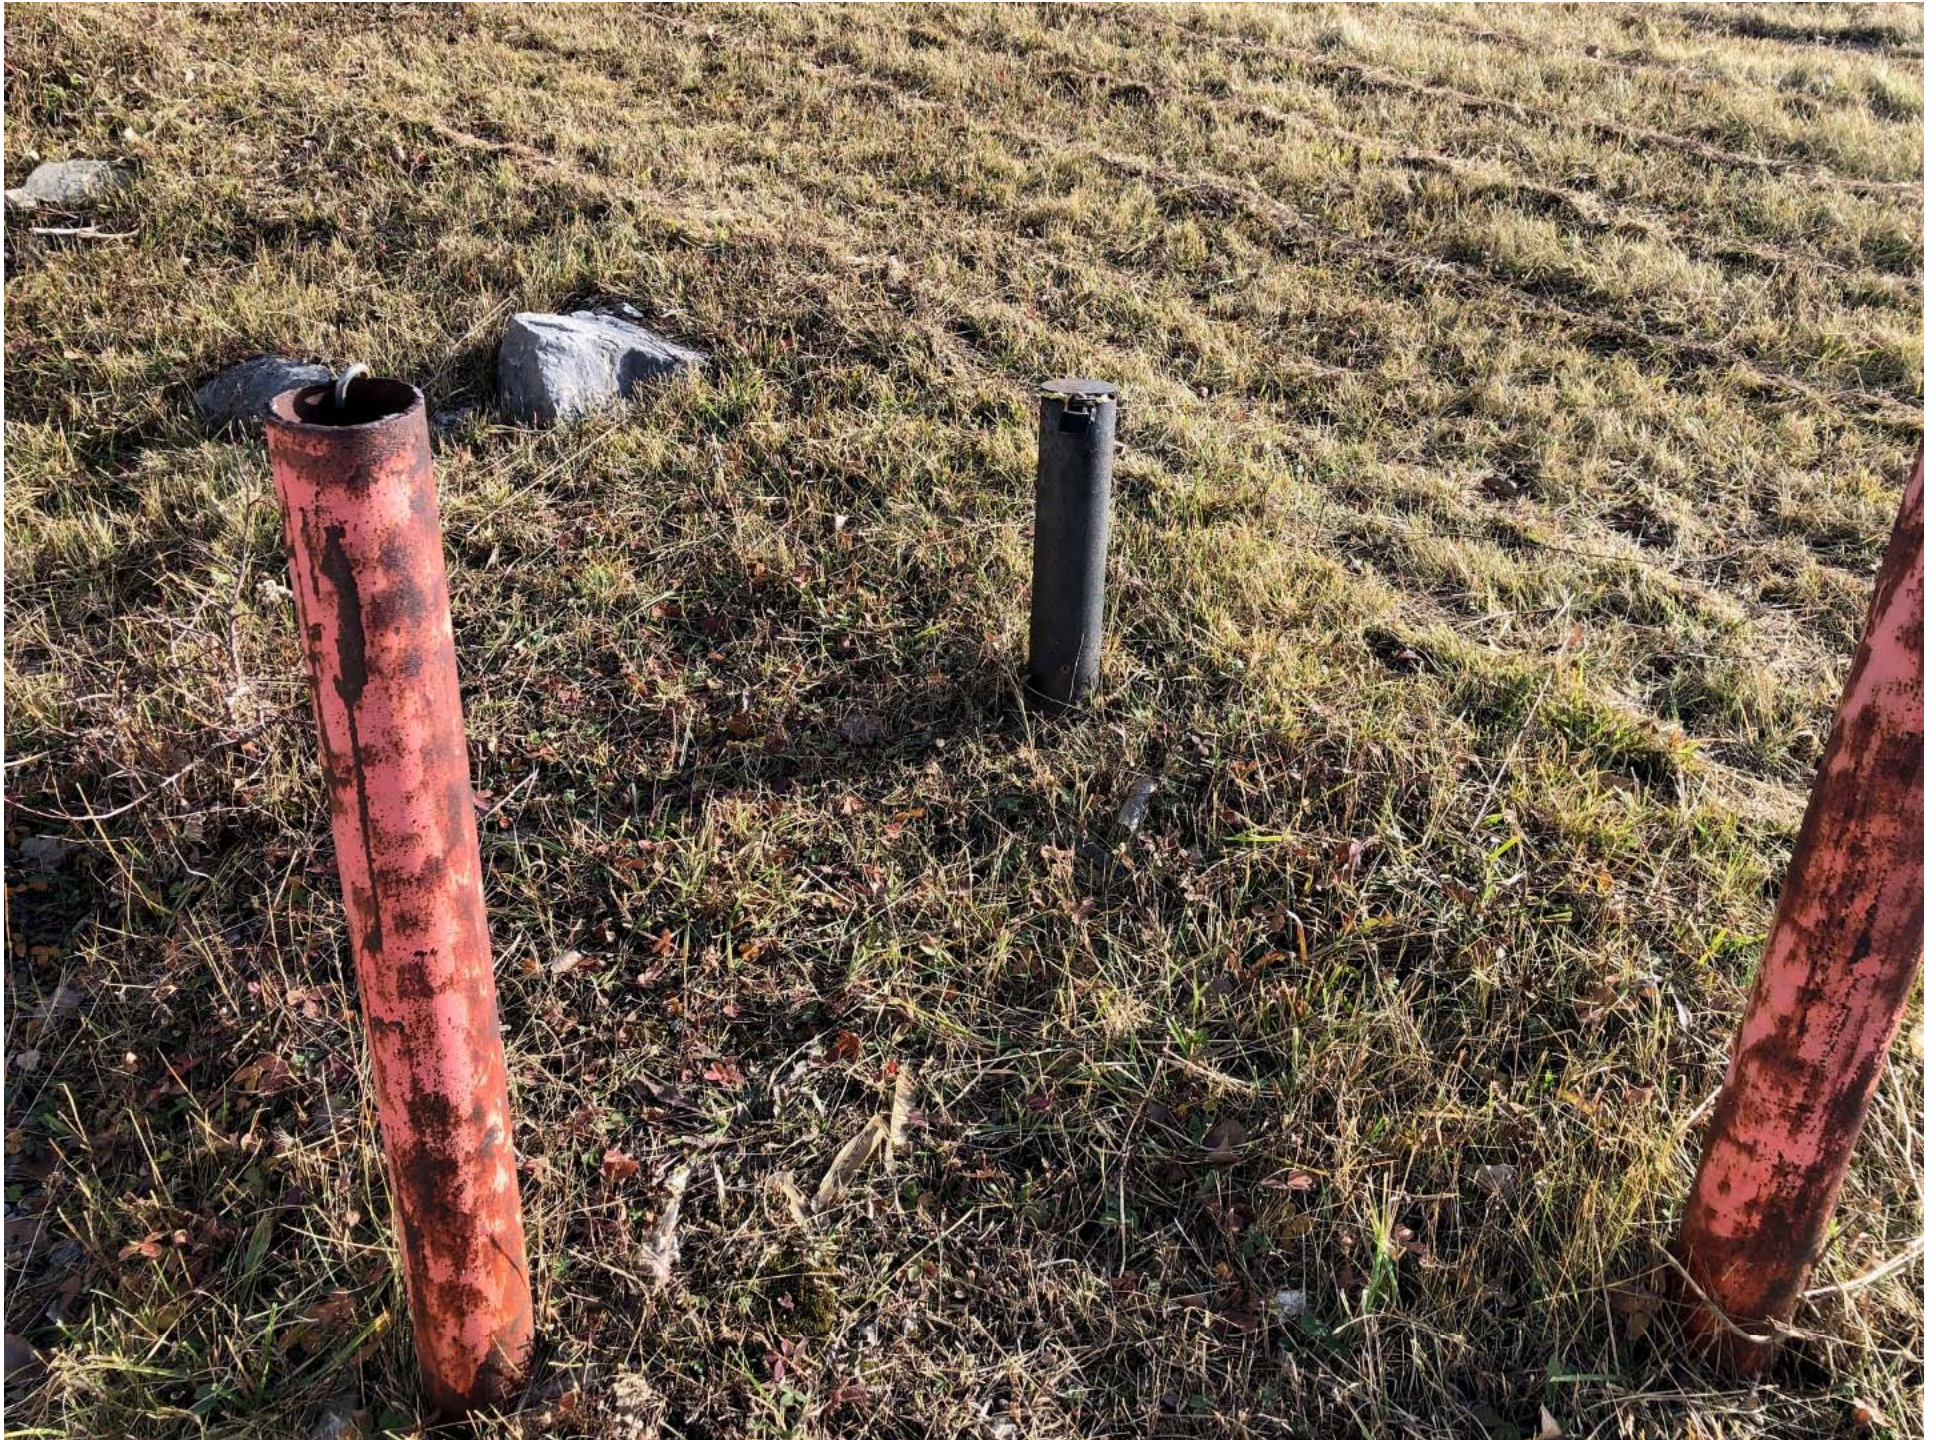
View of the stick-up, steel, protective casing and cover for groundwater monitoring well GW-4, and protective bollards, facing south.

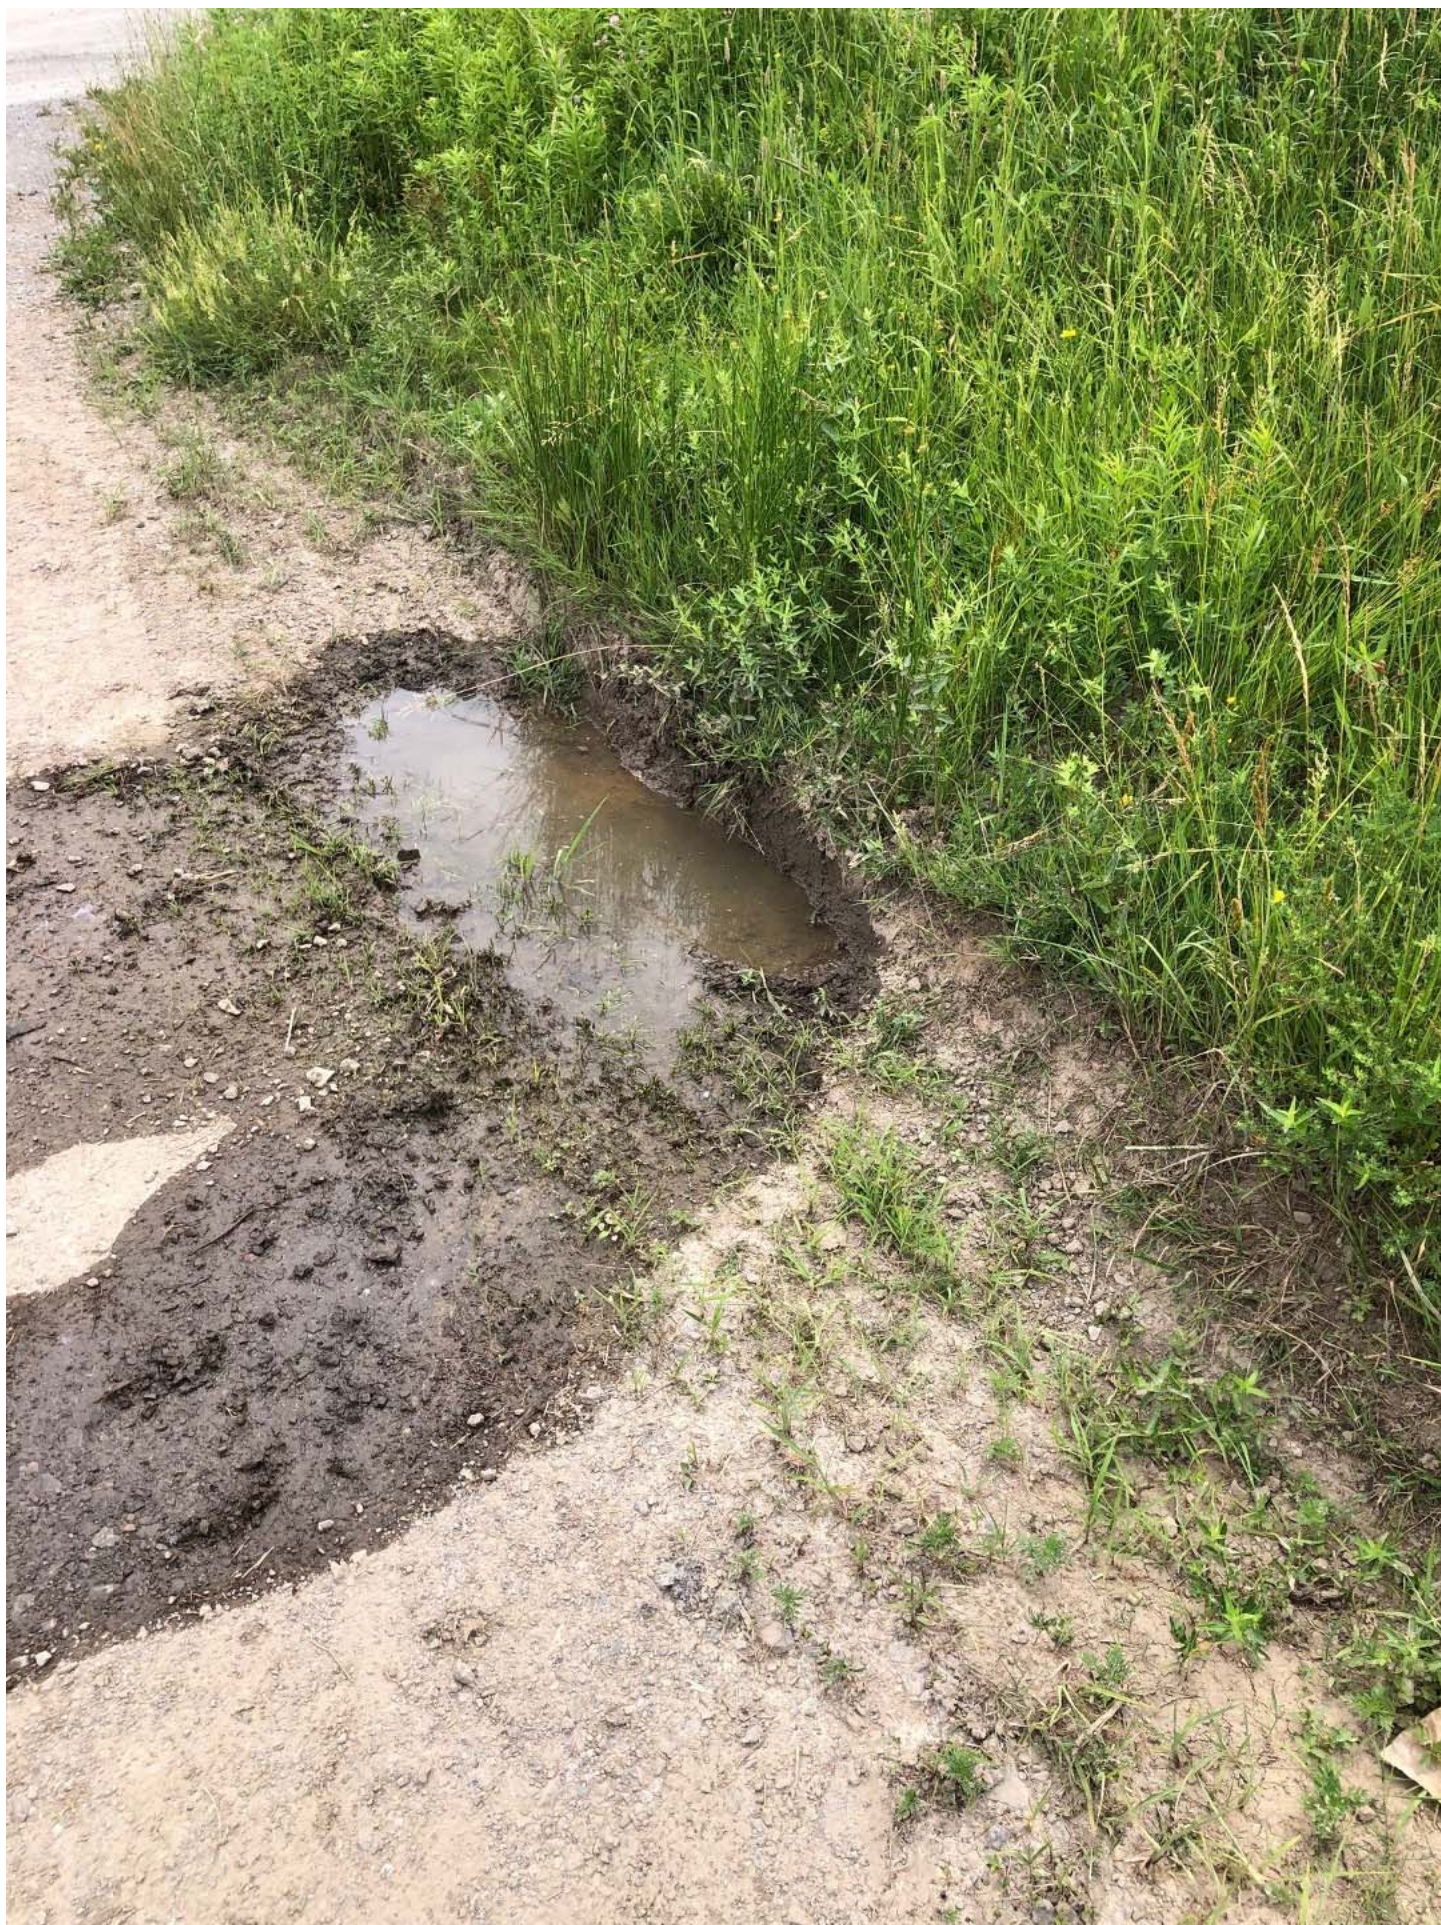
General Condition of Cover: Thick vegetation approximately 3 to 4 feet high (i.e., field grass, weeds, Crown Vetch, etc.) on the landfill. Some rutting along the northeastern slope, but no evident erosion observed. Refer to photographs in Attachment A.

View of standing water, present at the base of the northeastern slope in an area where rutting from truck traffic is evident, facing southeast.
