PERIODIC REVIEW REPORT
REPORTING PERIOD: JANUARY 31, 2022 THROUGH JANUARY 31, 2025

12975 CLARENCE CENTER ROAD
AKRON, NEW YORK
NYSDEC SITE NO. 915053

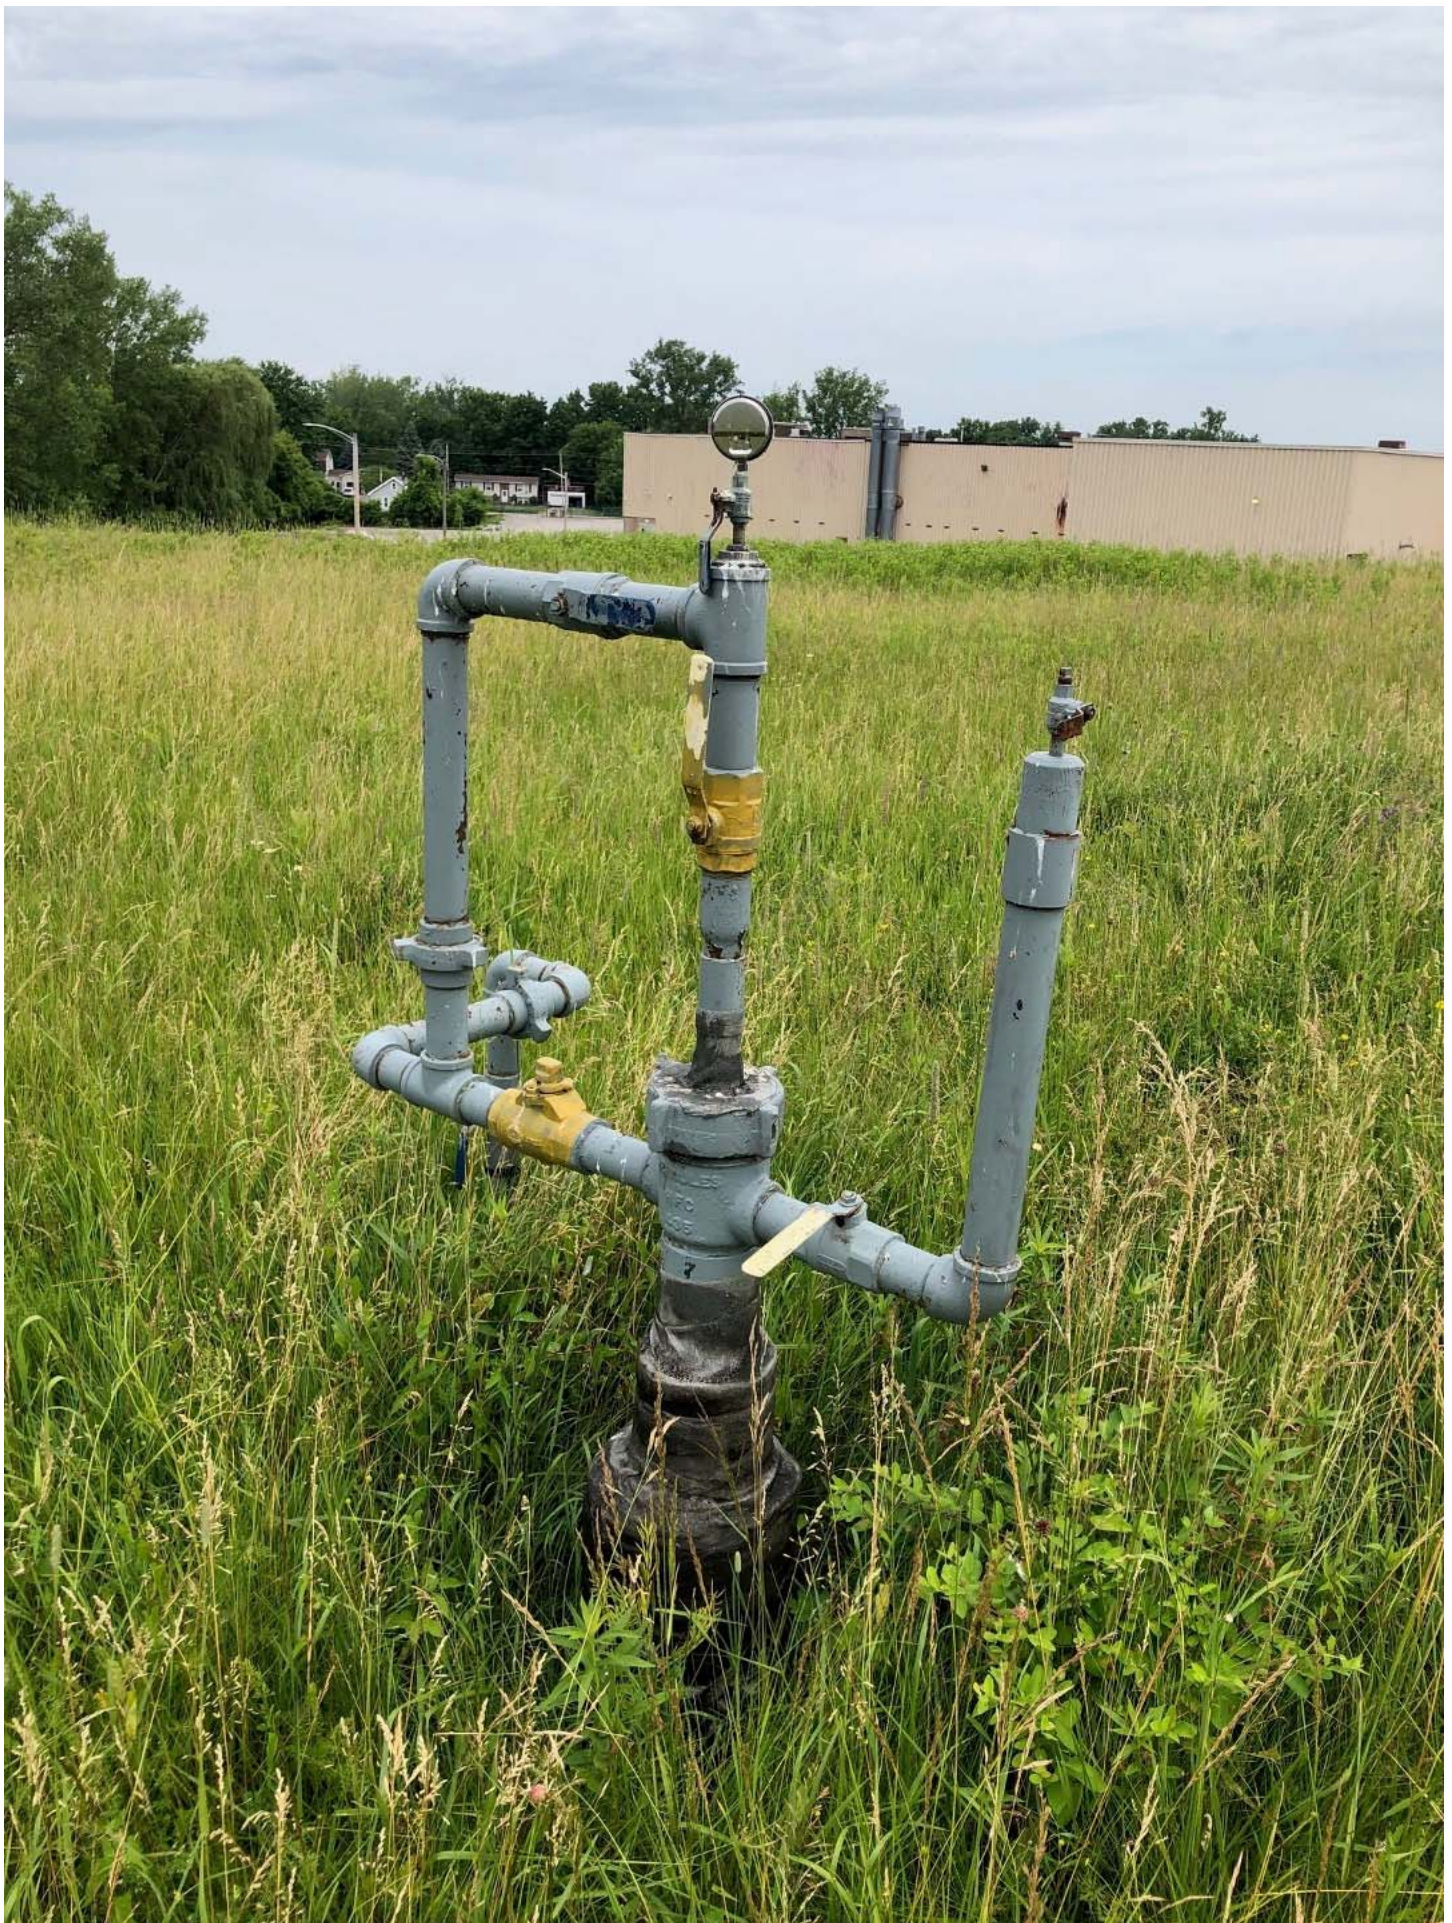
View of the gas well, facing north.

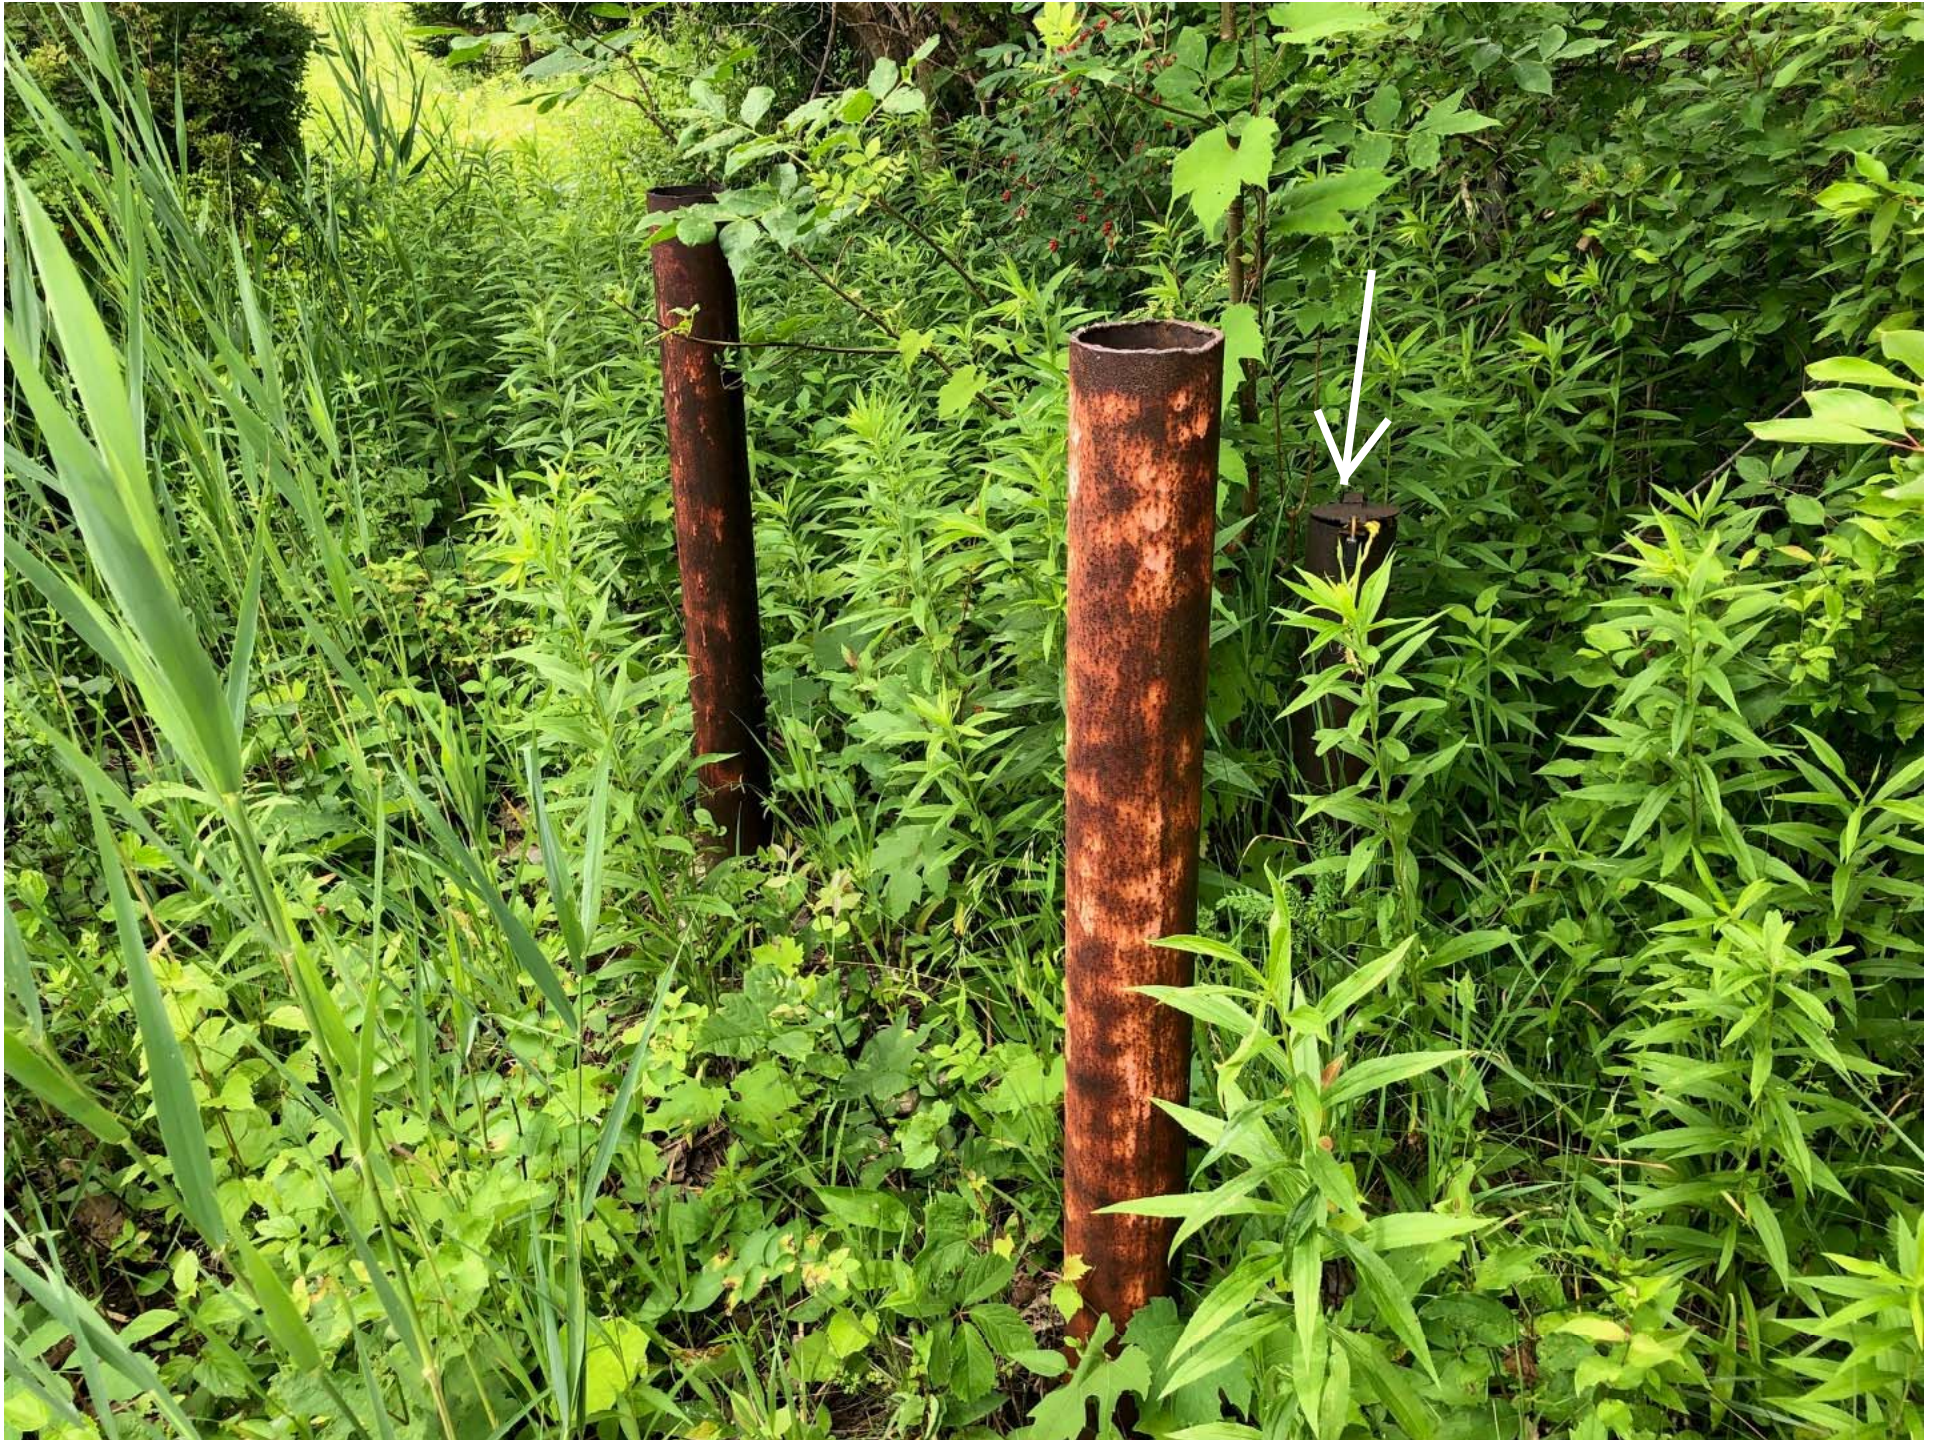
View of the stick-up, steel, protective casing and cover for groundwater monitoring well GW-3 (arrow), and protective bollards, facing southwest.

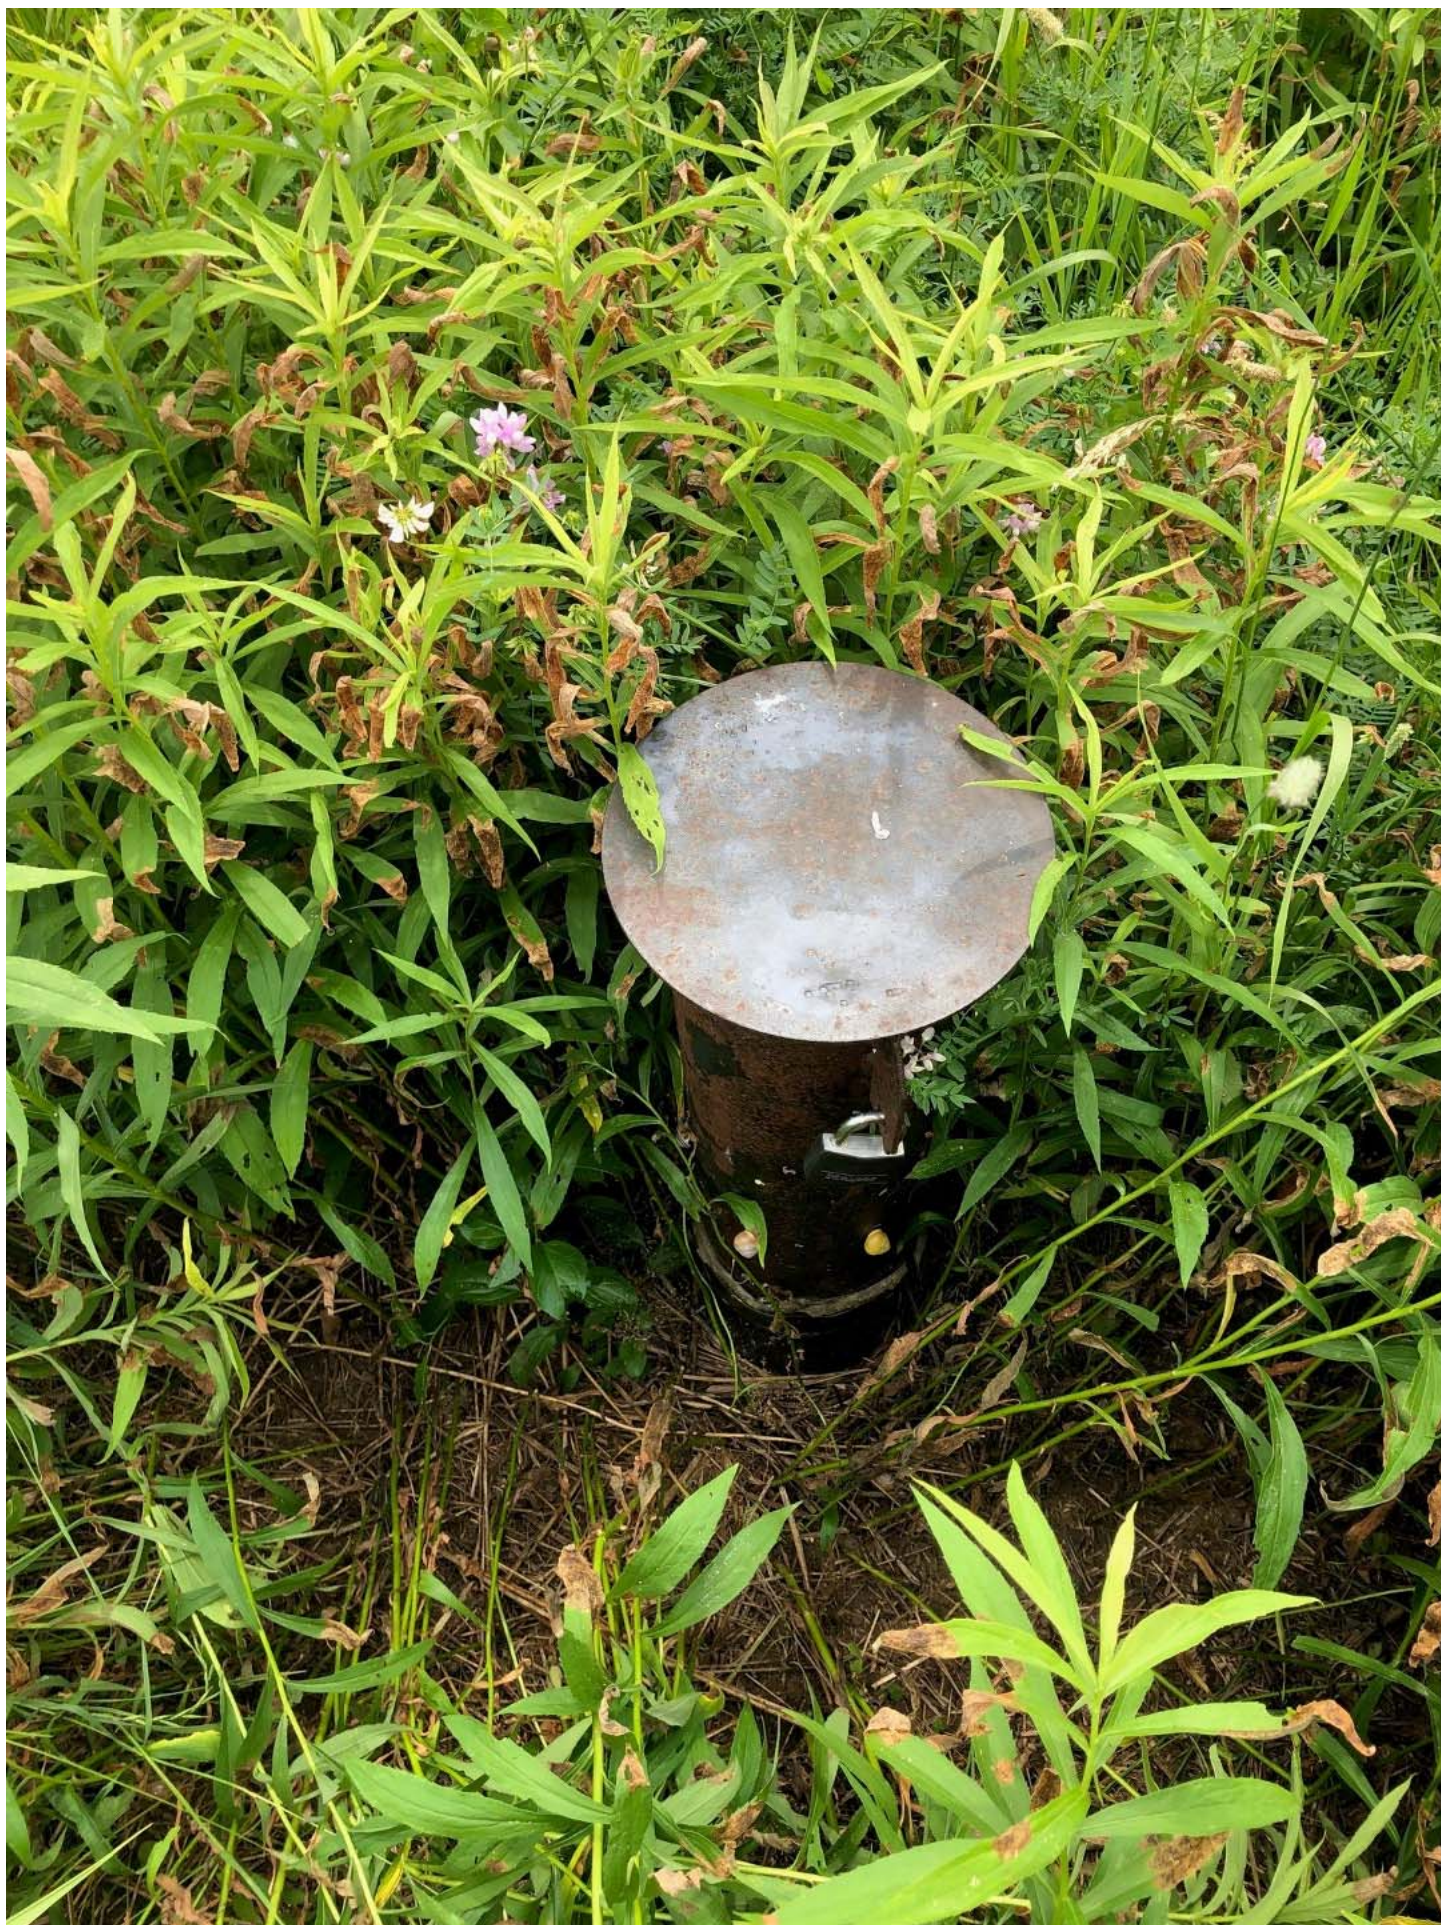
View of the stick-up, steel, protective casing and cover for groundwater monitoring well GW-5.

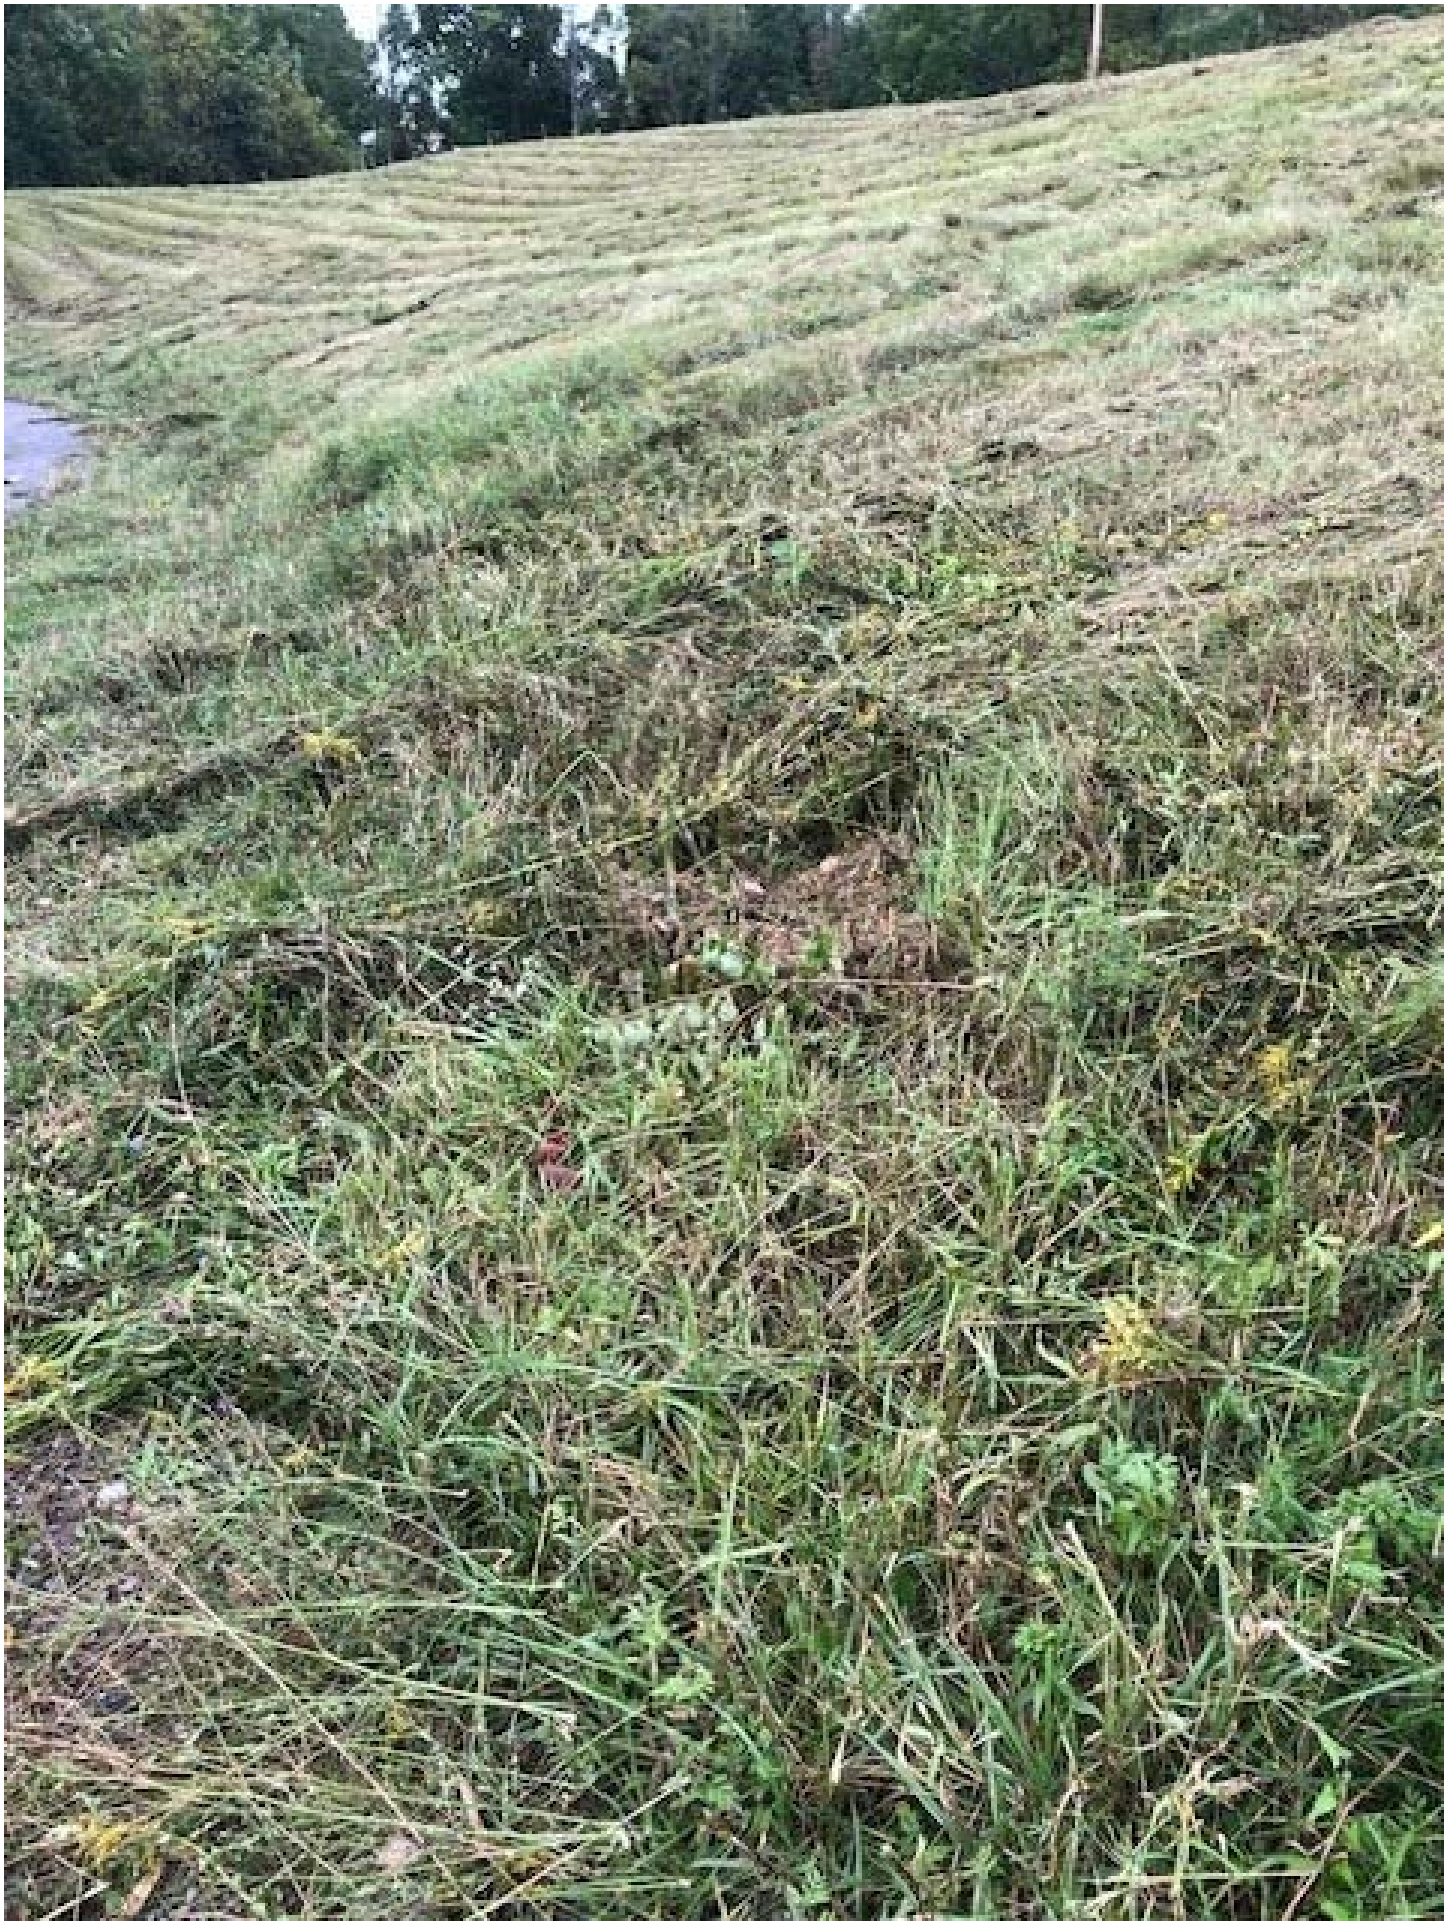
View of the recently cut vegetative cover on the northeast slope of the landfill, facing east.

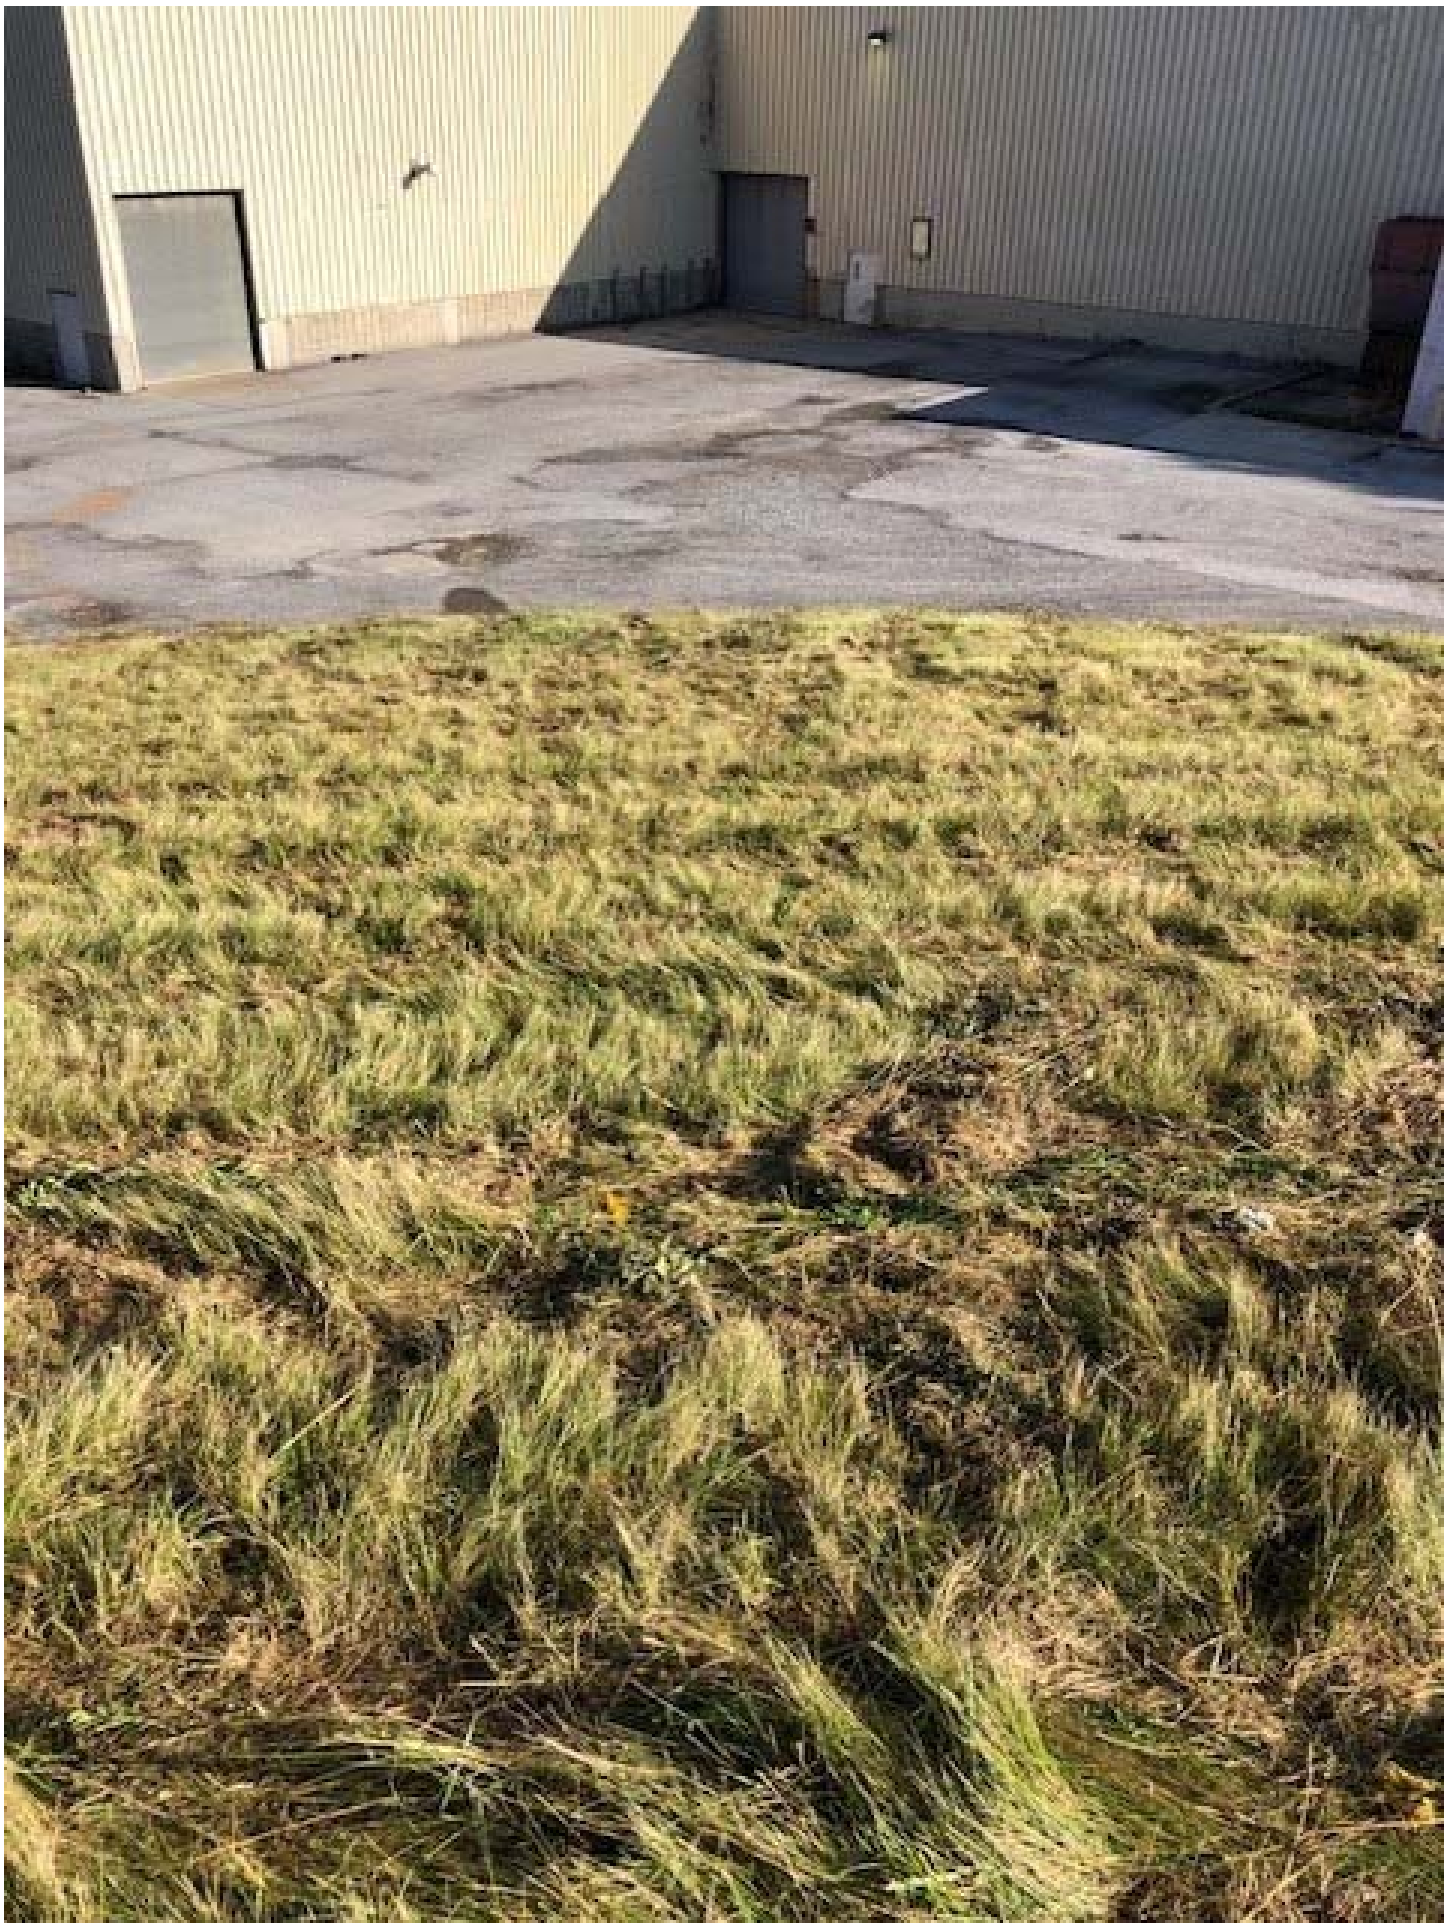
View of the vegetative cover on eastern portion/northern slope of the landfill area, and partial view of the Strippit facility, facing northwest.

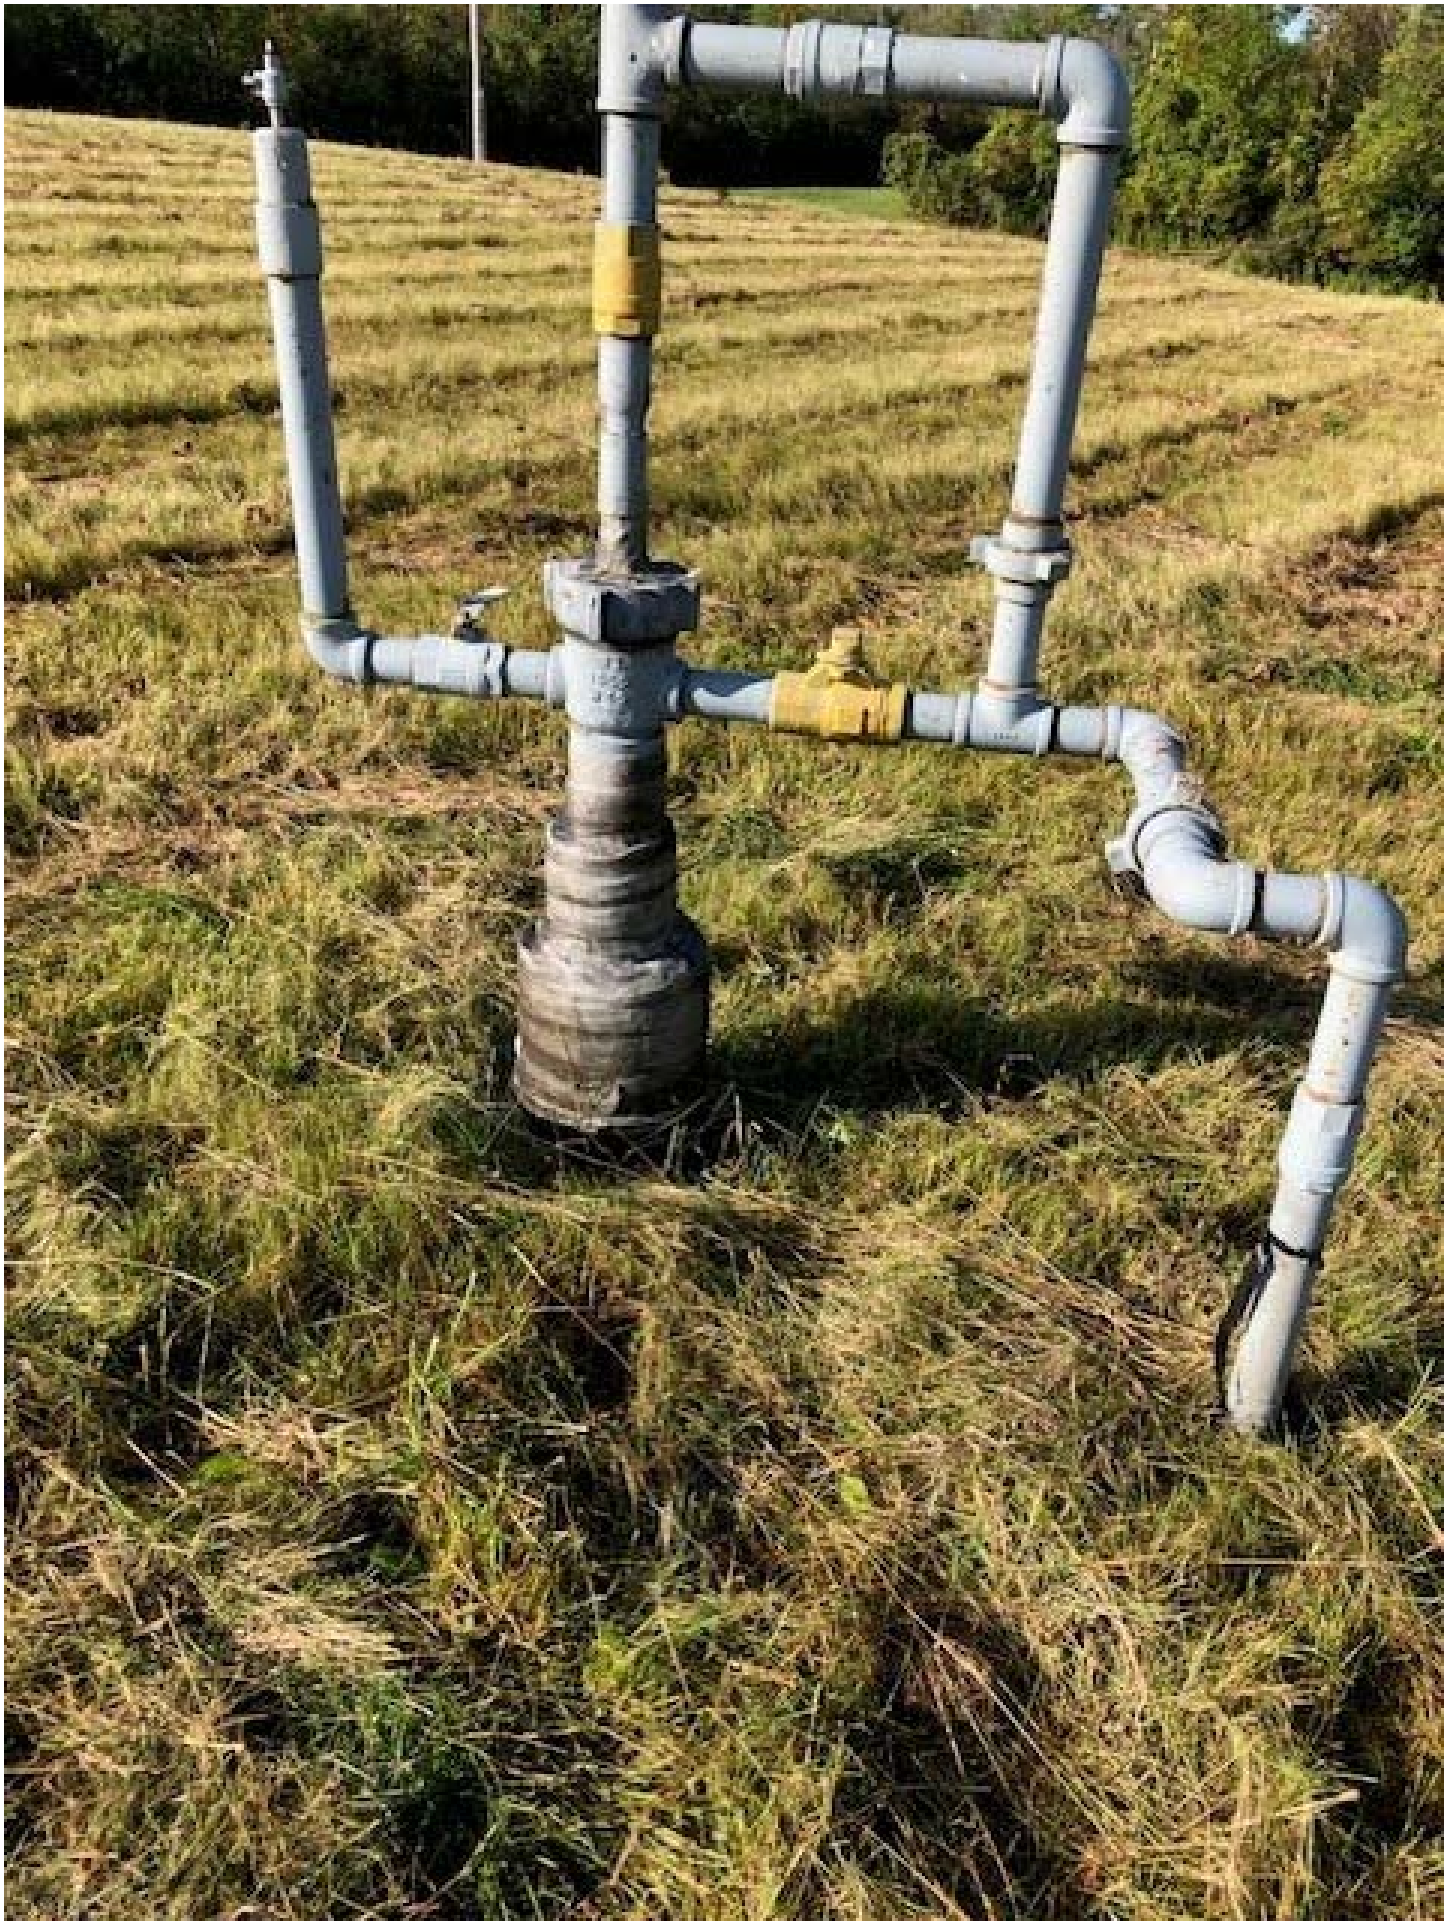
Condition of monitoring wells and gas wells: Abandonment of monitoring wells is being completed (i.e., well have been opened, bailers removed, and tremie grouting is proceeding). Gas well and decanting tank are in good condition.

View of the gas well, facing southwest.

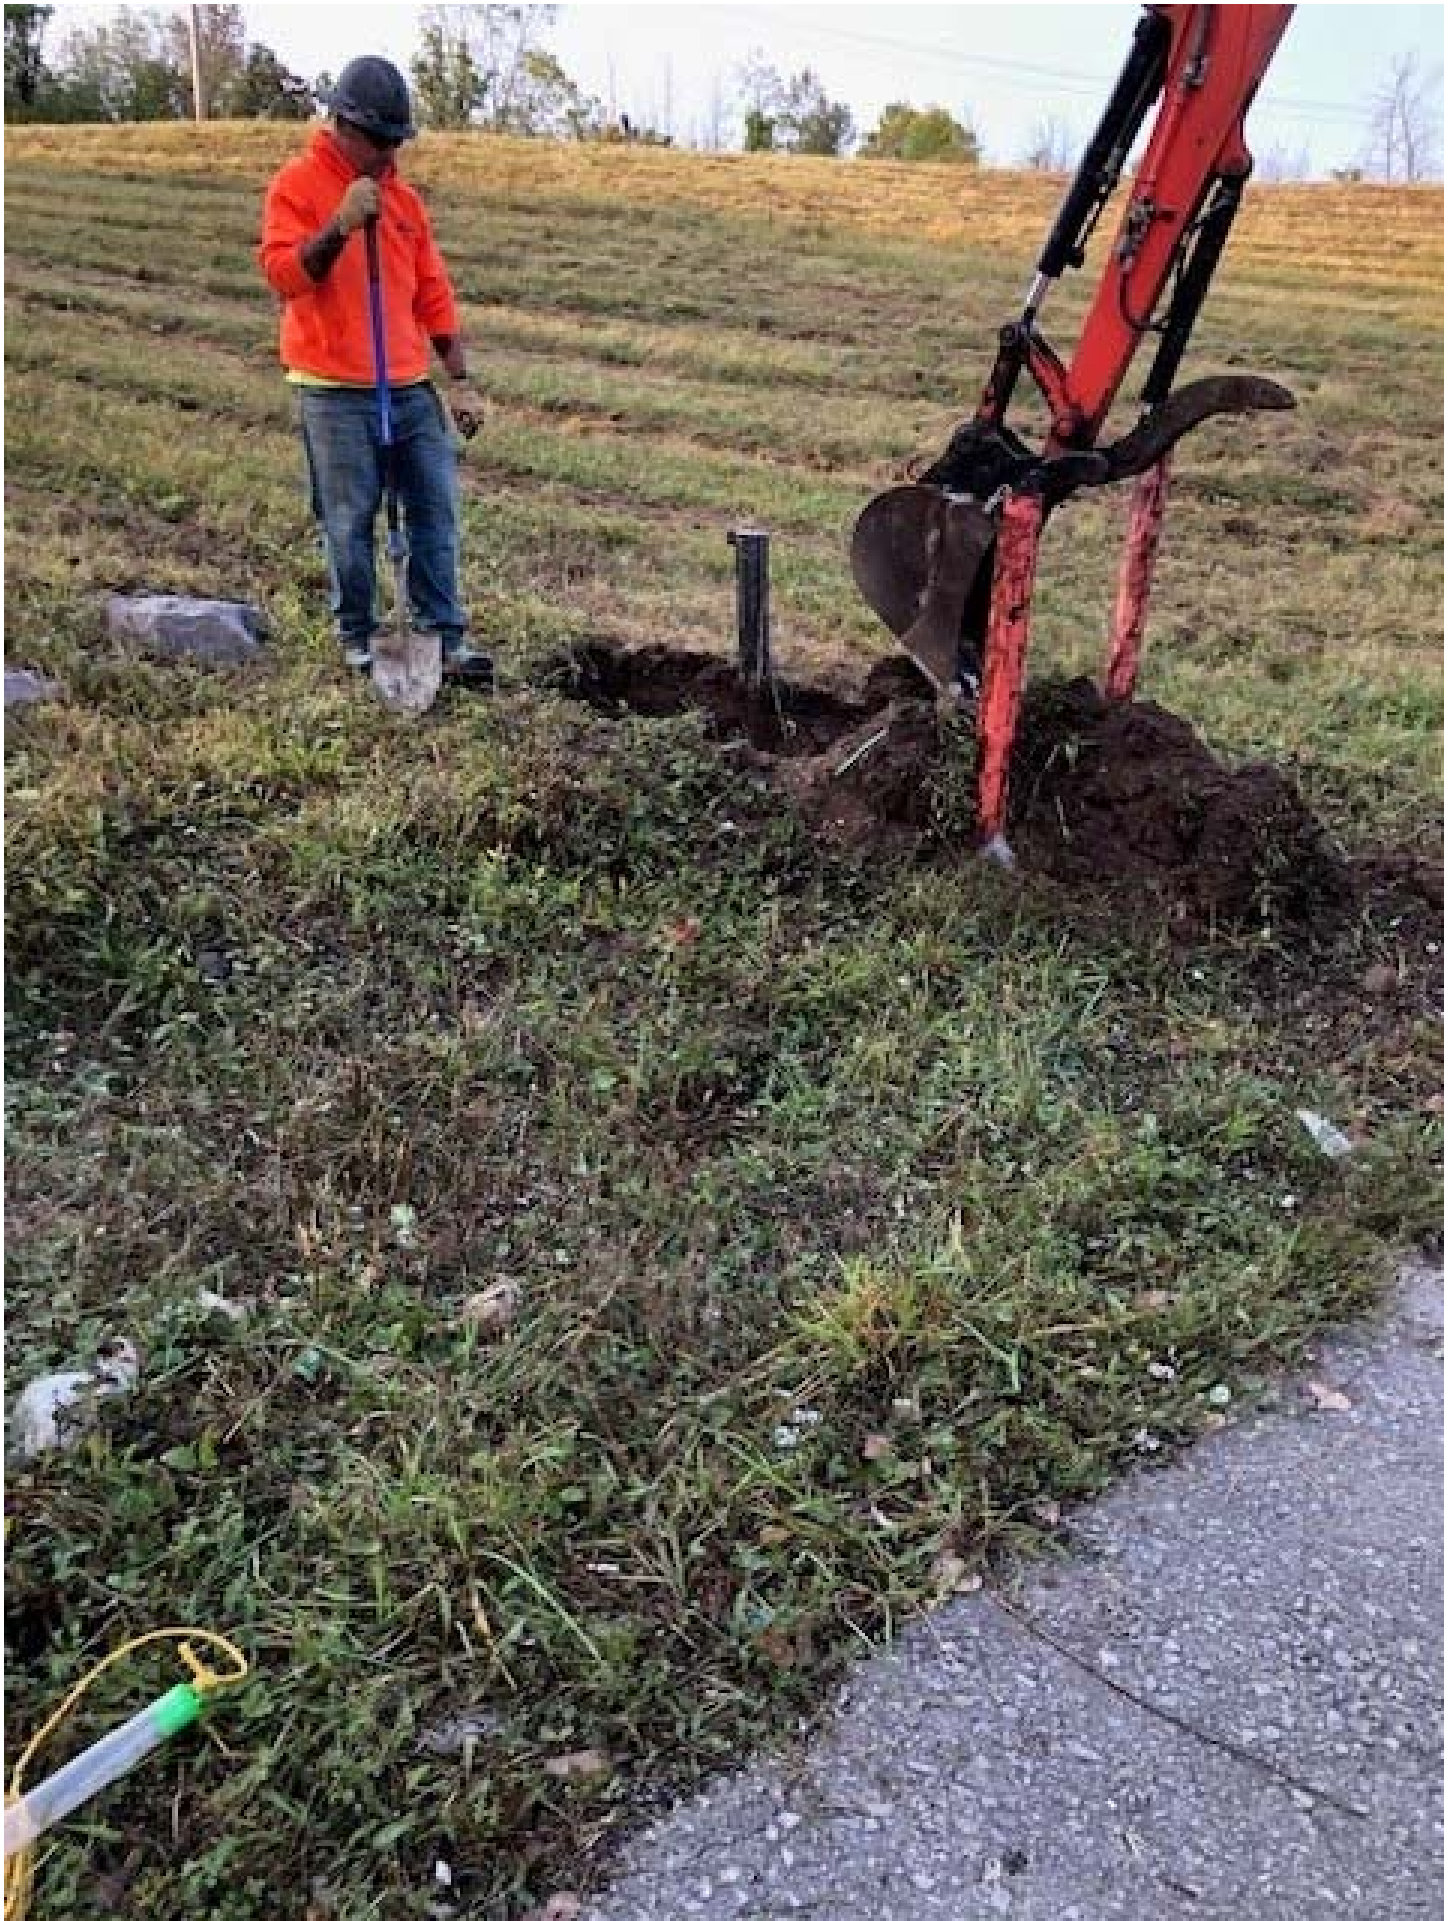
Representative view of monitoring well decommissioning work, completed in conjunction with the semi-annual landfill inspection.

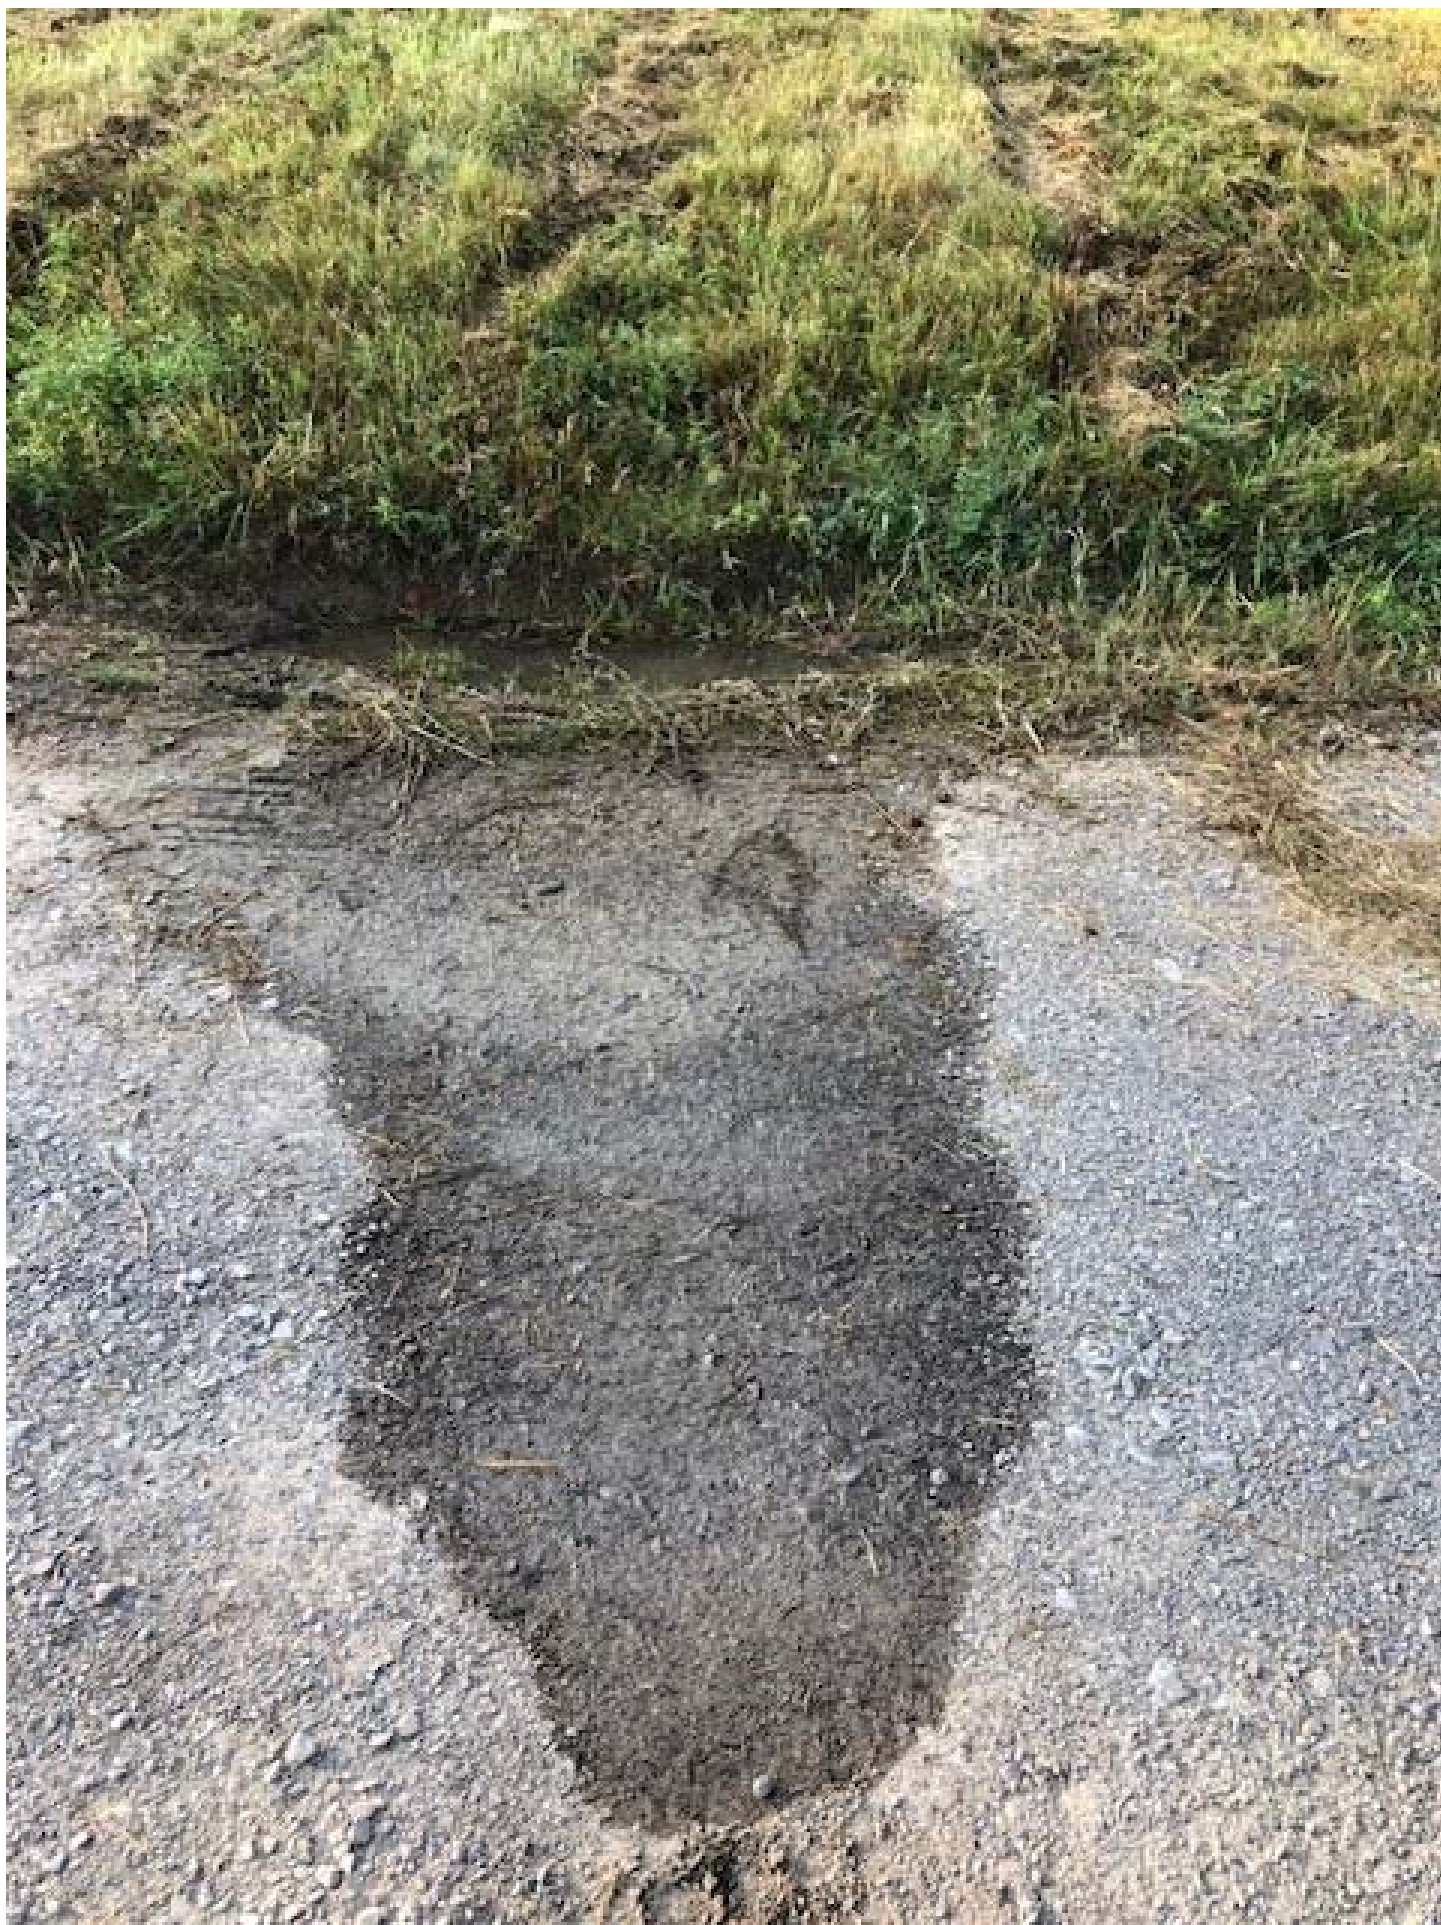
View of standing water present at the base of the northeastern slope of the landfill, facing south.
